# VEHICLE INSPECTION REPORT

**SJ17NKW**

## Iveco Daily 50-150

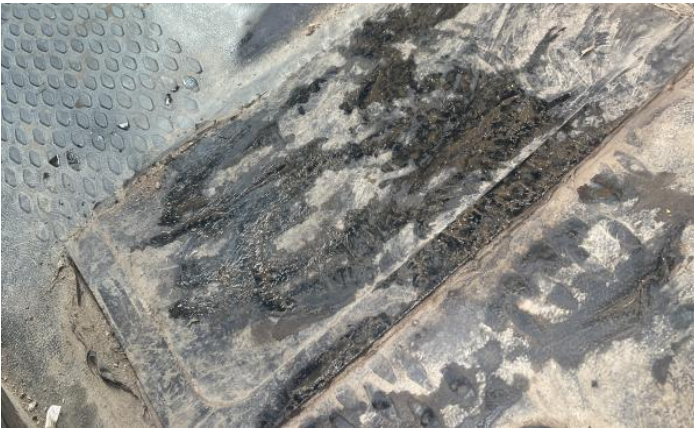
1: Carpets Front  
Torn  
Over 10mm

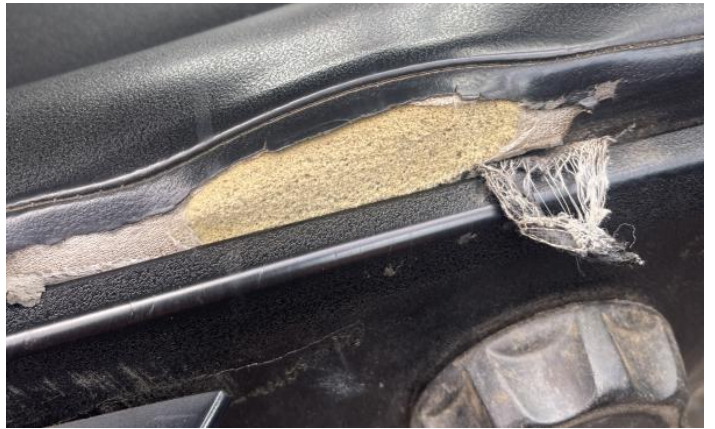
2: Seat Base Cover of  
Torn  
Over 3mm

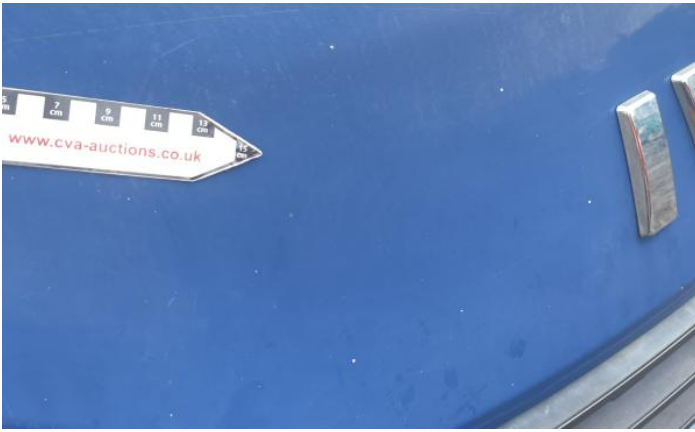
3: Bonnet  
Dented  
Over 30mm

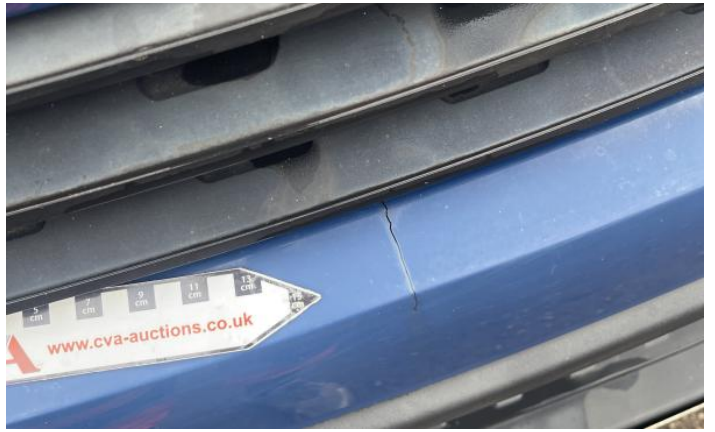
4: Bumper Front Moulding  
Broken  
Replace

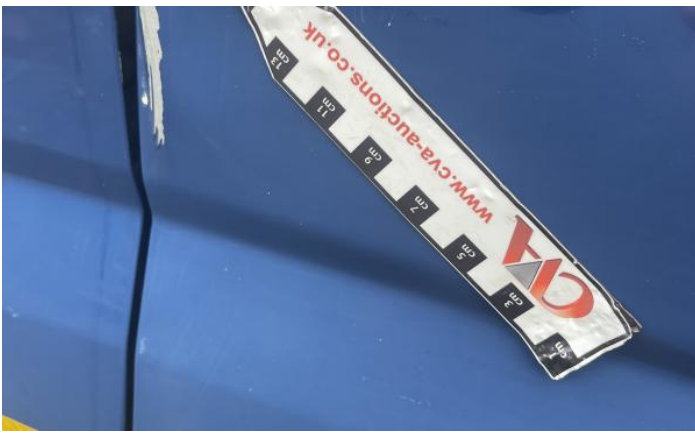
5: Wing osf  
Dented  
With Paint Damage

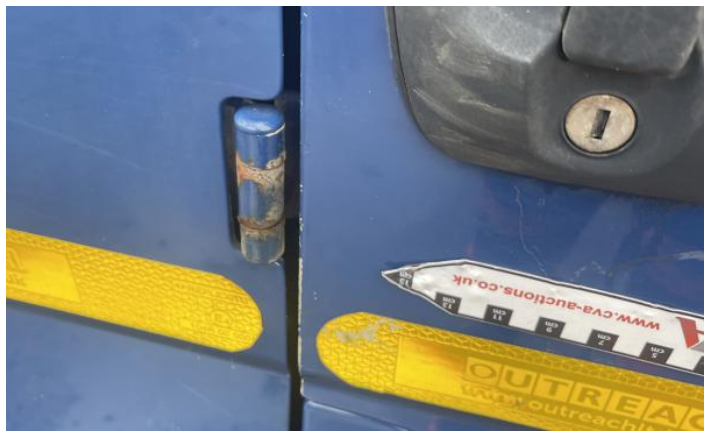
6: Door osf  
Chipped  
Edge Chip

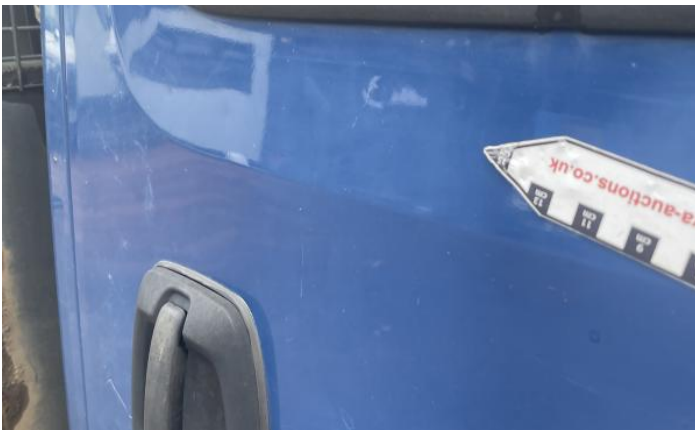
7: Door osr  
Dented  
With Paint Damage

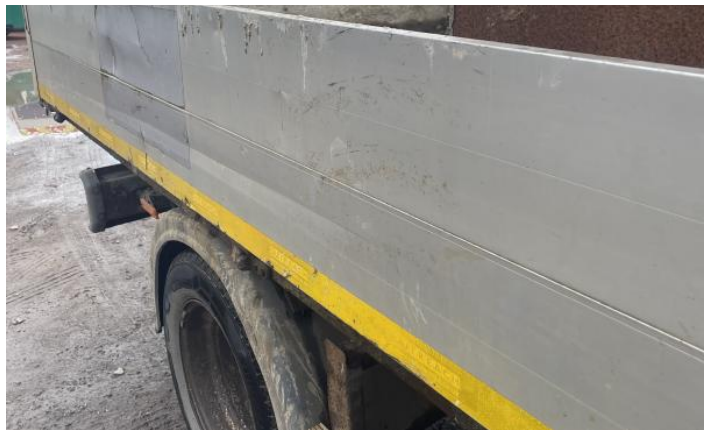
8: Qtr Panel osr  
Dented  
With Paint Damage

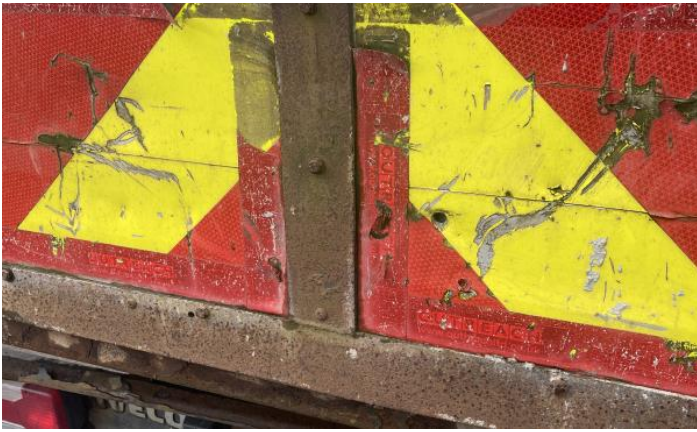
9: Tailgate  
Hole  
UpTo 10mm

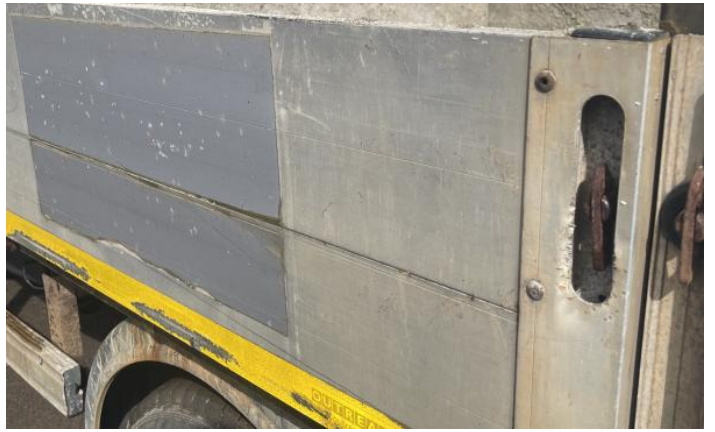
10: Qtr Panel nsr  
Dented  
With Paint Damage

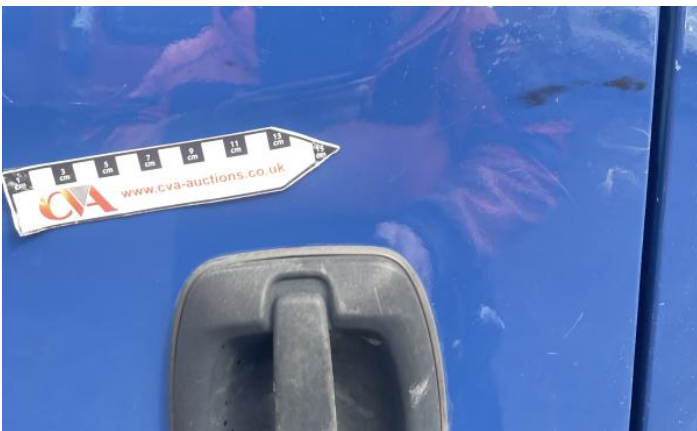
11: Door nsr  
Dented  
With Paint Damage

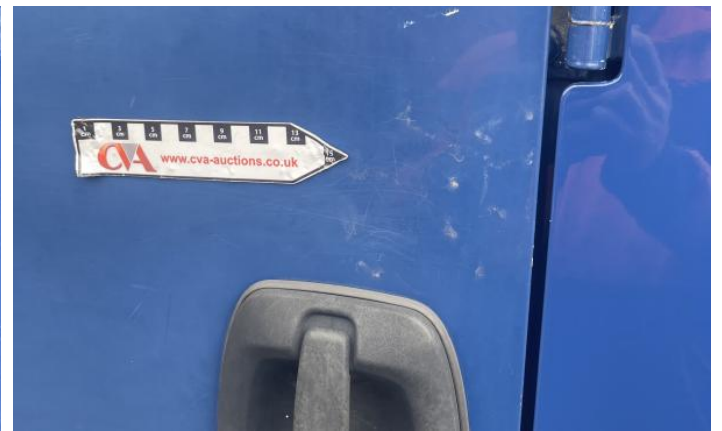
12: Door nsf  
Dented  
With Paint Damage

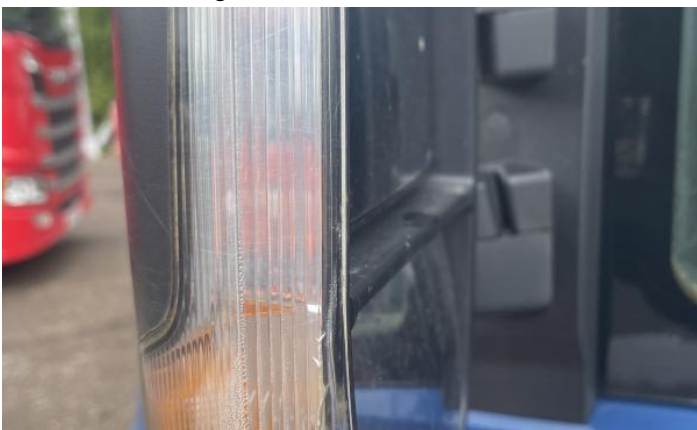
13: Flasher Side Repeater ns  
Broken  
Replace

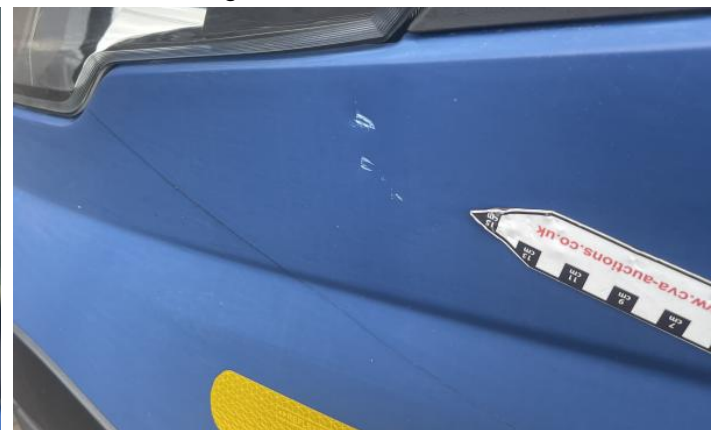
14: Wing nsf  
Dented  
With Paint Damage
