# VEHICLE INSPECTION REPORT

**RV70DCY**

## Iveco Eurocargo 75-160

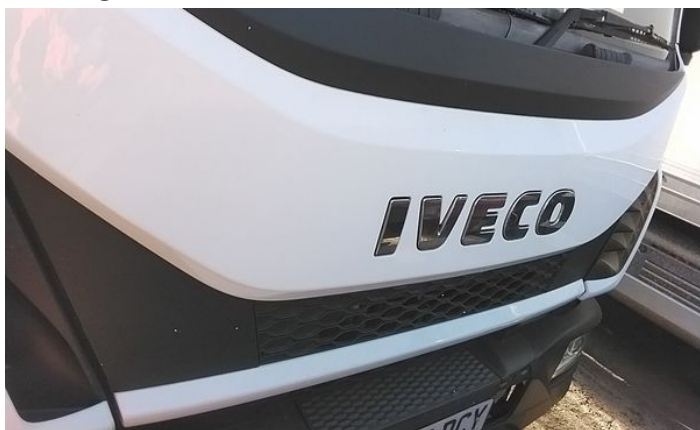
1: Bonnet  
Chipped  
Multiple Chips

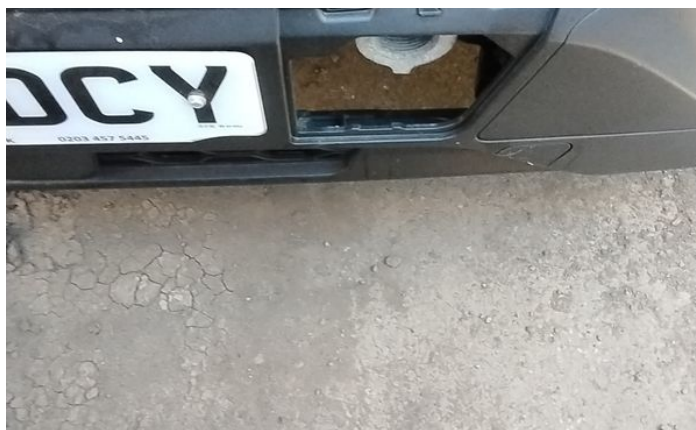
2: Bumper Front Moulding  
Missing  
Replace

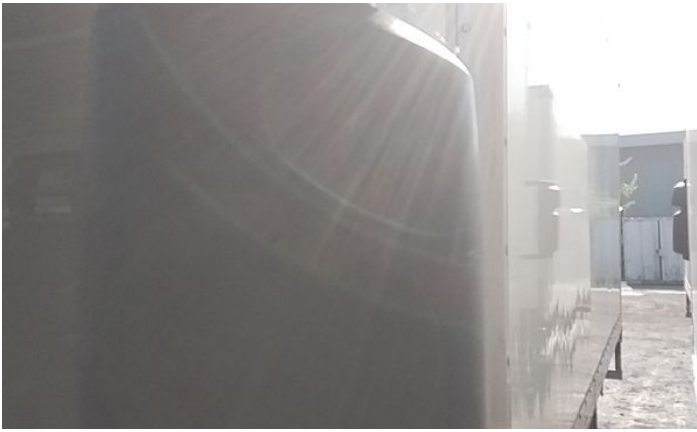
3: Door Mirror Assy nsf  
Scuffed (Unpainted)  
Over 100mm

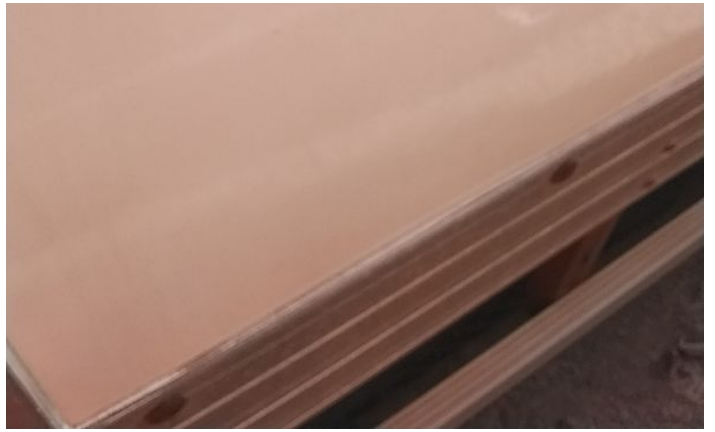
4: Qtr Panel nsr  
Scratched  
Over 25mm Thru Paint

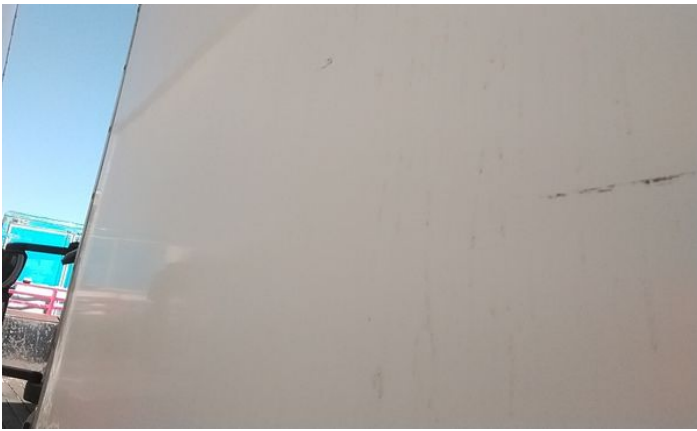
5: Qtr Panel nsr  
Scratched  
Over 25mm Thru Paint

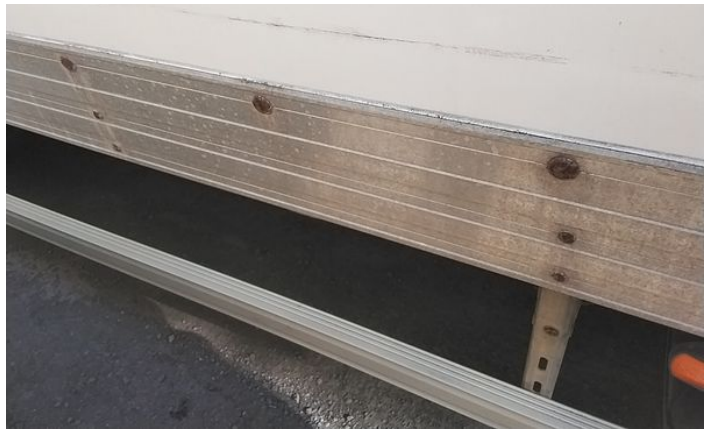
6: Qtr Panel nsr  
Scratched  
Over 25mm Thru Paint

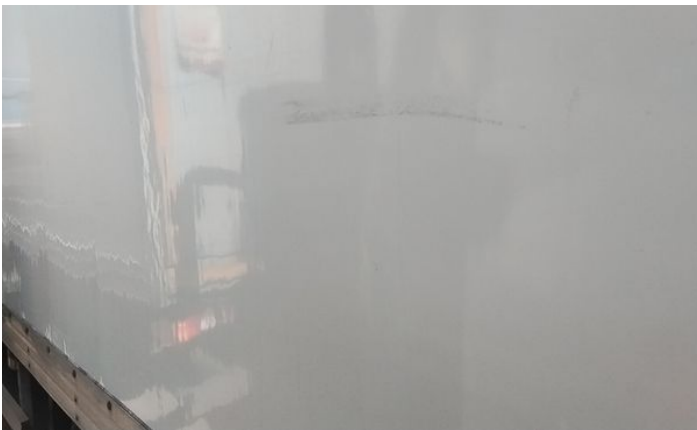
7: Qtr Panel nsr  
Scratched  
Over 25mm Thru Paint

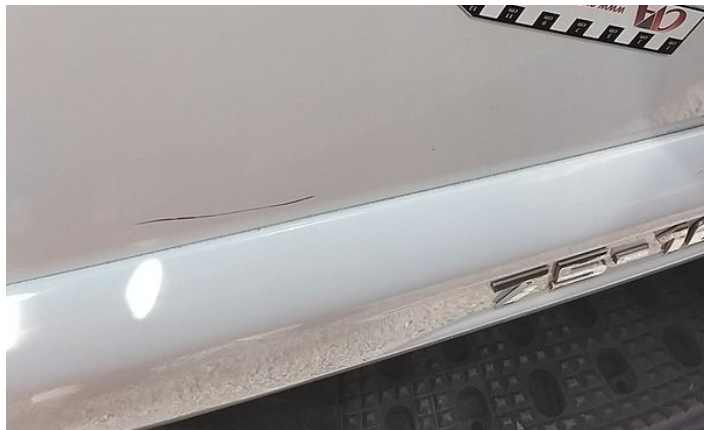
8: Door osf  
Dented  
With Paint Damage

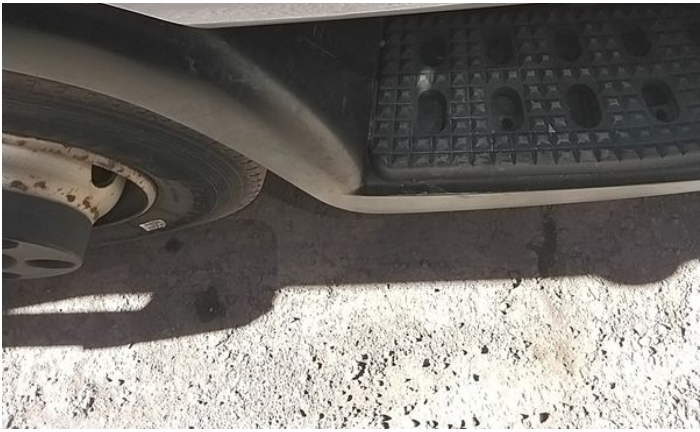
9: Door osf  
 Scratched  
 Over 25mm Thru Paint

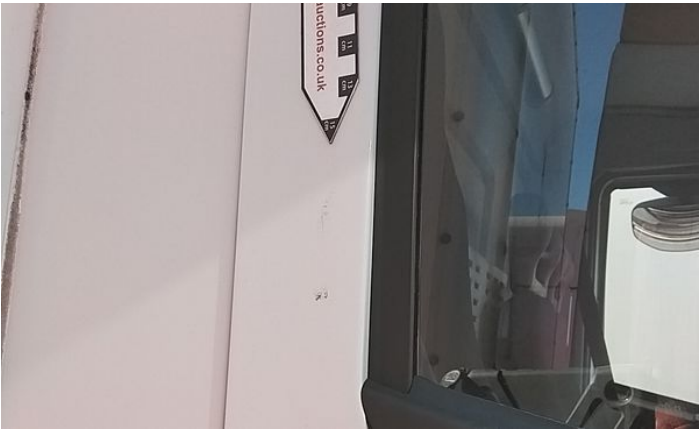
10: Door osf  
 Scratched  
 Over 25mm Thru Paint
