VEHICLE INSPECTION REPORT

DG16DVY

Man TGS 26.360

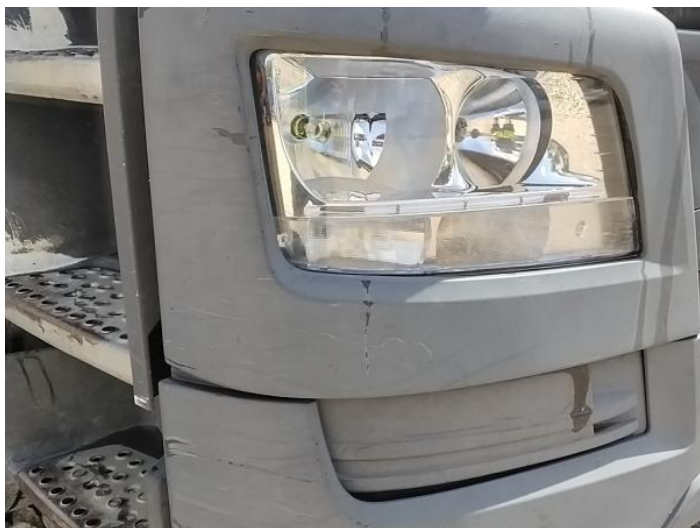
1: Bumper Front
Scratched
Over 25mm Not Thru Paint

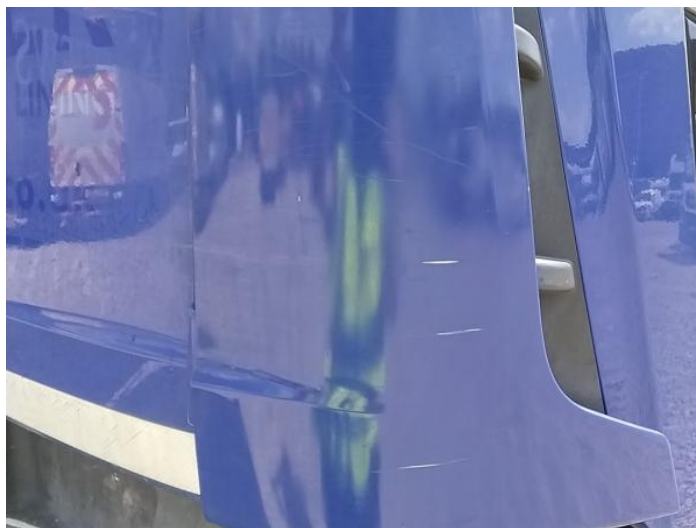
2: Moulding of Wing
Scratched (Painted)
Over 25mm Thru Paint

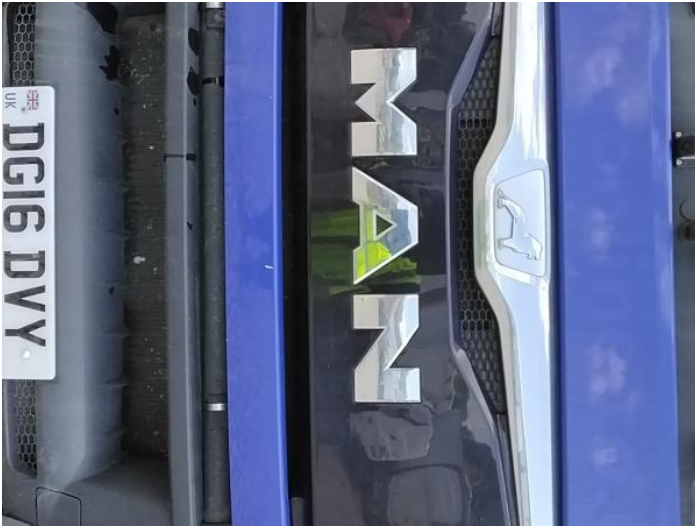
3: Bonnet
Scratched
UpTo 25mm Thru Paint

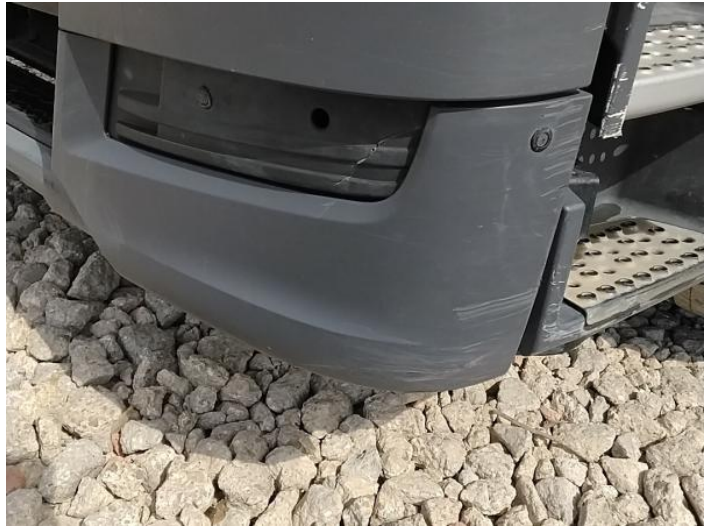
4: Bumper Front
Scratched
Over 25mm Not Thru Paint

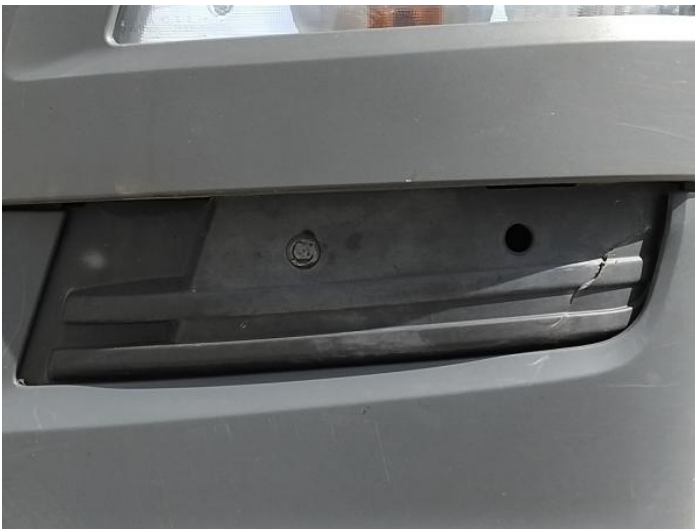
5: Moulding nsf Wing
Broken
Replace

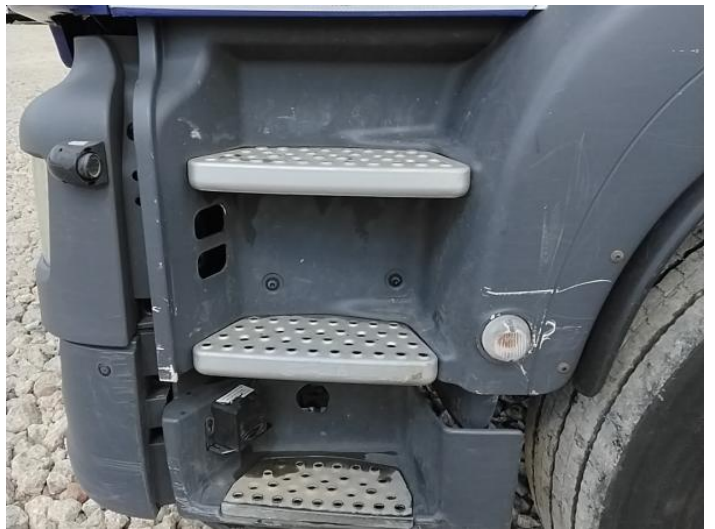
6: General Exterior
Soiled
Light

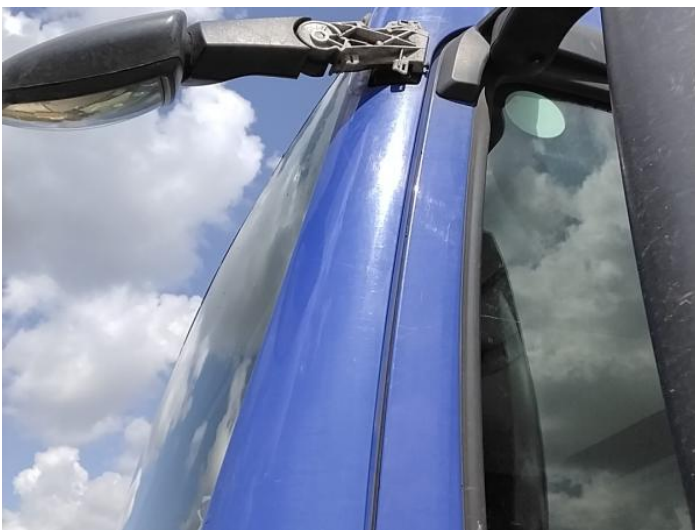
7: Door Mirror Assy nsf
Missing
Replace

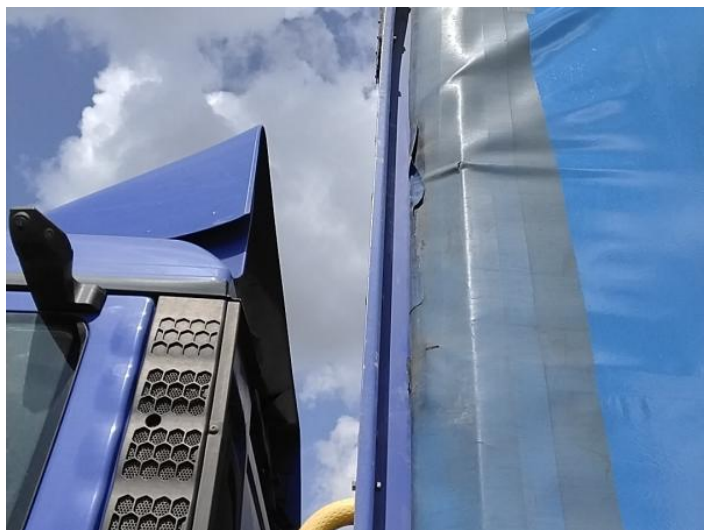
8: General Exterior
Soiled
Light

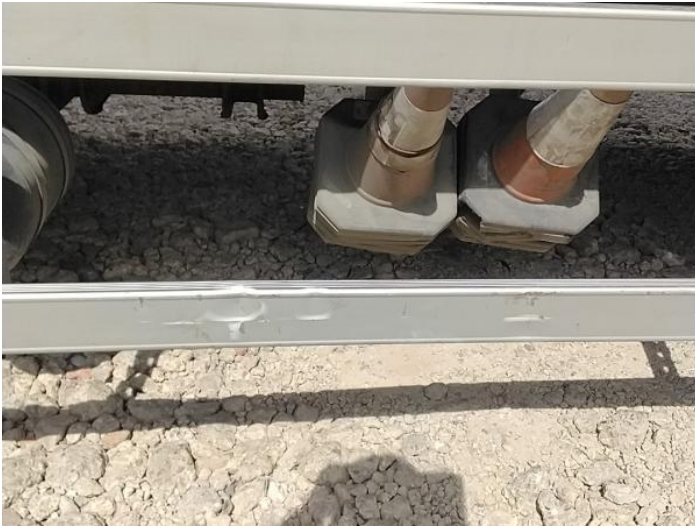
9: General Exterior
Soiled
Light

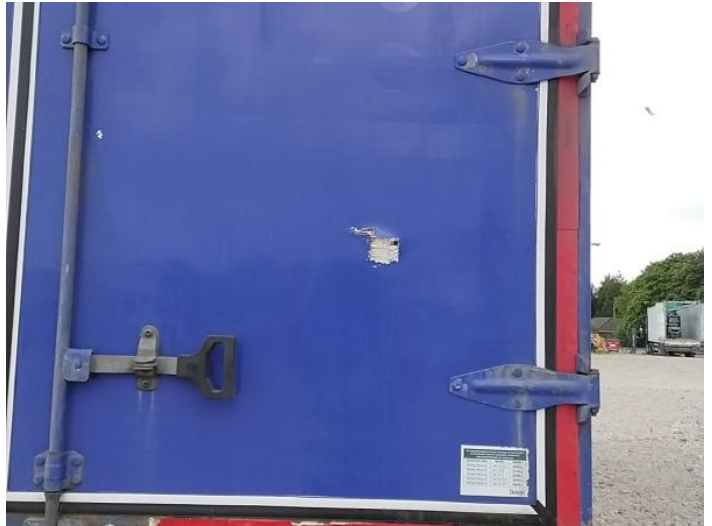
10: Door osr
Hole
Over 10mm

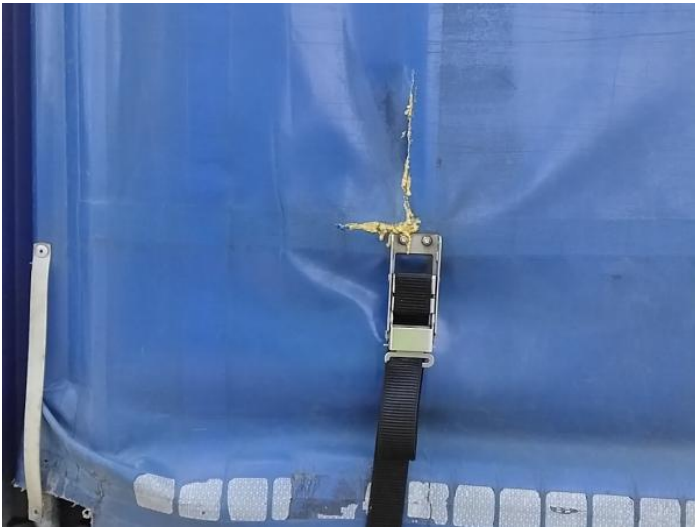
11: General Exterior
Soiled
Light

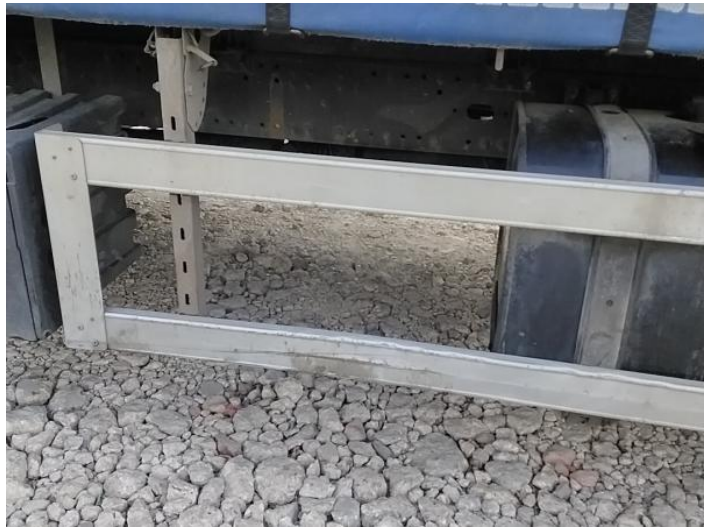
12: General Exterior
Soiled
Light

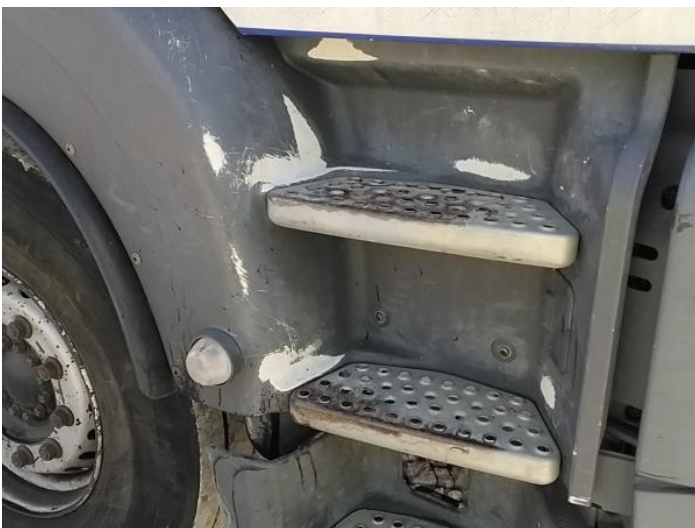
13: General Exterior
Soiled
Light

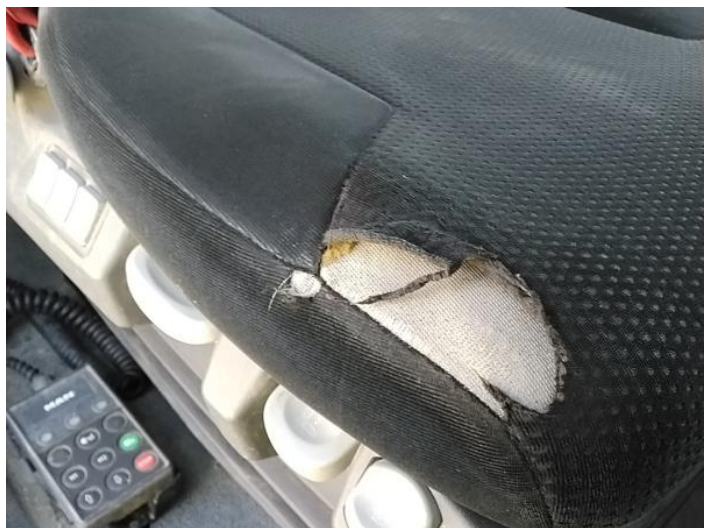
14: Seat Base Cover osf
Holed
Over 3mm
