VEHICLE INSPECTION REPORT

S14FGT

DAF XD 450

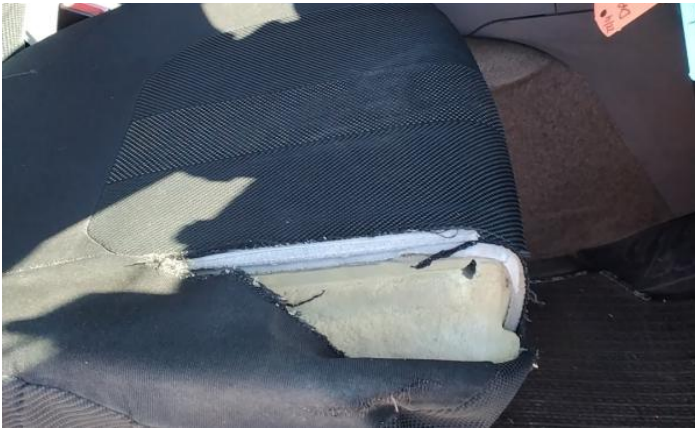
1: Seat Base Cover of
Holed
Over 3mm

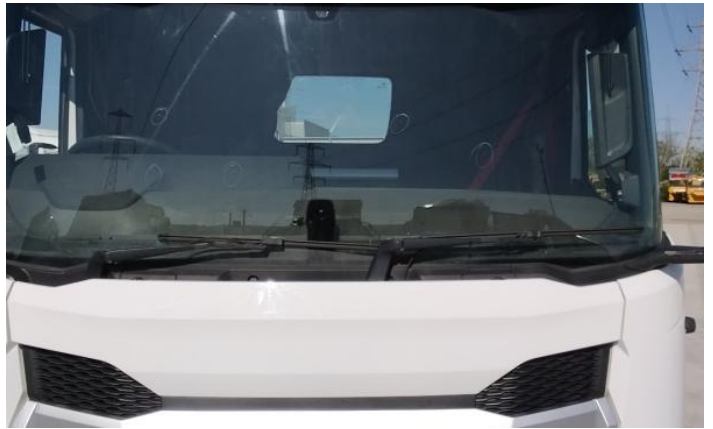
2: Screen Front
Chipped
Over 10mm

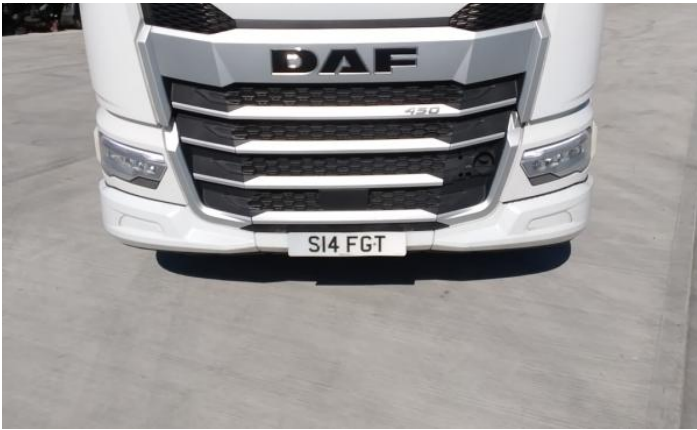
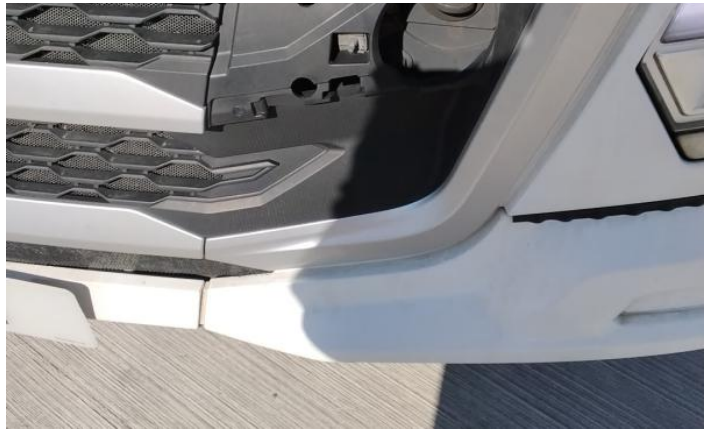
3: Bonnet
Chipped
Multiple Chips

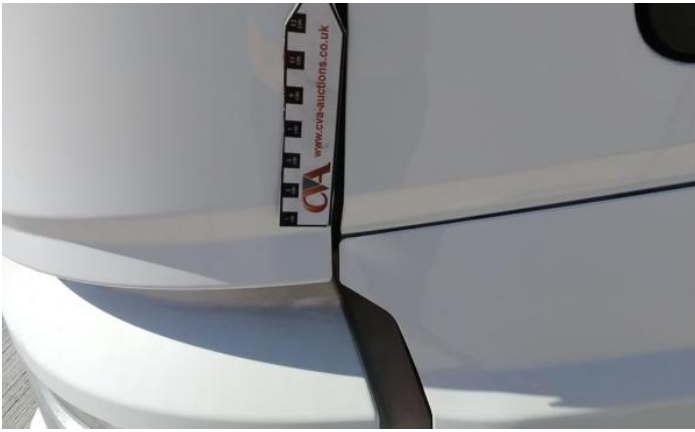
9: Wing nsf
Scratched
UpTo 25mm Not Thru Paint

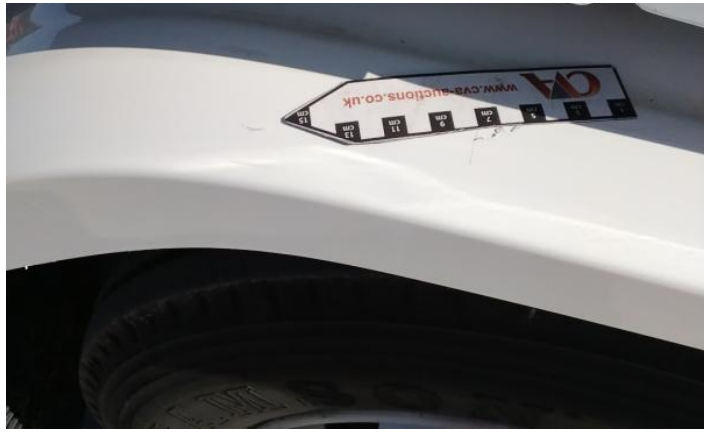
10: Wing Front Arch Extension os
Scratched (Painted)
UpTo 25mm Thru Paint

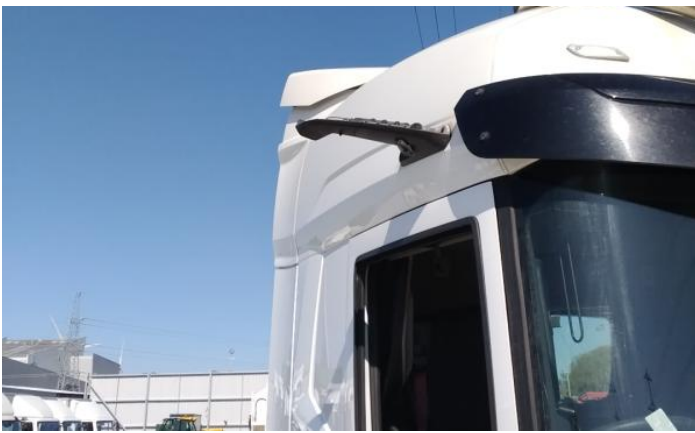
11: Door Mirror Assy osf
Broken
Replace

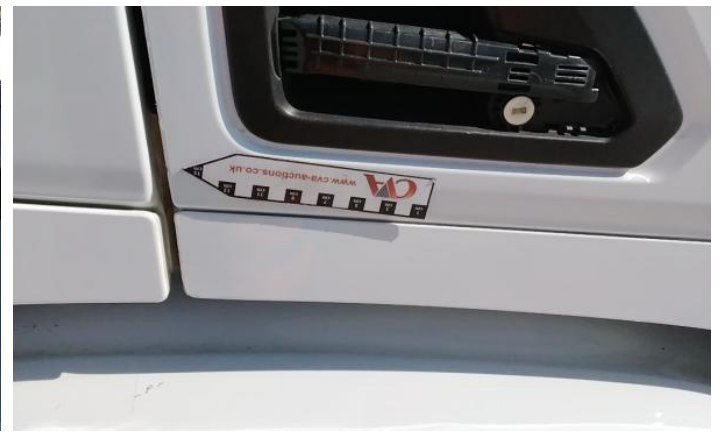
12: Door osf
Chipped
Multiple Chips

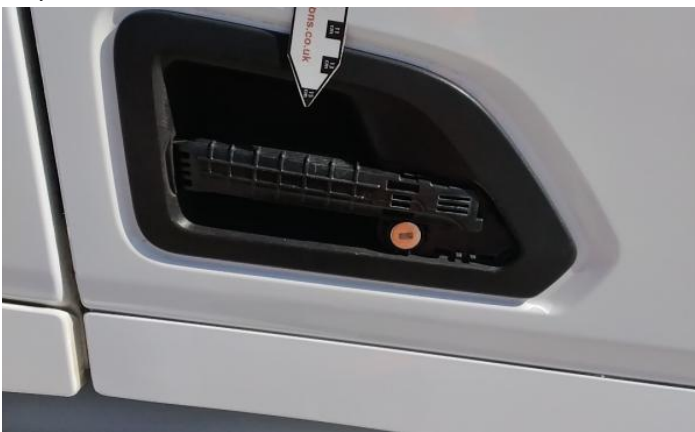
13: Handle Outer osf
Missing
Replace

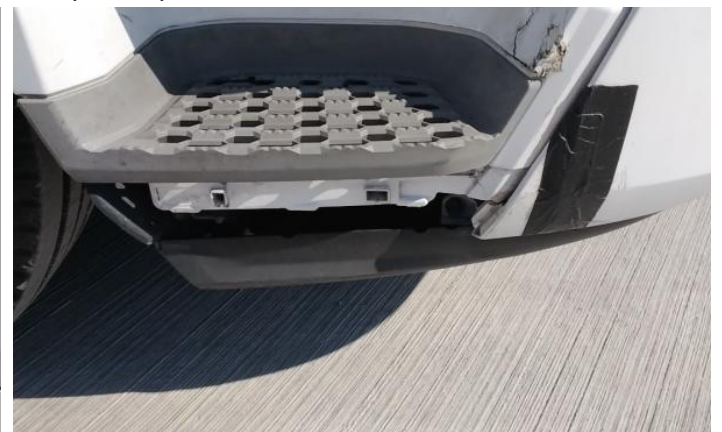
14: Wing osf
Cracked
Replace

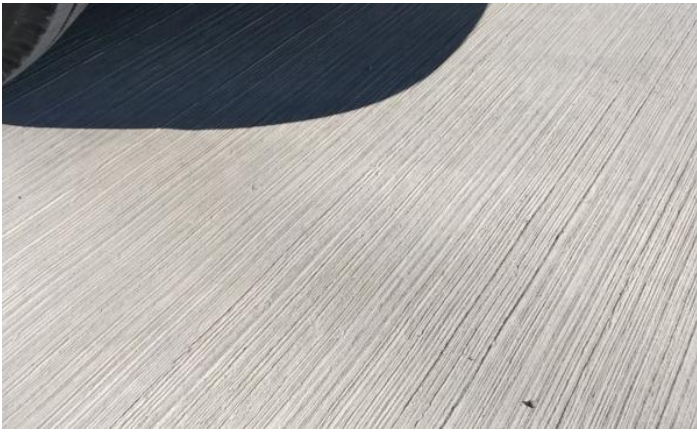
15: Wing Front Arch Extension os
Missing
Replace
