VEHICLE INSPECTION REPORT

PJ20PPU

Mercedes-Benz Sprinter 314 CDI

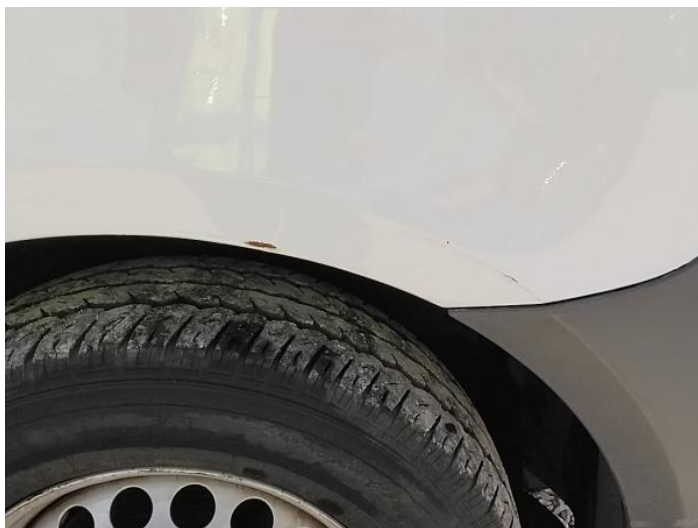
1: Wing osf
Rusted
Over 5mm

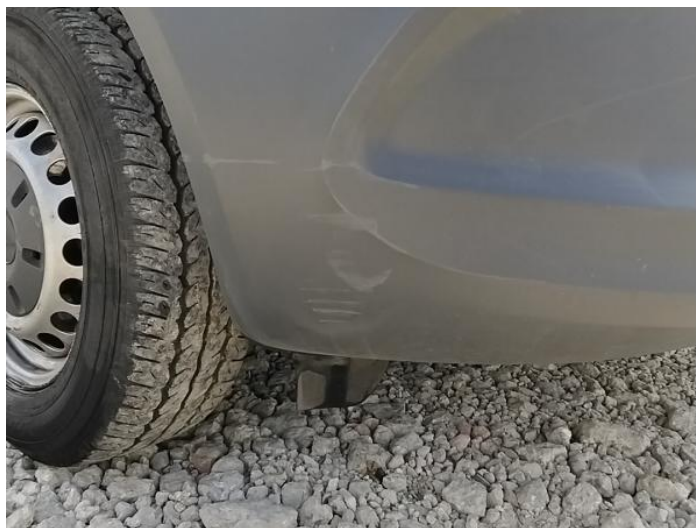
2: Bumper Front
Scratched
Over 25mm Not Thru Paint

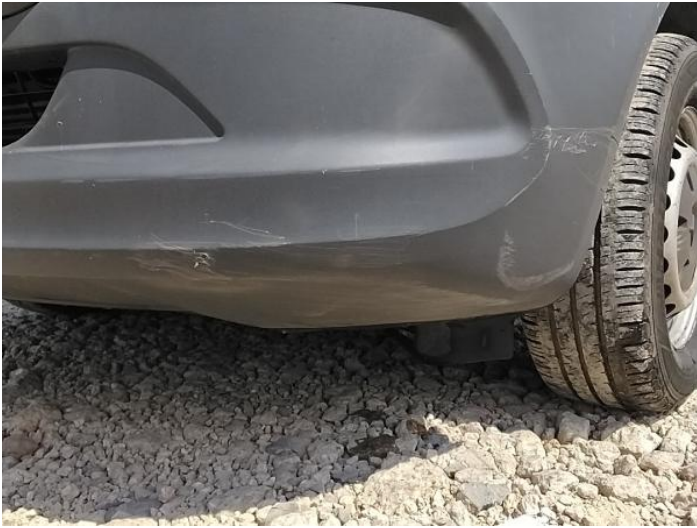
3: Bumper Front
Scratched
Over 25mm Not Thru Paint

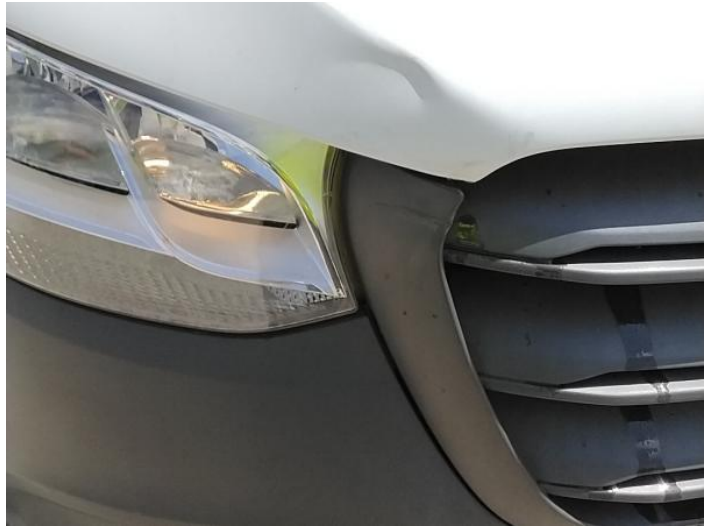
4: Bonnet
Dented
Over 30mm

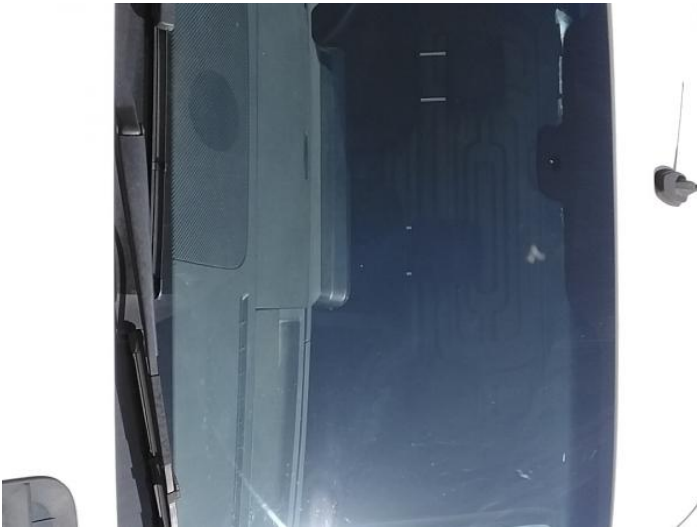
5: Screen Front
Chipped
UpTo 10mm

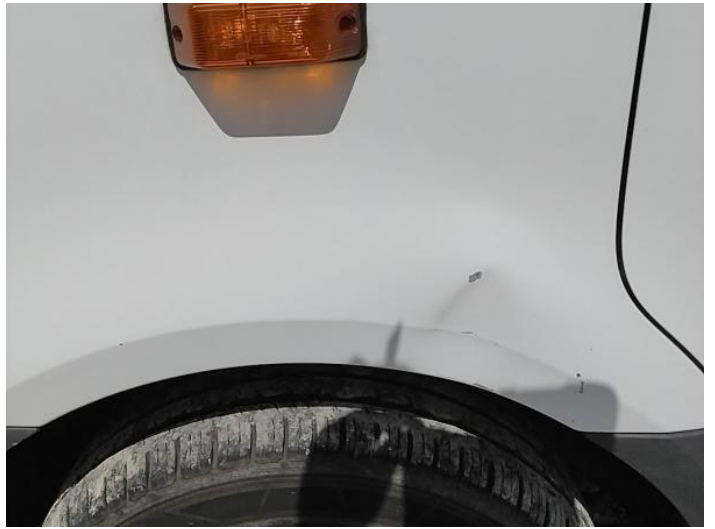
6: Wing nsf
Dented
With Paint Damage

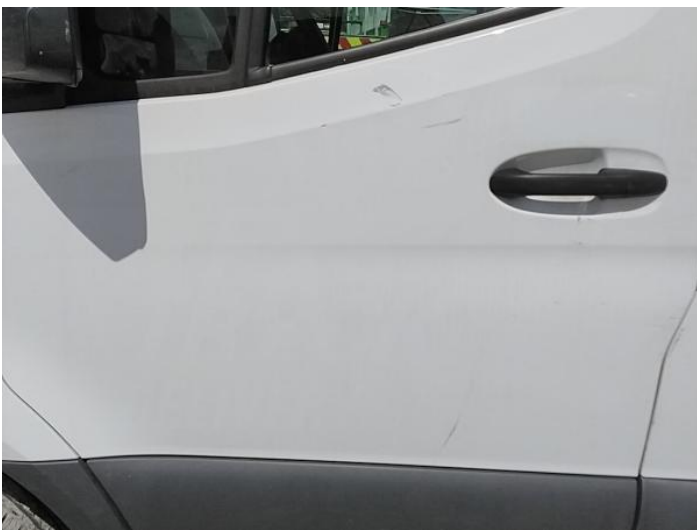
7: Door nsf
Scratched
Over 25mm Thru Paint

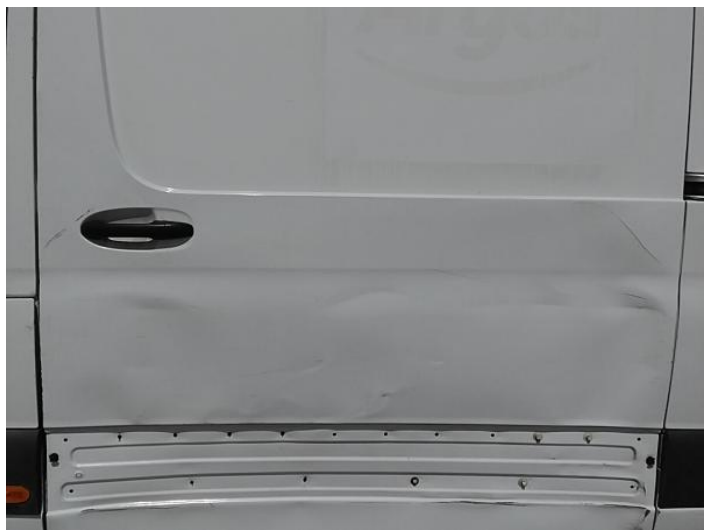
8: Door nsr
Dented
Over 30% Of Panel

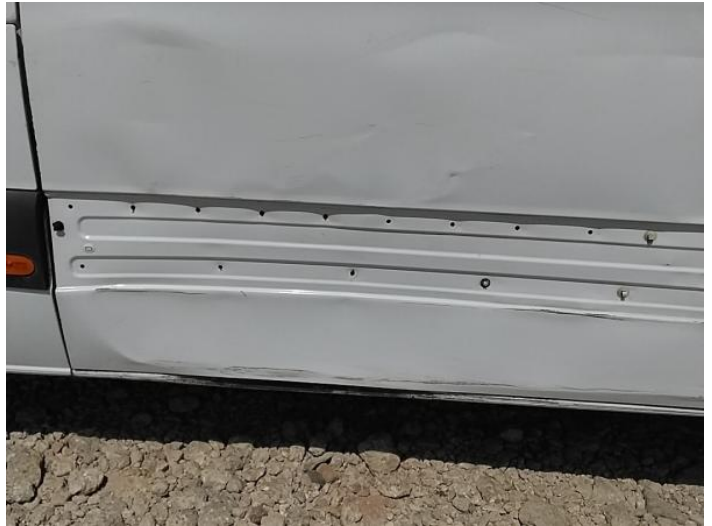
10: Door Moulding nsr
Missing
Replace

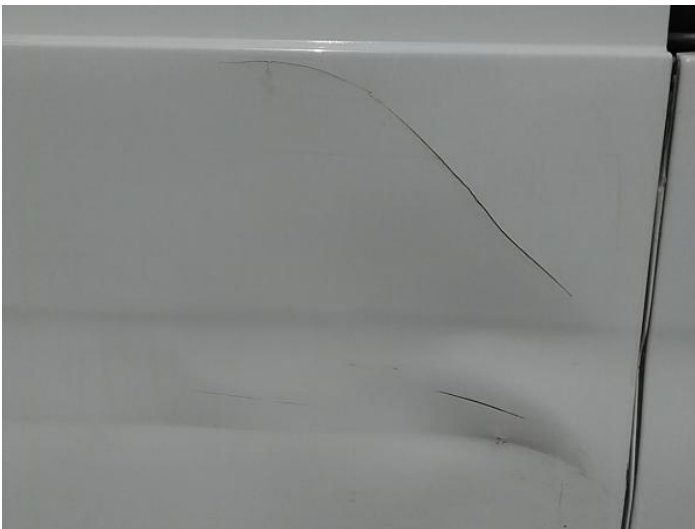
11: Door nsr
Cracked
Replace

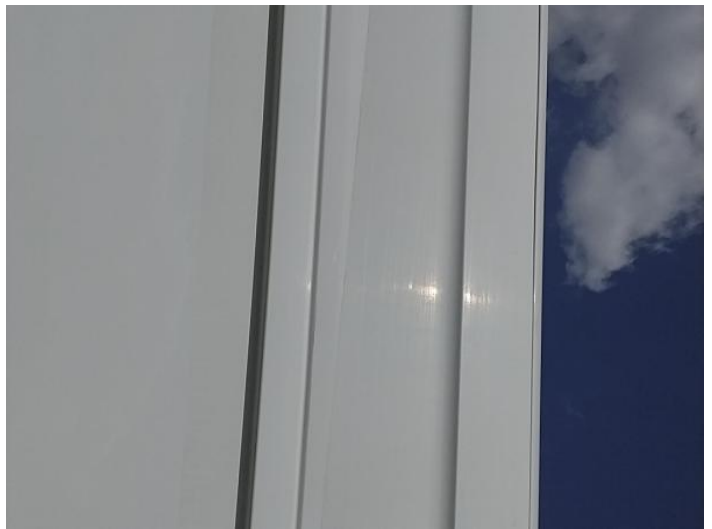
12: Door nsr
Dented
With Paint Damage

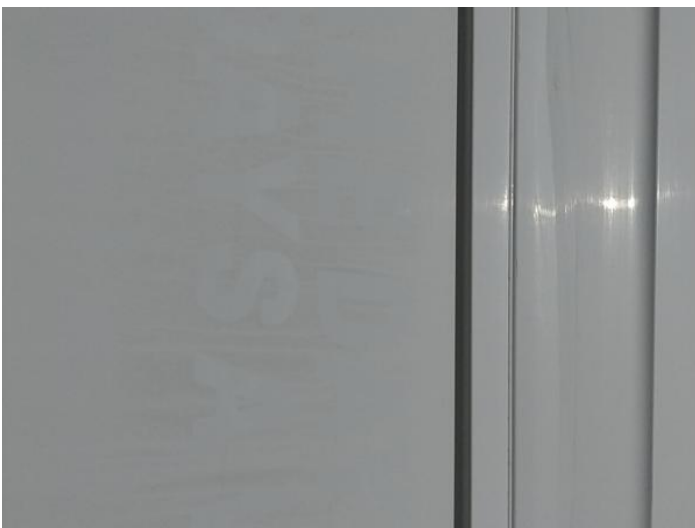
13: Qtr Panel nsr
Dented
Over 30mm

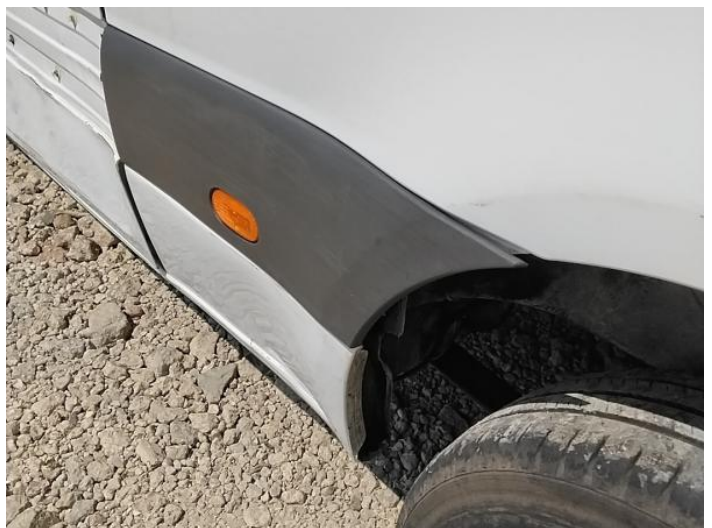
14: Qtr Panel Trim ns
Broken
Replace

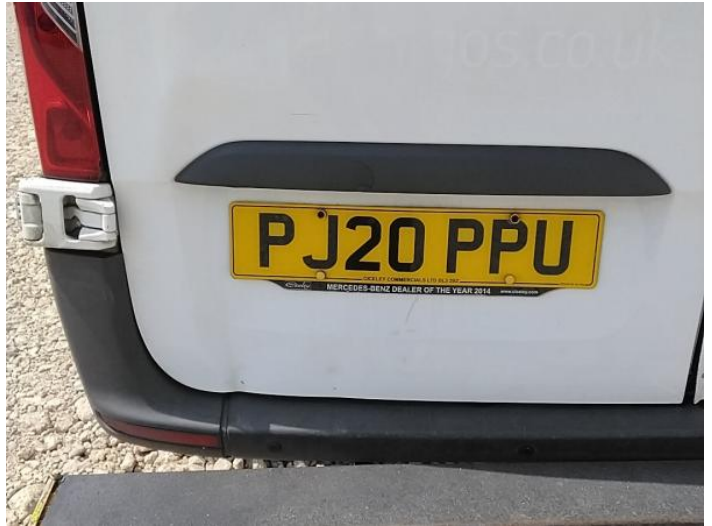
16: Door nsr
Dented
Over 30mm

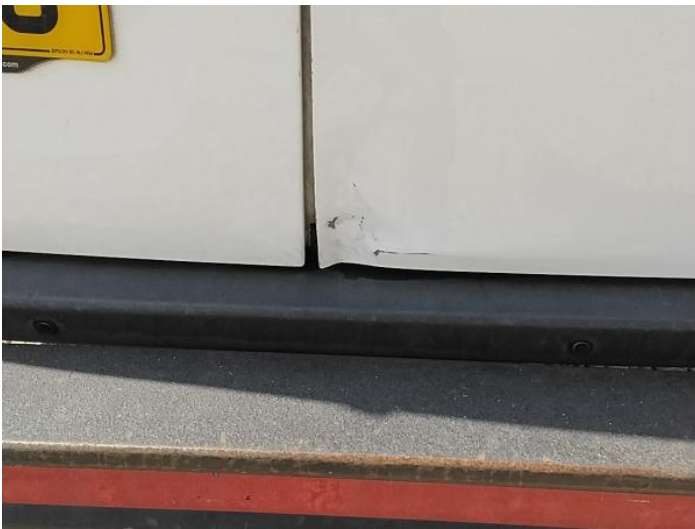
17: Door osr
Dented
With Paint Damage

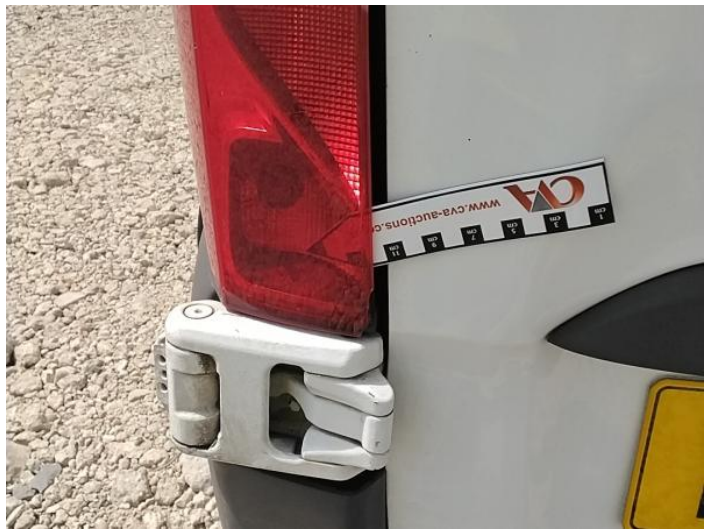
18: Lamp nsr
Broken
Replace

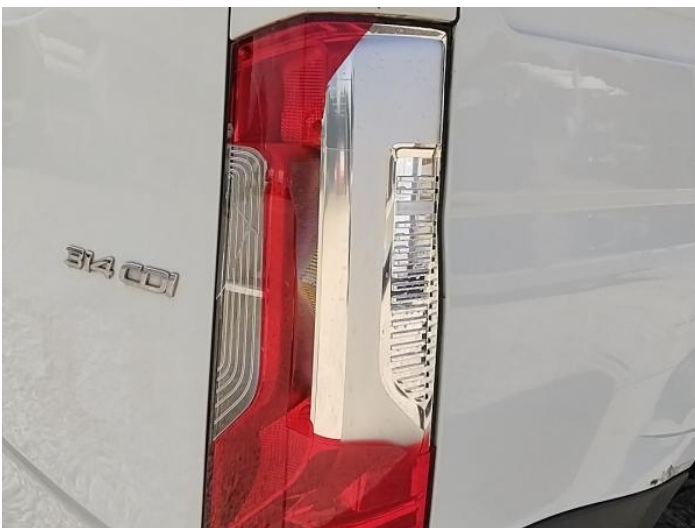
19: Lamp osr
Broken
Replace

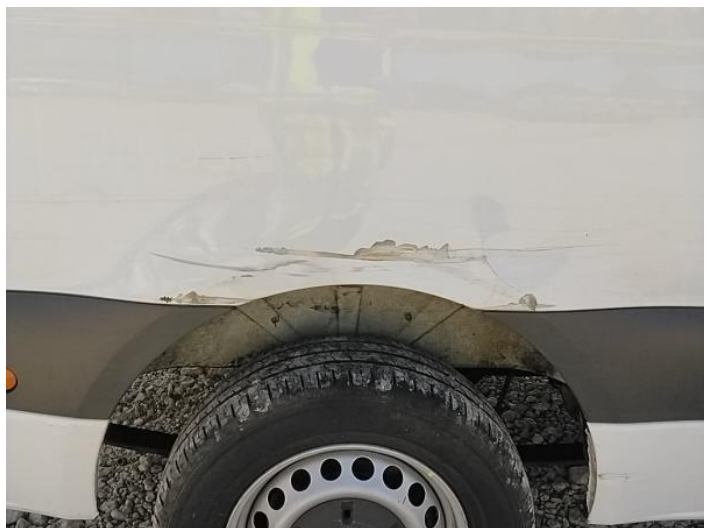
20: Qtr Panel osr
Dented
With Paint Damage

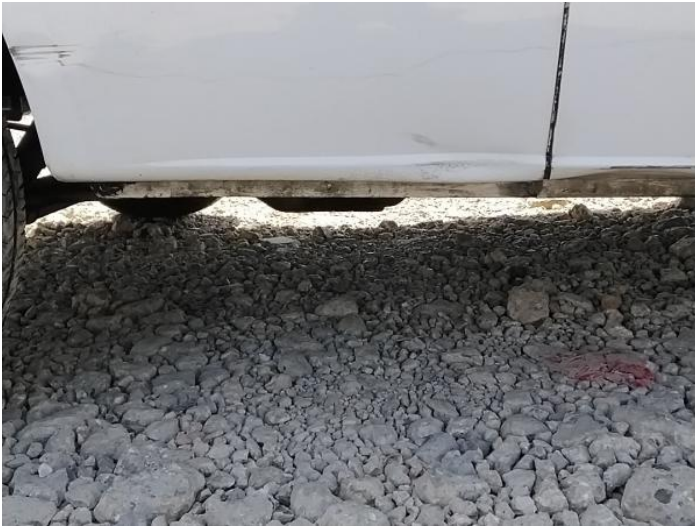
21: Sill os
Dented
With Paint Damage

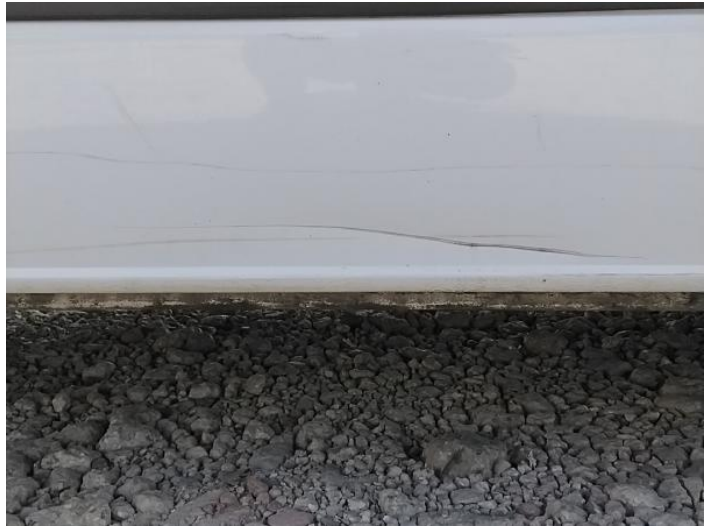
22: General Exterior
Soiled
Light

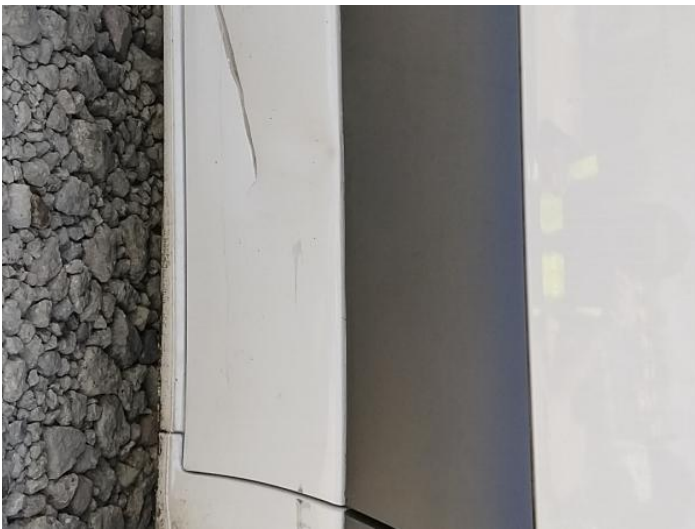
23: Door osf
Dented
With Paint Damage

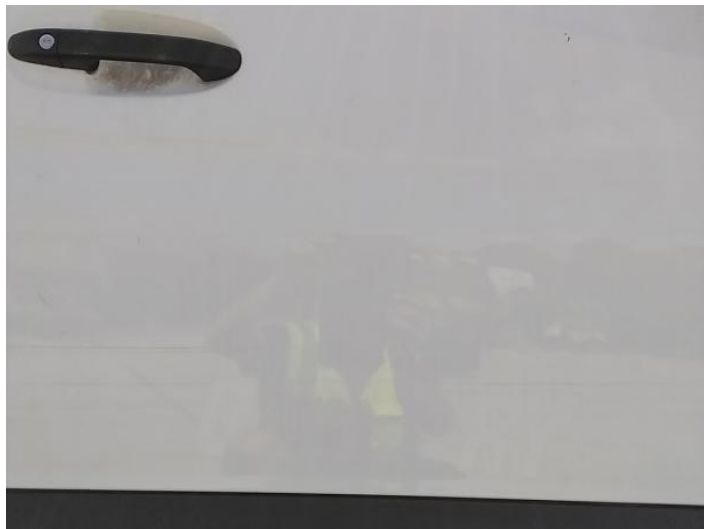
24: Door osf
Scratched
Over 25mm Thru Paint

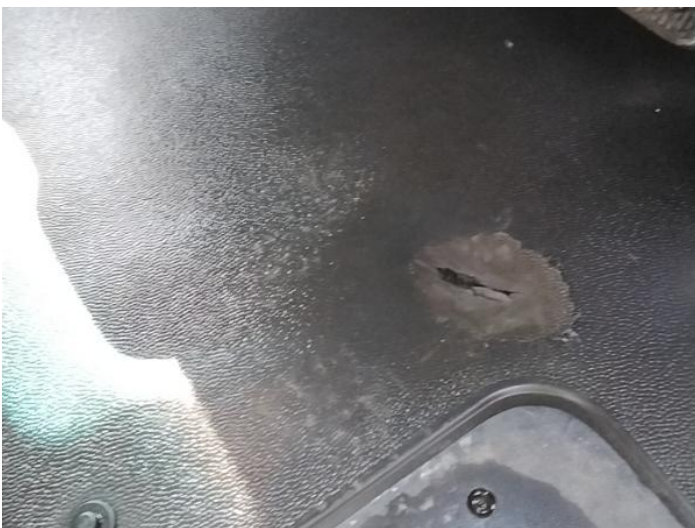
25: Carpets Front
Holed
Over 3mm

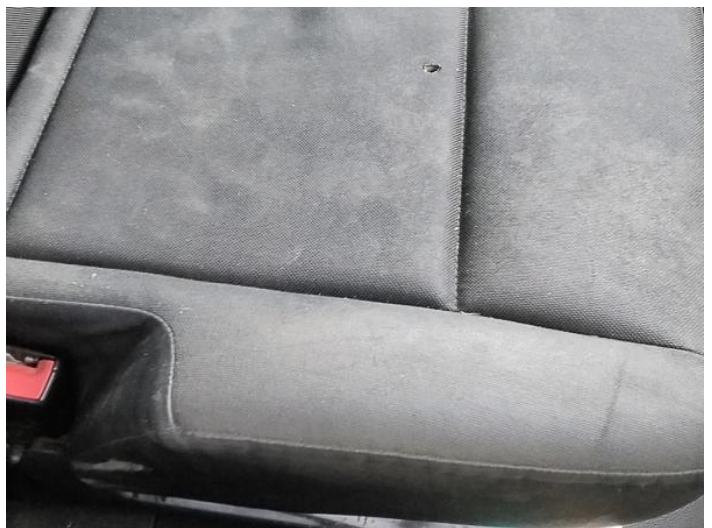
26: Seat Base Cover nsf
Holed
Over 3mm
