# VEHICLE INSPECTION REPORT

**PK21CKV**

## Fiat Ducato 35 2.3 Multijet 140ps

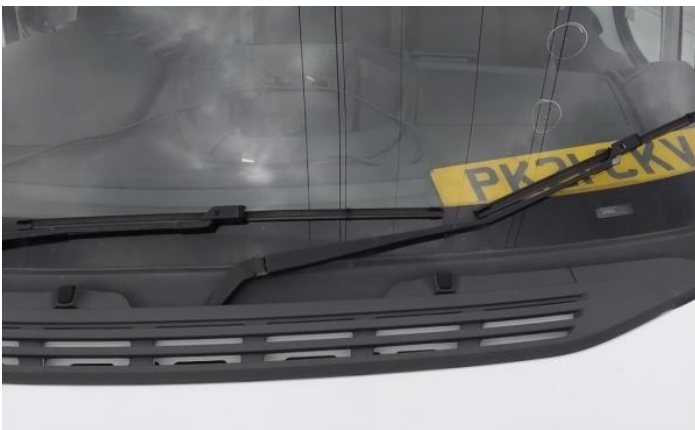
1: Screen Front  
Cracked  
Replace

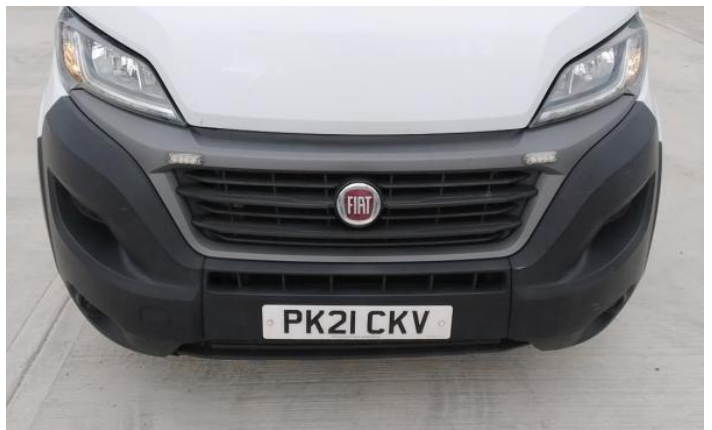
2: Bonnet  
Chipped  
Multiple Chips

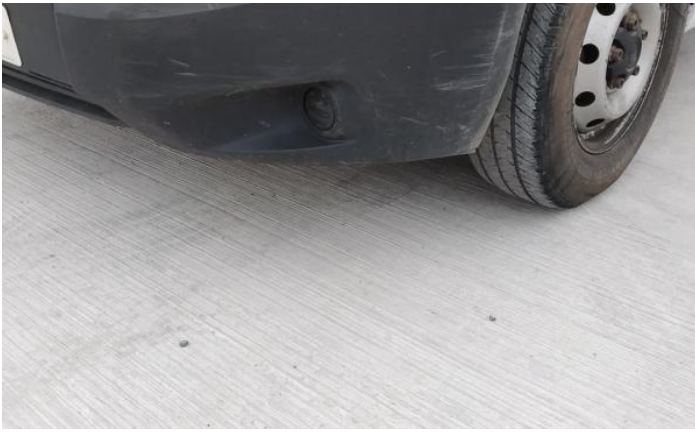
3: Bumper Front  
Scratched  
Over 100mm Thru Paint

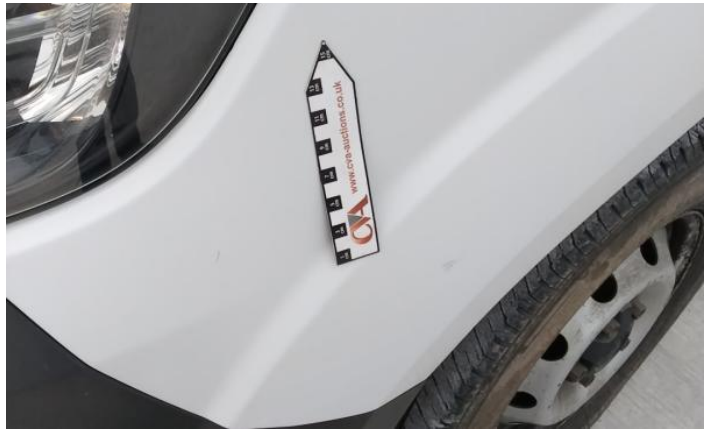
4: Wing nsf  
Chipped  
Multiple Chips

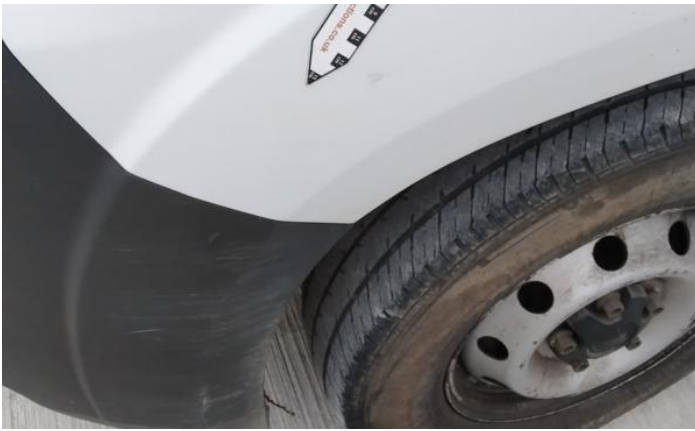
5: Wing nsf  
Scratched  
Over 25mm Thru Paint

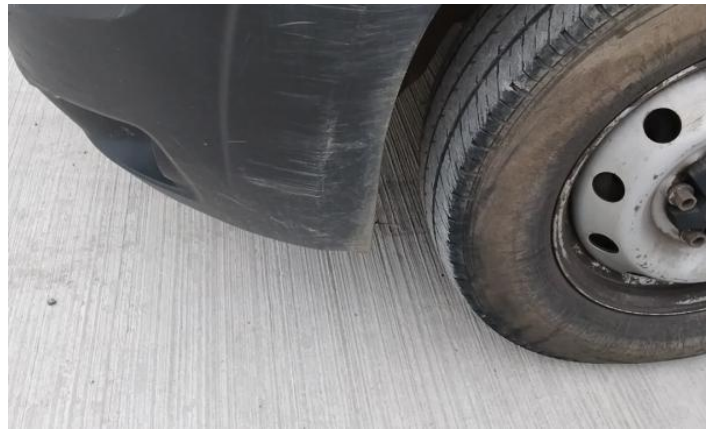
6: Bumper Front  
Scratched  
Over 100mm Thru Paint

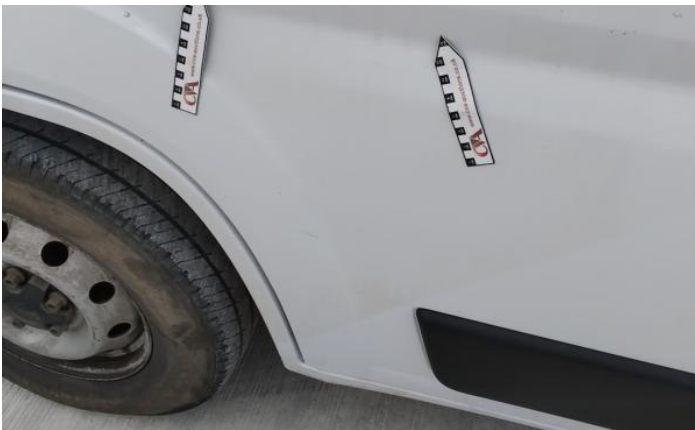
7: Door nsf  
Scratched  
Over 25mm Thru Paint

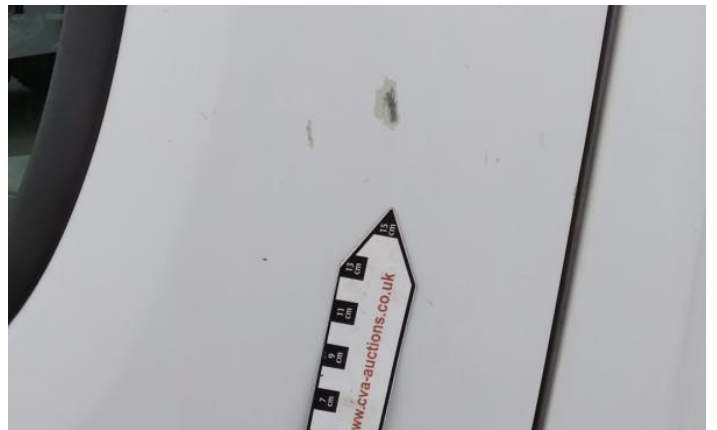
8: Door nsf  
Scratched  
Over 25mm Thru Paint

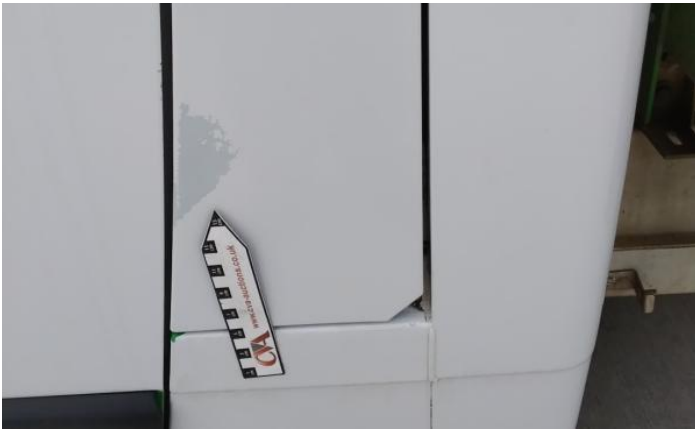
9: Fuel Flap  
Scratched  
Over 25mm Thru Paint

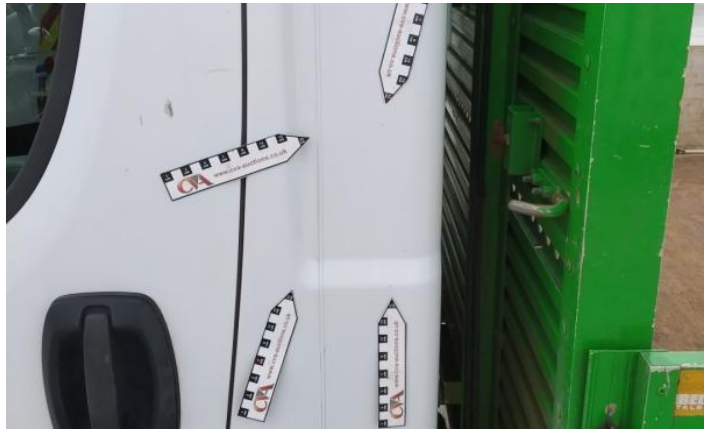
10: Qtr Panel nsr  
Scratched  
Over 25mm Thru Paint

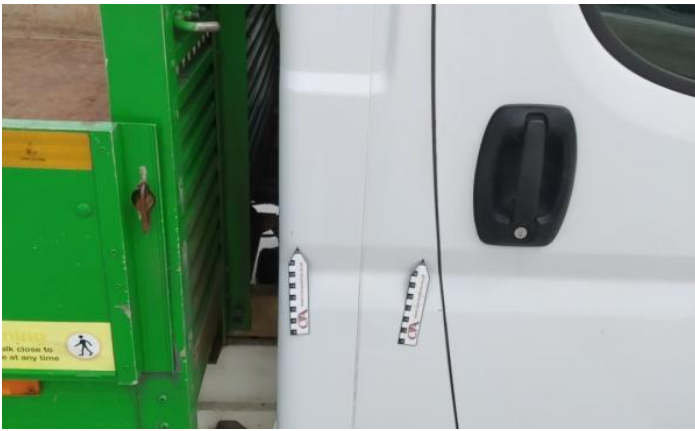
11: Qtr Panel osr  
Scratched  
Over 25mm Thru Paint

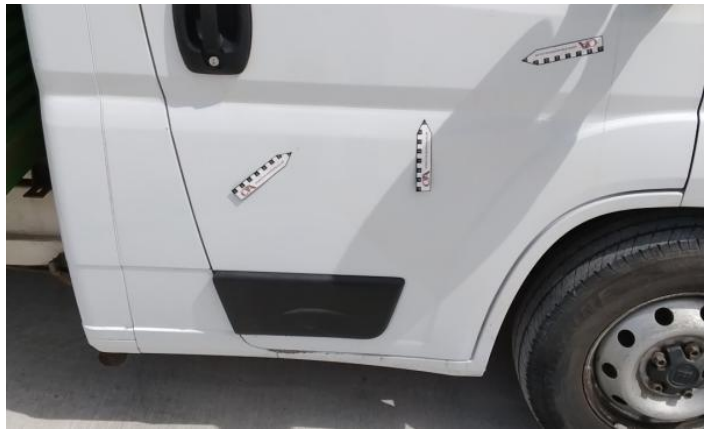
12: Door osf  
Chipped  
Multiple Chips

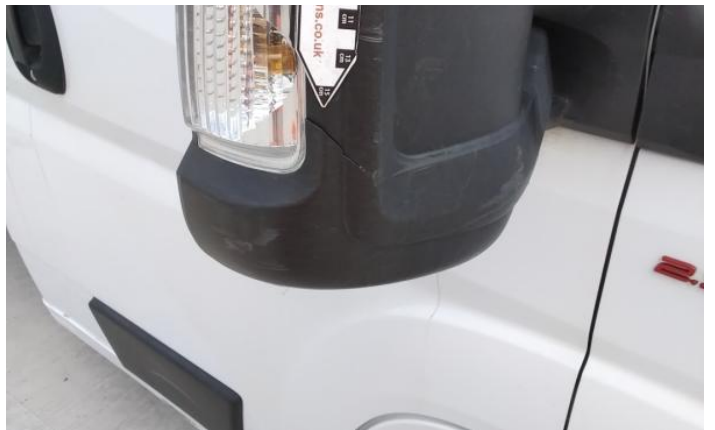
14: Door Mirror Assy osf  
Broken  
Replace

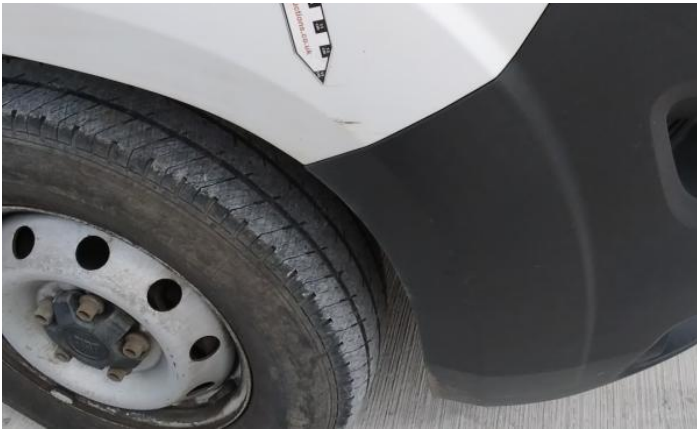
15: Wing osf  
Scratched  
Over 25mm Thru Paint

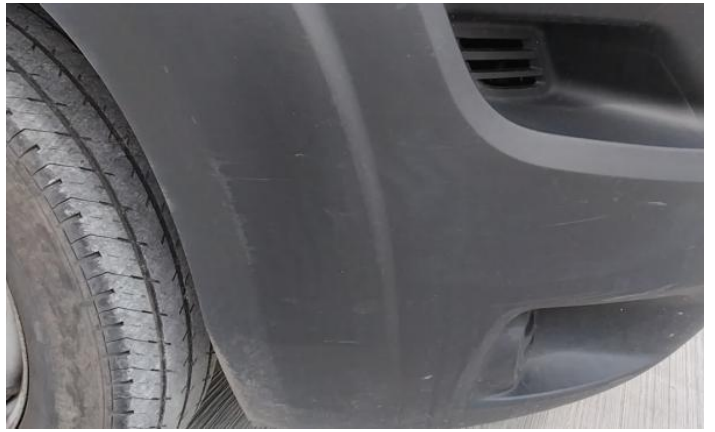
16: Bumper Front  
Scratched  
Over 100mm Thru Paint

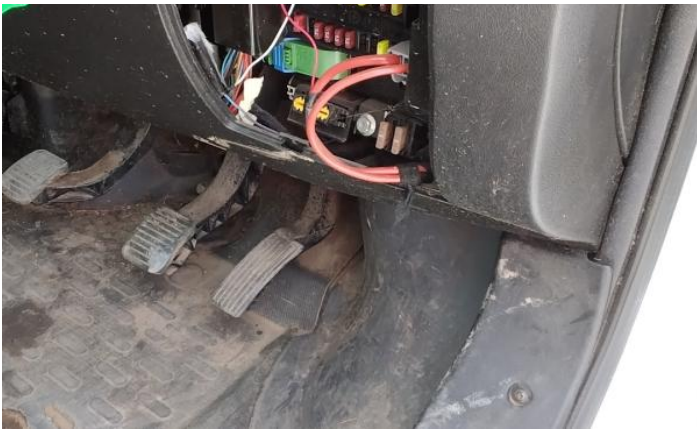
17: Fascia Panel  
Missing  
Replace

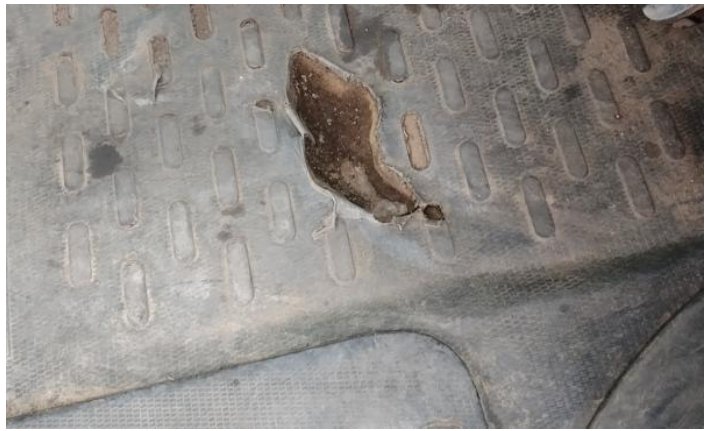
18: Carpets Front  
Holed  
Over 3mm

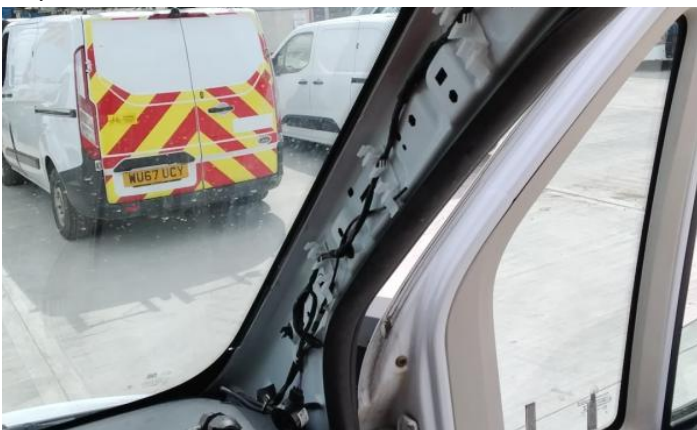
19: Fascia Trim  
Missing  
Replace

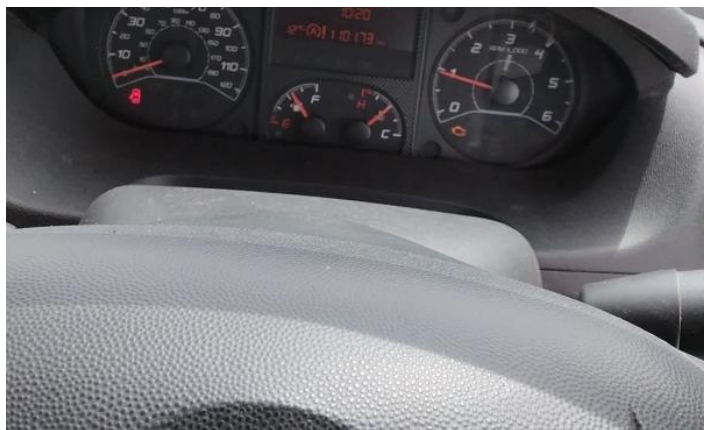
\*LIMP MODE, WARNING LIGHT ON DASH\* AD-BLUE, TOW BAR, E/ MIRRORS

20: Dash Warning Lights  
Displayed  
No Action
