# VEHICLE INSPECTION REPORT

**YL18DLV**

## Ford Transit 350 2.0 TDCI 170PS

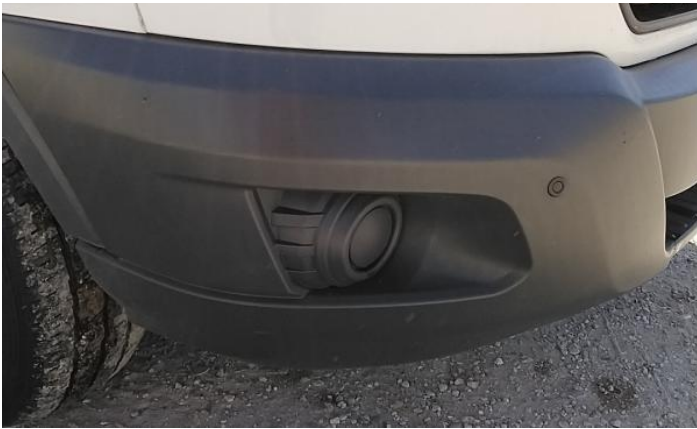
1: Bumper Front Moulding  
Scuffed (Unpainted)  
Over 100mm

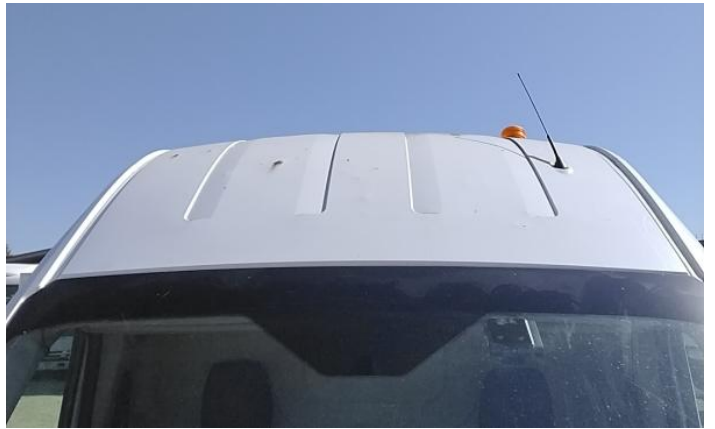
2: Roof  
Rusted  
Over 5mm

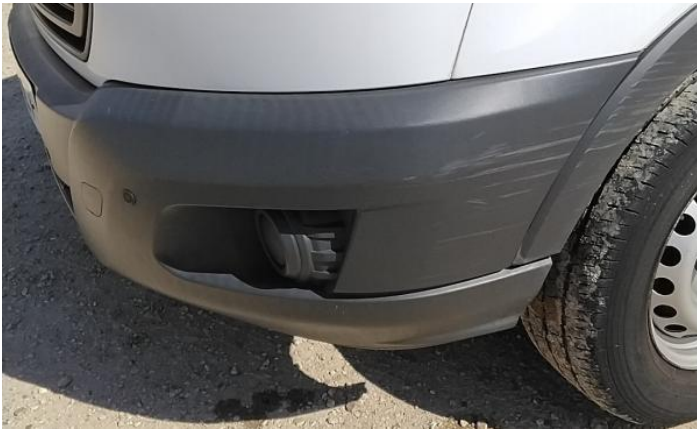
3: Bumper Front Moulding  
Scuffed (Unpainted)  
Over 100mm

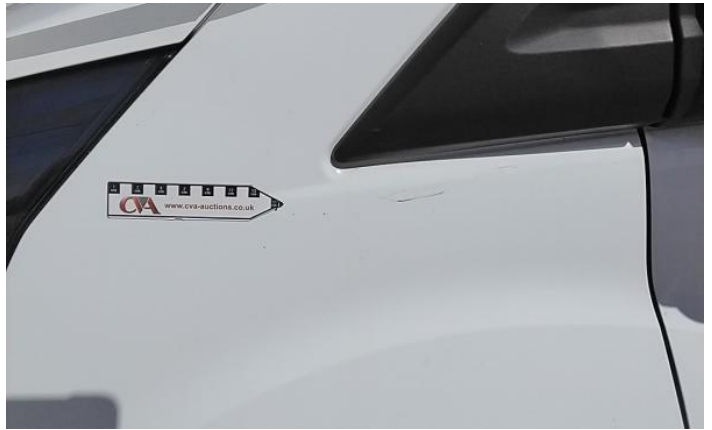
4: Wing nsf  
Scratched  
Over 25mm Not Thru Paint

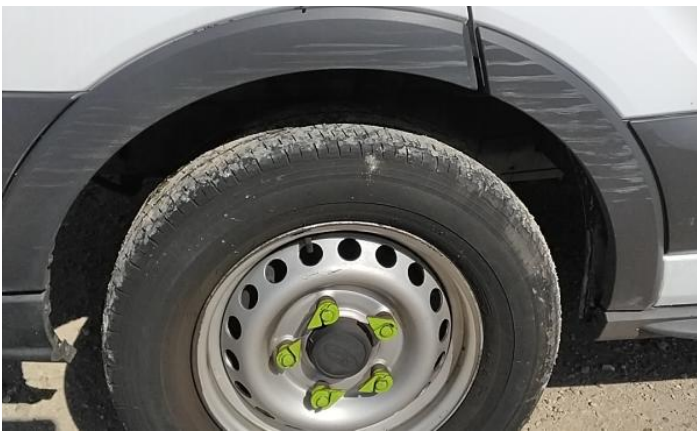
5: Wing Front Arch Extension ns  
Scuffed (Unpainted)  
Over 100mm

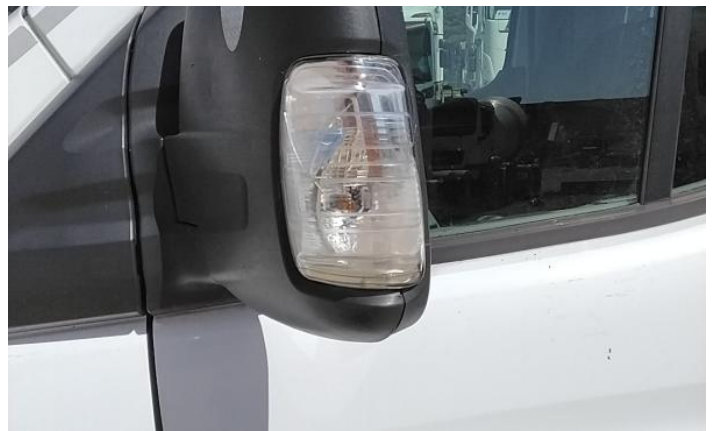
6: Flasher Side Repeater ns  
Broken  
Replace

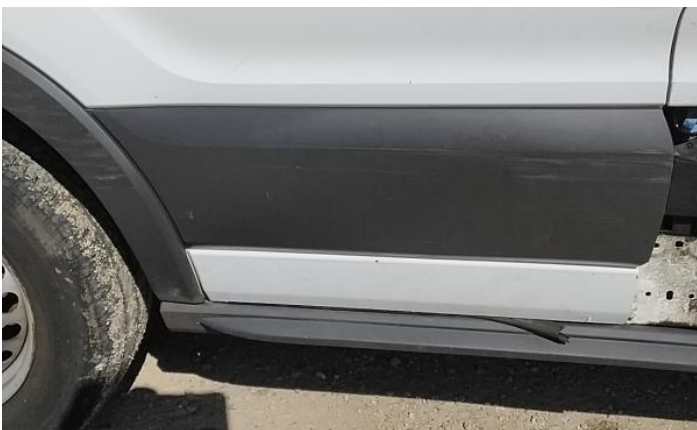
7: Door Moulding nsf  
Scuffed (Unpainted)  
Over 100mm

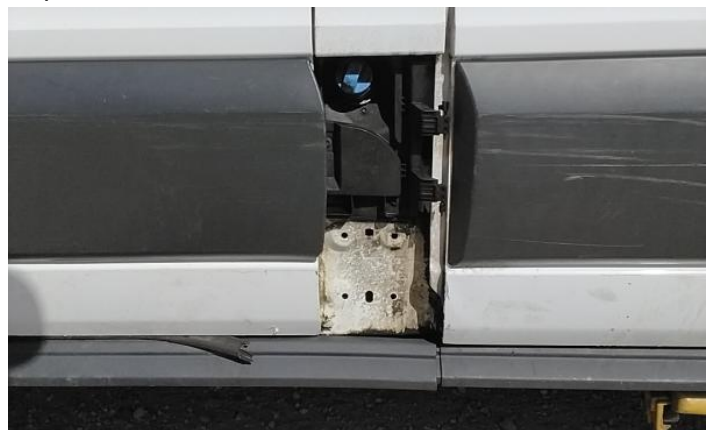
8: Fuel Flap  
Missing  
Replace

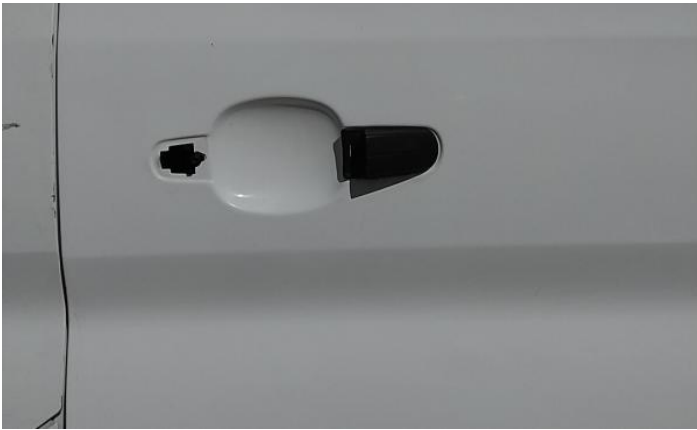
9: Handle Outer nsr  
Broken  
Replace

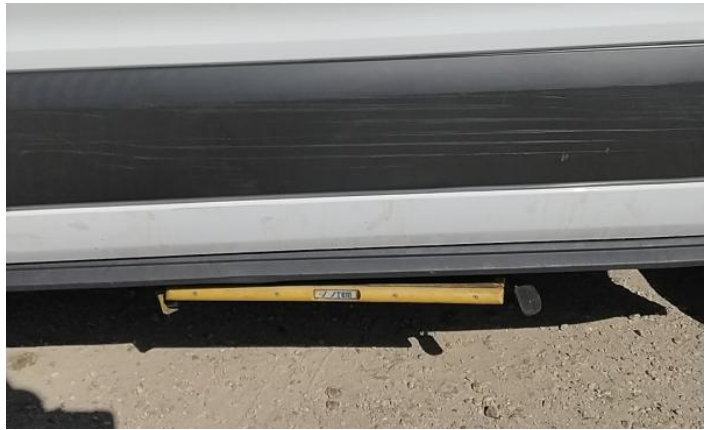
10: Door Moulding nsr  
Scuffed (Unpainted)  
Over 100mm

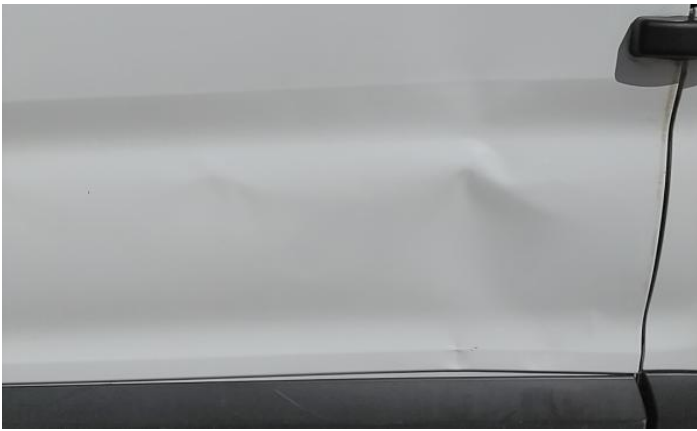
11: Door nsr  
Dented  
Over 30mm

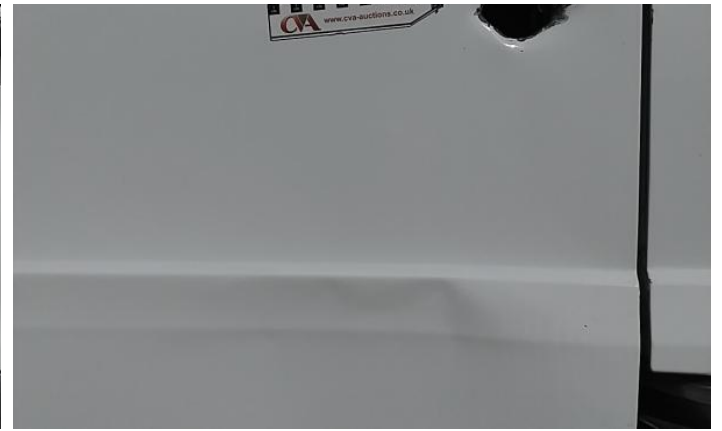
12: Door nsr  
Hole  
Over 10mm

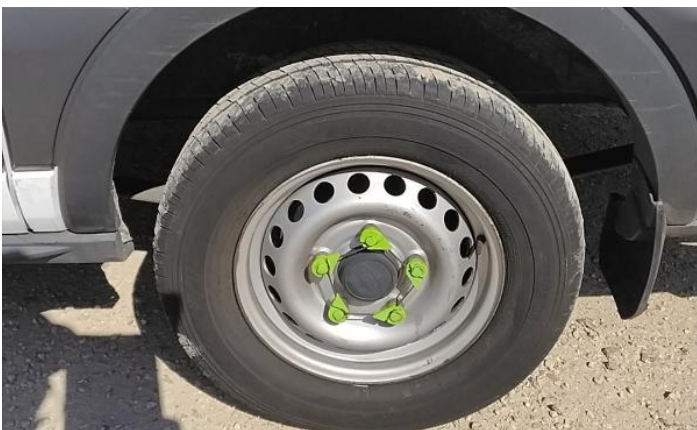
13: Qtr Panel Arch Extension ns  
Scuffed (Unpainted)  
Over 100mm

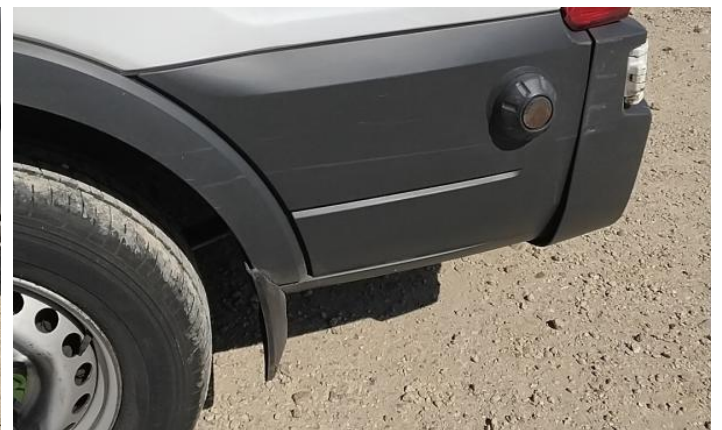
14: Qtr Panel Moulding ns  
Scuffed (Unpainted)  
Over 100mm

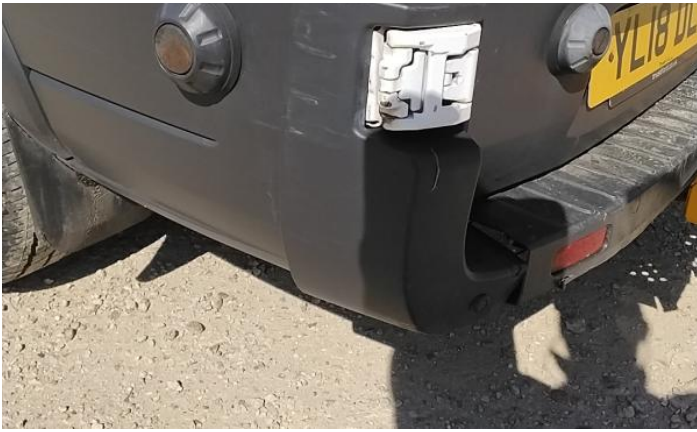
15: Bumper Rear Moulding  
Scuffed (Unpainted)  
Over 100mm

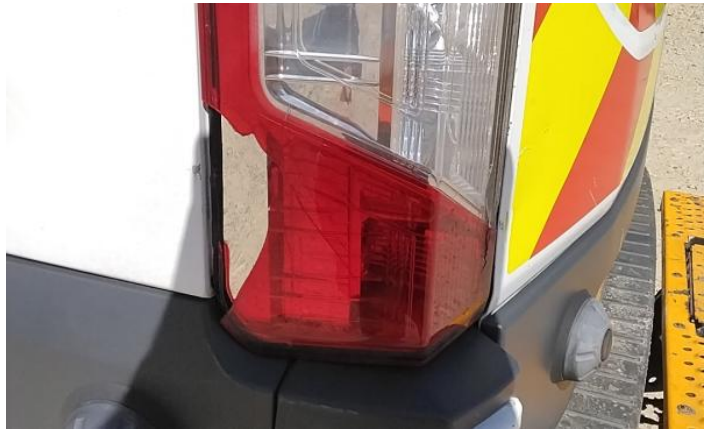
16: Lamp nsr  
Broken  
Replace

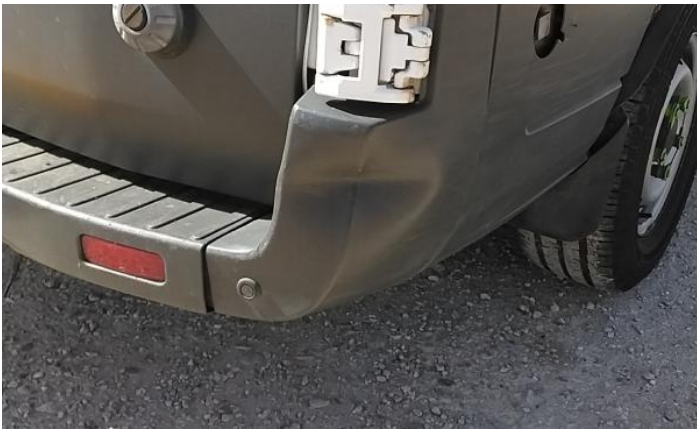
17: Bumper Rear  
Dented  
Over 30mm

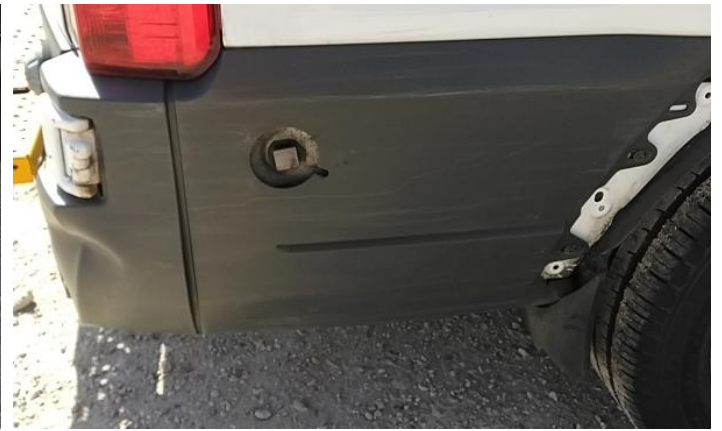
18: Qtr Panel Moulding os  
Scuffed (Unpainted)  
Over 100mm

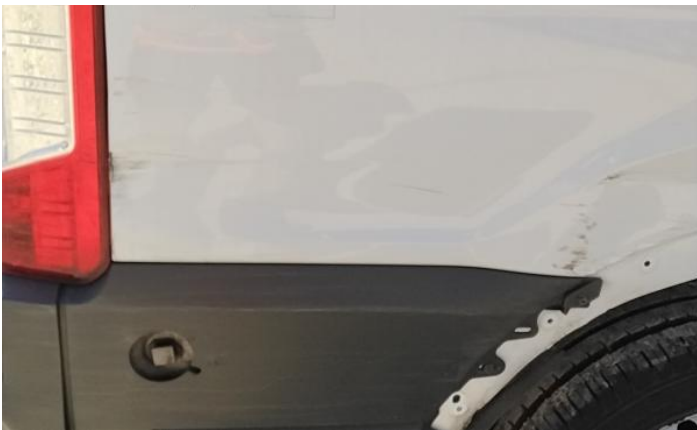
19: Qtr Panel osr  
Dented  
With Paint Damage

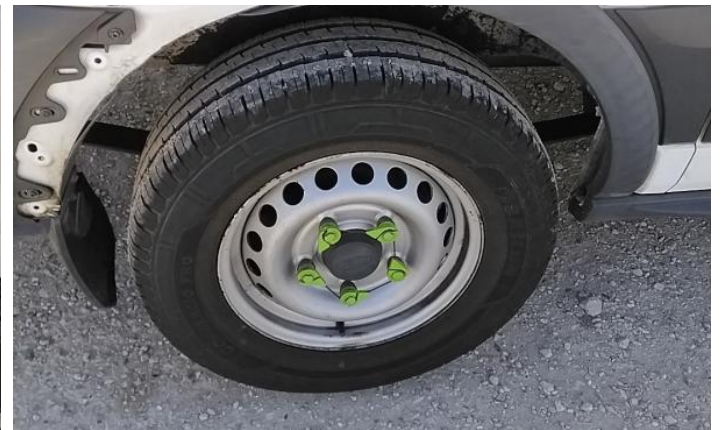
20: Qtr Panel Arch Extension os  
Broken  
Replace

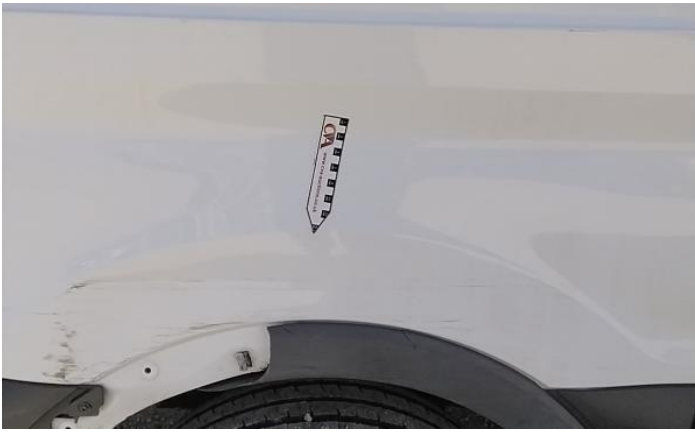
21: Qtr Panel osr  
Scratched  
Over 25mm Thru Paint

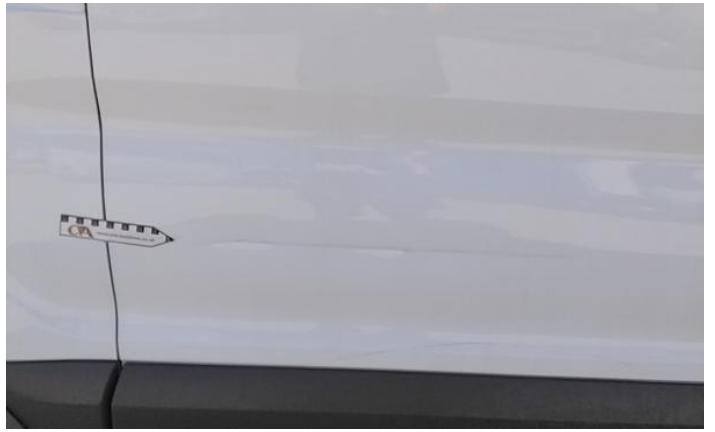
22: Qtr Panel osr  
Dented  
With Paint Damage

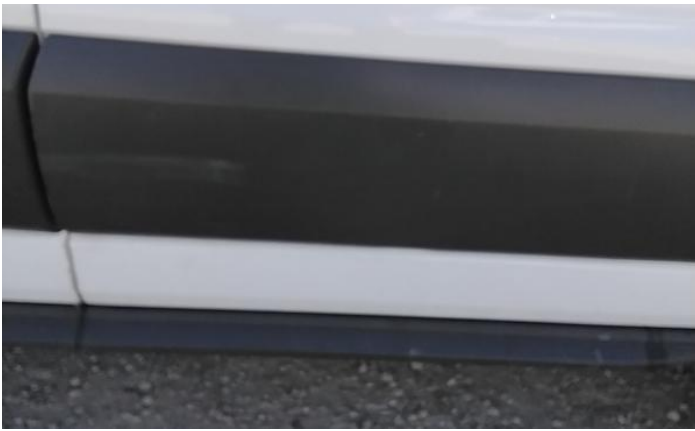
23: Door Moulding osf  
Scuffed (Unpainted)  
UpTo 100mm

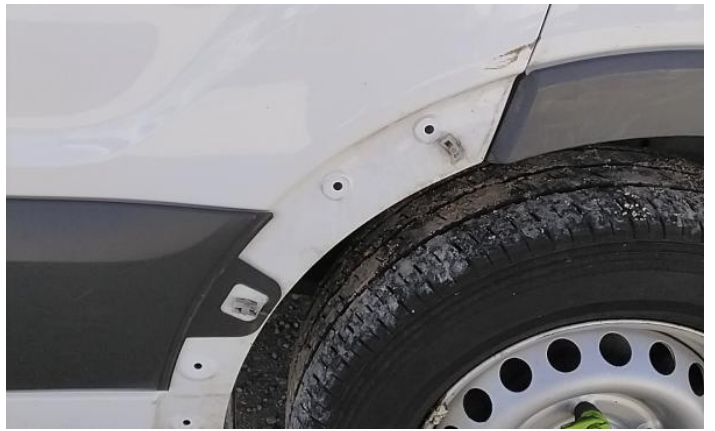
24: Wing Front Arch Extension os  
Missing  
Replace

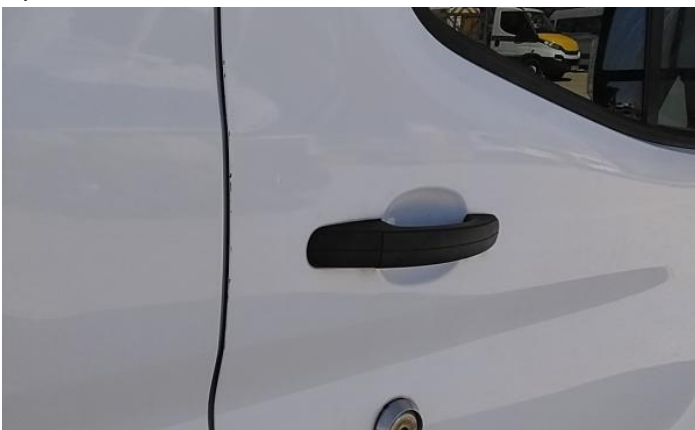
25: Door osf  
Chipped  
Edge Chip

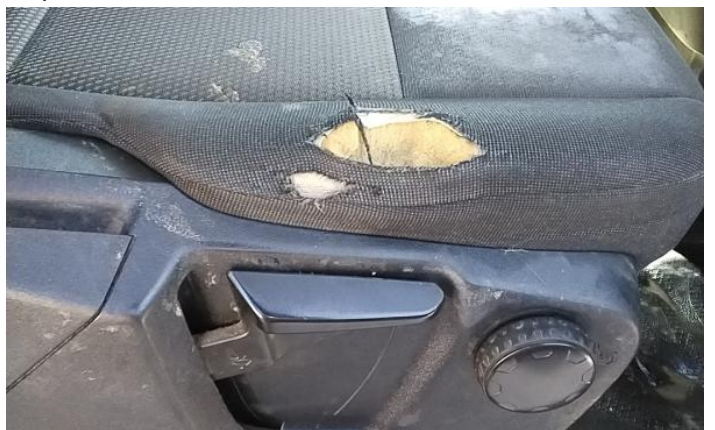
26: Seat Base Cover osf  
Holed  
Over 3mm
