VEHICLE INSPECTION REPORT

SV65JZX

Mercedes-Benz Antos 1824

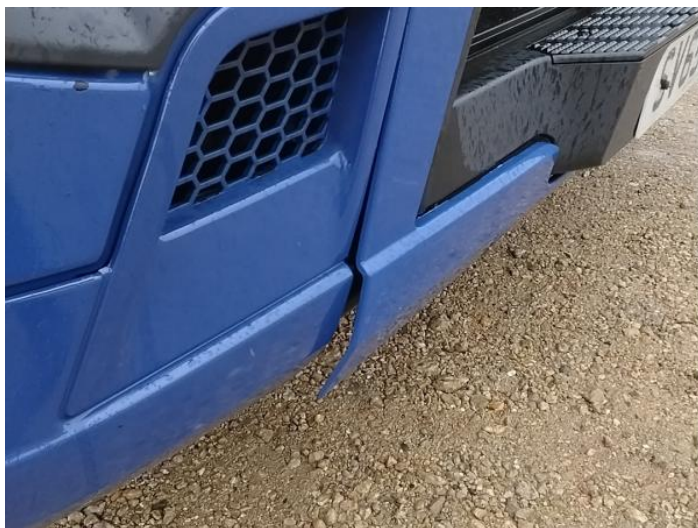
1: Bumper Front
Insecure
Action Required

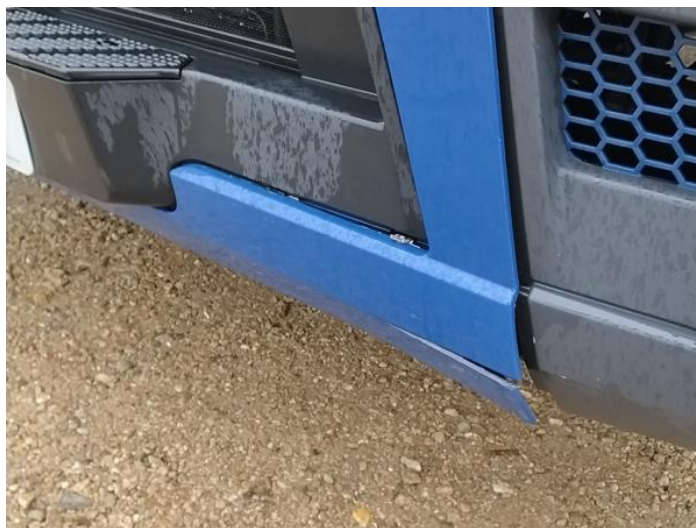
2: Bumper Front
Insecure
Action Required

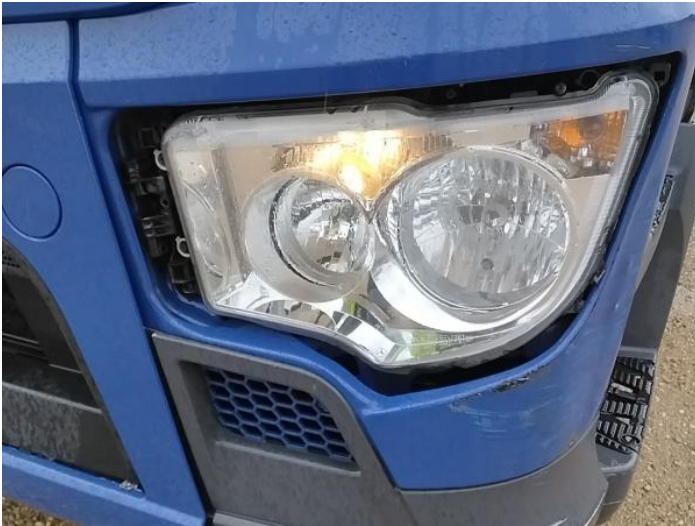
3: Headlamp ns
Missing
Replace

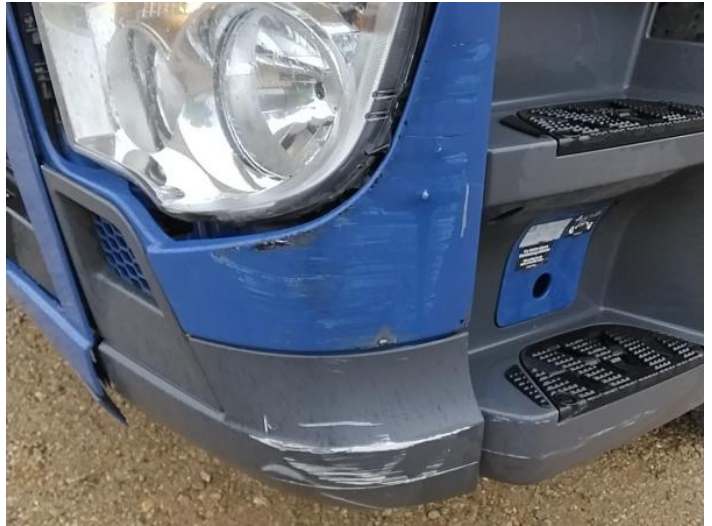
4: Bumper Front
Scratched
Over 100mm Thru Paint

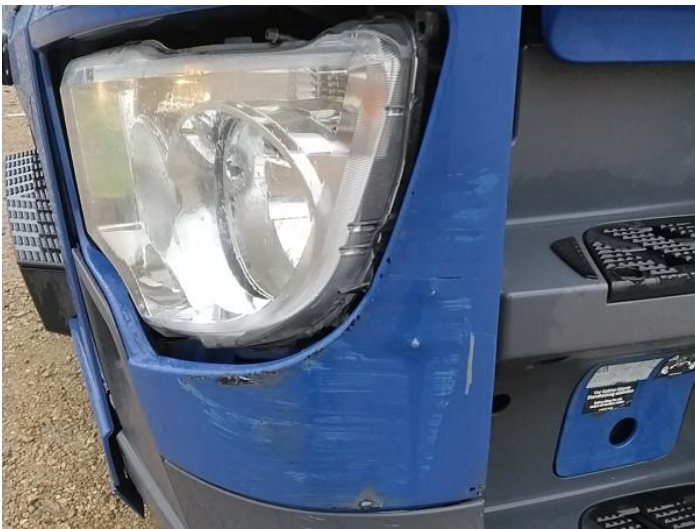
5: Fog Lamp Surrounds
Scratched (Painted)
Over 25mm Thru Paint

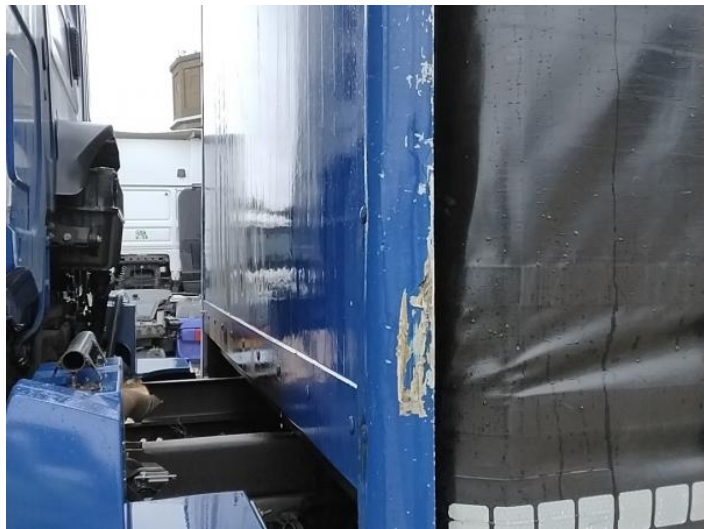
6: C Post ns
Scratched
Over 25mm Thru Paint

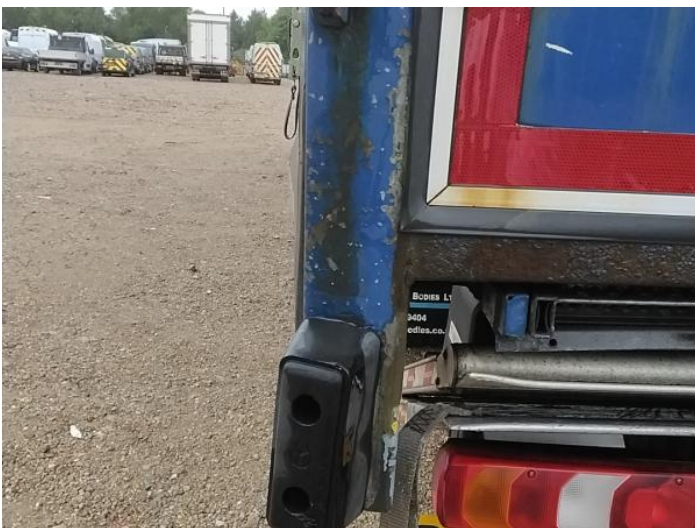
7: General Exterior
Soiled
Light

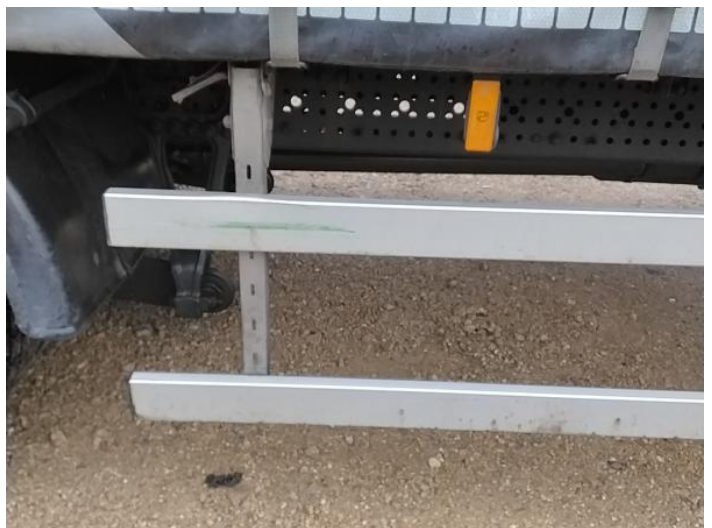
8: General Exterior
Soiled
Light

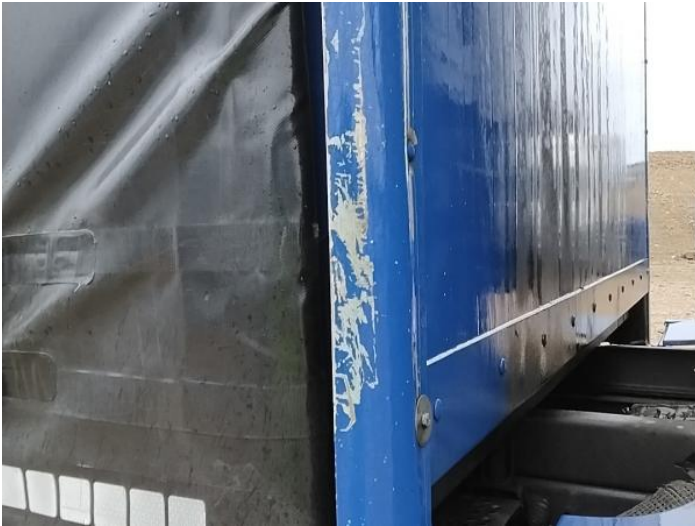
9: C Post os
Scratched
Over 25mm Thru Paint

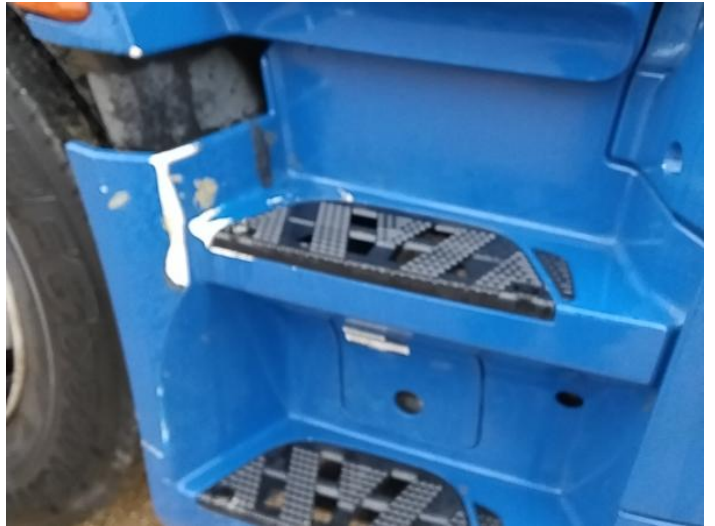
10: General Exterior
Soiled
Light

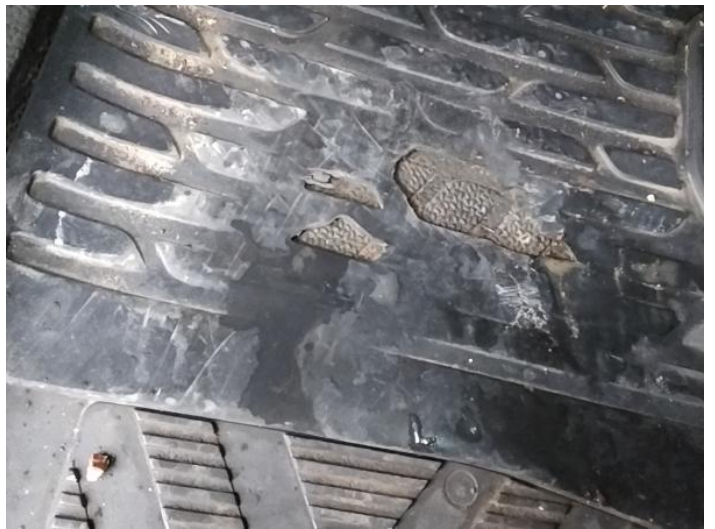
12: Carpets Front
Holed
Over 3mm

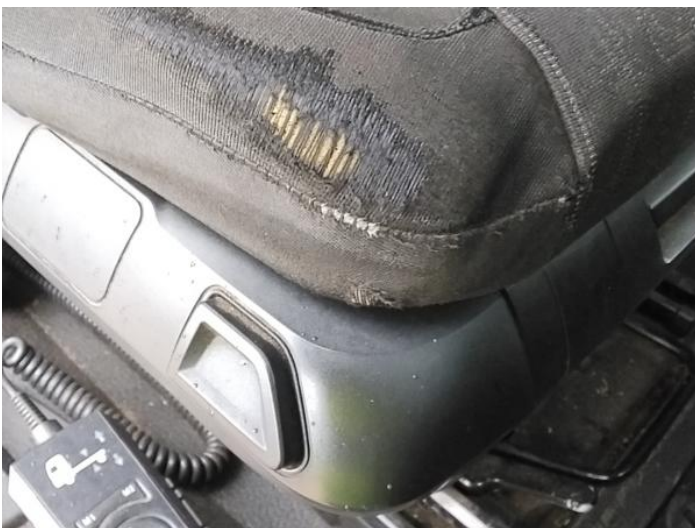
13: Seat Base Cover osf
Holed
Over 3mm
