VEHICLE INSPECTION REPORT

SV65JZW

Mercedes-Benz Antos 1824

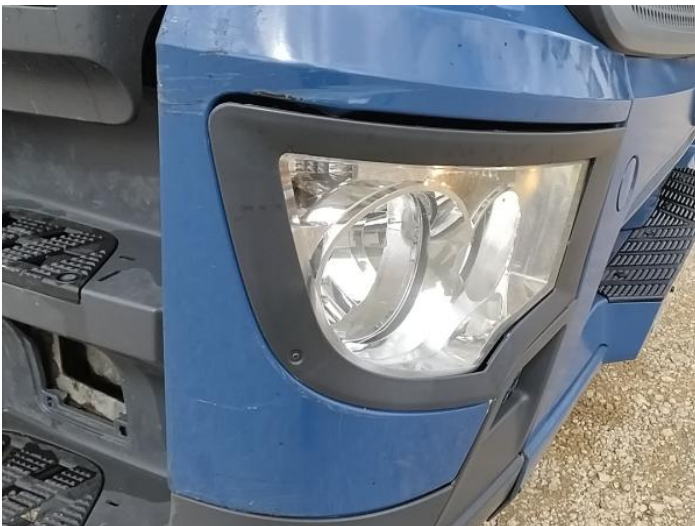
1: Moulding of Wing
Scratched (Painted)
Over 25mm Thru Paint

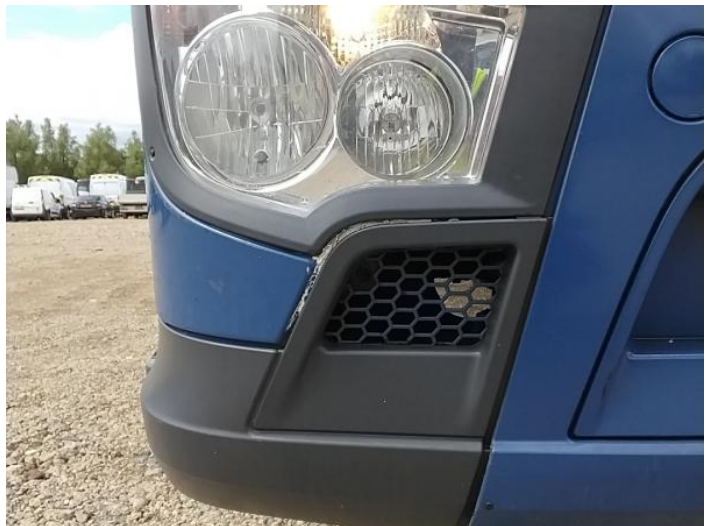
2: Moulding of Wing
Scratched (Painted)
Over 25mm Thru Paint

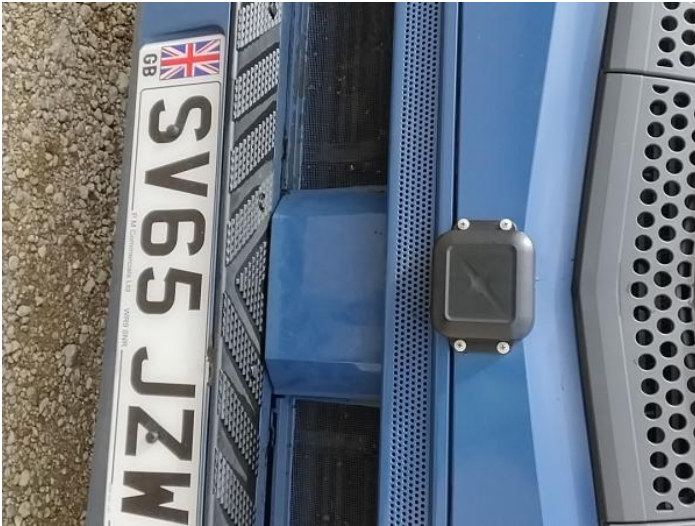
3: Bumper Front Grill
Broken
Replace

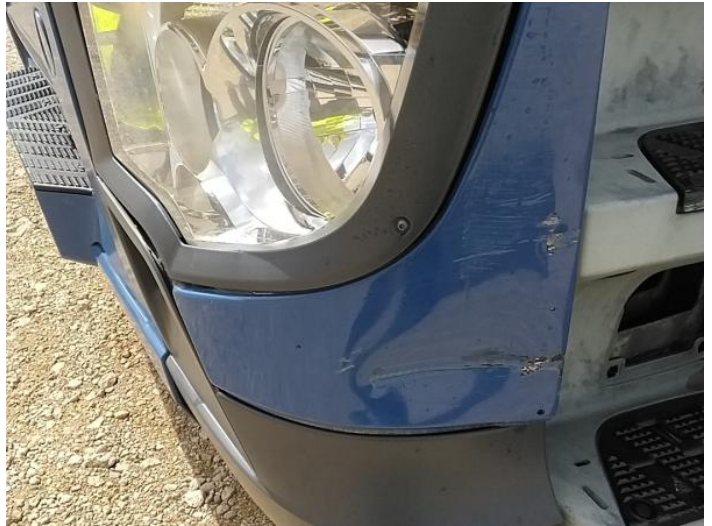
4: Moulding nsf Wing
Scratched (Painted)
Over 25mm Thru Paint

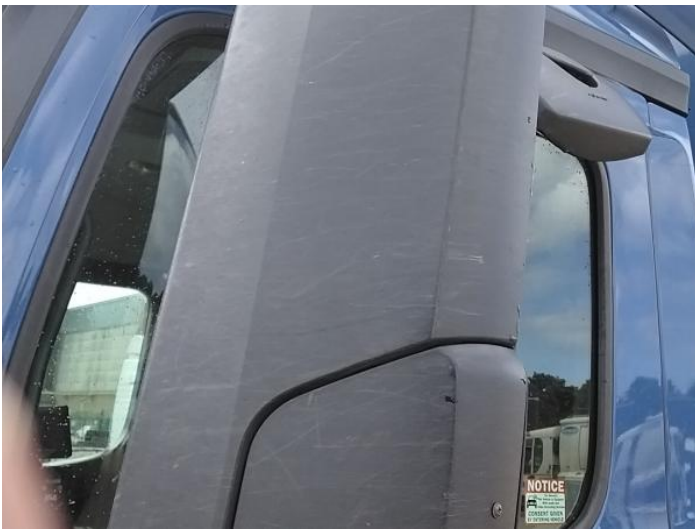
5: Door Mirror Assy nsf
Broken
Replace

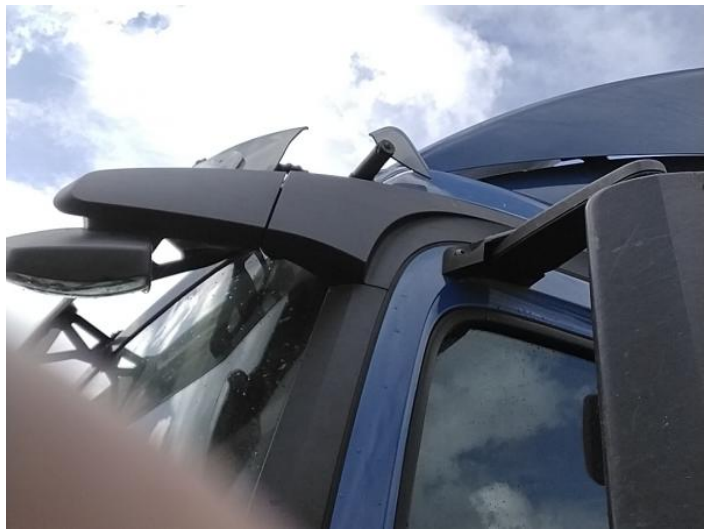
6: General Exterior
Soiled
Light

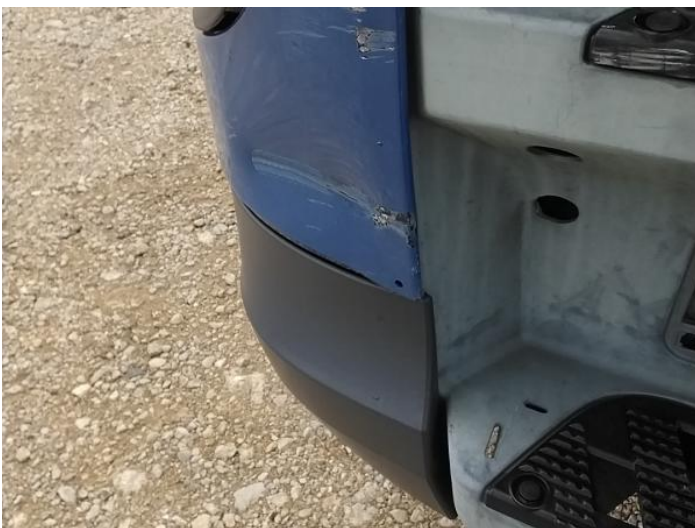
7: Moulding nsf Wing
Scratched (Painted)
Over 25mm Thru Paint

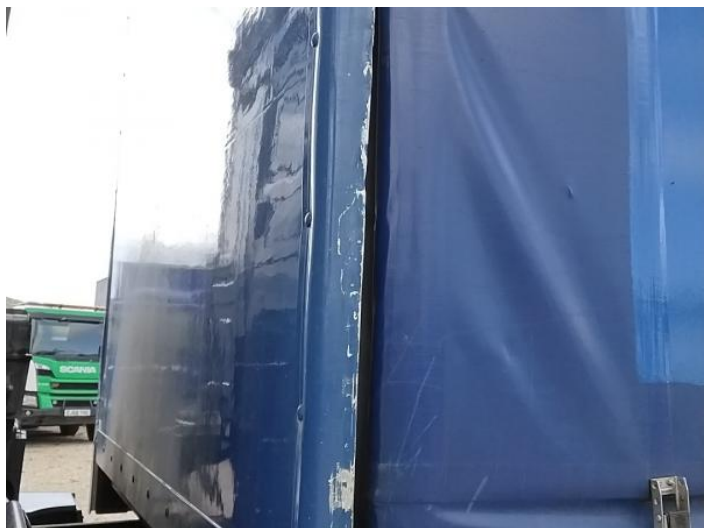
8: C Post ns
Scratched
Over 25mm Thru Paint

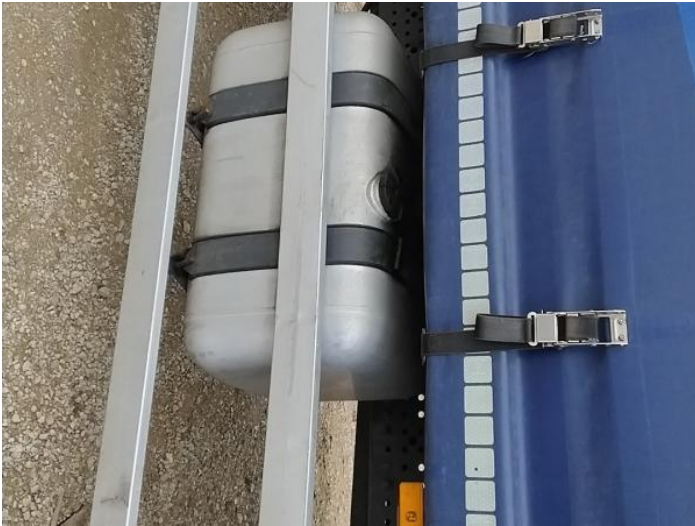
9: General Exterior
Soiled
Light

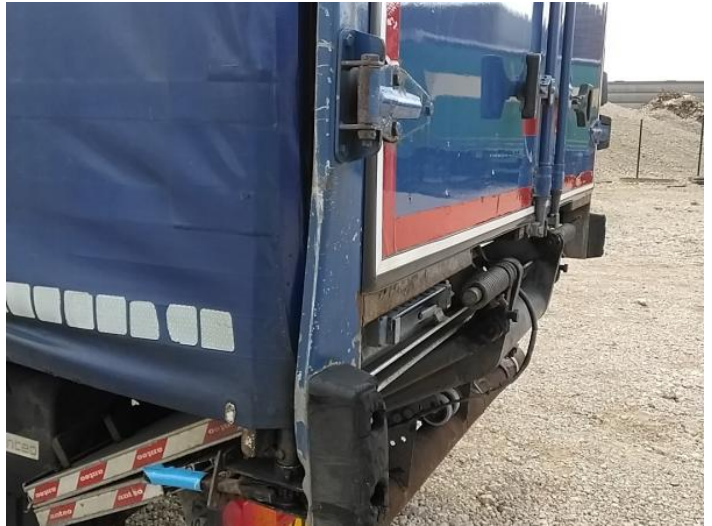
10: Door Moulding nsr
Scratched (Painted)
Over 25mm Thru Paint

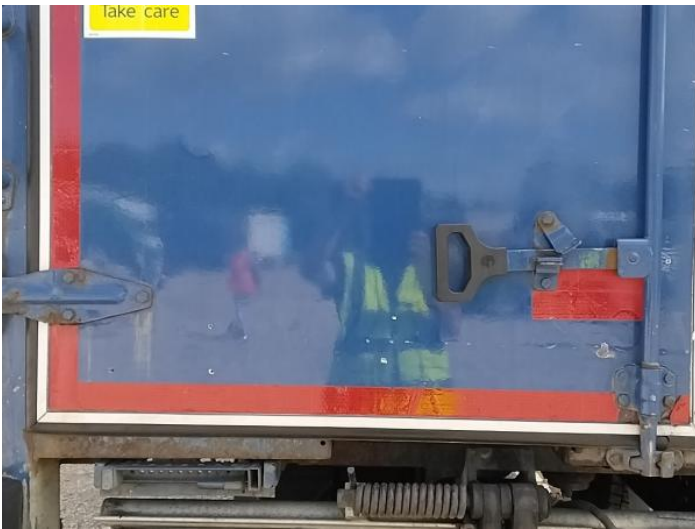
11: Door nsr
Scratched
Over 25mm Thru Paint

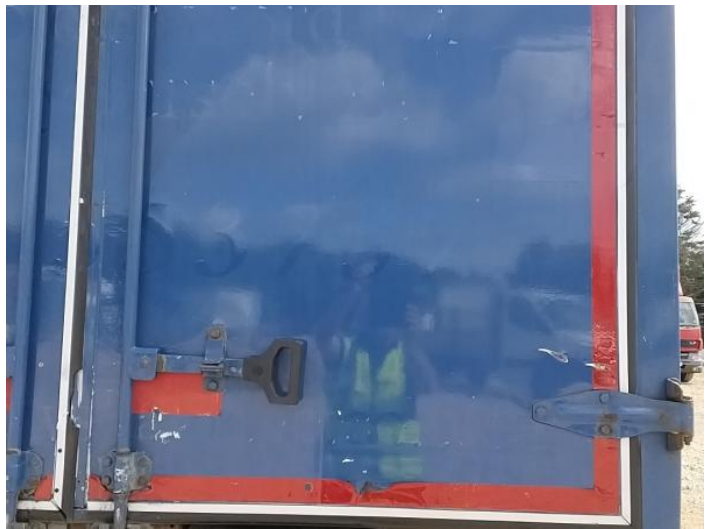
12: Door osr
Scratched
Over 25mm Thru Paint

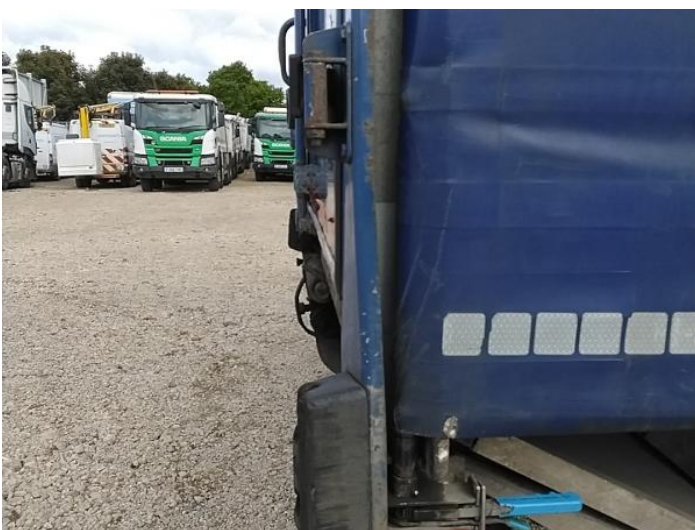
13: Door Moulding osr
Scratched (Painted)
Over 25mm Thru Paint

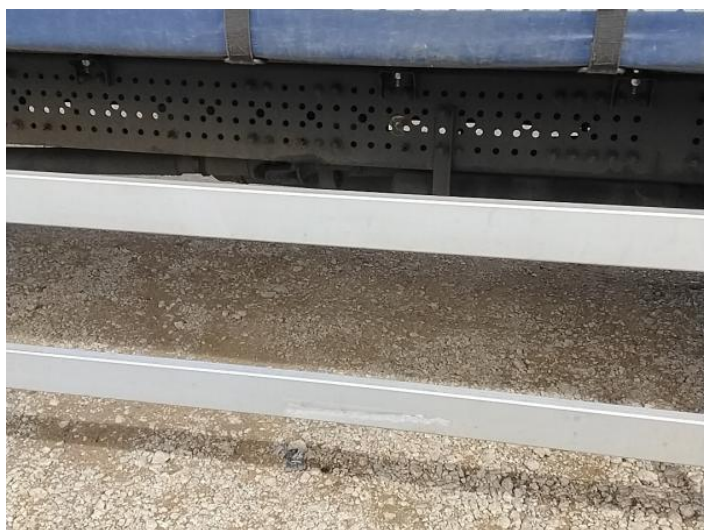
14: General Exterior
Soiled
Light

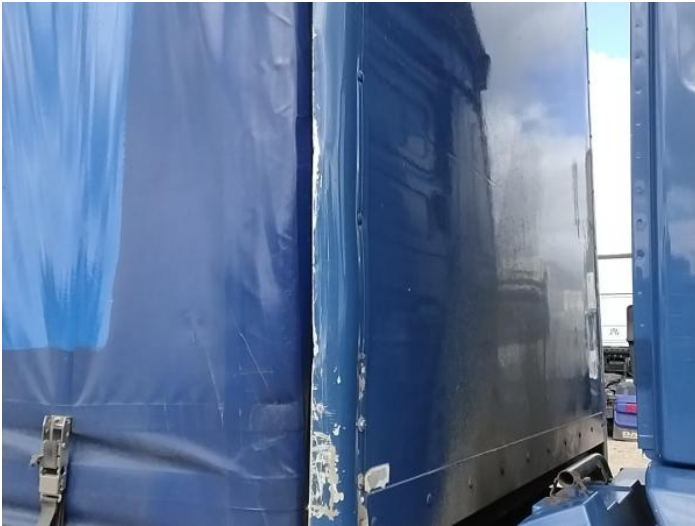
15: C Post os
Scratched
Over 25mm Thru Paint

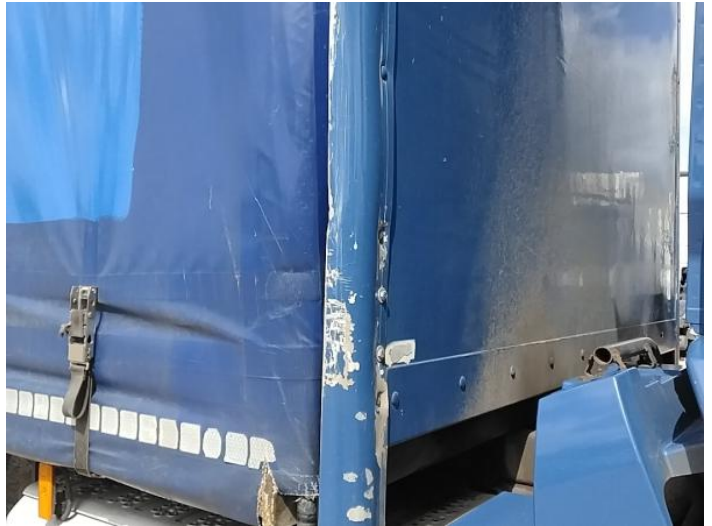
16: C Post os
Dented
With Paint Damage

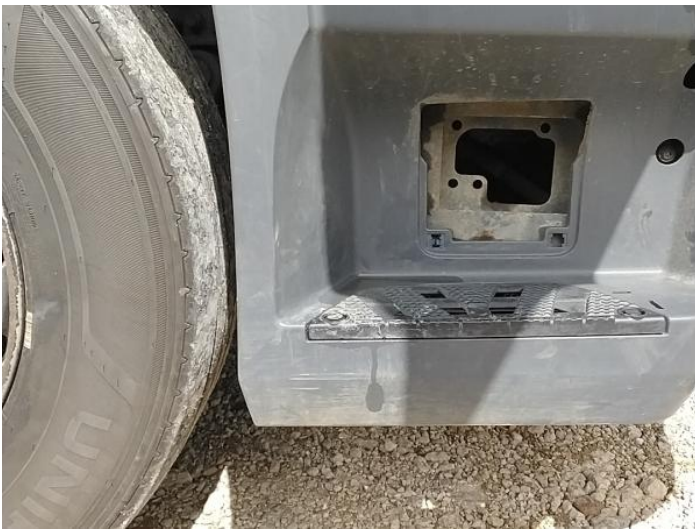
17: General Exterior
Soiled
Light

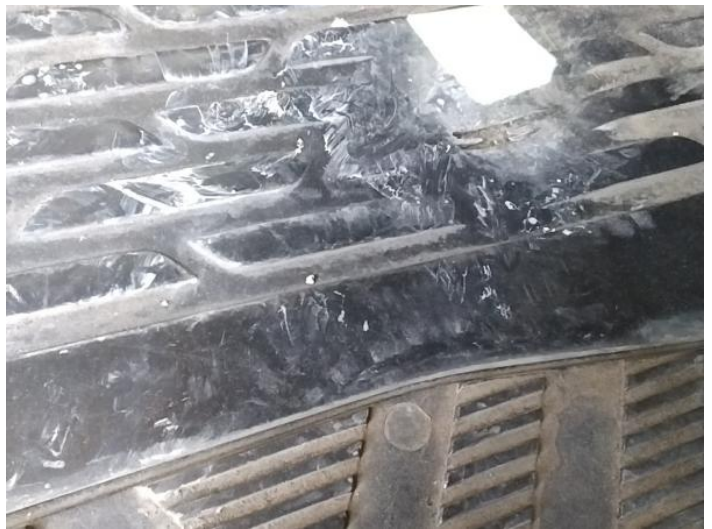
18: Carpets Front
Holed
Over 3mm

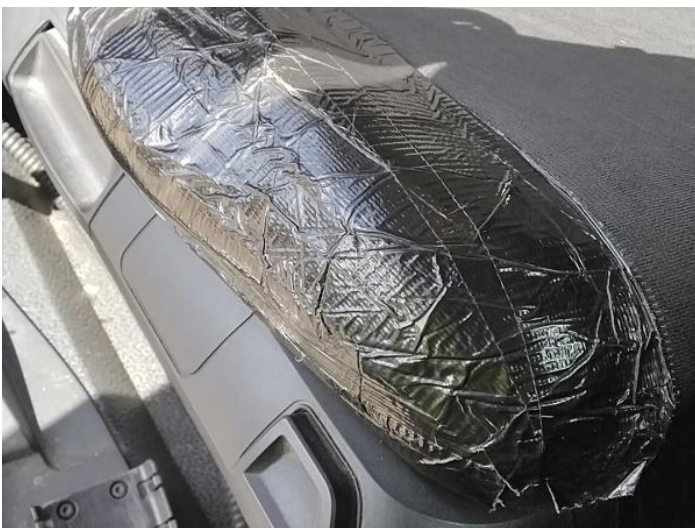
19: Seat Base Cover osf
Torn
Over 3mm

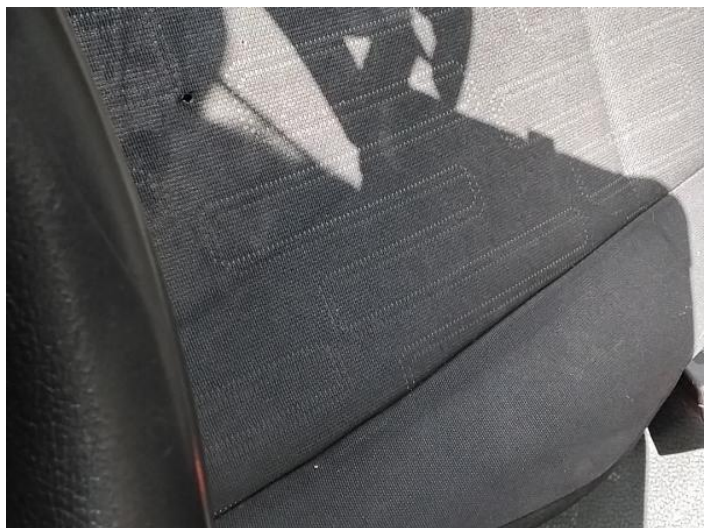
20: Seat Base Cover osf
Holed
Over 3mm
