**COMMERCIAL VEHICLE AUCTIONS LTD**  
THE UK'S MOST ESTABLISHED COMMERCIAL VEHICLE AUCTIONEERS

# VEHICLE INSPECTION REPORT

**CU67PWX**

## Ford Transit 350 2.0 TDCi 170ps H3

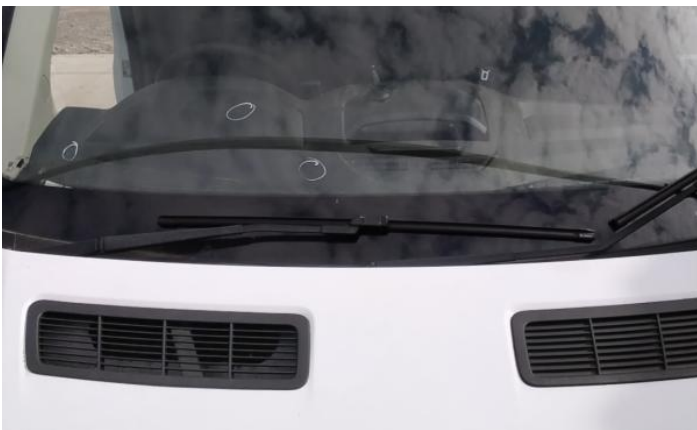
1: Screen Front  
Chipped  
Over 10mm

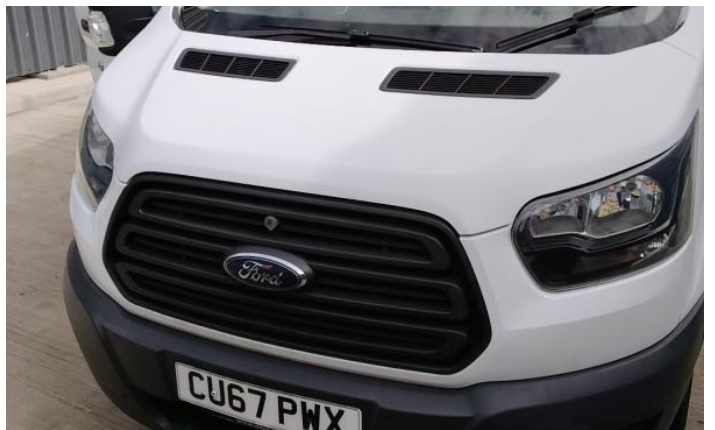
2: Bonnet  
Chipped  
Multiple Chips

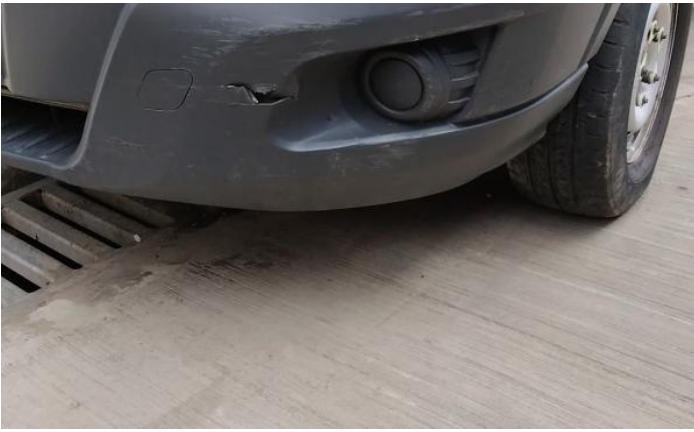
3: Bumper Front  
Hole  
Over 25mm

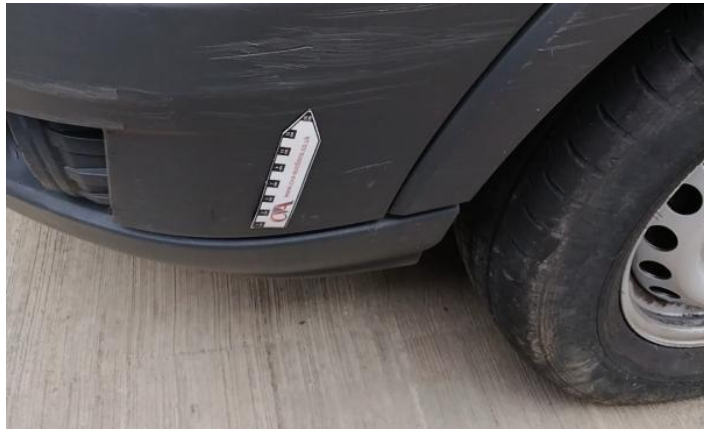
4: Bumper Front  
Scratched  
Over 100mm Thru Paint

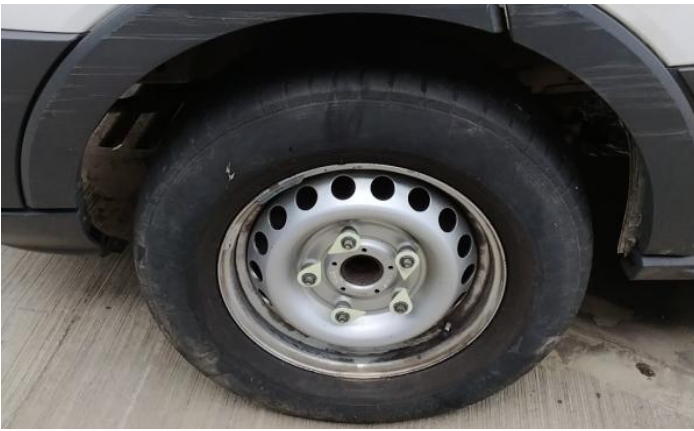
5: Wing Front Arch Extension nsf  
Scratched (Painted)  
Over 25mm Thru Paint

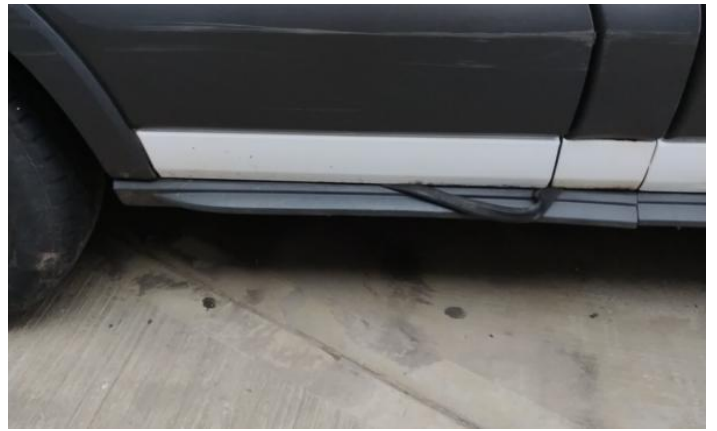
6: Door Moulding nsf  
Scratched (Painted)  
Over 25mm Thru Paint

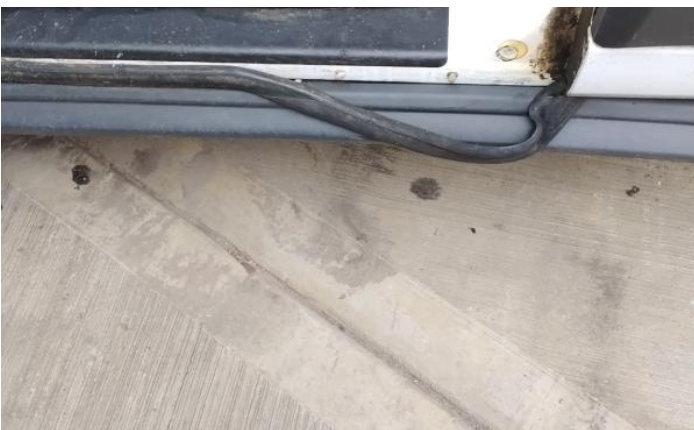
7: Aperture Seal nsf  
Broken  
Replace

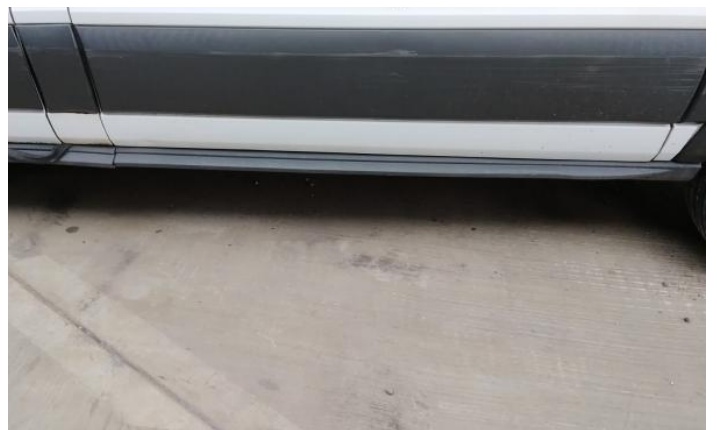
8: Qtr Panel Moulding nsf  
Scratched (Painted)  
Over 25mm Thru Paint

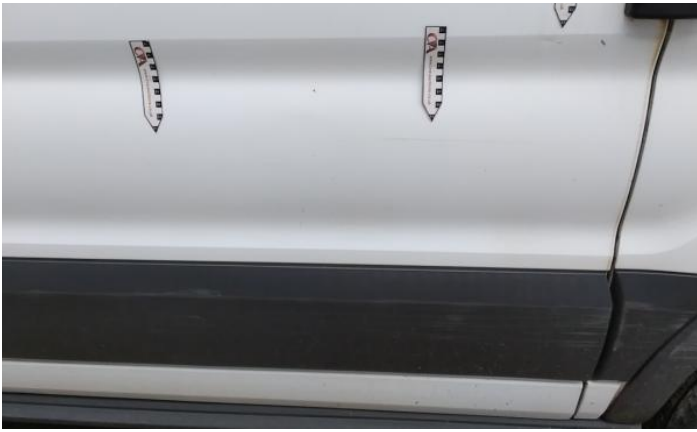
9: Qtr Panel nsr  
Scratched  
Over 25mm Thru Paint

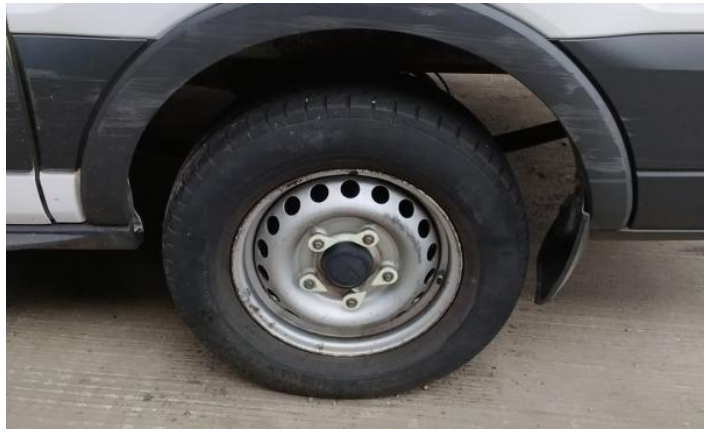
10: Qtr Panel Arch Extension ns  
Scratched (Painted)  
Over 25mm Thru Paint

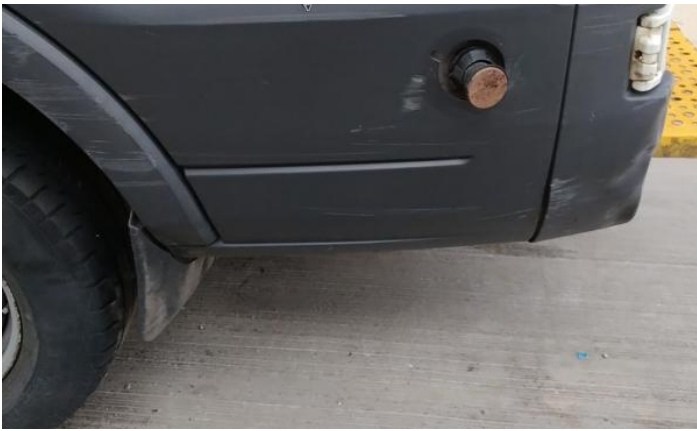
11: Qtr Panel Moulding ns  
Scratched (Painted)  
Over 25mm Thru Paint

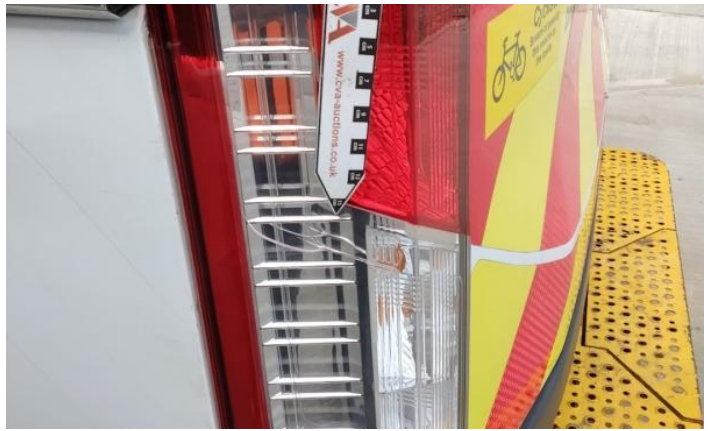
12: Lamp nsr  
Broken  
Replace

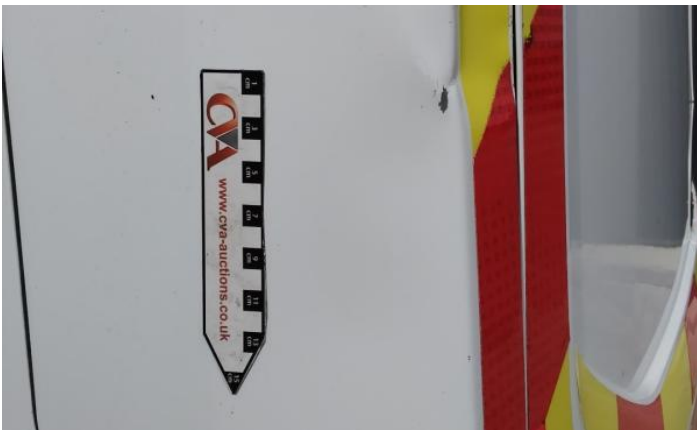
13: Panel Rear  
Dented  
With Paint Damage

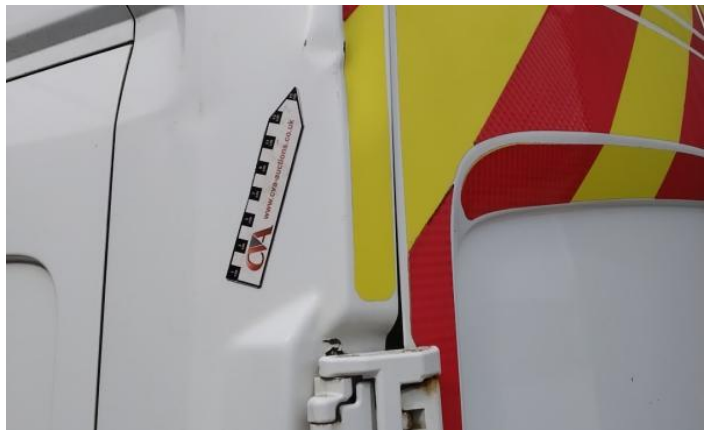
14: Panel Rear  
Dented  
With Paint Damage

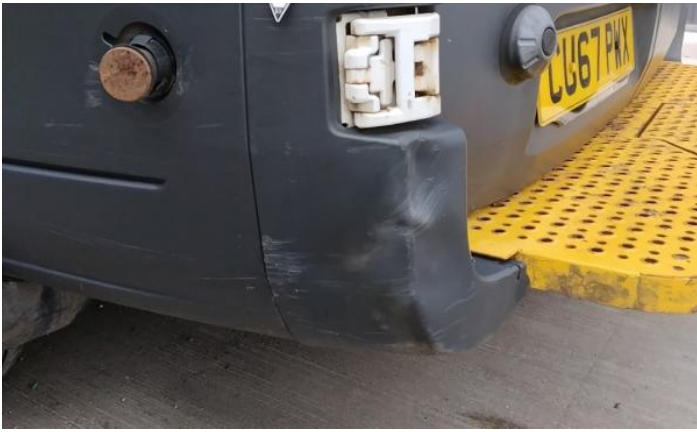
15: Bumper Rear  
Dented  
Over 30mm

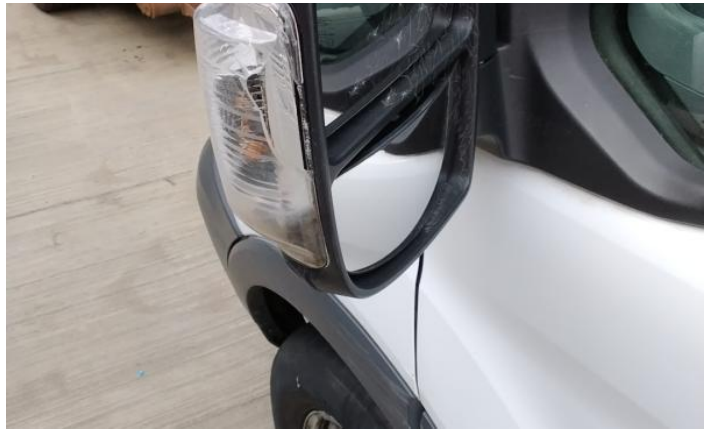
16: Door Mirror Glass ns  
Broken  
Replace

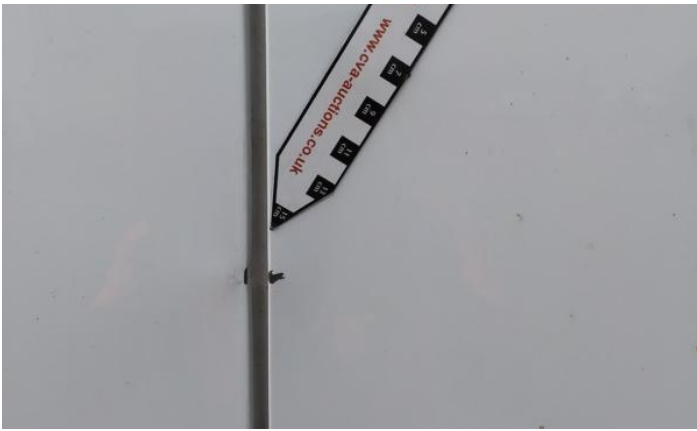
17: Door nsr  
Dented  
With Paint Damage

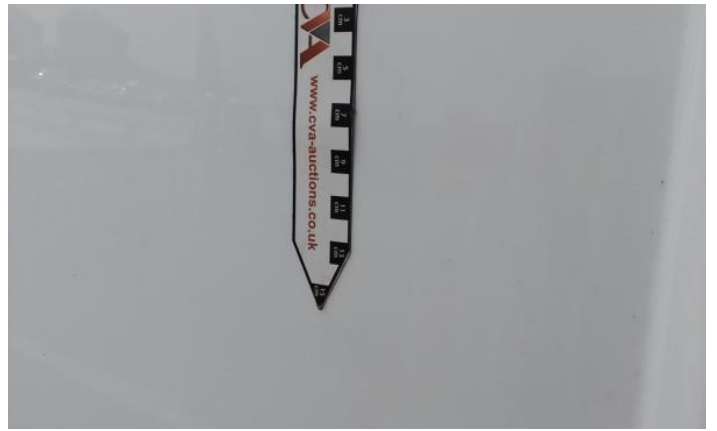
18: Door osr  
Dented  
Over 2 UpTo 10mm

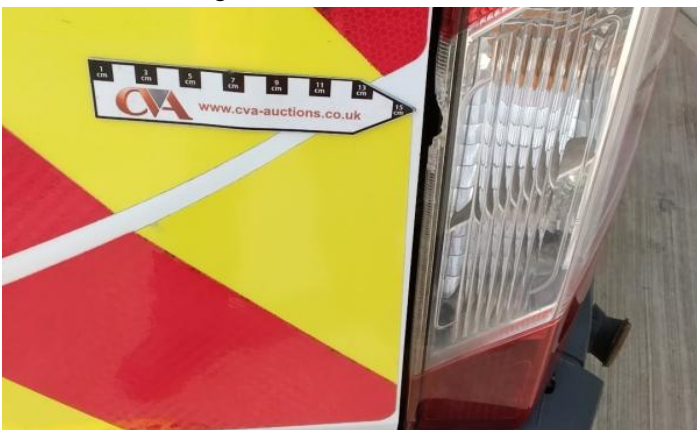
19: Lamp osr  
Broken  
Replace

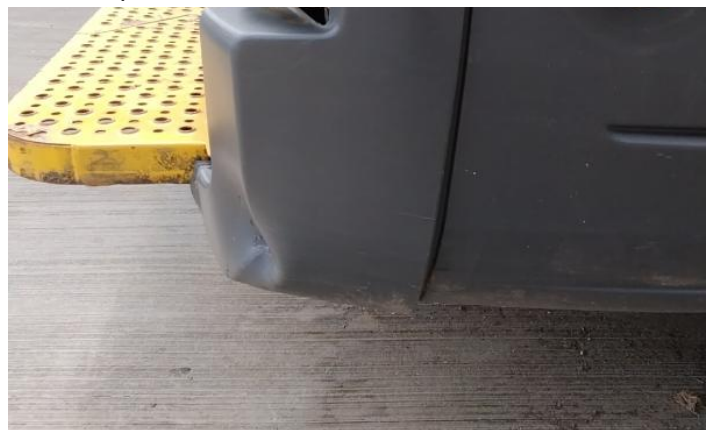
20: Bumper Rear  
Dented  
Over 30mm

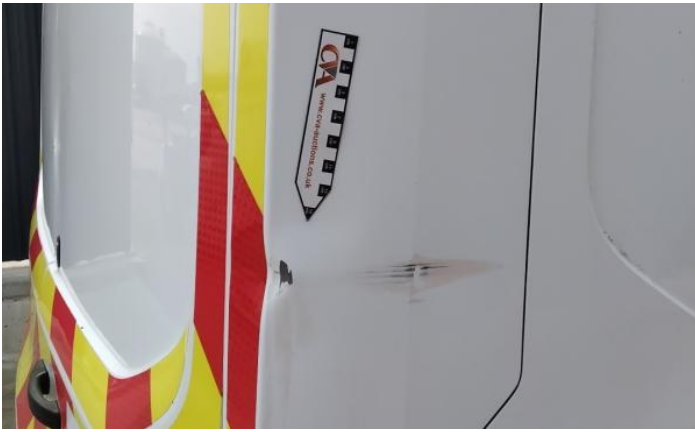
21: Panel Rear  
Dented  
With Paint Damage

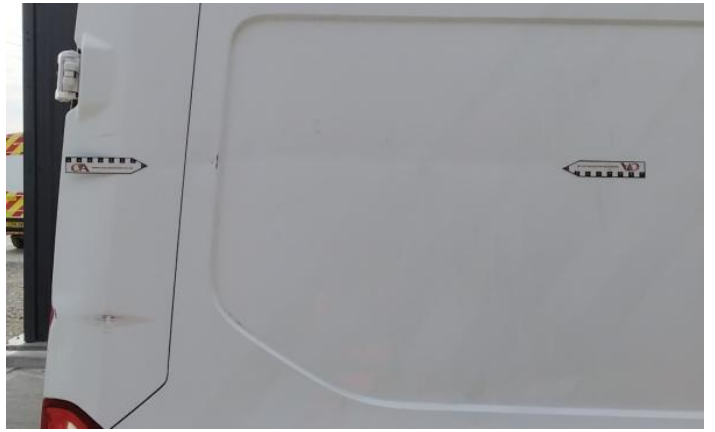
22: Qtr Panel osr  
Dented  
With Paint Damage

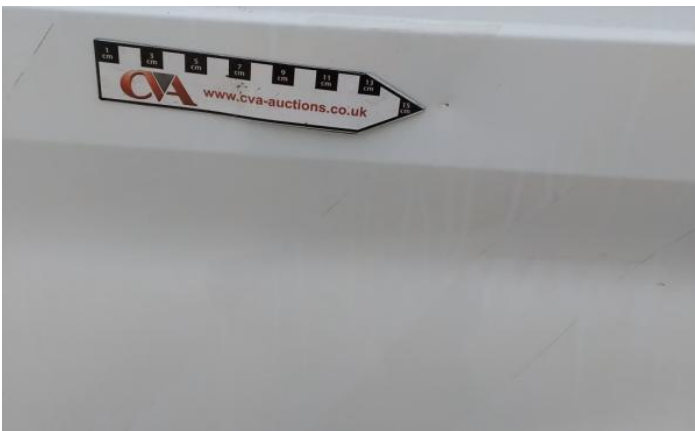
23: Qtr Panel osr  
Dented  
Between 10mm + 30mm

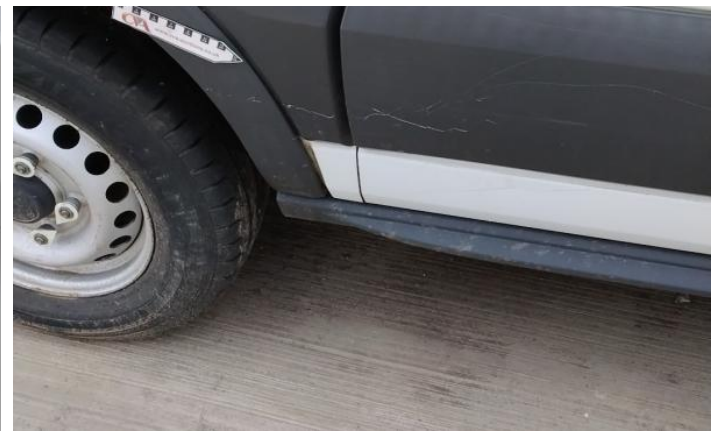
24: Qtr Panel Moulding os  
Scratched (Painted)  
Over 25mm Thru Paint

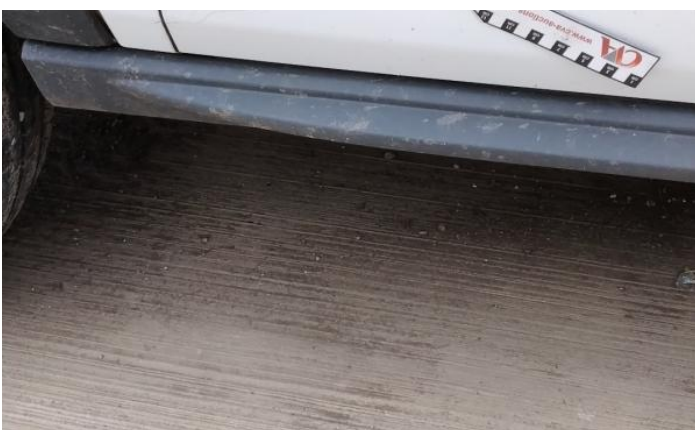
25: Qtr Panel osr  
Dented  
With Paint Damage

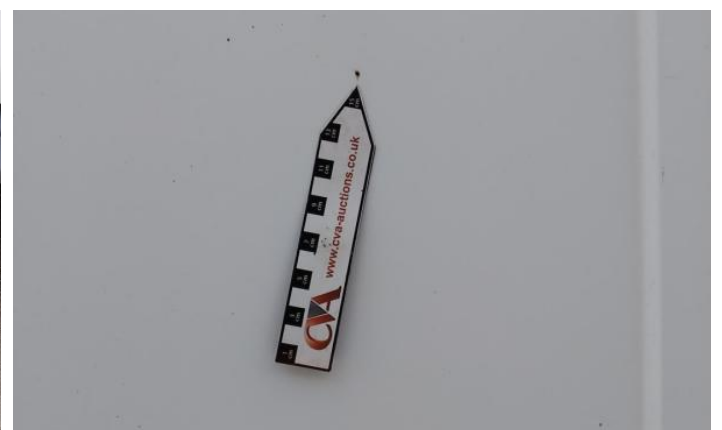
26: Qtr Panel osr  
Rusted  
Up To 5mm

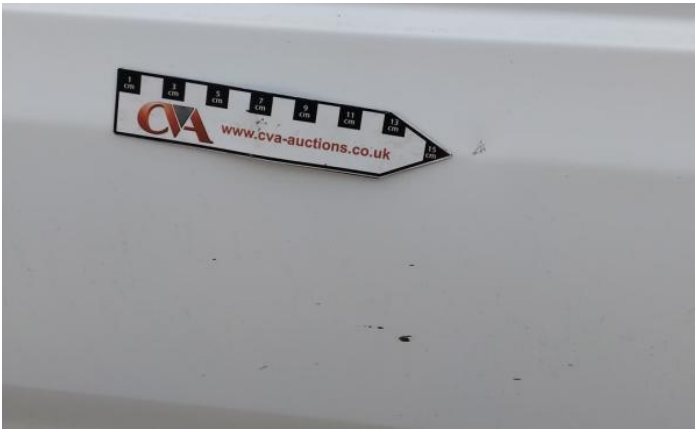
27: Qtr Panel osr  
Dented  
With Paint Damage

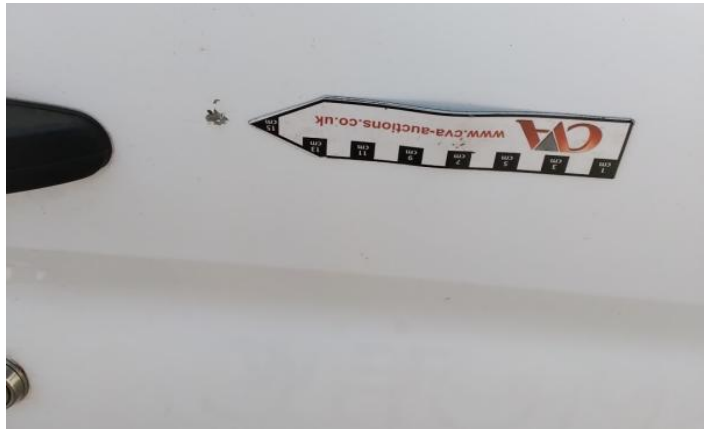
28: Door osf  
Scratched  
Over 25mm Thru Paint

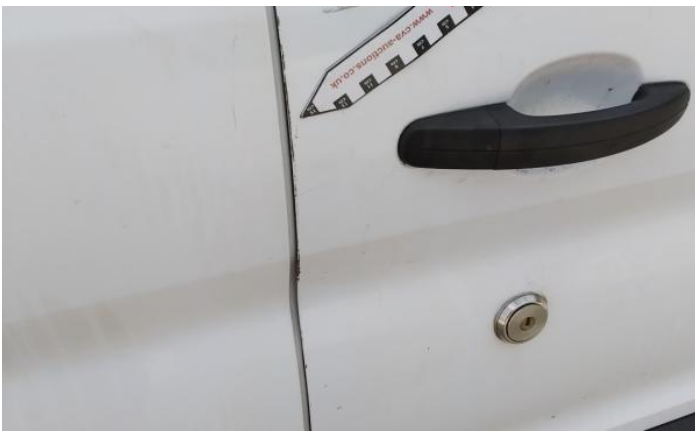
29: Door osf  
Chipped  
Multiple Chips

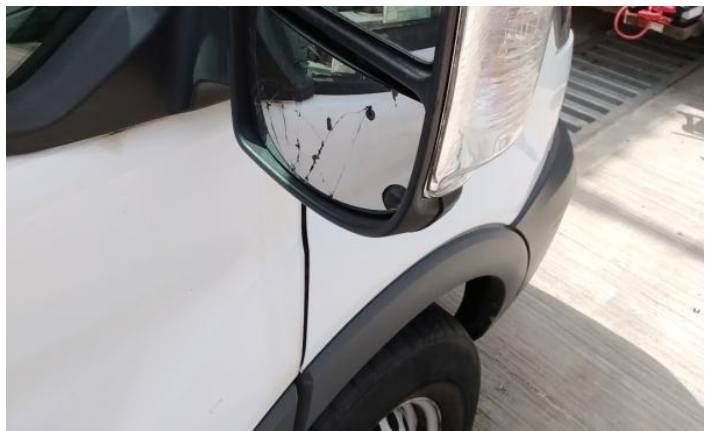
30: Door Mirror Glass os  
Broken  
Replace

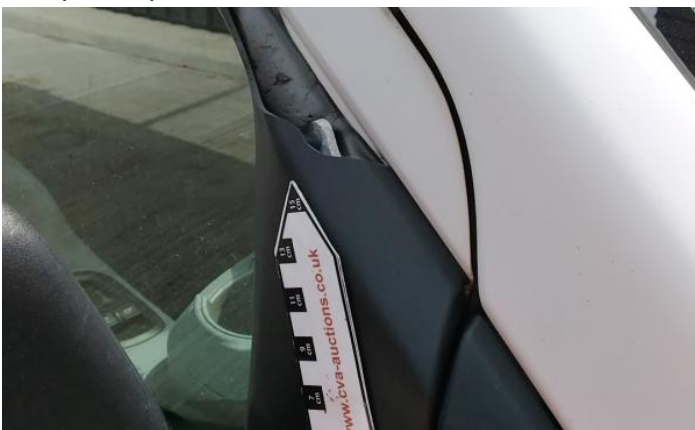
31: Door Mirror Assy osf  
Broken  
Replace

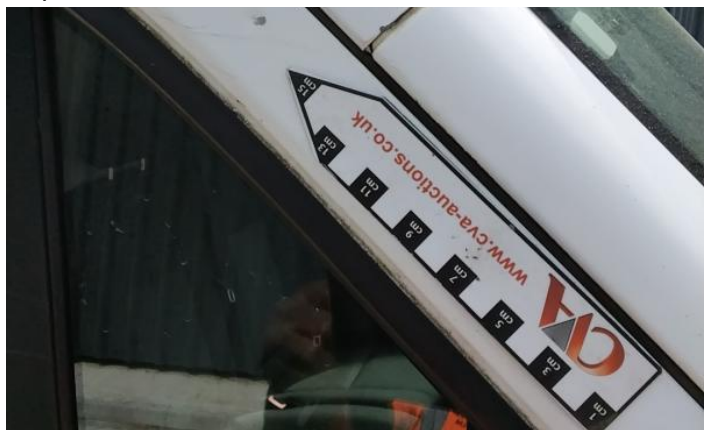
32: Door osf  
Chipped  
1 To 5

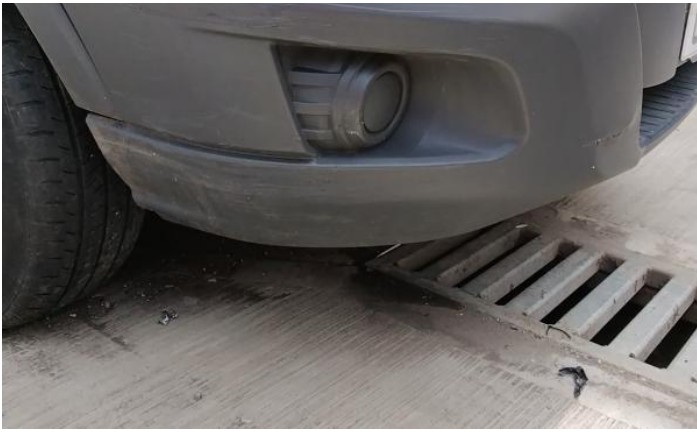
33: Bumper Front  
Scratched  
Over 100mm Thru Paint

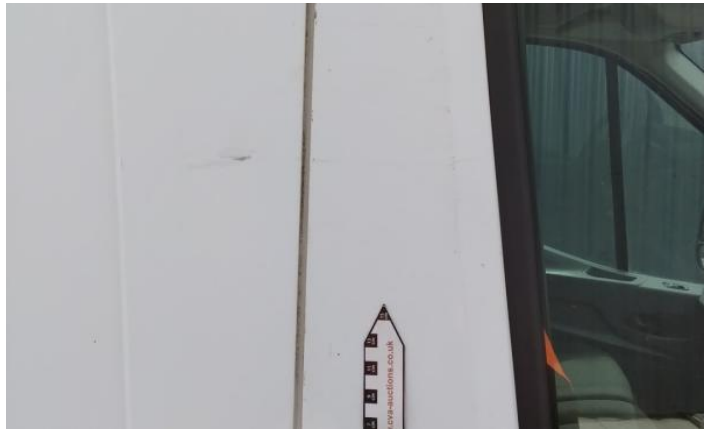
34: Door osf  
Scratched  
Over 25mm Thru Paint

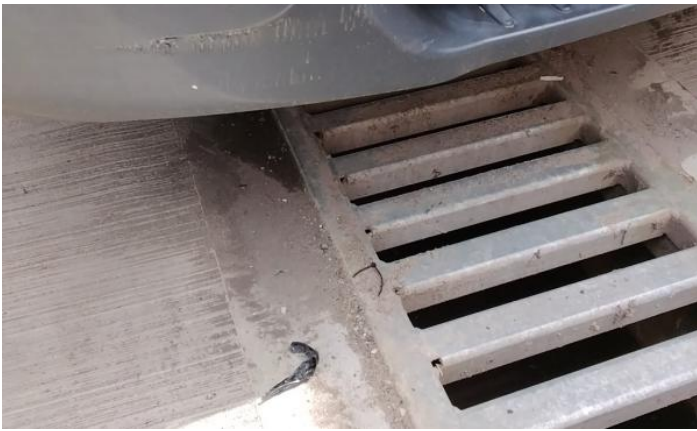
35: Bumper Front  
Scratched  
Over 100mm Thru Paint
