VEHICLE INSPECTION REPORT

KX15YMU

Mercedes-Benz Antos 1824

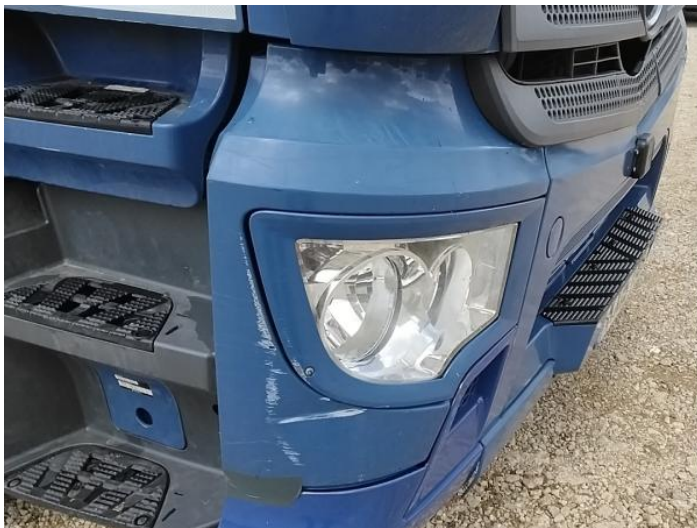
1: Wing nsf
Scratched
Over 25mm Thru Paint

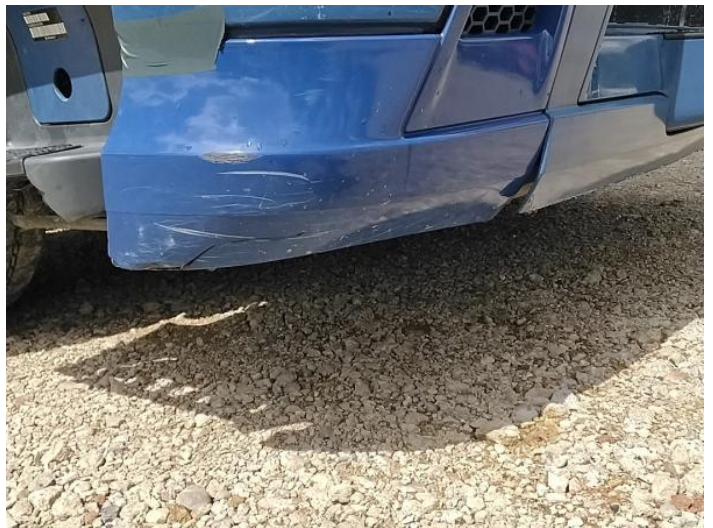
2: Bumper Front
Cracked
Over 25mm

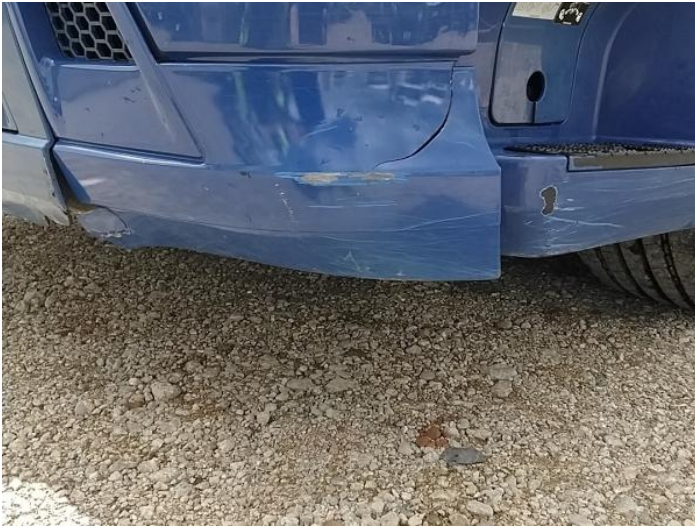
3: Bumper Front
Cracked
Over 25mm

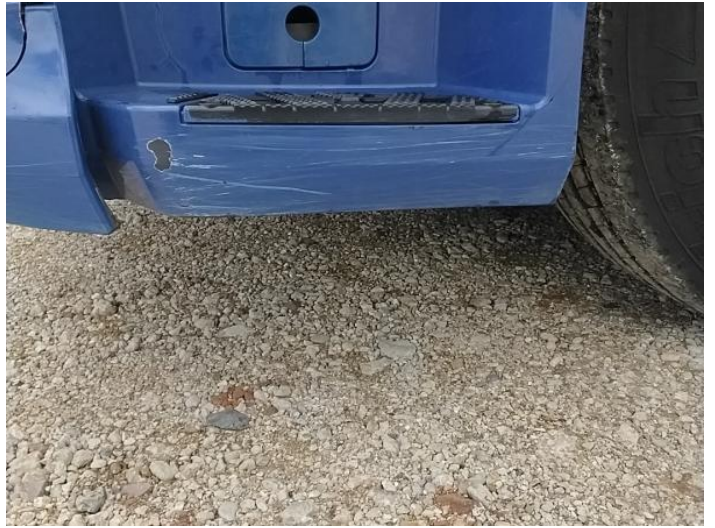
4: General Exterior
Soiled
Light

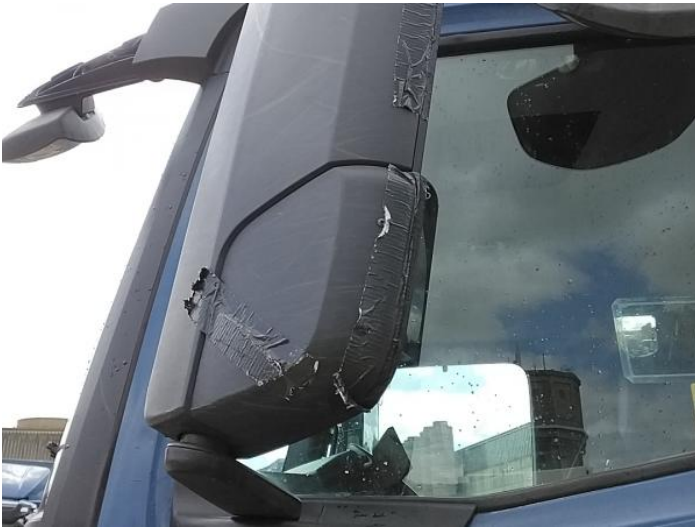
5: Door Mirror Assy nsf
Broken
Replace

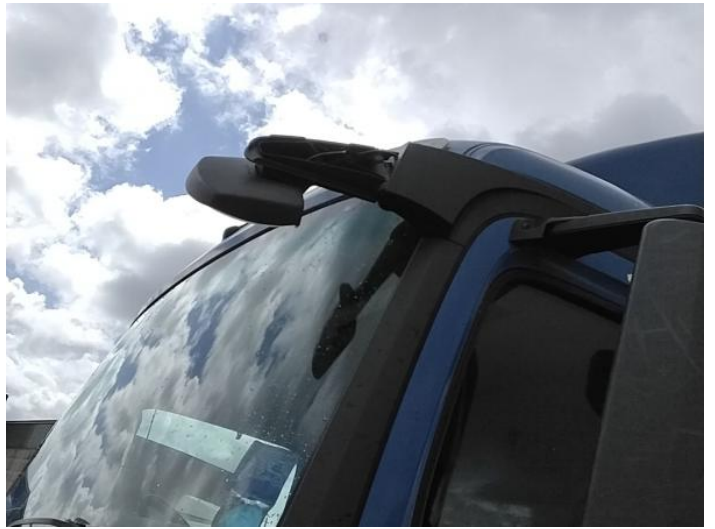
6: Door Mirror Assy nsf
Missing
Replace

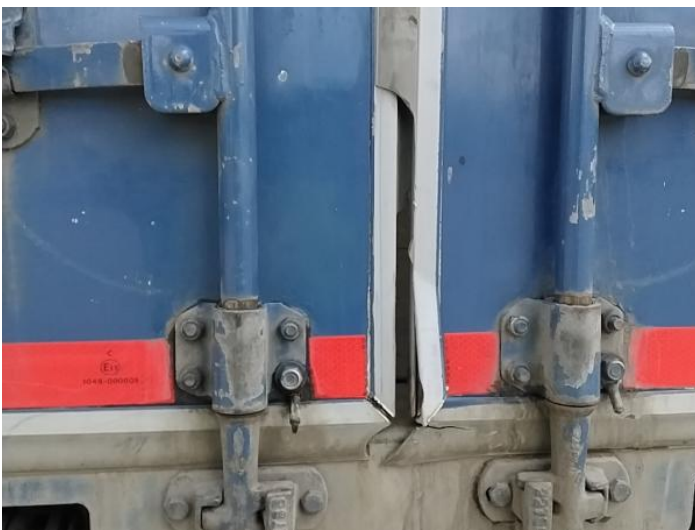
7: Door osr
Hole
Over 10mm

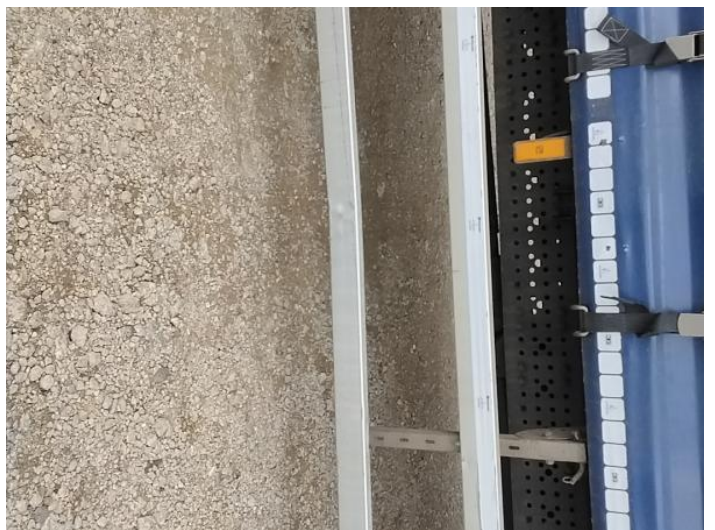
8: General Exterior
Soiled
Light

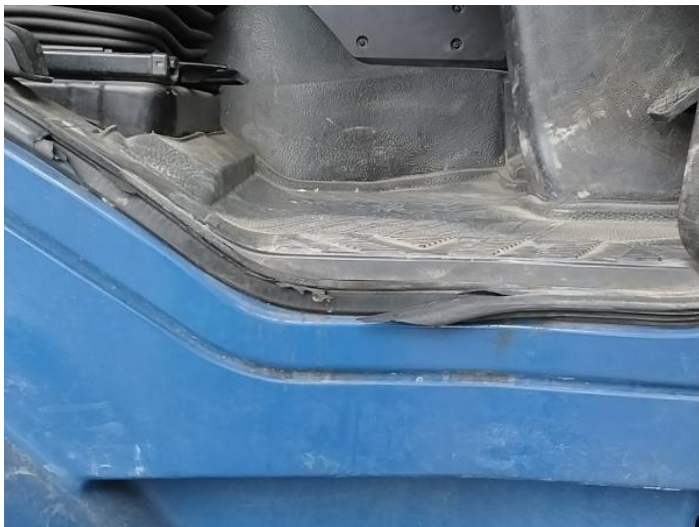
9: General Exterior
Soiled
Light

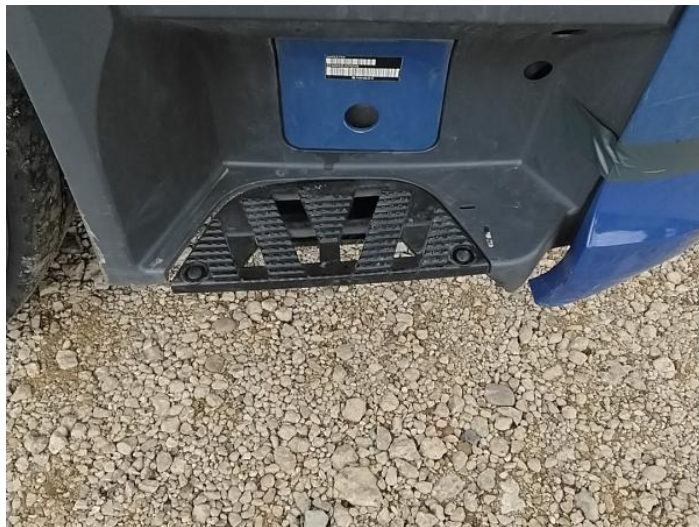
10: General Exterior
Soiled
Light

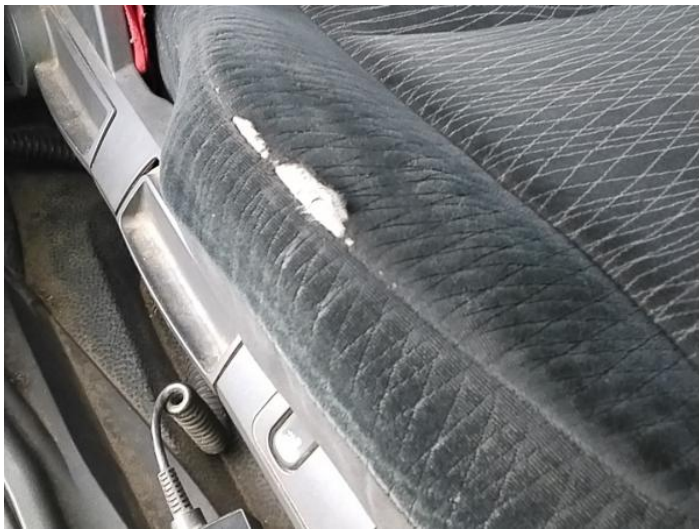
11: Seat Base Cover osf
Torn
Over 3mm
