VEHICLE INSPECTION REPORT

BJ68OEO

Mercedes-Benz Citan 109CDI

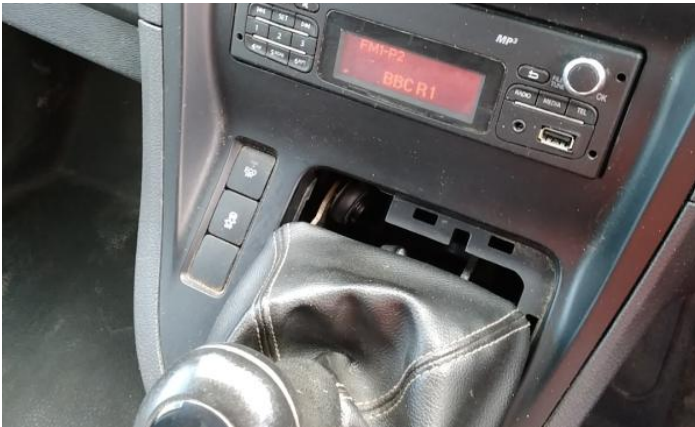
1: Fascia Trim
Damaged
Replace

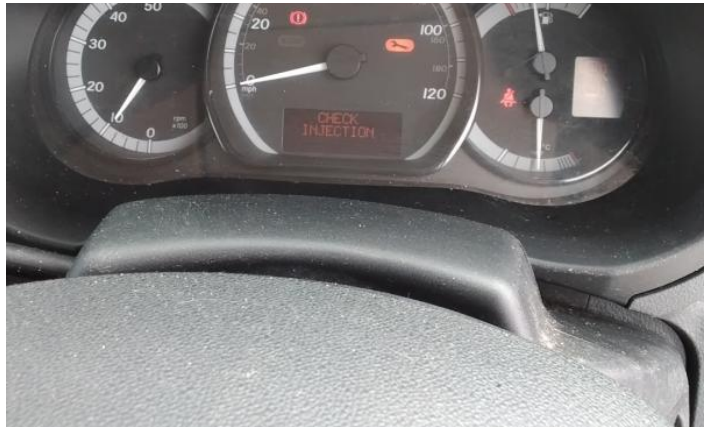
WARNING LIGHTS ON DASH, SIDE LOAD DOOR

2: Dash Warning Lights
Displayed
No Action

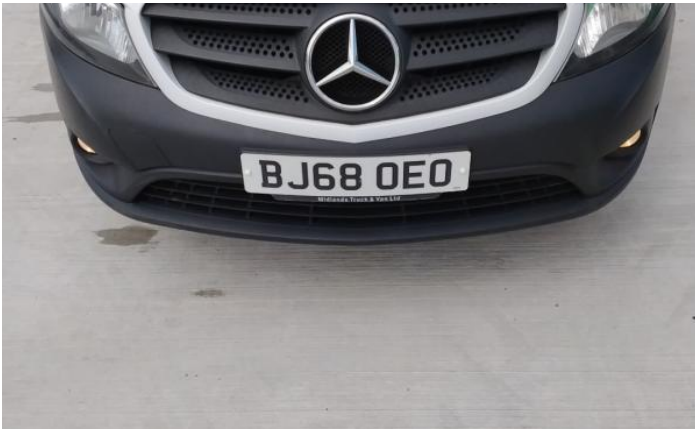
3: Bonnet
Chipped
Multiple Chips

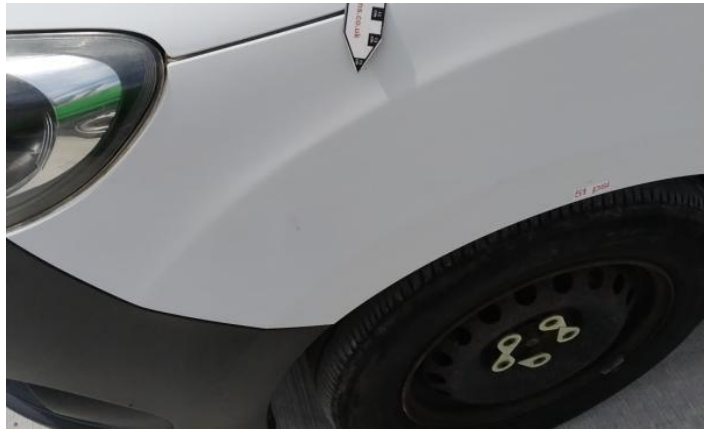
4: Wing nsf
Scratched
Over 25mm Not Thru Paint

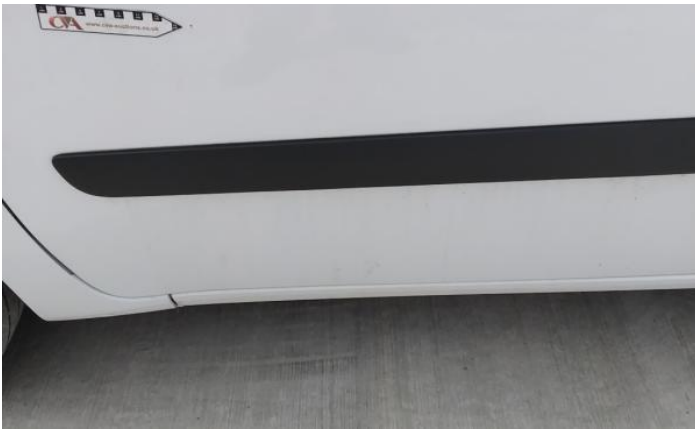
5: Door nsf
Chipped
Multiple Chips

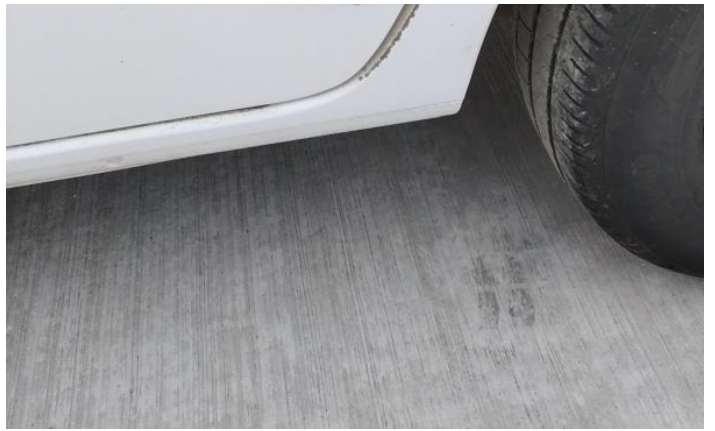
6: Qtr Panel nsr
Scratched
Over 25mm Thru Paint

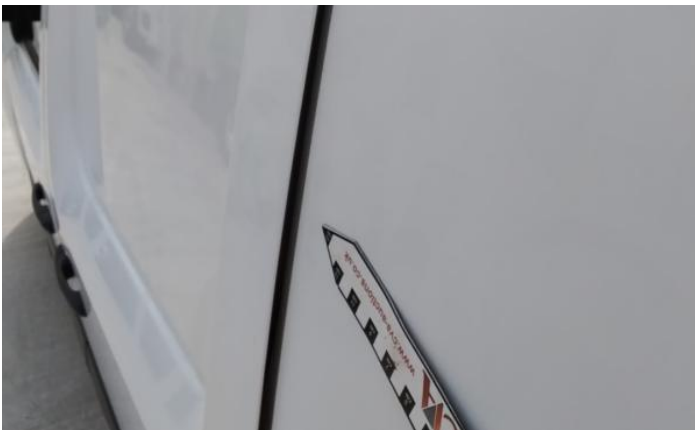
7: Qtr Panel nsr
Dented
Hail - Severe

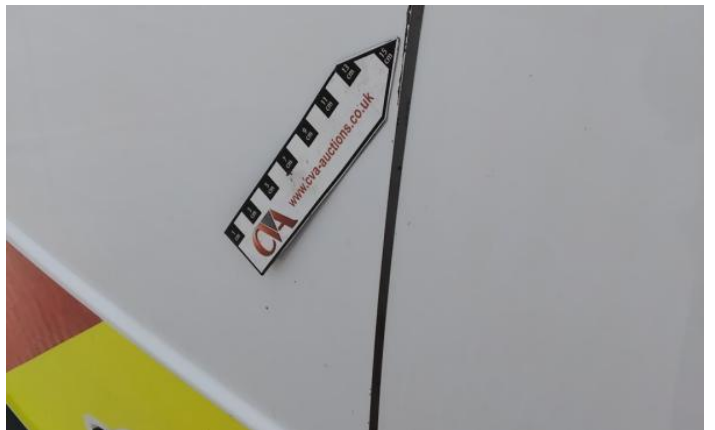
8: Door nsr
Chipped
Multiple Chips

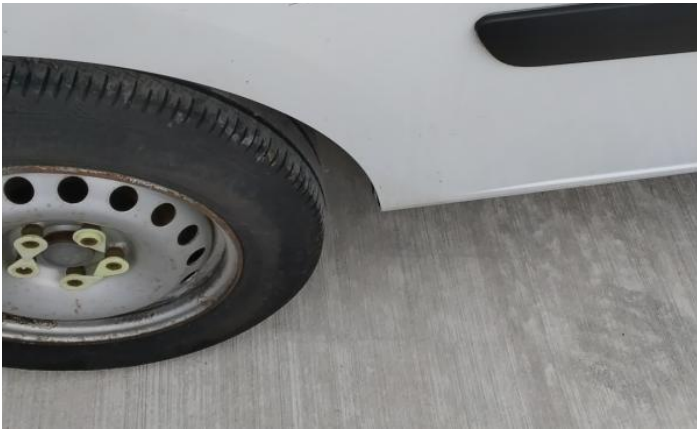
9: Qtr Panel osr
Scratched
Over 25mm Thru Paint

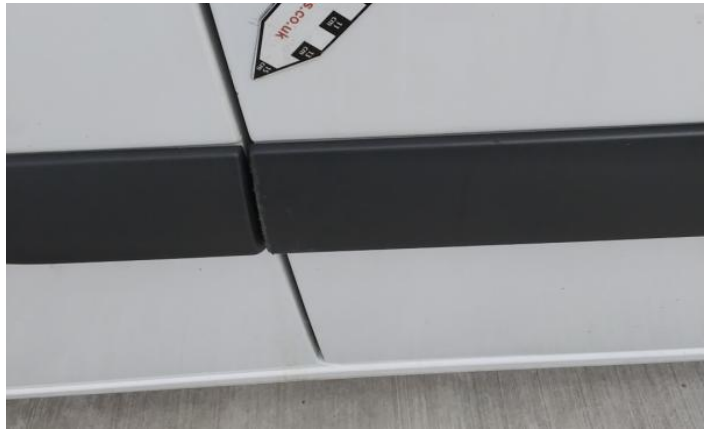
10: Door osf
Chipped
Multiple Chips

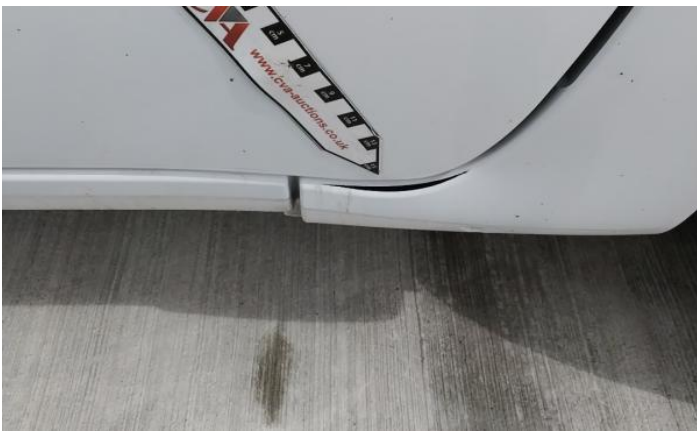
11: Moulding osf Wing
Broken
Replace

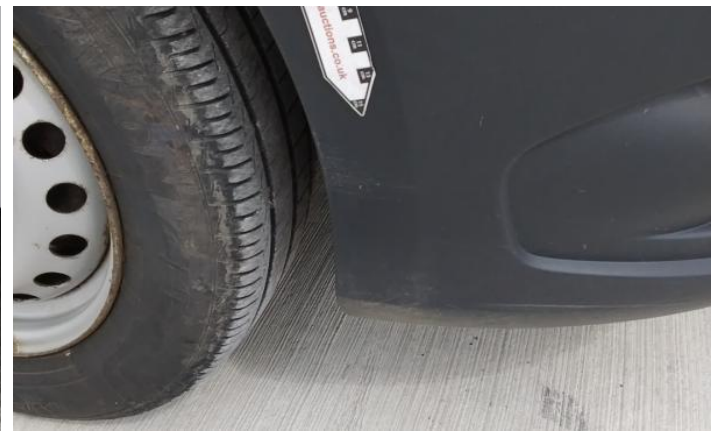
12: Bumper Front
Scratched
Over 100mm Thru Paint

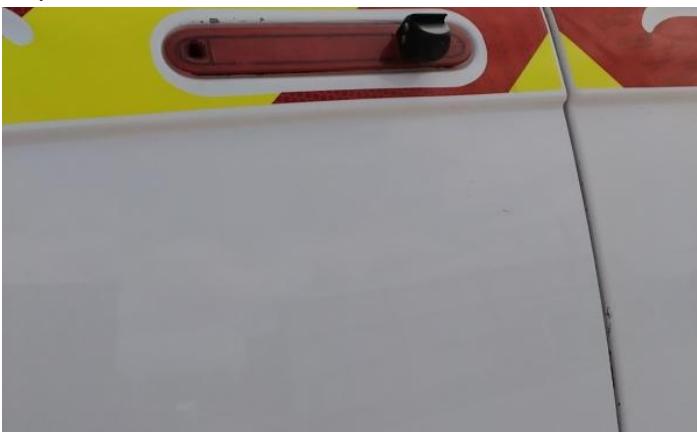
13: Lamp nsr
Broken
Replace
