# VEHICLE INSPECTION REPORT

**NU21XMJ**

## Iveco Stralis 460

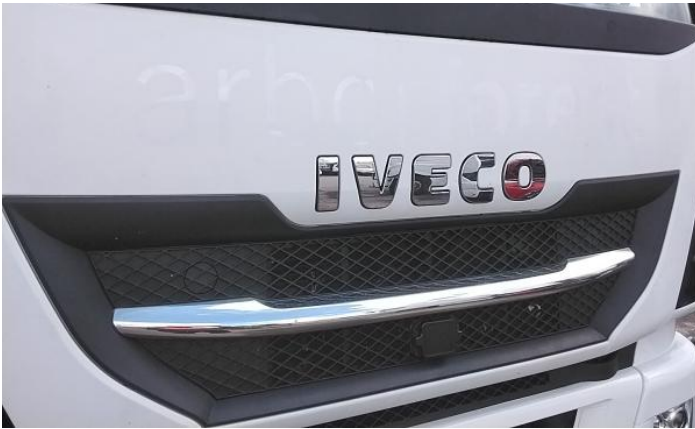
1: Bonnet  
Chipped  
Multiple Chips

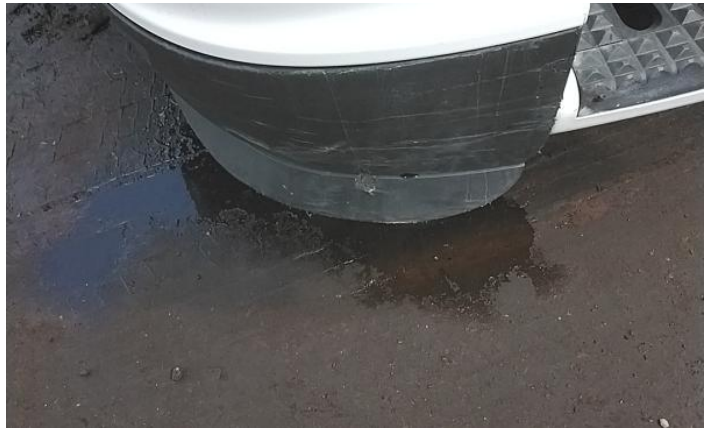
2: Bumper Front  
Scratched  
Over 100mm Thru Paint

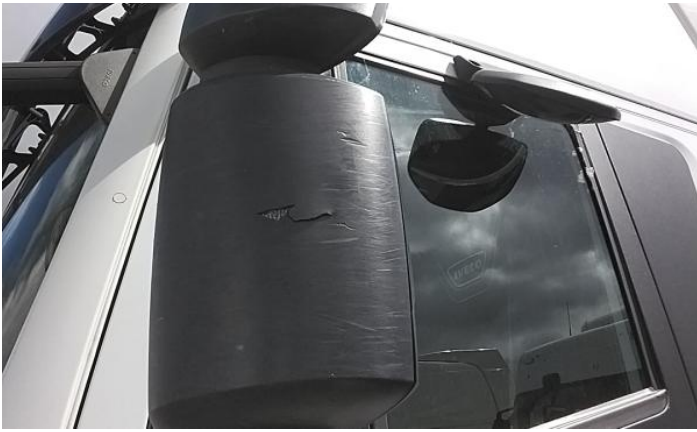
3: Door Mirror Assy nsf  
Broken  
Replace

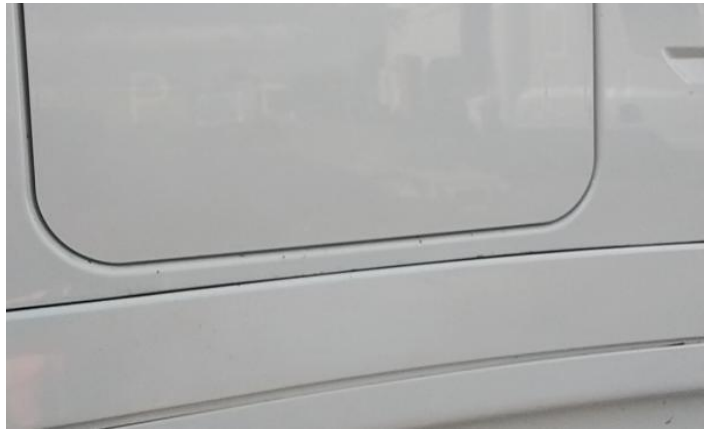
4: Qtr Panel osr  
Chipped  
Multiple Chips

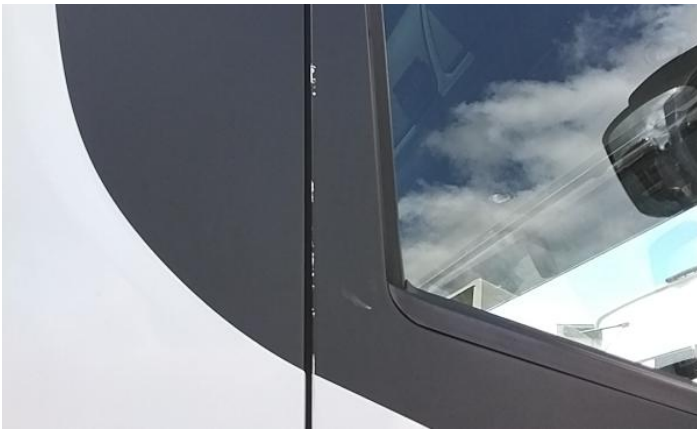
5: Door osf  
Scratched  
Over 25mm Thru Paint

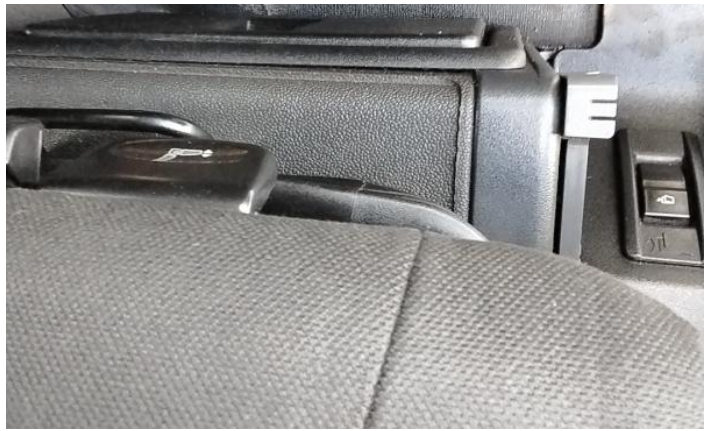
6: Seat Base Cover osf  
Burn  
Over 3mm
