# VEHICLE INSPECTION REPORT

**MJ07HHU**

## Ford Transit T350 2.4 TDCI 115PS

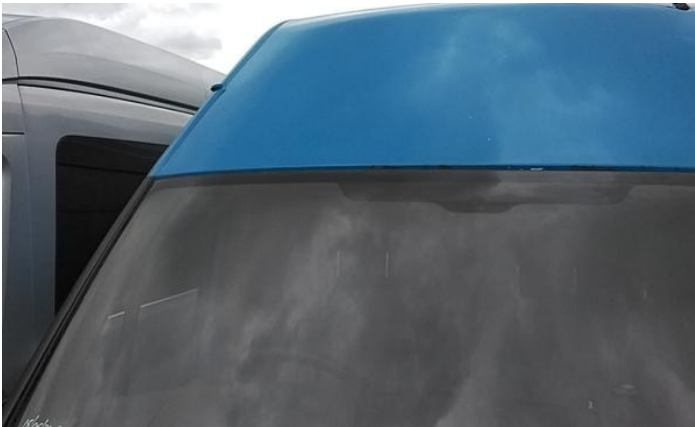
1: Roof  
Dented  
Over 30mm

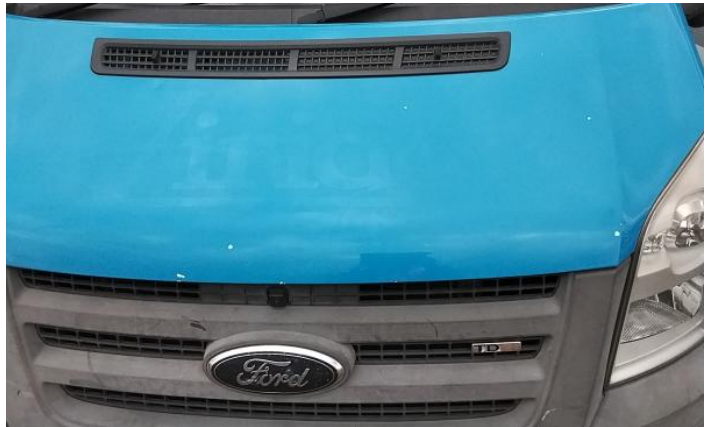
2: Bonnet  
Chipped  
Multiple Chips

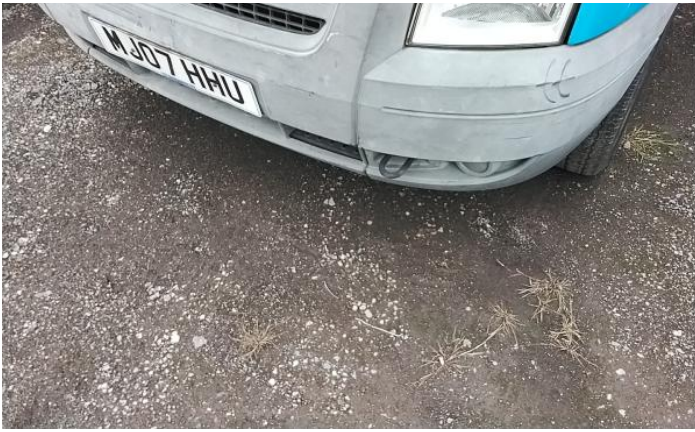
3: Bumper Front  
Scratched  
Over 100mm Thru Paint

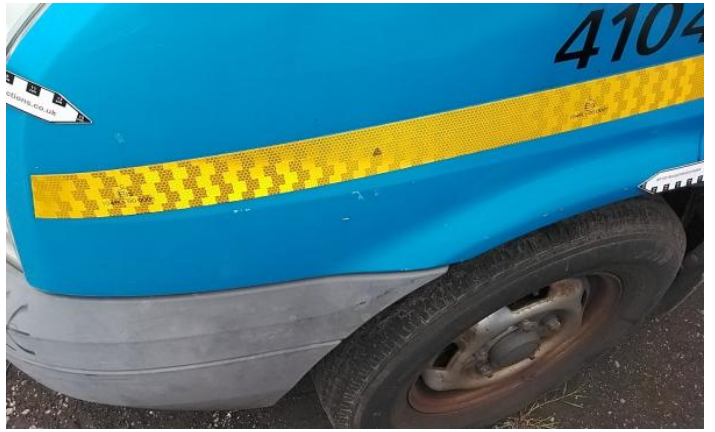
4: Wing nsf  
Scratched  
Over 25mm Thru Paint

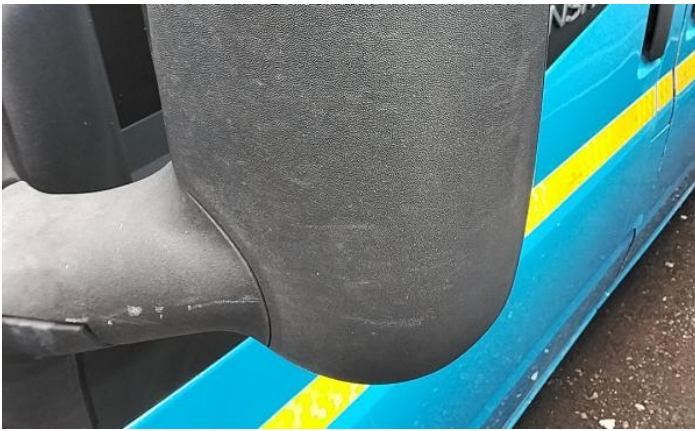
5: Door Mirror Assy nsf  
Scuffed (Unpainted)  
Over 100mm

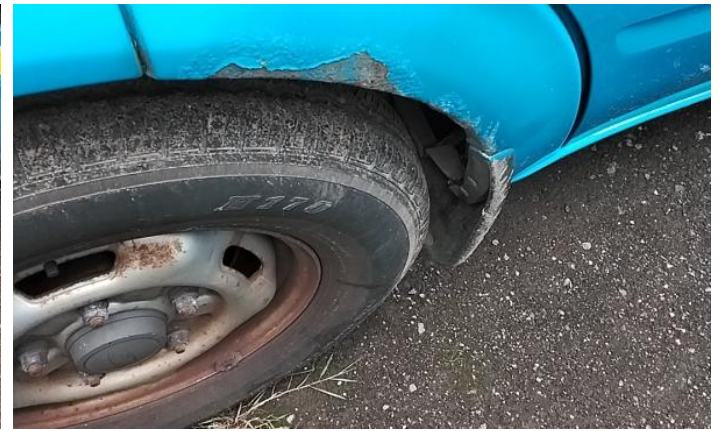
6: Wing nsf  
Rusted  
Over 5mm

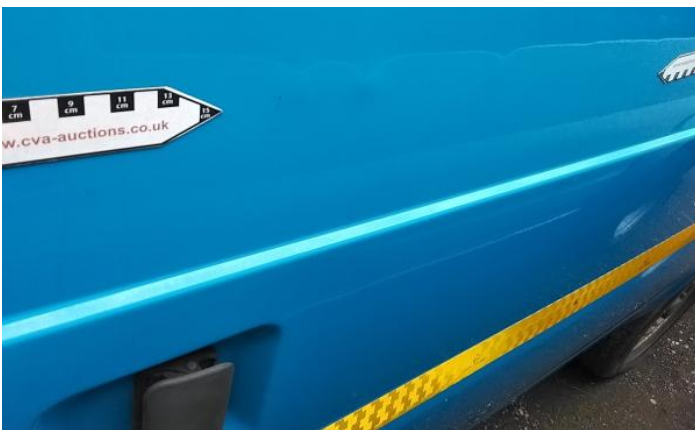
7: Qtr Panel nsr  
Dented  
Over 30mm

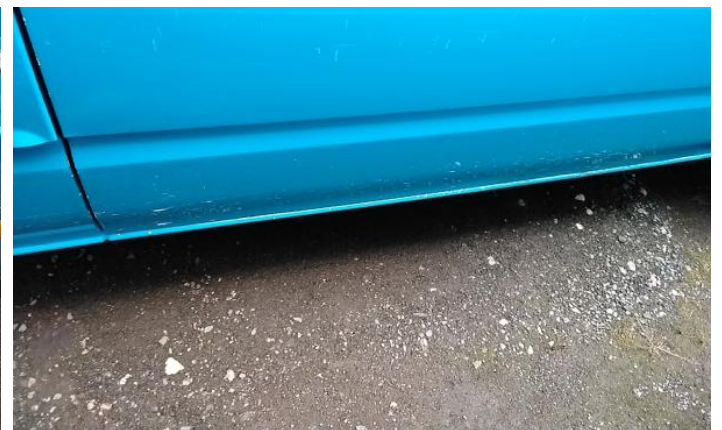
8: Qtr Panel nsr  
Chipped  
Multiple Chips

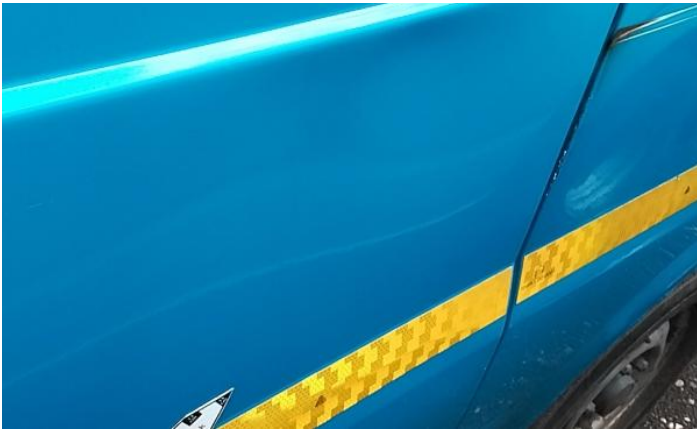
9: Qtr Panel nsr  
Dented  
Over 30mm

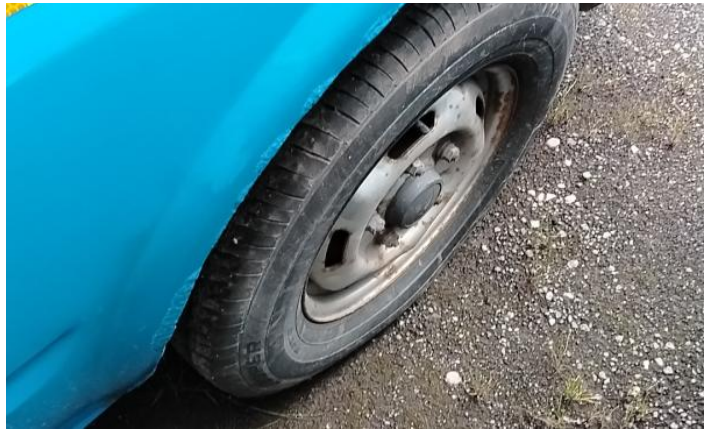
10: Qtr Panel nsr  
Rusted  
Over 5mm

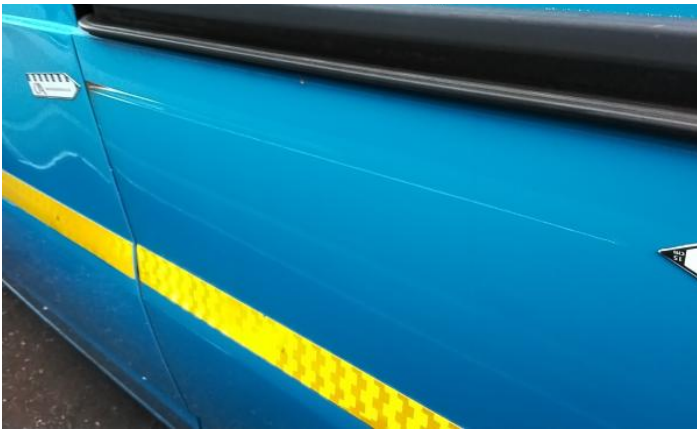
11: Qtr Panel nsr  
Scratched  
Over 25mm Thru Paint

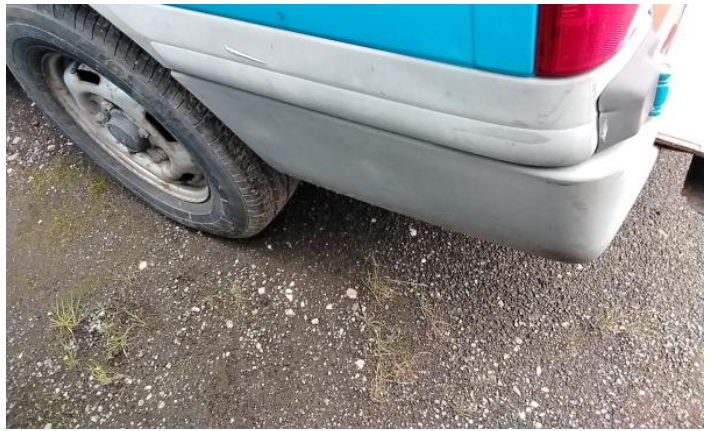
12: Qtr Panel Moulding ns  
Scuffed (Unpainted)  
Over 100mm

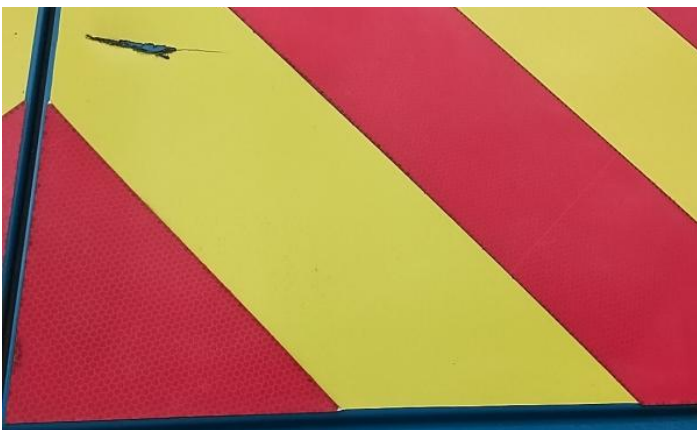
13: Door osr  
Dented  
With Paint Damage

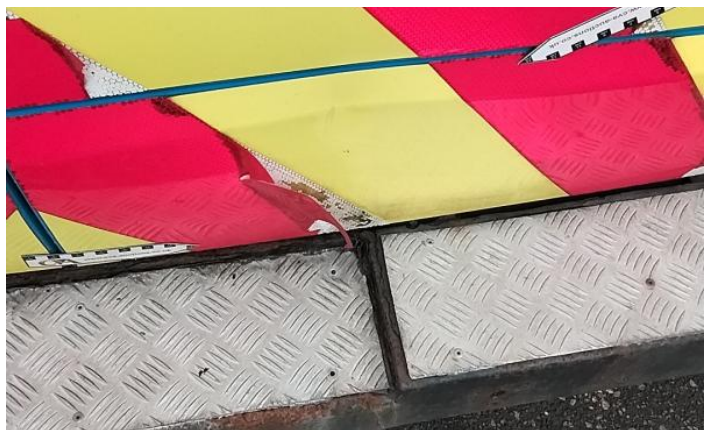
14: Door osr  
Dented  
Over 30mm

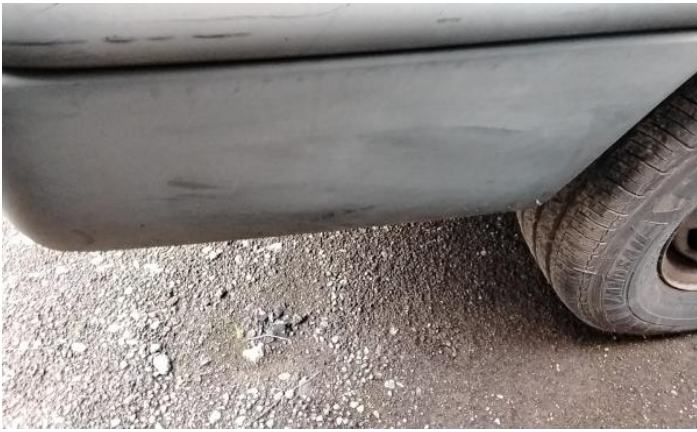
15: Qtr Panel Moulding os  
Scuffed (Unpainted)  
Over 100mm

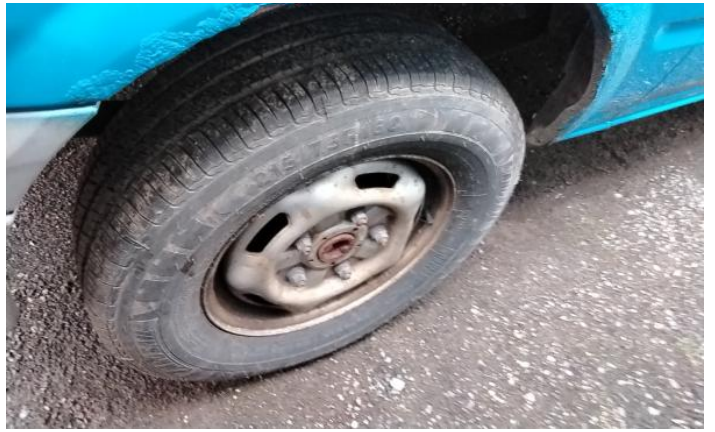
16: Qtr Panel osr  
Rusted  
Over 5mm

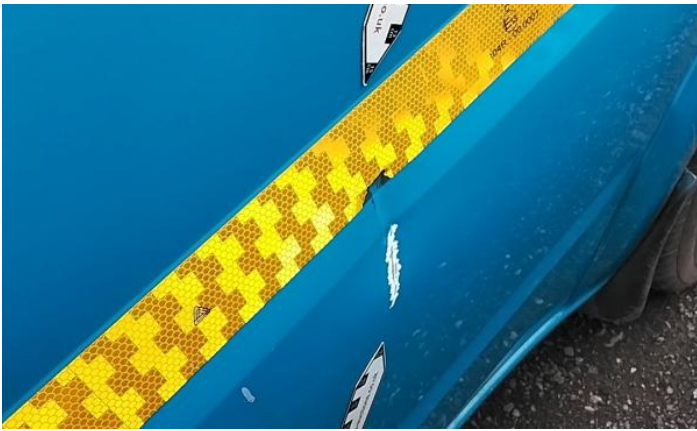
17: Door osf  
Dented  
With Paint Damage

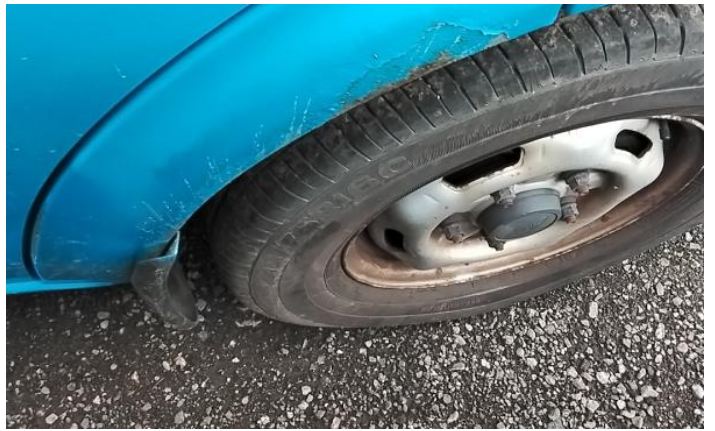
18: Wing osf  
Rusted  
Over 5mm

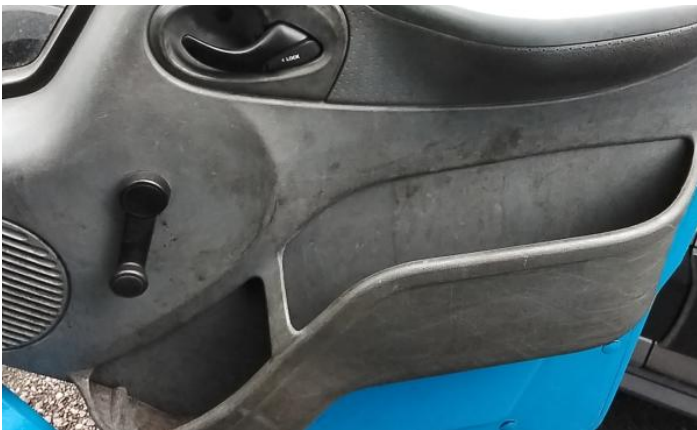
19: Door Pad osf  
Soiled  
Heavy

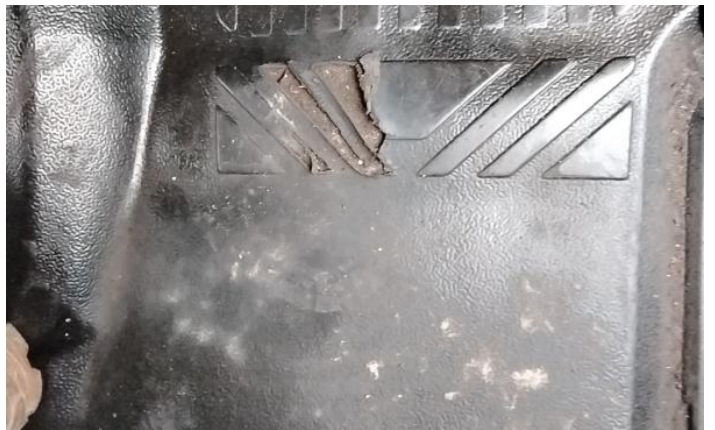
20: Carpets Front  
Torn  
Over 10mm

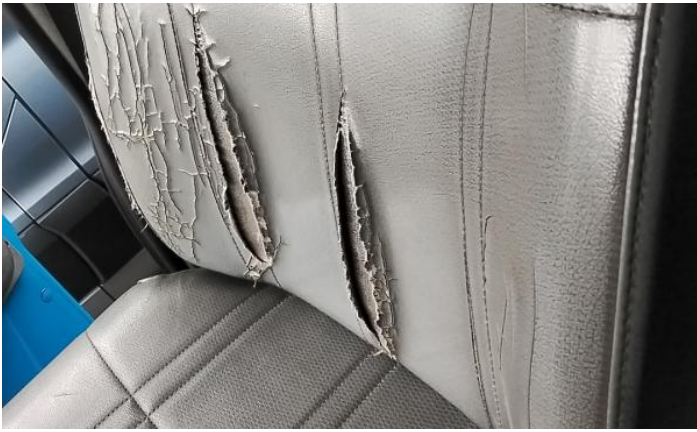
21: Seat Back Cover osf  
Torn  
Over 3mm

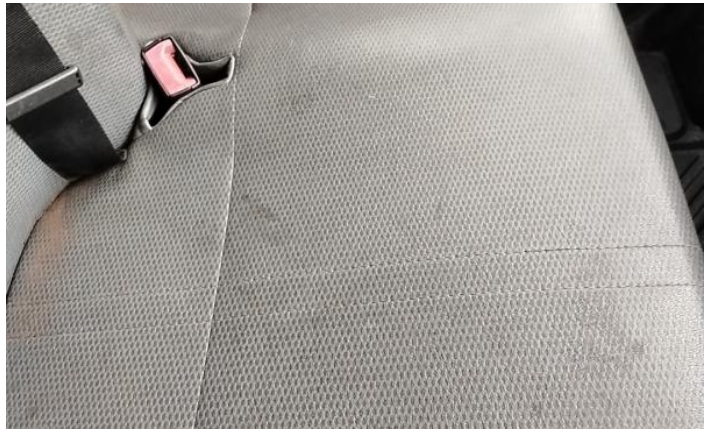
22: Seat Base Cover nsf  
Soiled  
Heavy

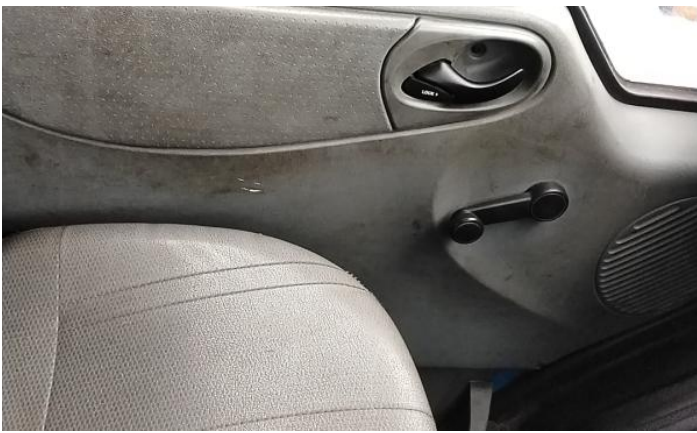
23: Door Pad nsf  
Soiled  
Heavy
