# VEHICLE INSPECTION REPORT

**BX67CSZ**

## Renault Master 35 2.3 DCI 135PS

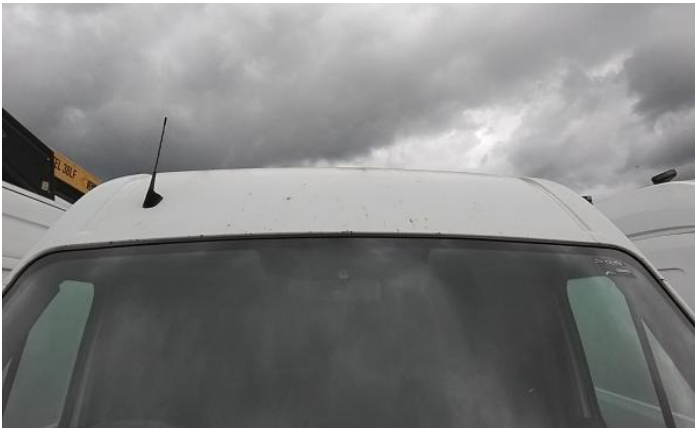
1: Roof  
Chipped  
Multiple Chips

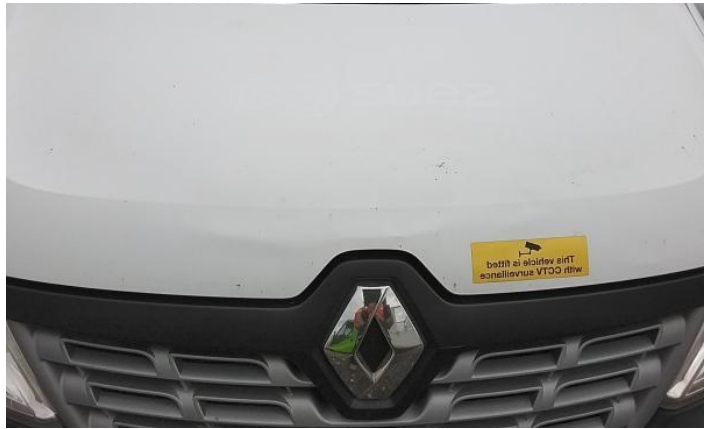
2: Bonnet  
Chipped  
Multiple Chips

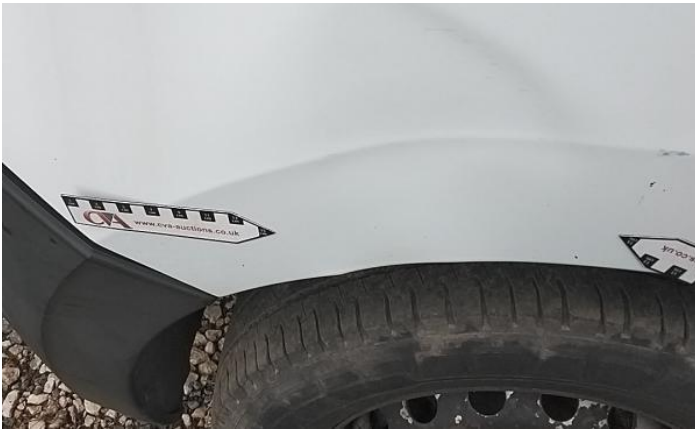
3: Wing nsf  
Dented  
With Paint Damage

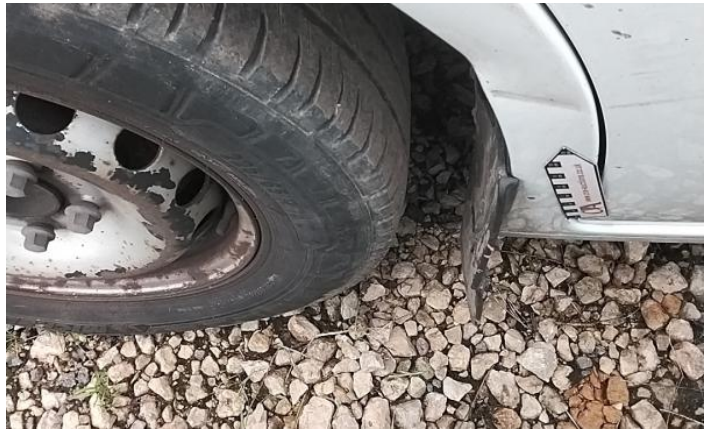
4: Wing nsf  
Dented  
With Paint Damage

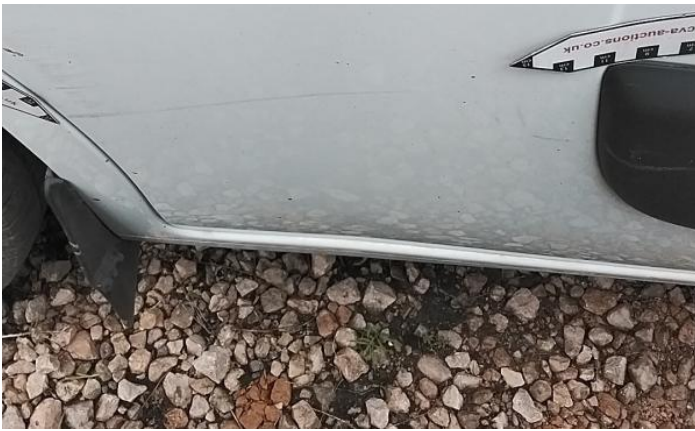
5: Door nsf  
Scratched  
Over 25mm Not Thru Paint

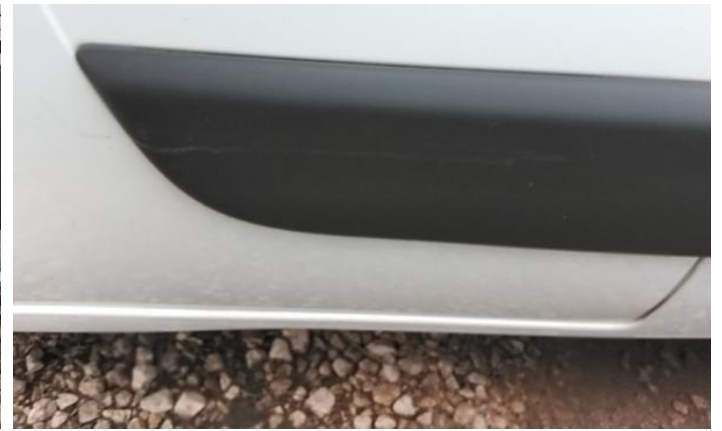
6: Door Moulding nsf  
Scuffed (Unpainted)  
Over 100mm

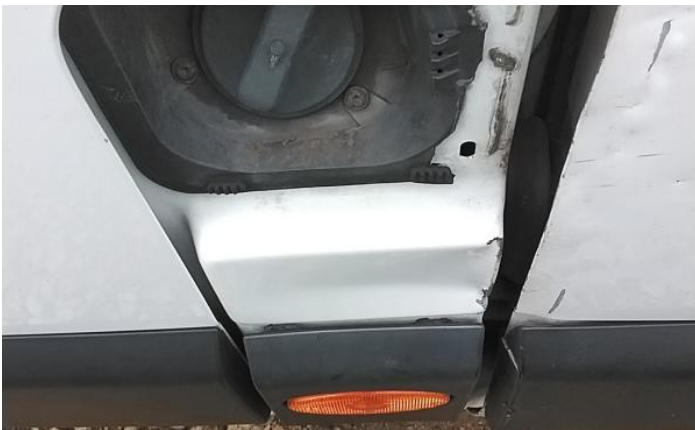
7: Fuel Flap  
Missing  
Replace

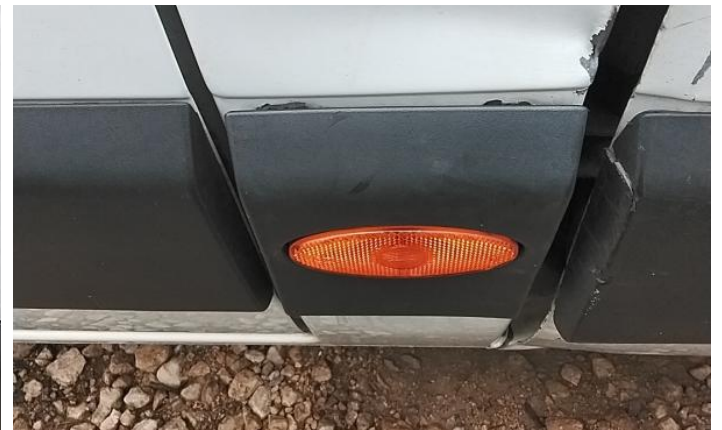
8: B Post ns  
Dented  
With Paint Damage

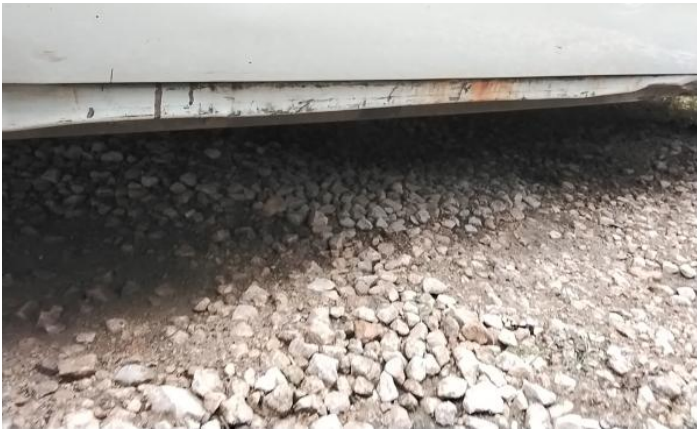
9: Sill ns  
Dented  
Over 30% Of Panel

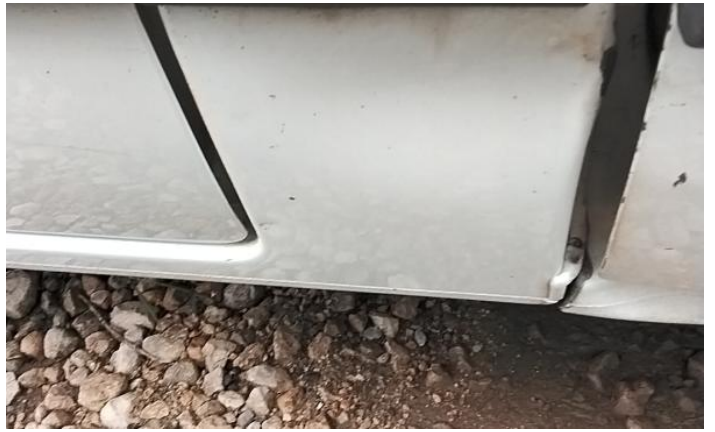
10: B Post ns  
Dented  
Over 30mm

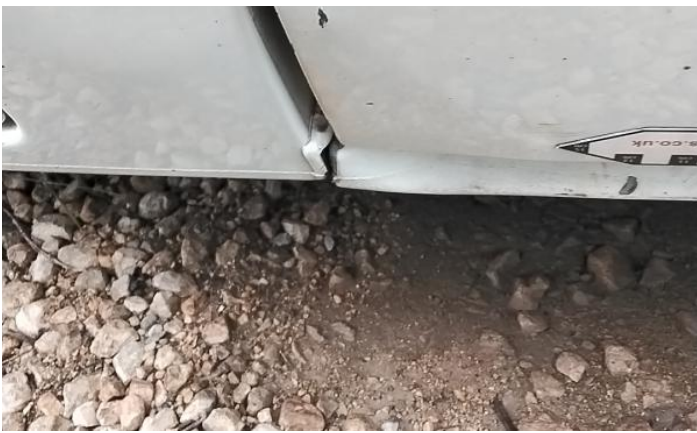
11: Qtr Panel nsr  
Dented  
Over 30mm

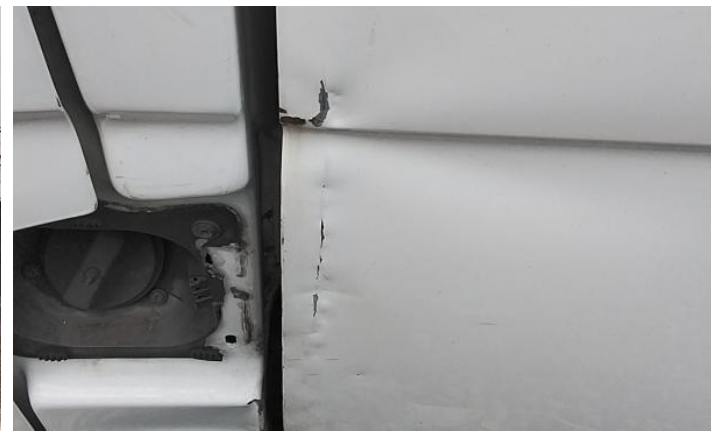
12: Qtr Panel nsr  
Dented  
With Paint Damage

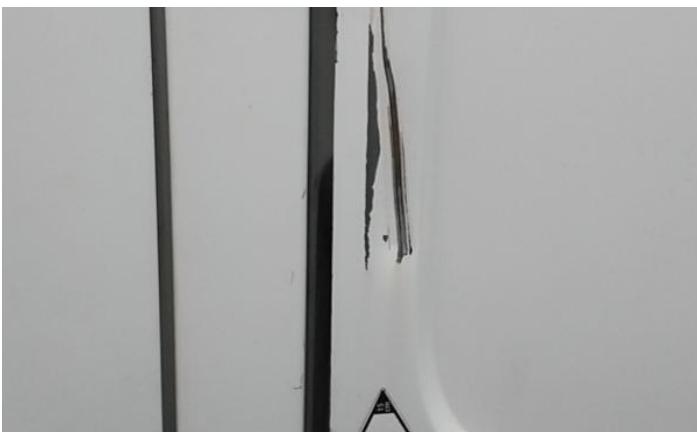
13: Qtr Panel nsr  
Dented  
With Paint Damage

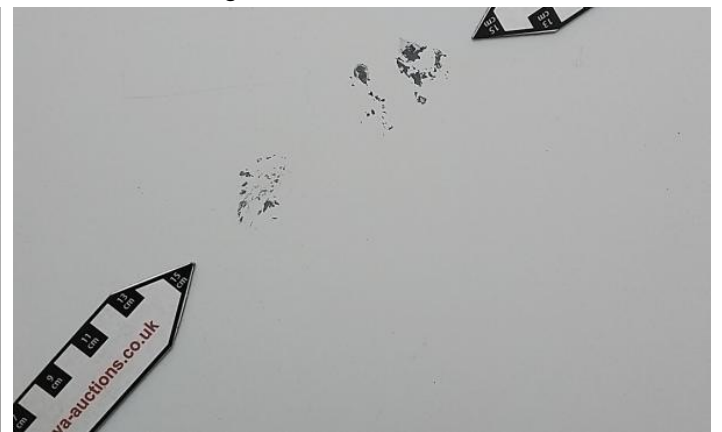
14: Qtr Panel nsr  
Scratched  
Over 25mm Thru Paint

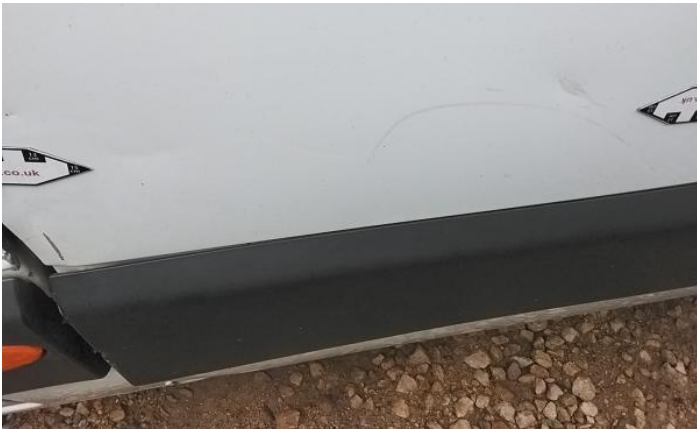
15: Qtr Panel nsr  
Dented  
With Paint Damage

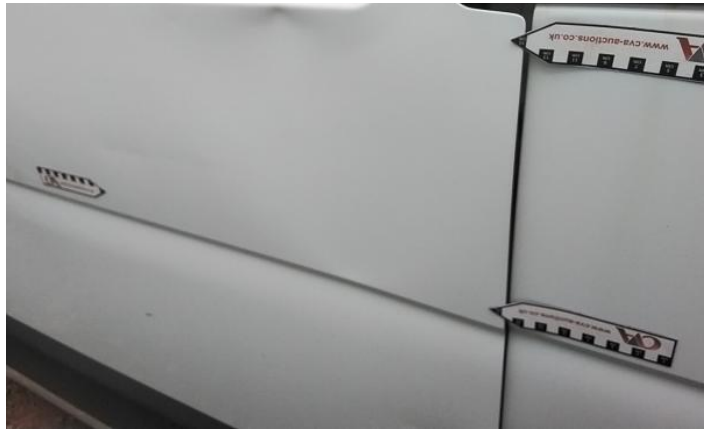
16: Qtr Panel nsr  
Dented  
Over 30mm

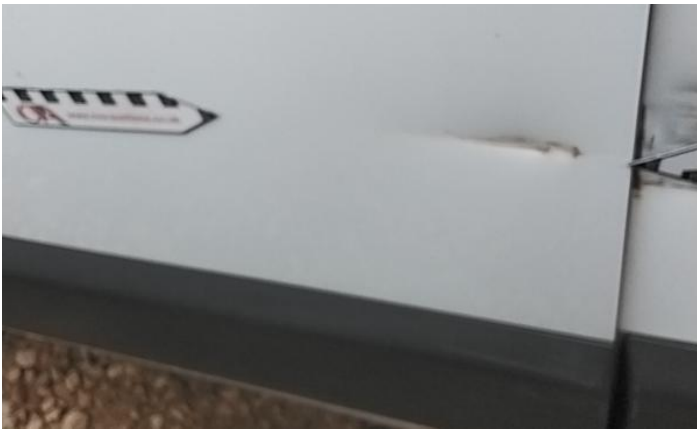
17: Qtr Panel nsr  
Dented  
With Paint Damage

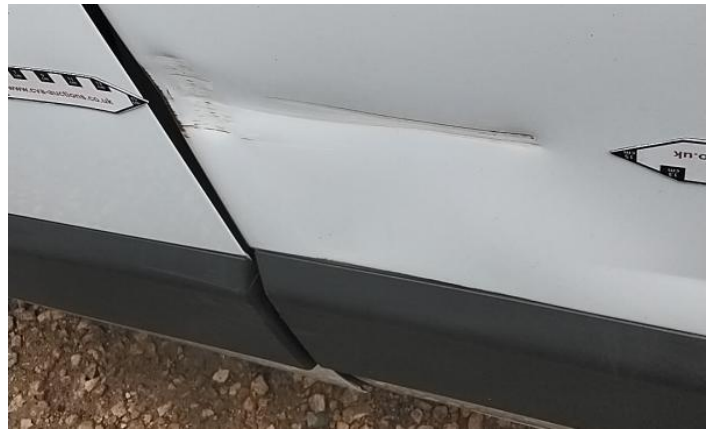
18: Qtr Panel nsr  
Dented  
With Paint Damage

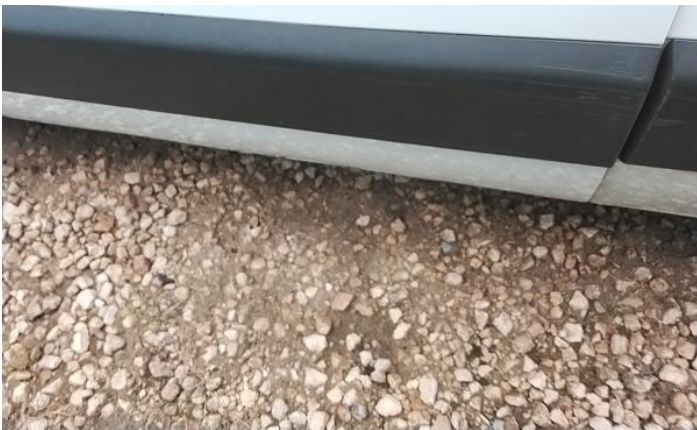
19: Qtr Panel Moulding ns  
Scuffed (Unpainted)  
Over 100mm

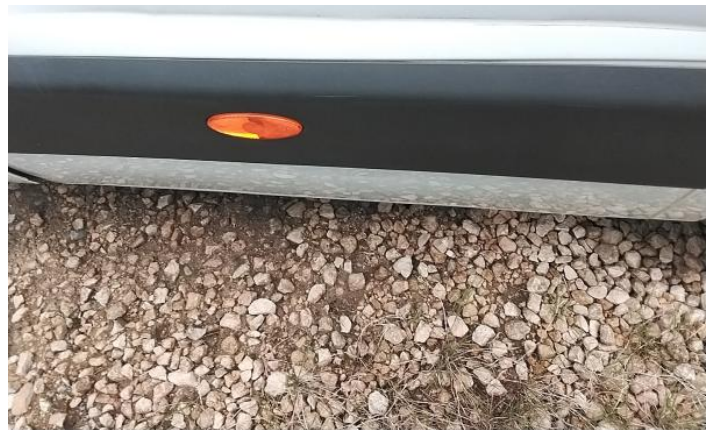
20: Qtr Panel Moulding ns  
Scuffed (Unpainted)  
Over 100mm

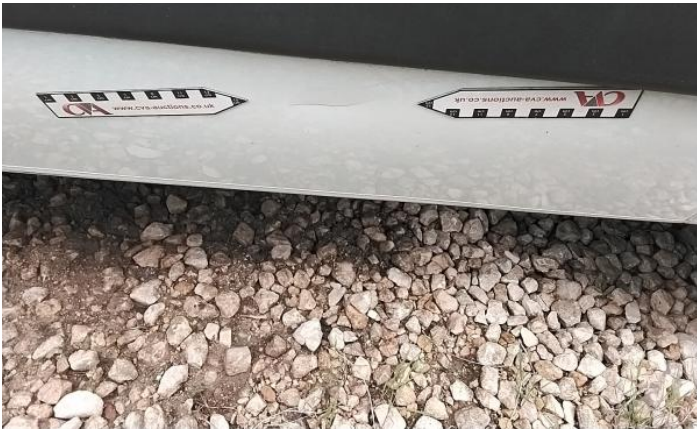
21: Qtr Panel nsr  
Dented  
With Paint Damage

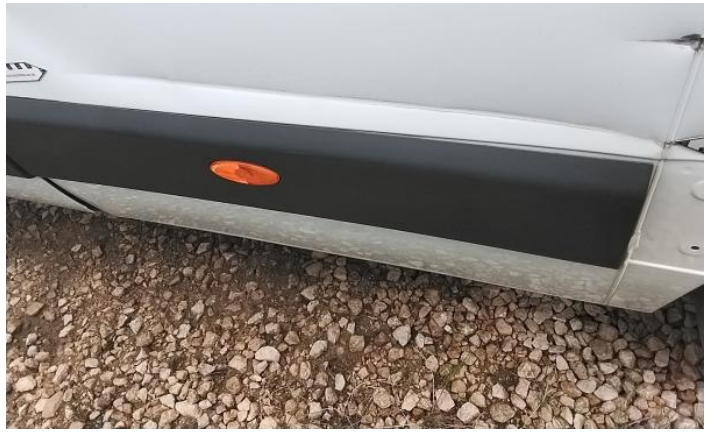
22: Qtr Panel nsr  
Dented  
With Paint Damage

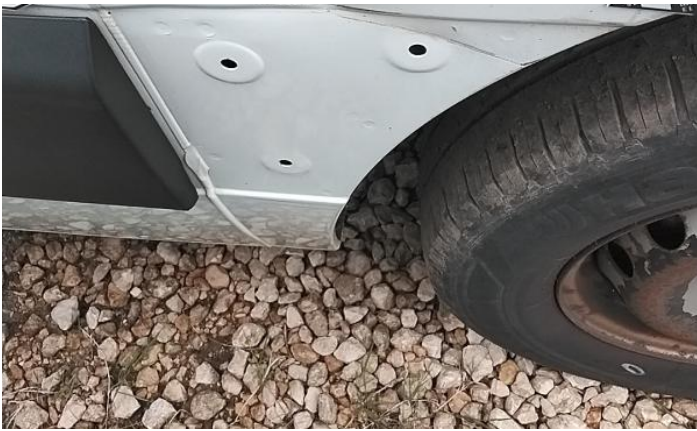
23: Qtr Panel nsr  
Dented  
With Paint Damage

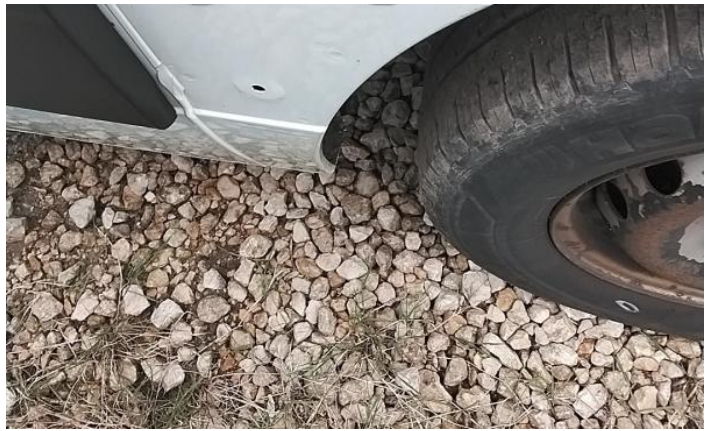
24: Qtr Panel Moulding ns  
Missing  
Replace

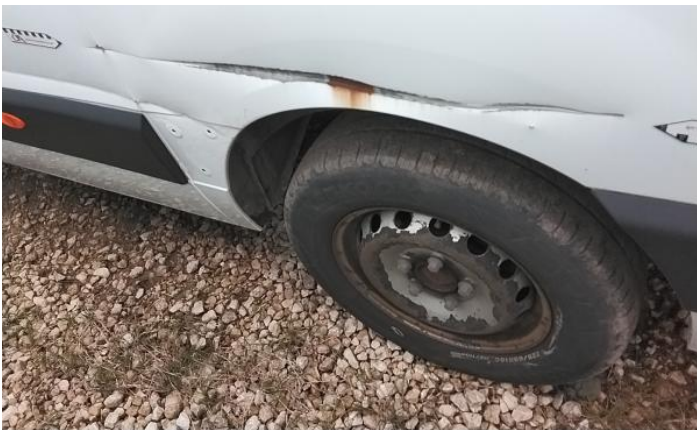
25: Qtr Panel nsr  
Dented  
With Paint Damage

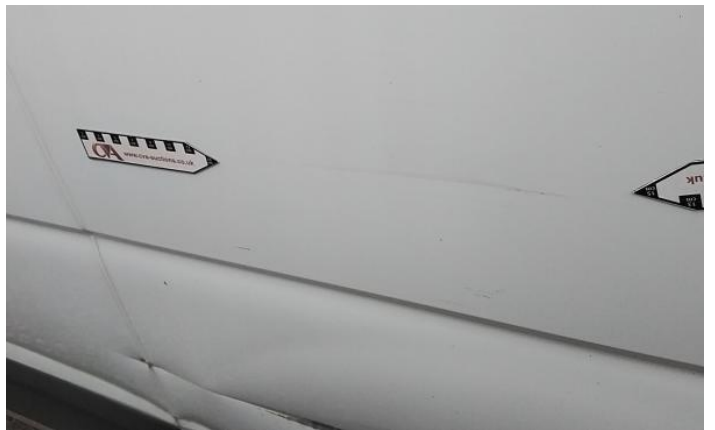
26: Qtr Panel nsr  
Dented  
With Paint Damage

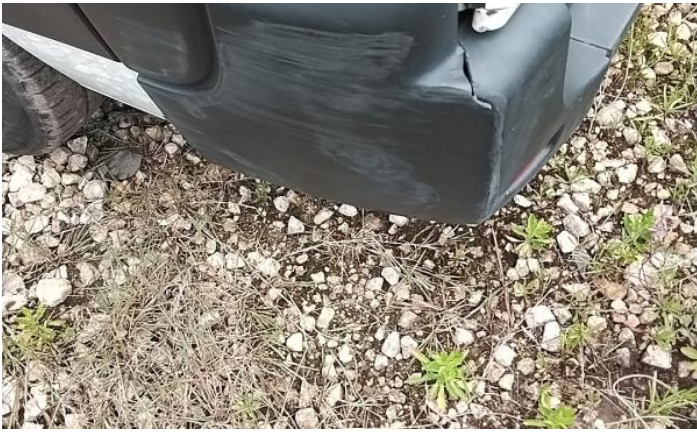
27: Qtr Panel Moulding ns  
Broken  
Replace

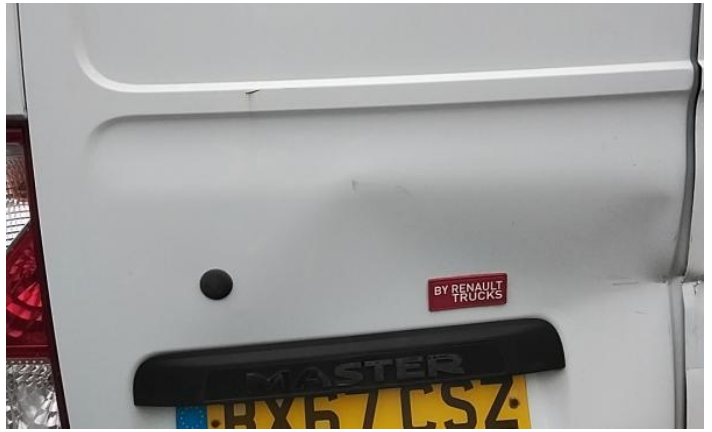
28: Door nsr  
Dented  
Over 30% Of Panel

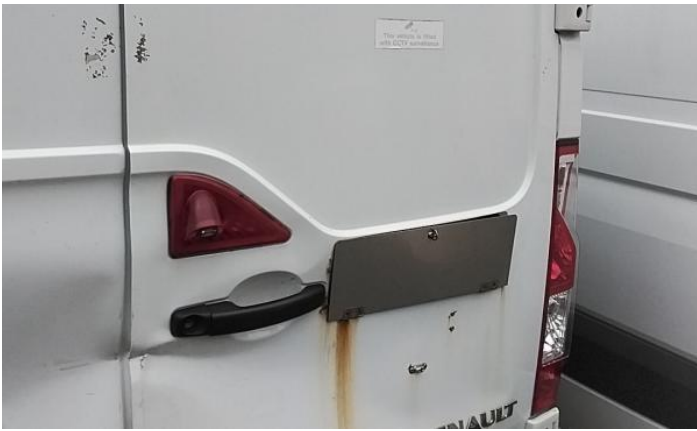
29: Door osr  
Dented  
Over 30% Of Panel

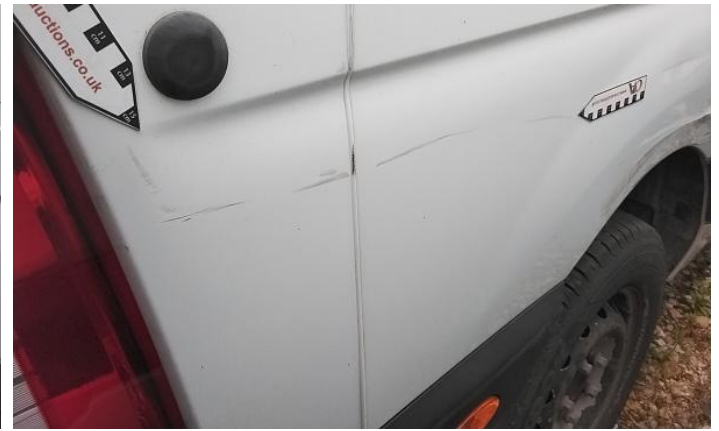
30: Qtr Panel osr  
Scratched  
Over 25mm Thru Paint

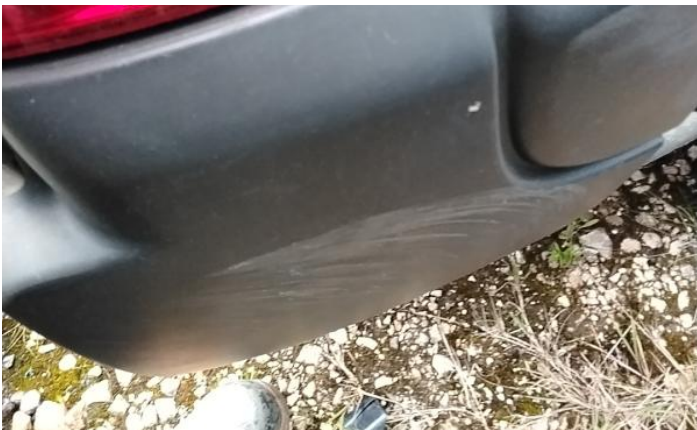
31: Bumper Rear Moulding  
Scuffed (Unpainted)  
Over 100mm

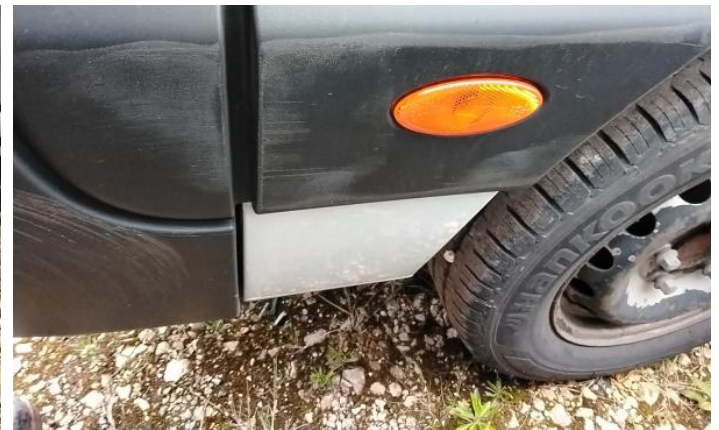
32: Qtr Panel Moulding os  
Scuffed (Unpainted)  
Over 100mm

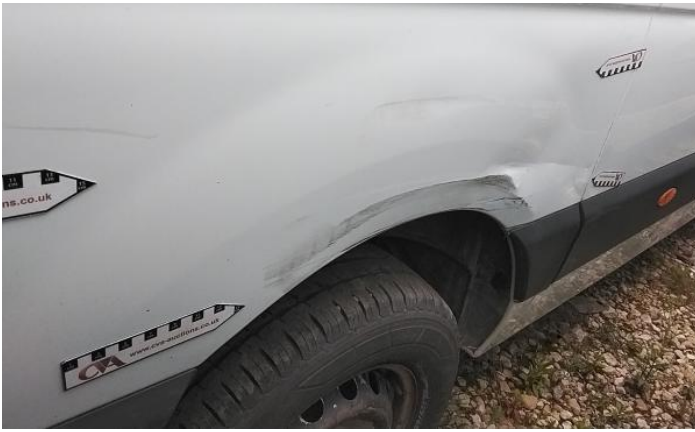
33: Qtr Panel osr  
Dented  
With Paint Damage

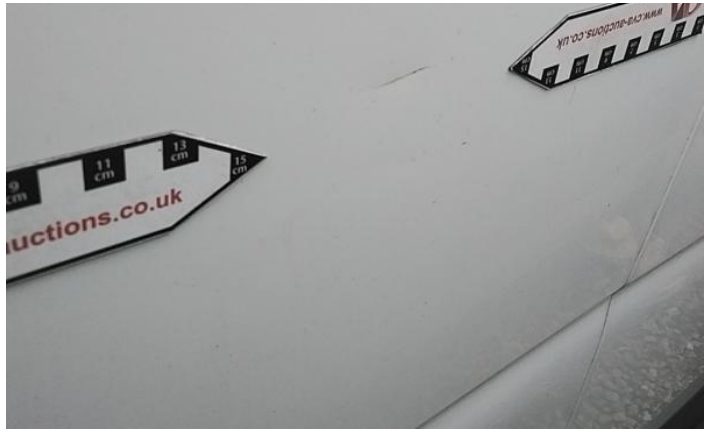
34: Qtr Panel osr  
Dented  
With Paint Damage

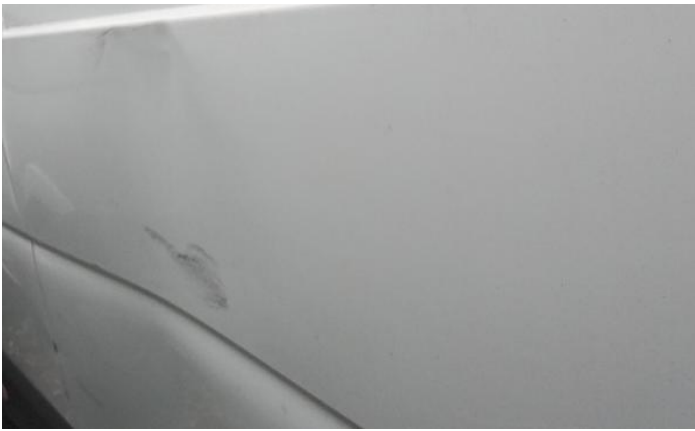
35: Qtr Panel osr  
Dented  
Over 30% Of Panel

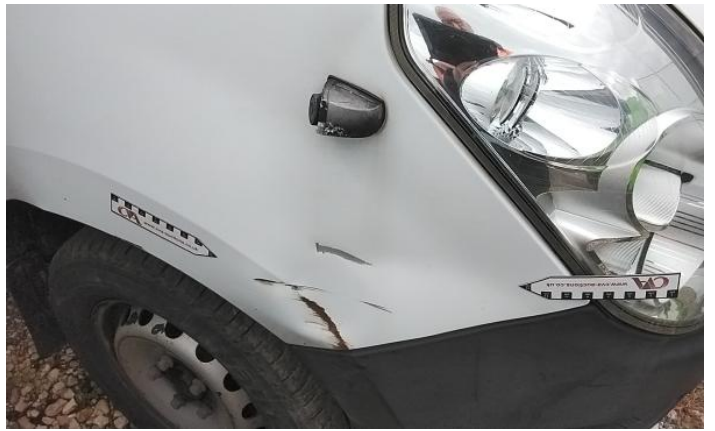
36: Wing osf  
Dented  
With Paint Damage

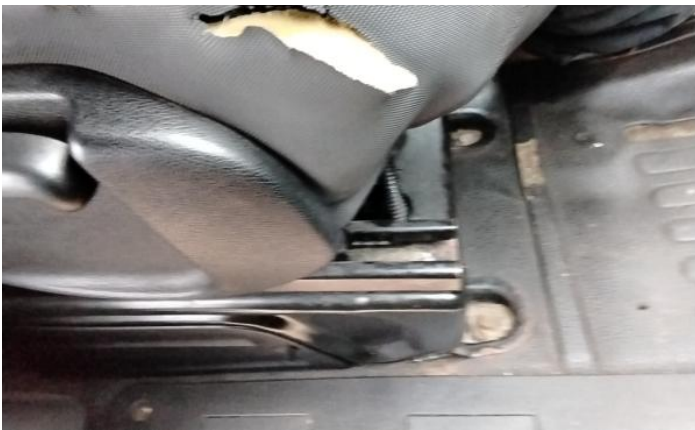
37: Seat Base Cover osf  
Torn  
Over 3mm

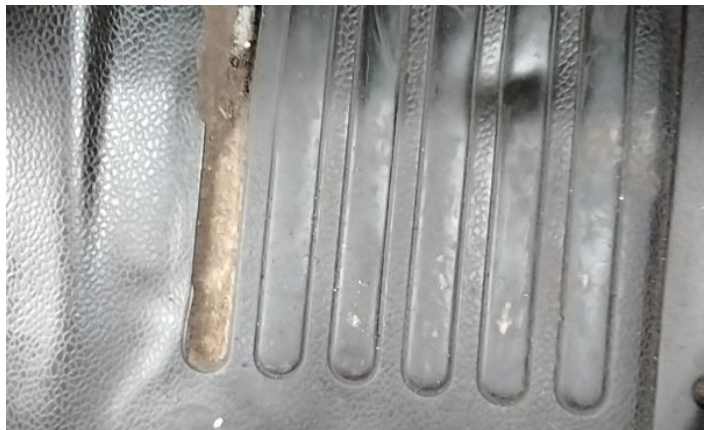
38: Carpets Front  
Torn  
Over 10mm

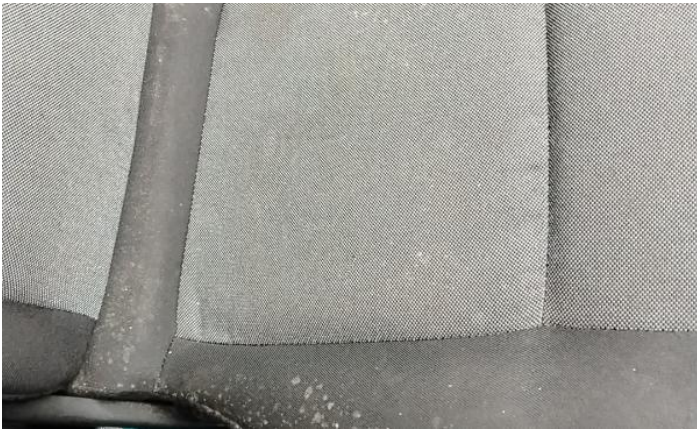
39: Seat Base Cover nsf  
Soiled  
Heavy
