VEHICLE INSPECTION REPORT

WN12BCY

Mercedes-Benz Sprinter 513 CDI

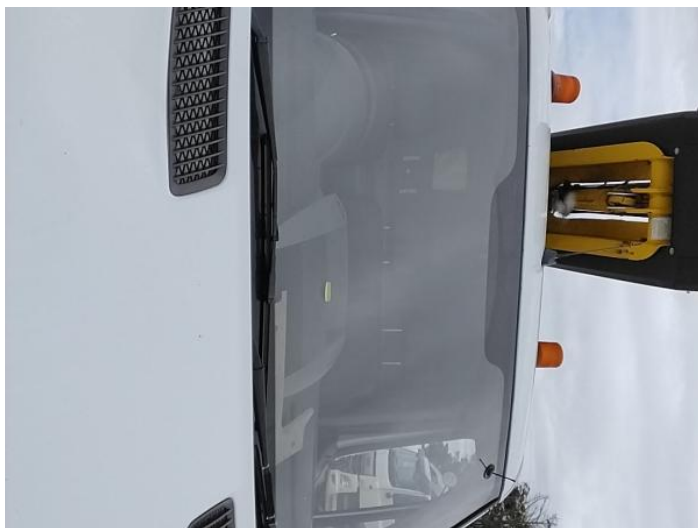
1: Screen Front
Chipped
UpTo 10mm

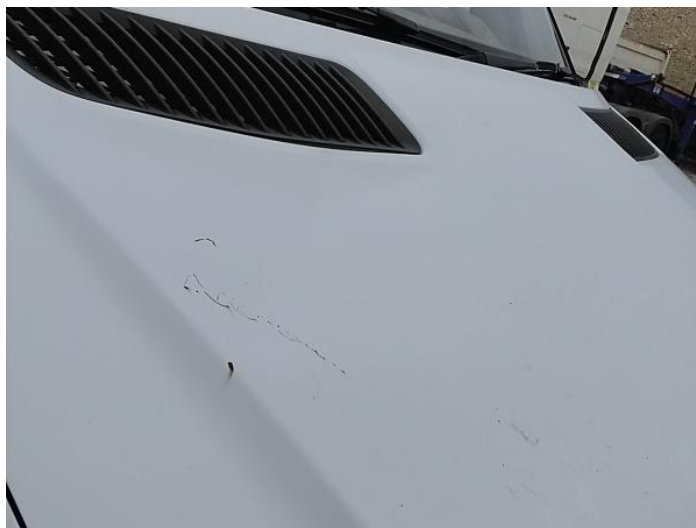
2: Bonnet
Dented
With Paint Damage

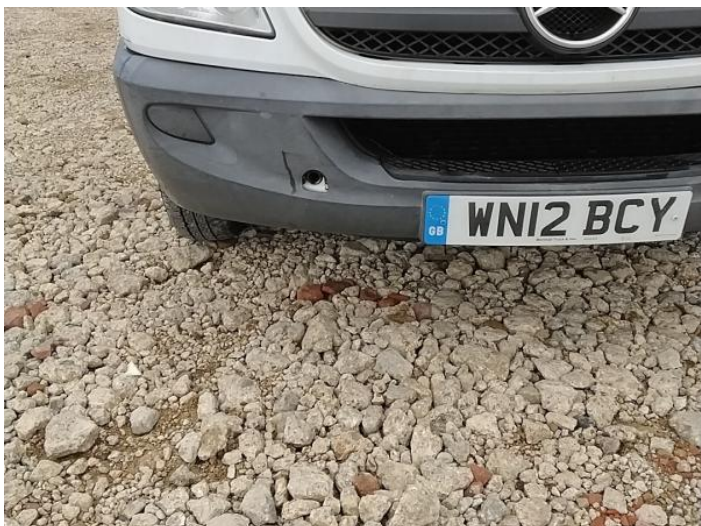
3: Front TowEye Cvr
Missing
Replace

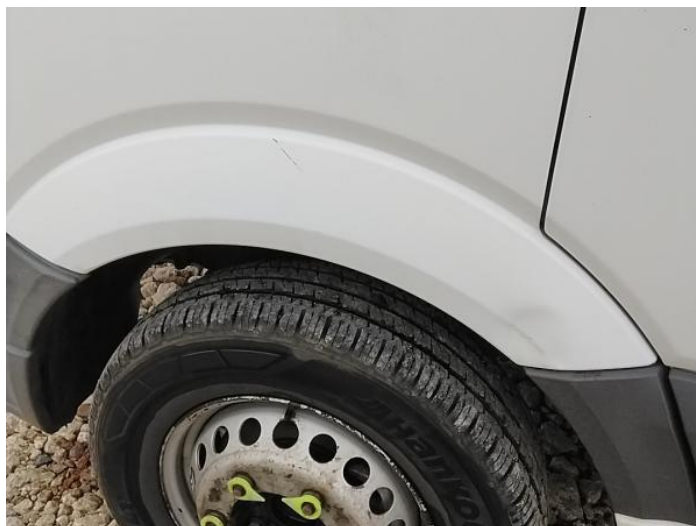
4: Wing nsf
Dented
Over 30mm

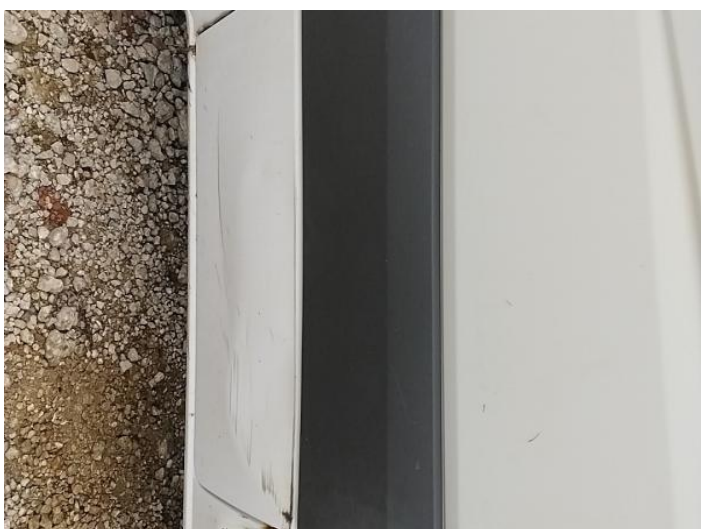
5: Door nsf
Dented
With Paint Damage

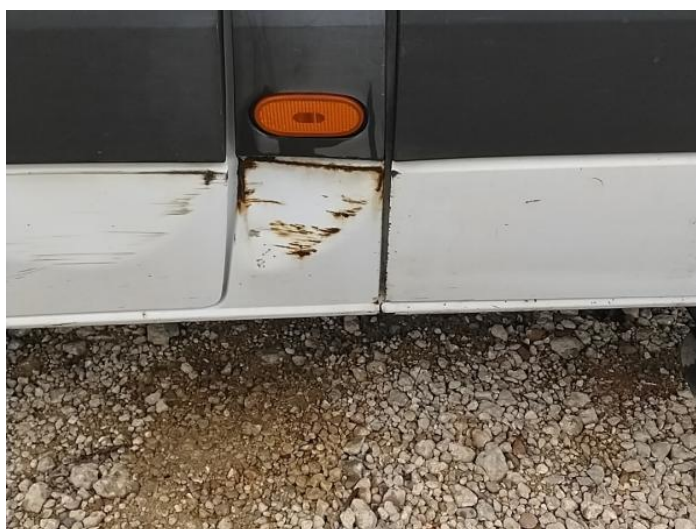
6: B Post ns
Dented
With Paint Damage

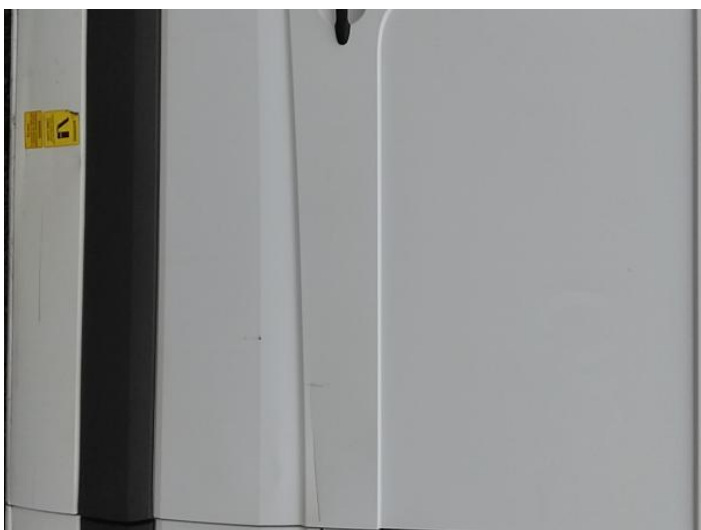
7: Door nsr
Dented
With Paint Damage

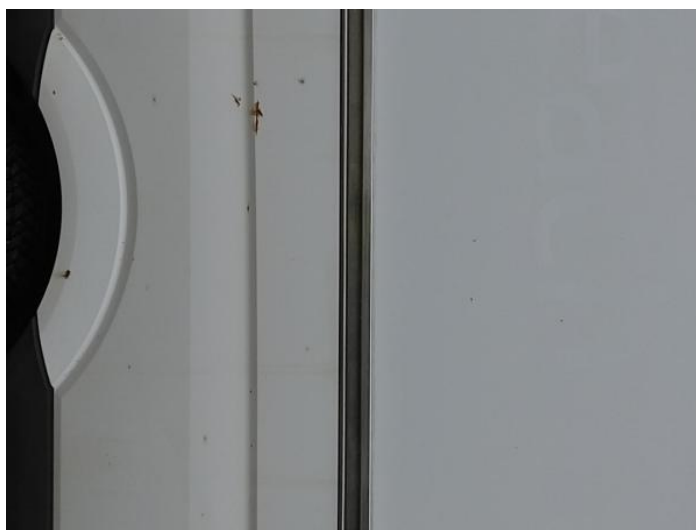
8: Qtr Panel nsr
Rusted
Over 5mm

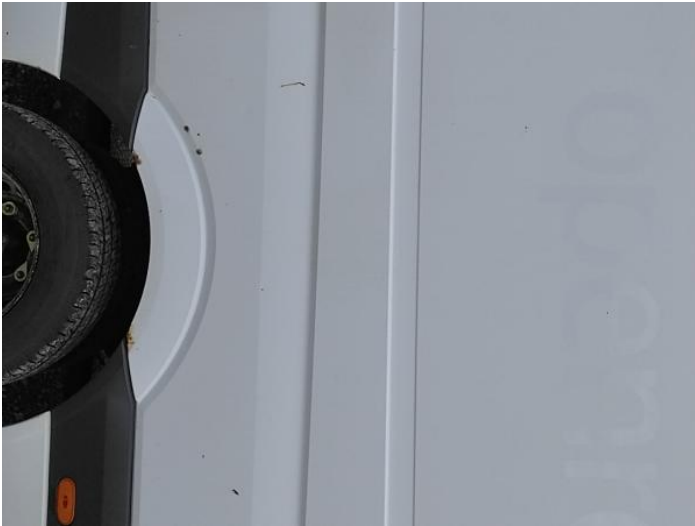
9: Qtr Panel osr
Rusted
Over 5mm

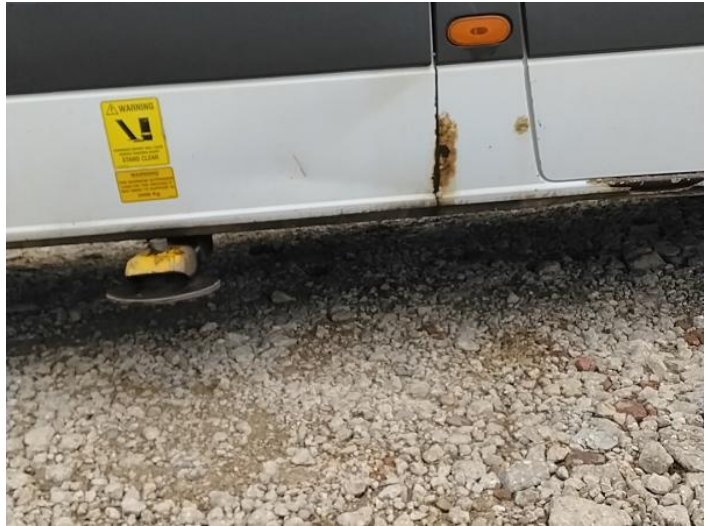
10: B Post os
Rusted
Over 5mm

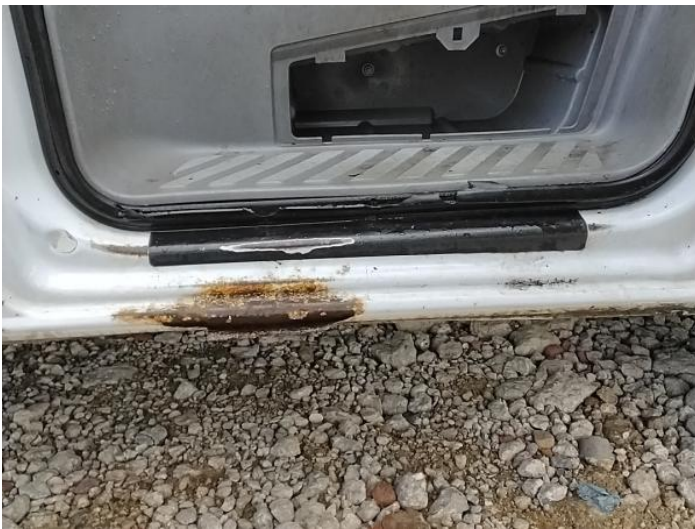
11: Sill os
Rusted
Over 5mm

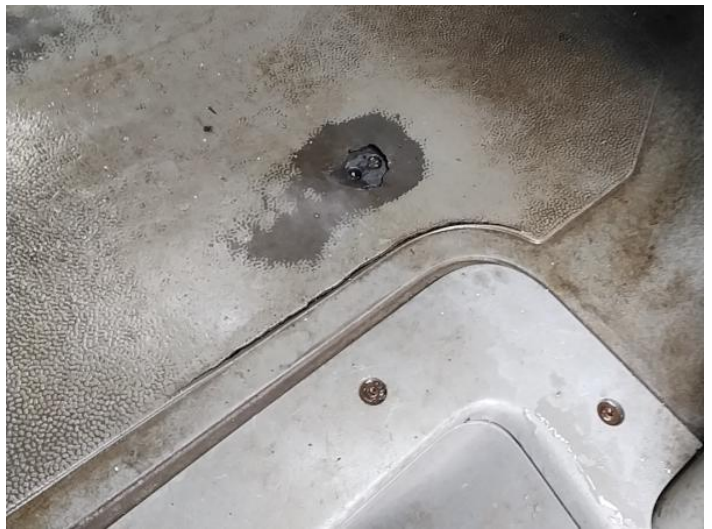
12: Carpets Front
Holed
Over 3mm

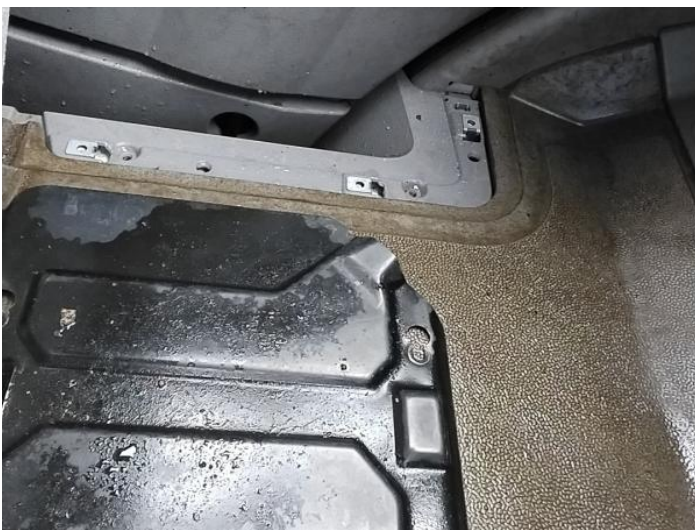
13: General Interior
Soiled
Light
