VEHICLE INSPECTION REPORT

DX70TFY

Daf LF 180

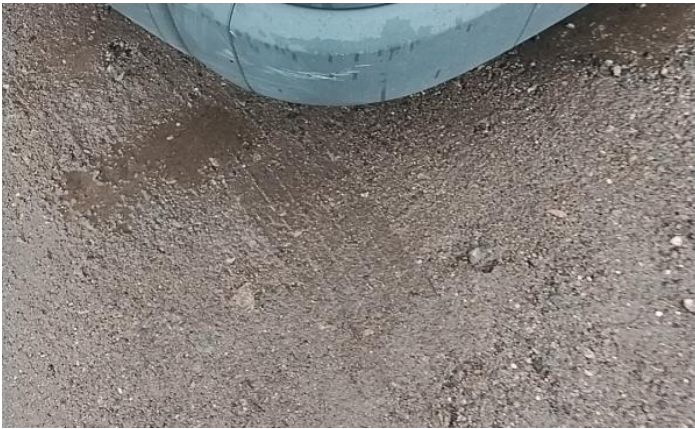
1: Bumper Front
Scratched
Over 100mm Thru Paint

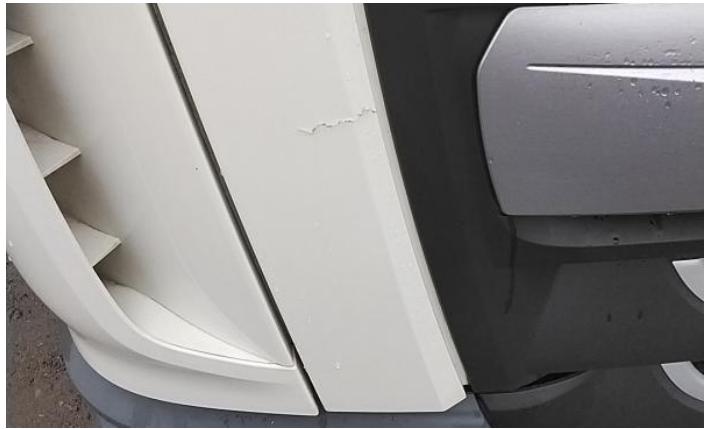
2: Bonnet
Cracked
Replace

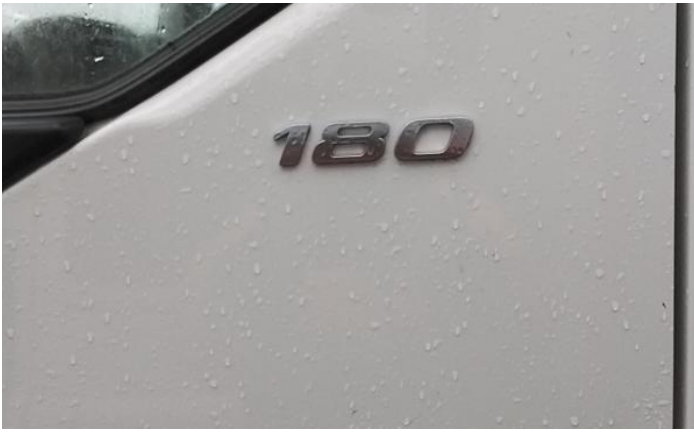
3: Door nsf
Chipped
Multiple Chips

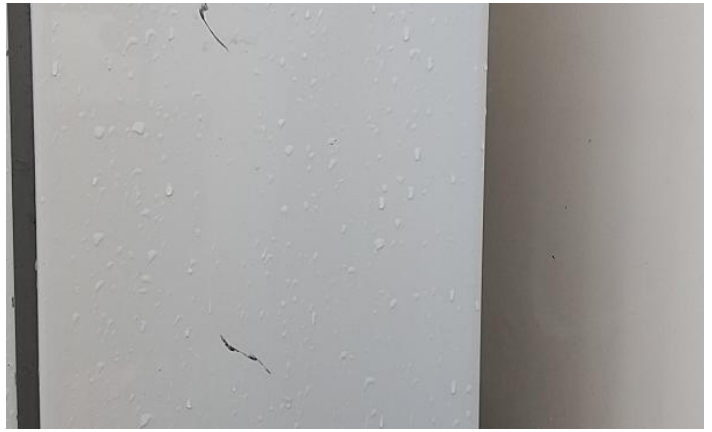
4: Qtr Panel nsr
Scratched
Over 25mm Thru Paint

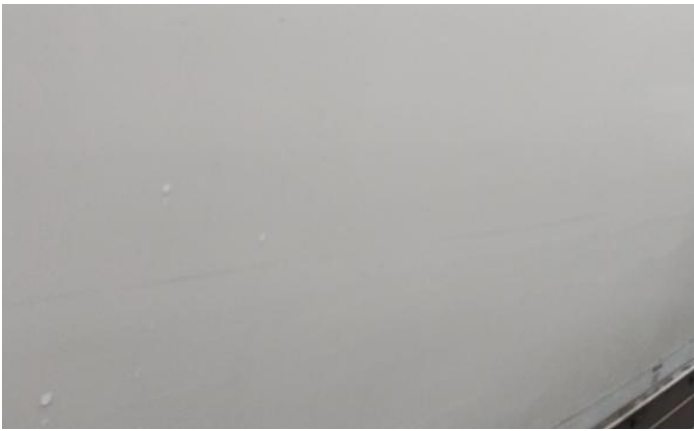
5: Qtr Panel nsr
Scratched
Over 25mm Not Thru Paint

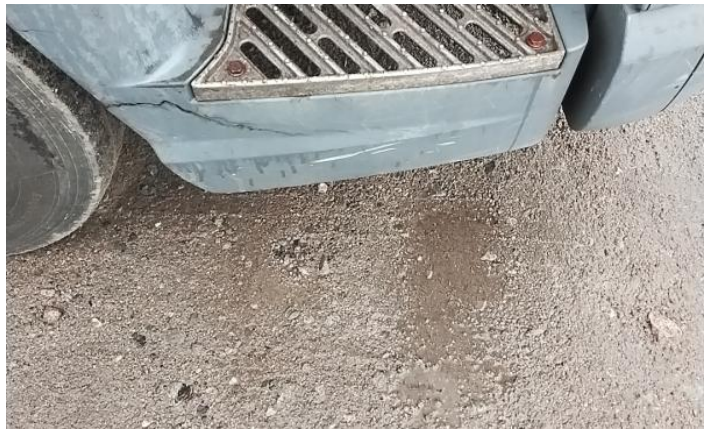
6: Bumper Front Moulding
Broken
Replace

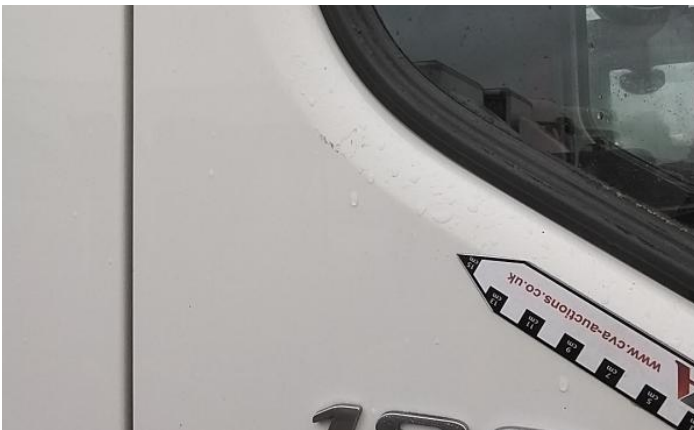
7: Door osf
Scratched
Over 25mm Thru Paint

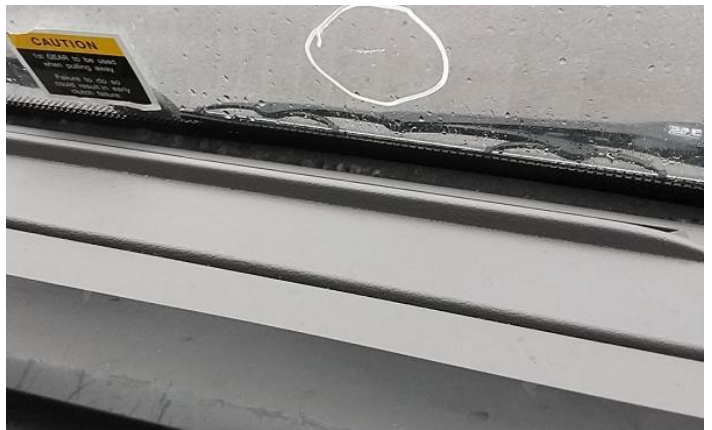
8: Screen Front
Cracked
Replace

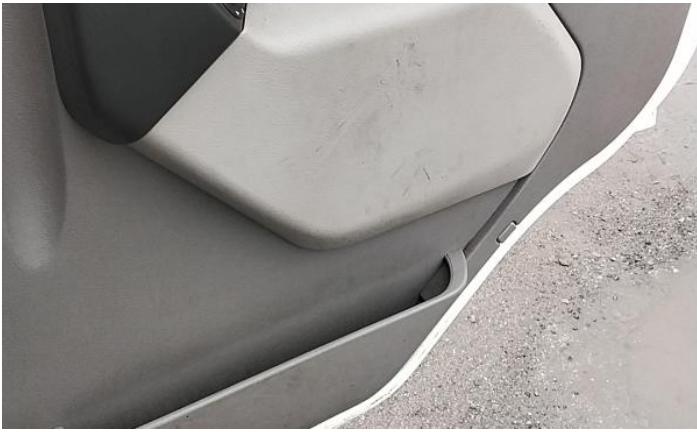
9: Door Pad osf
Soiled
Heavy
