**COMMERCIAL VEHICLE AUCTIONS LTD**  
THE UK'S MOST ESTABLISHED COMMERCIAL VEHICLE AUCTIONEERS

# VEHICLE INSPECTION REPORT

**LO69LNT**

## Ford Ranger 2.0 EcoBlue 170PS

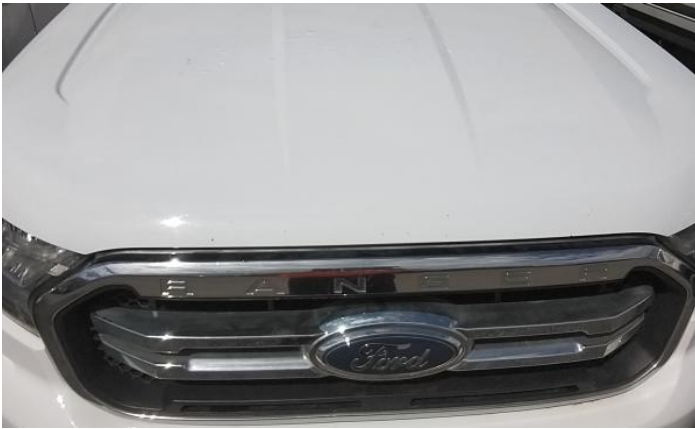
1: Bonnet  
Chipped  
Multiple Chips

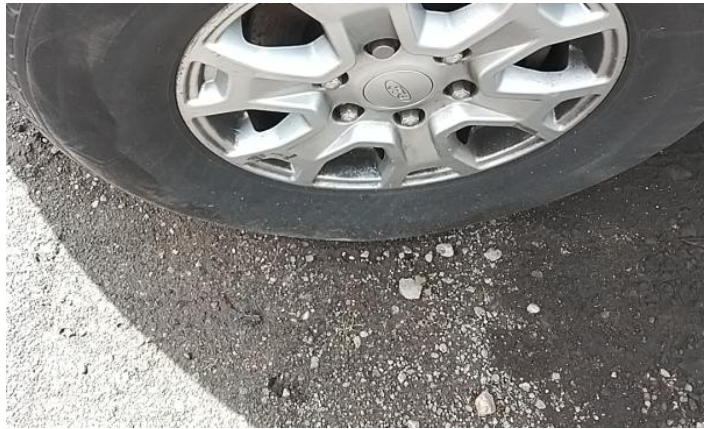
2: Wheel nsf  
Scratched  
Over 50mm

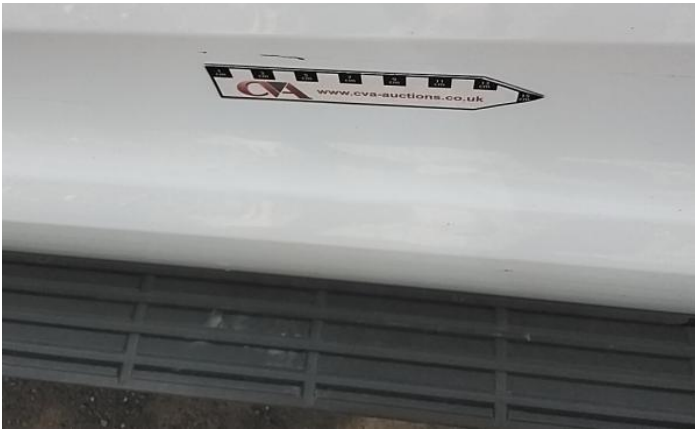
3: Door nsf  
Scratched  
Over 25mm Thru Paint

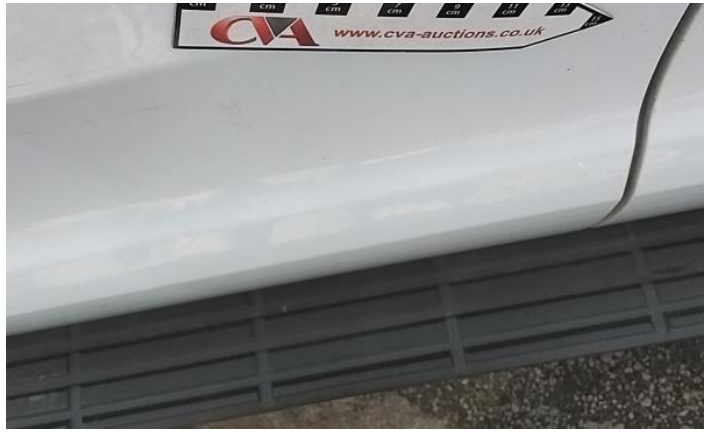
4: Door nsf  
Scratched  
Over 25mm Thru Paint

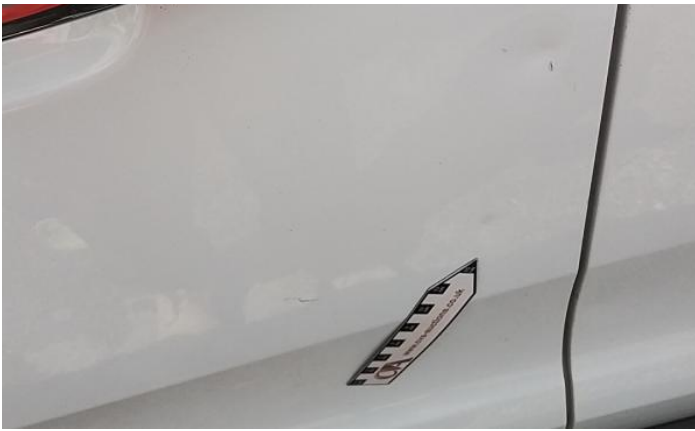
5: Door nsf  
Dented  
Over 30mm

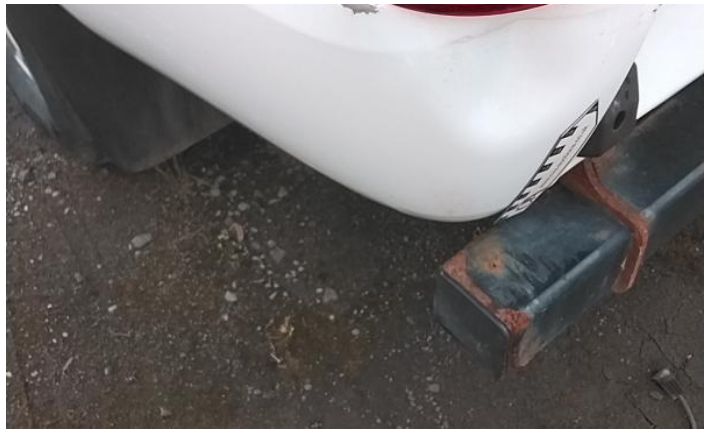
6: Qtr Panel nsr  
Dented  
With Paint Damage

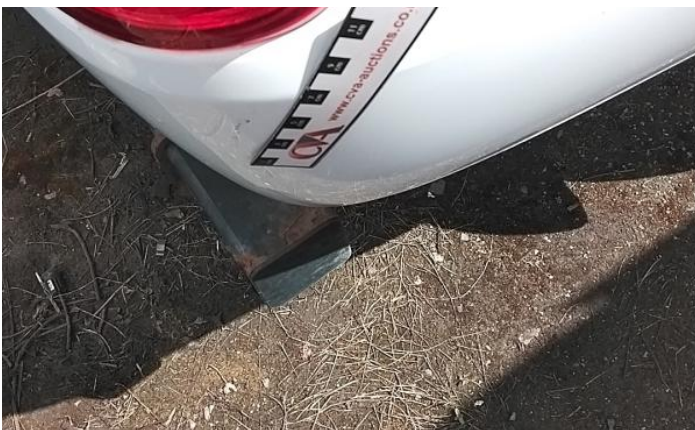
7: Qtr Panel osr  
Scratched  
Over 25mm Thru Paint

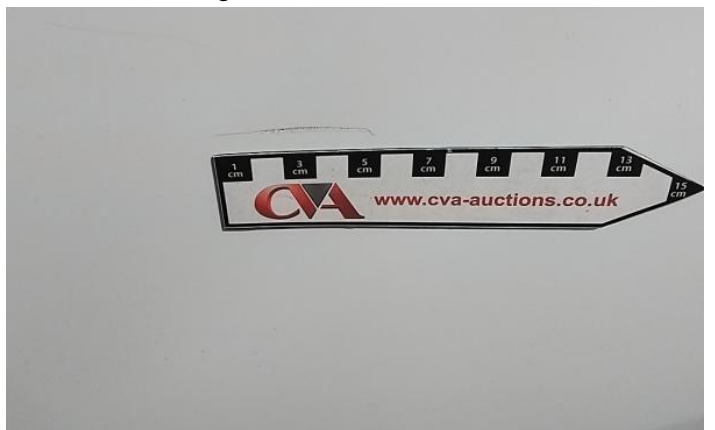
8: Qtr Panel osr  
Scratched  
Over 25mm Thru Paint

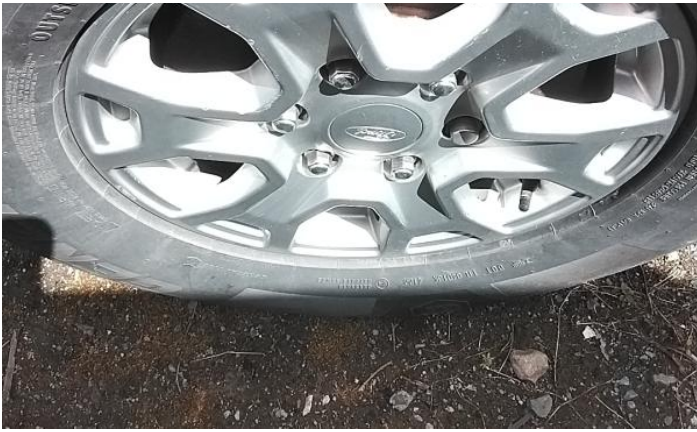
9: Wheel osr  
Scratched  
Over 50mm

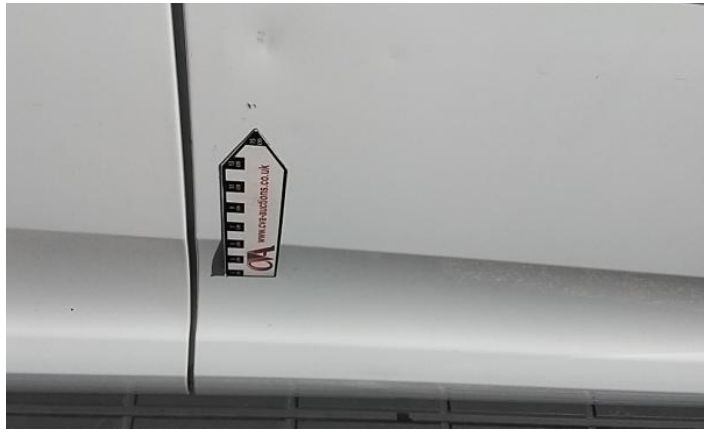
10: Door osf  
Dented  
With Paint Damage

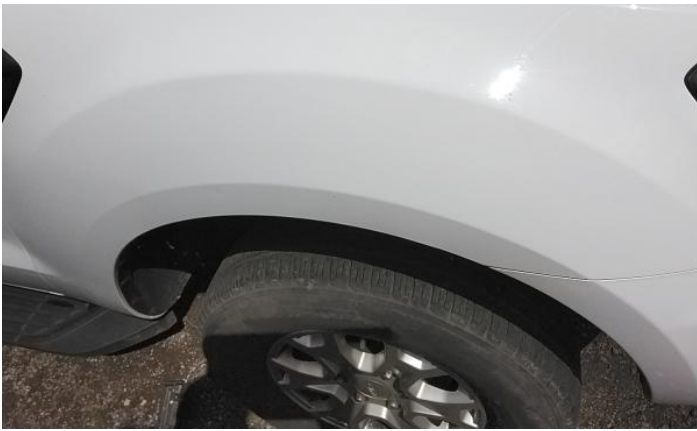
11: Wing osf  
Chipped  
Multiple Chips

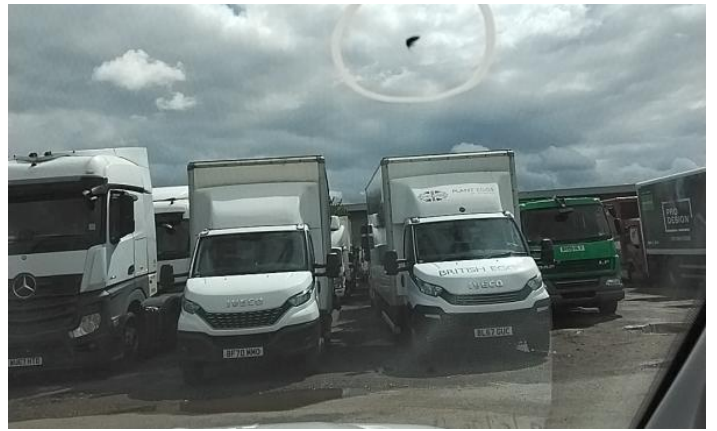
12: Screen Front  
Chipped  
Up To 10mm

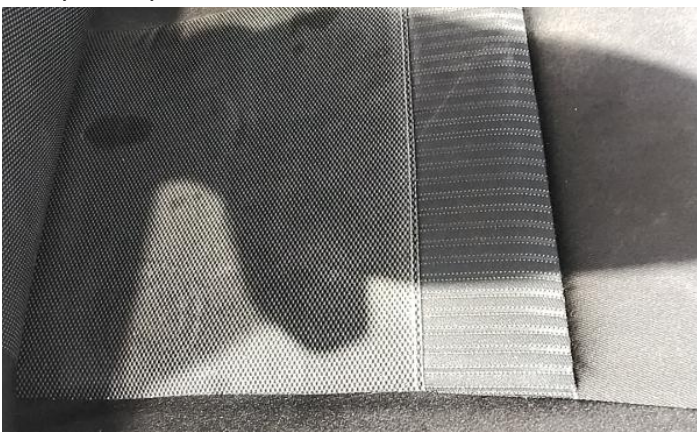
13: Seat Base Cover nsf  
Soiled  
Heavy
