COMMERCIAL VEHICLE AUCTIONS LTD
THE UK'S MOST ESTABLISHED COMMERCIAL VEHICLE AUCTIONEERS

VEHICLE INSPECTION REPORT

MK68NHM

MAN TGL 12.250

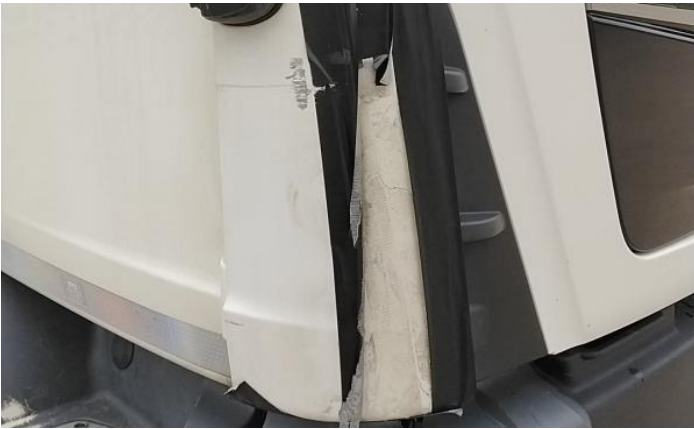
1: Wing osf
Cracked
Replace

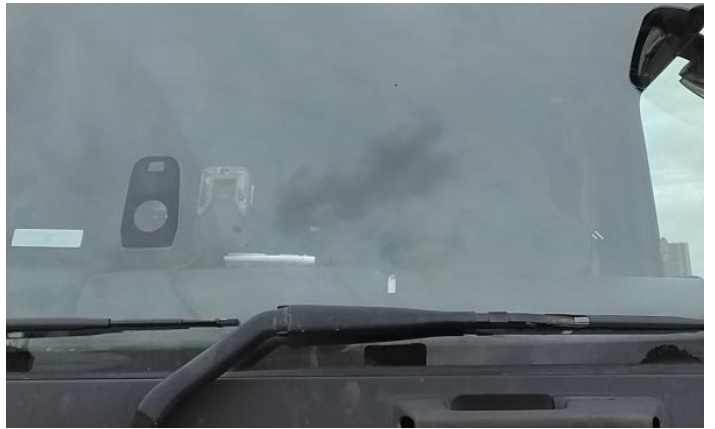
2: Screen Front
Chipped
UpTo 10mm

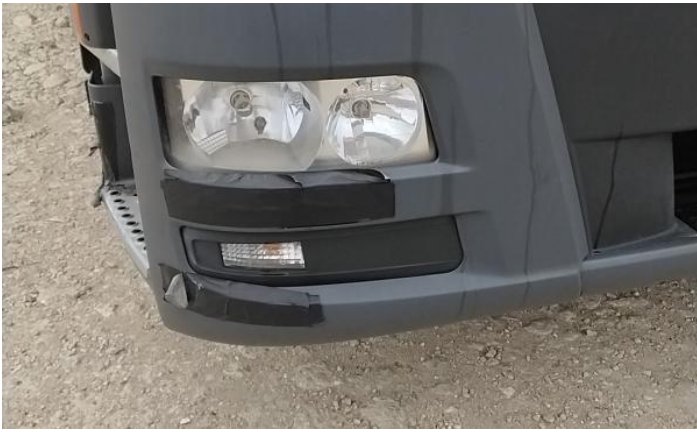
3: Bumper Front Moulding
Broken
Replace

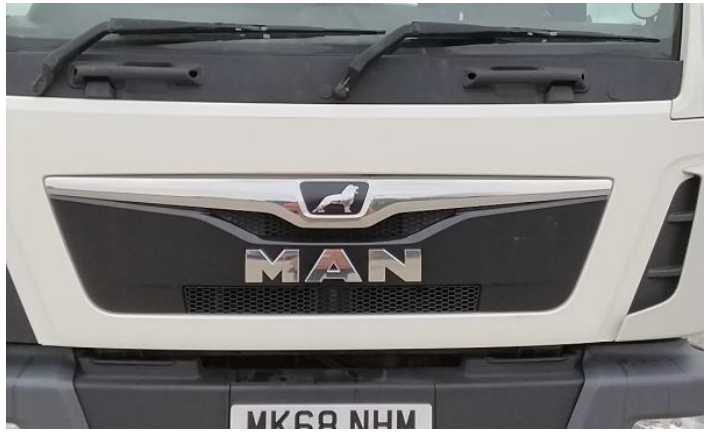
4: Bonnet
Chipped
Multiple Chips

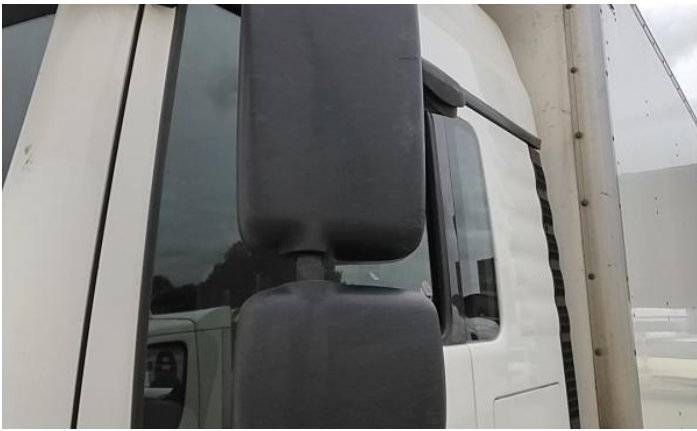
5: Door Mirror Assy nsf
Broken
Replace

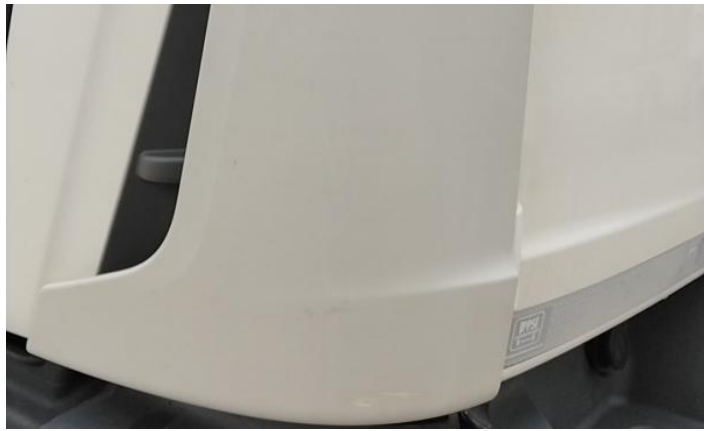
6: Wing nsf
Scratched
Over 25mm Thru Paint

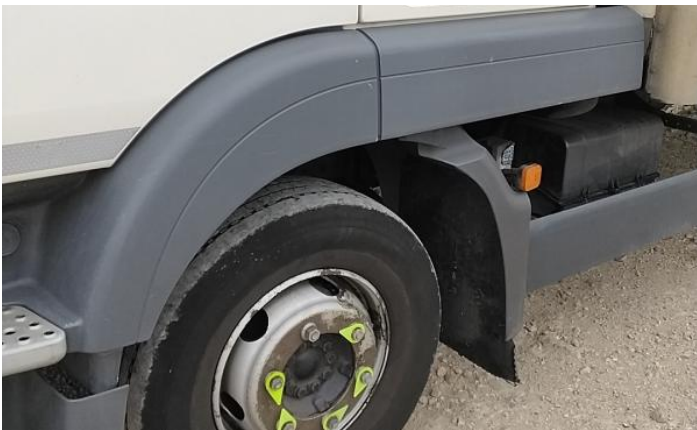
7: Wing Front Arch Extension ns
Scuffed (Unpainted)
UpTo 100mm

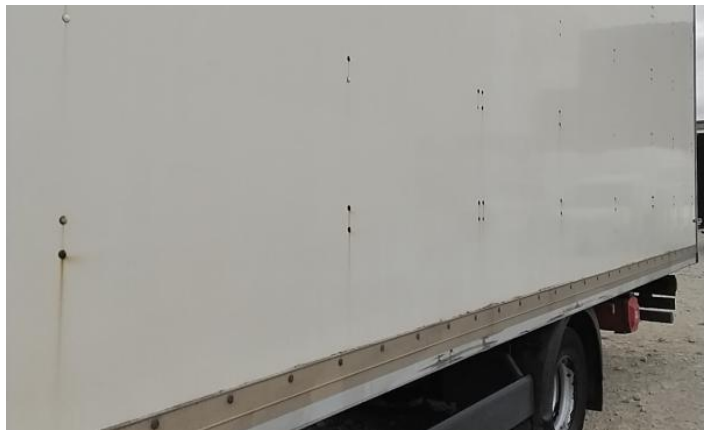
8: Qtr Panel nsr
Scratched
Over 25mm Thru Paint

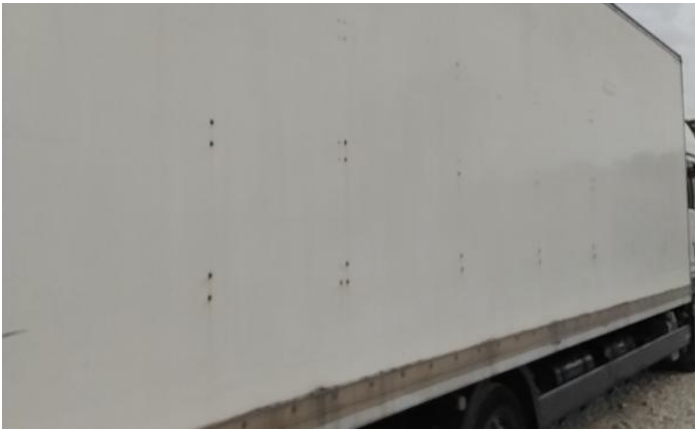
9: Qtr Panel osr
Scratched
Over 25mm Not Thru Paint

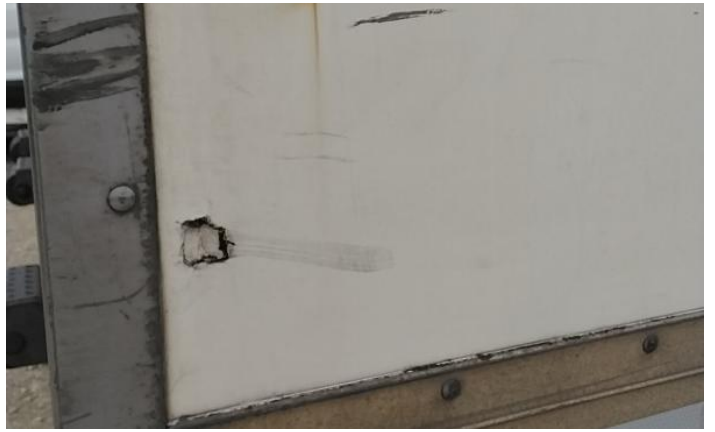
10: Qtr Panel osr
Scratched
Over 25mm Thru Paint

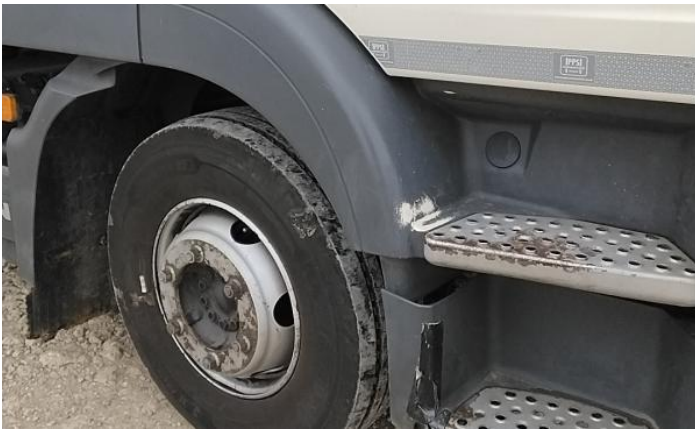
11: Wing Front Arch Extension os
Broken
Replace

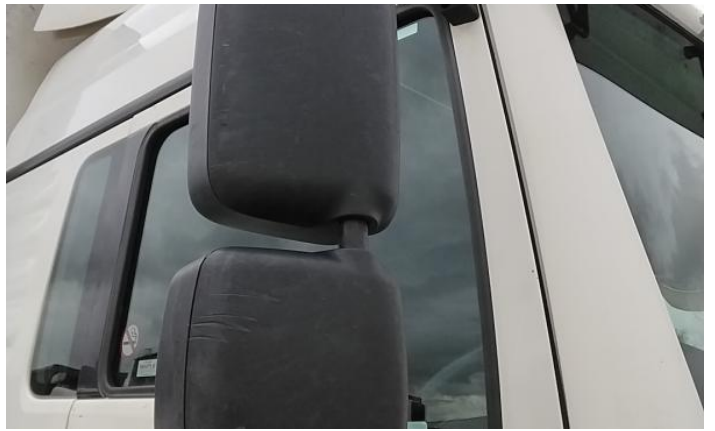
12: Door Mirror Assy osf
Scuffed (Unpainted)
Over 100mm

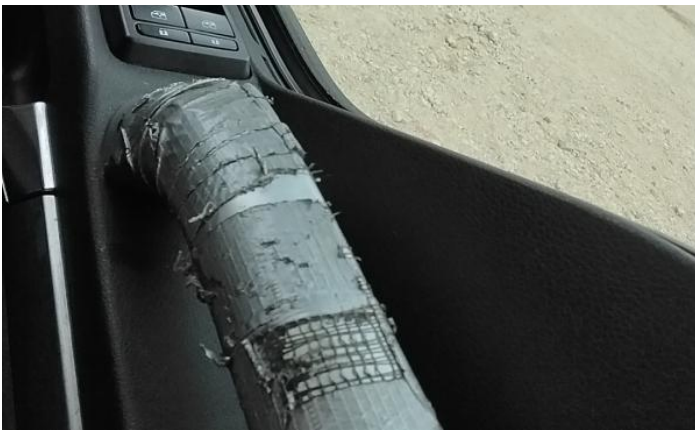
13: Door Pad osf
Broken
Replace

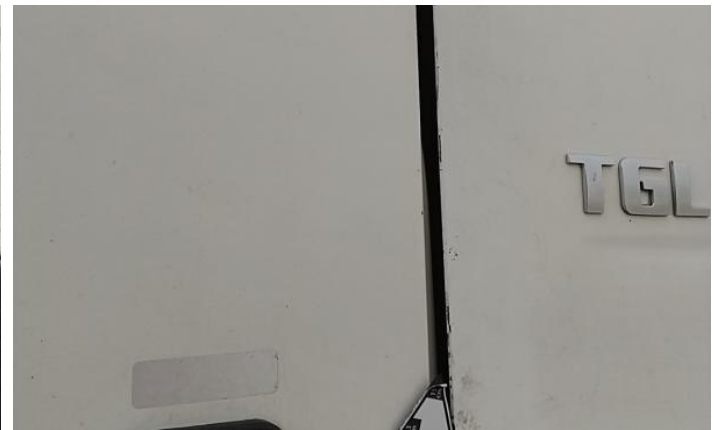
14: Door osf
Chipped
Edge Chip
