# VEHICLE INSPECTION REPORT

**RE70LBU**

## Iveco Eurocargo 75-160

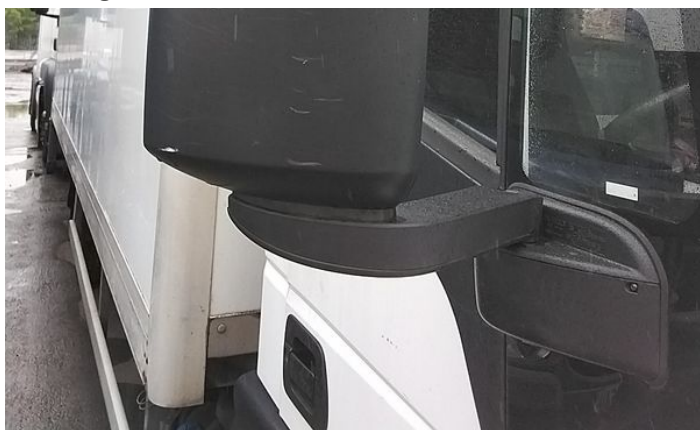
1: Door Mirror Assy of  
Scuffed (Unpainted)  
Over 100mm

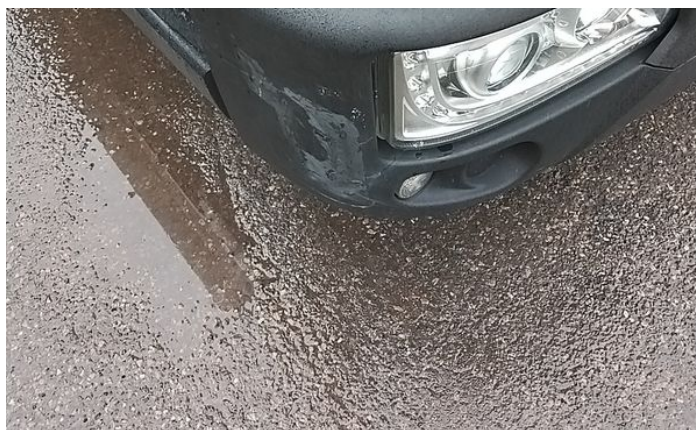
2: Bumper Front  
Poor Previous Repair  
Rippled Up To 30%

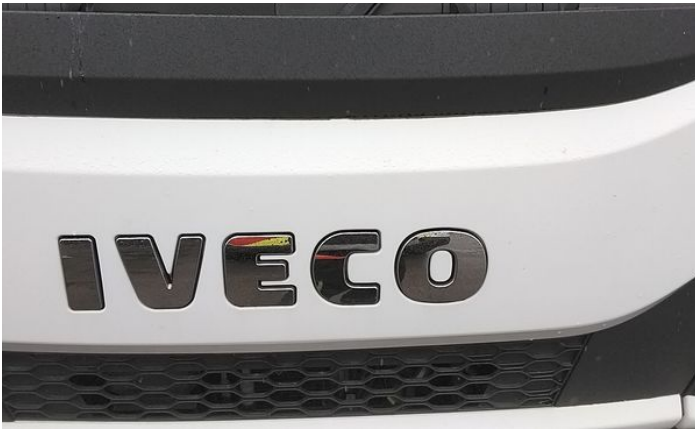
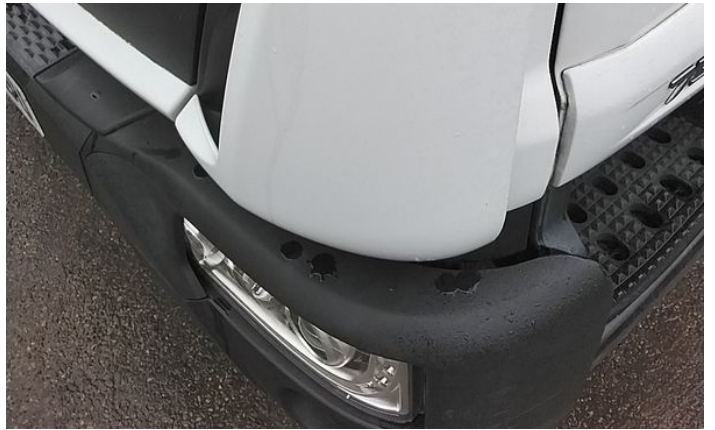
3: Bonnet  
Chipped  
Multiple Chips

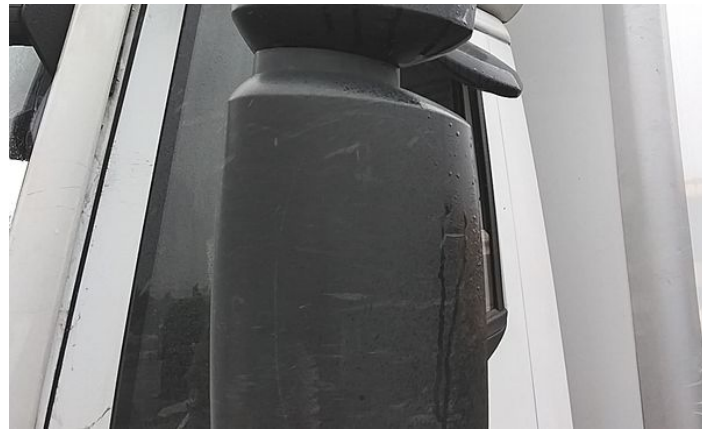
4: Panel Front  
Scratched  
Over 25mm Thru Paint

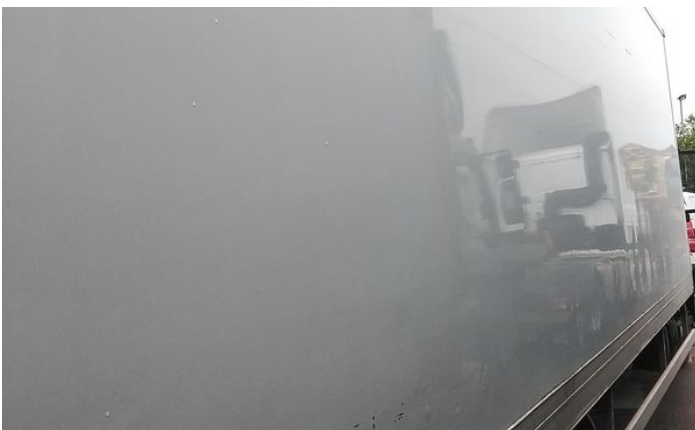
6: Qtr Panel nsr  
Scratched  
Over 25mm Thru Paint

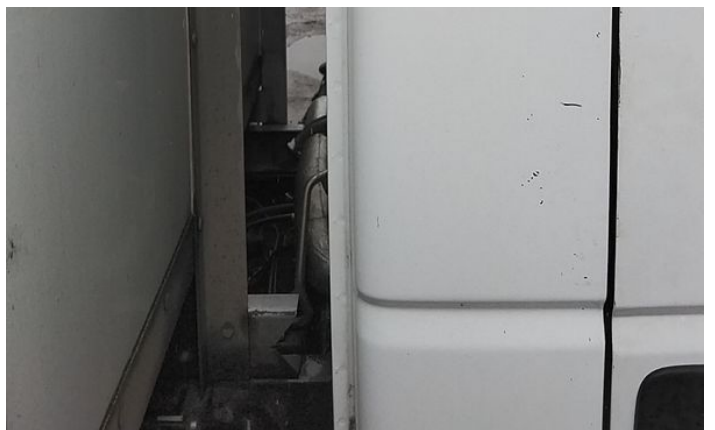
7: Qtr Panel osr  
Scratched  
Over 25mm Thru Paint

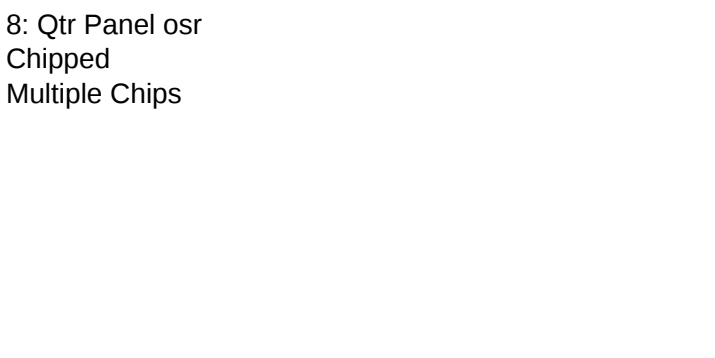
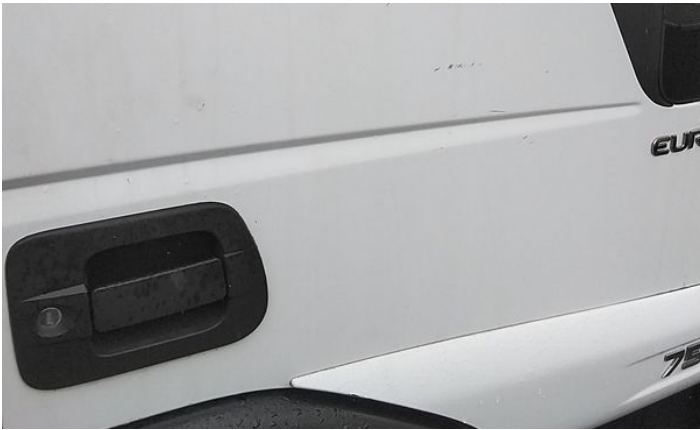
9: Door osf  
Chipped  
Multiple Chips

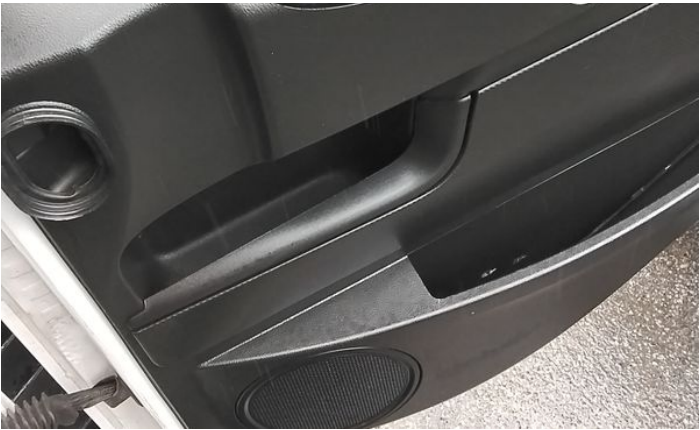
10: Door Pad osf  
Broken  
Replace

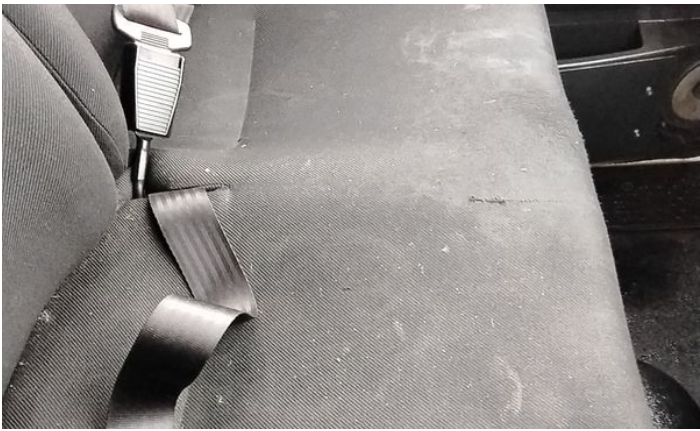
11: Seat Base Cover nsf  
Torn  
Over 3mm
