VEHICLE INSPECTION REPORT

PN21CXT

Fiat Ducato 35 2.3 MULTIJET 140PS

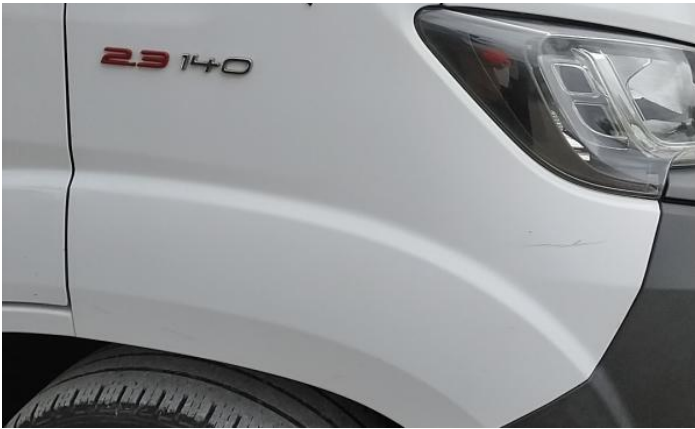
1: Wing of
Scratched
Over 25mm Not Thru Paint

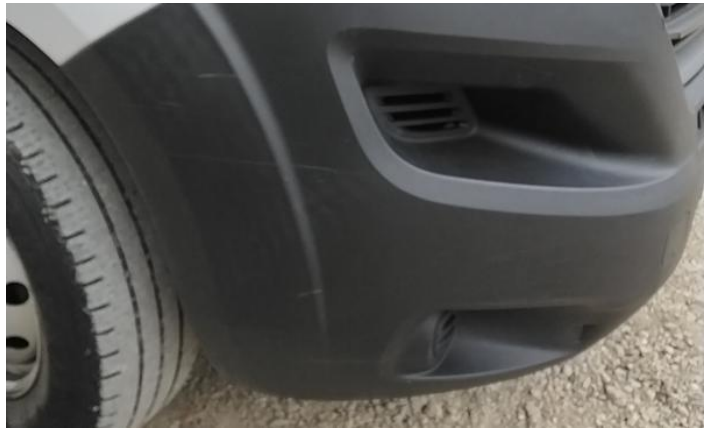
2: Bumper Front Moulding
Scuffed (Unpainted)
Over 100mm

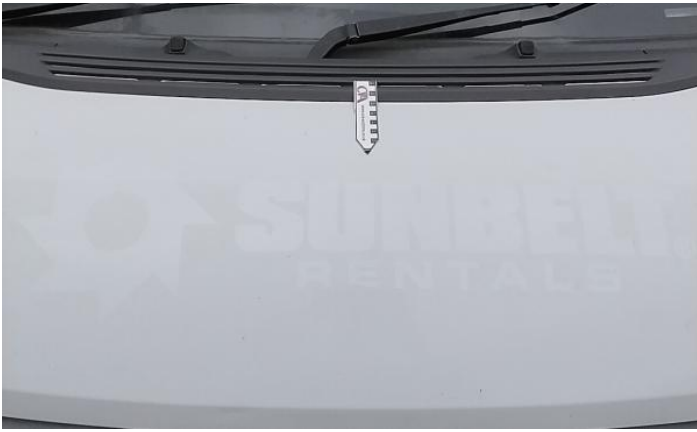
3: Bonnet
Chipped
Multiple Chips

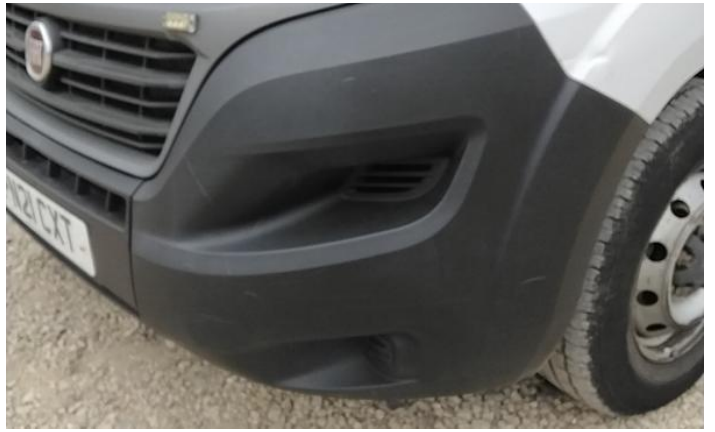
4: Bumper Front Moulding
Scuffed (Unpainted)
Over 100mm

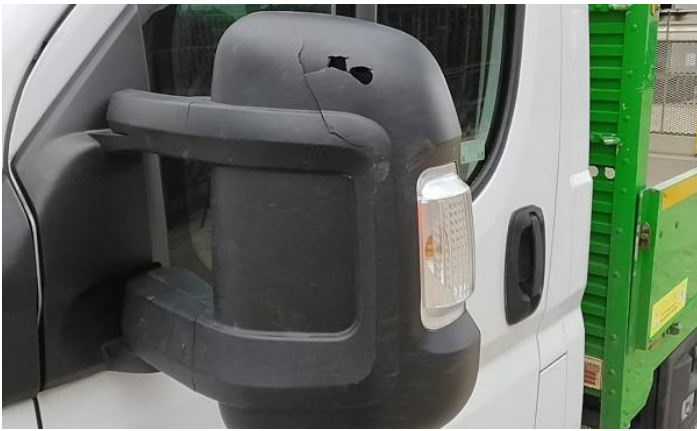
5: Door Mirror Assy nsf
Broken
Replace

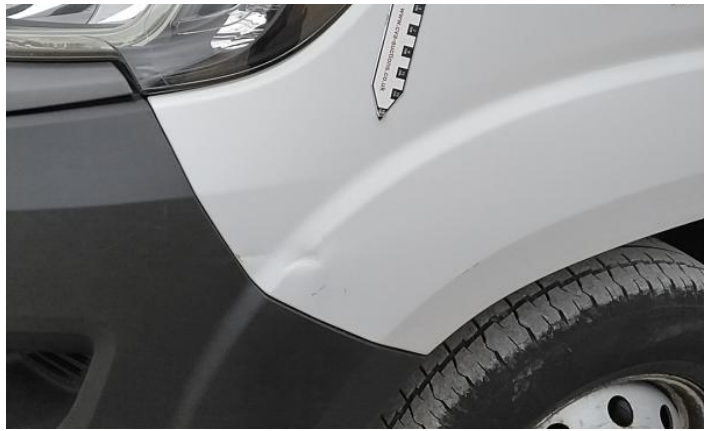
6: Wing nsf
Dented
With Paint Damage

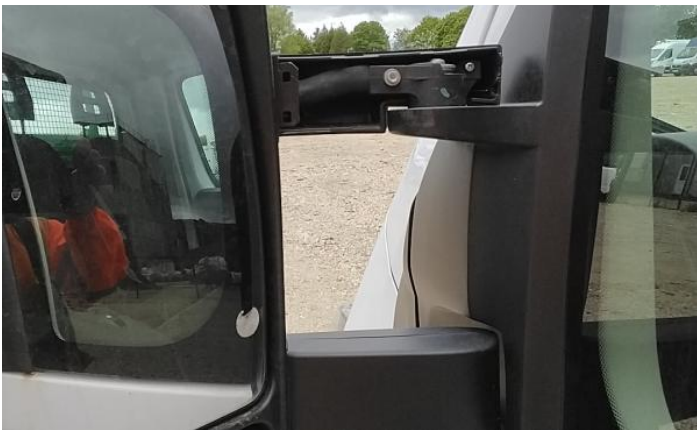
7: Door Mirror Assy nsf
Broken
Replace

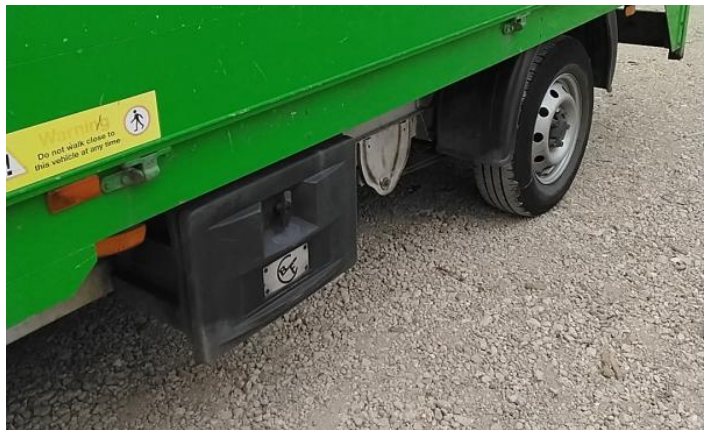
8: Qtr Panel nsr
Scratched
Over 25mm Thru Paint

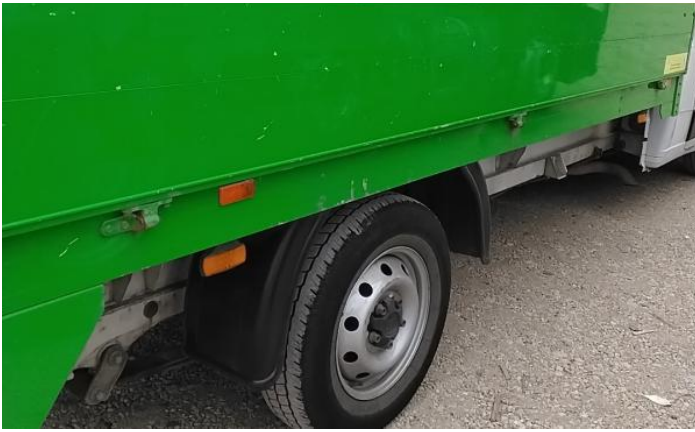
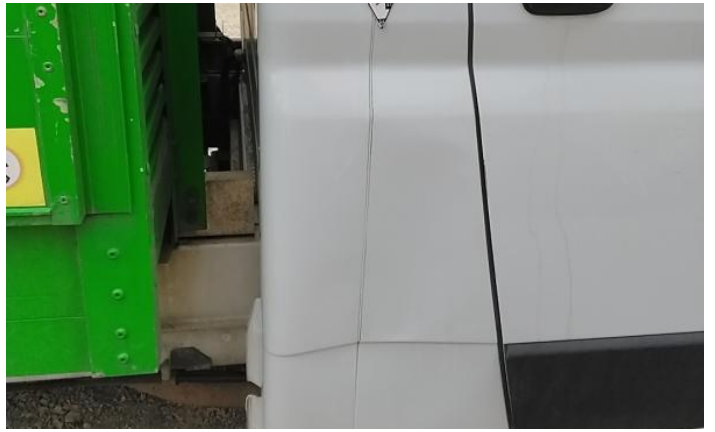
9: Qtr Panel osr
Scratched
Over 25mm Thru Paint

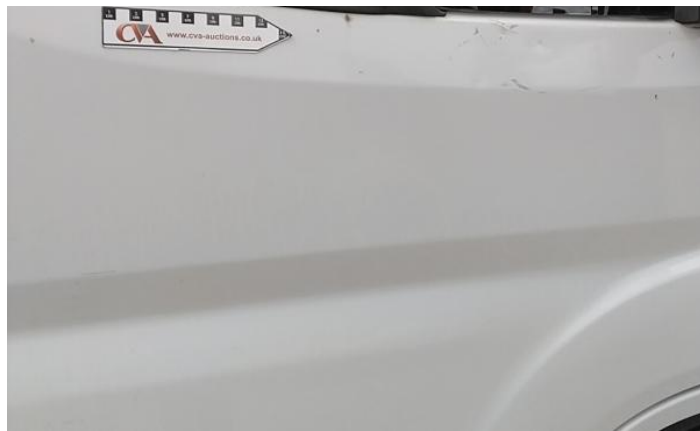
10: B Post os
Dented
Over 30mm

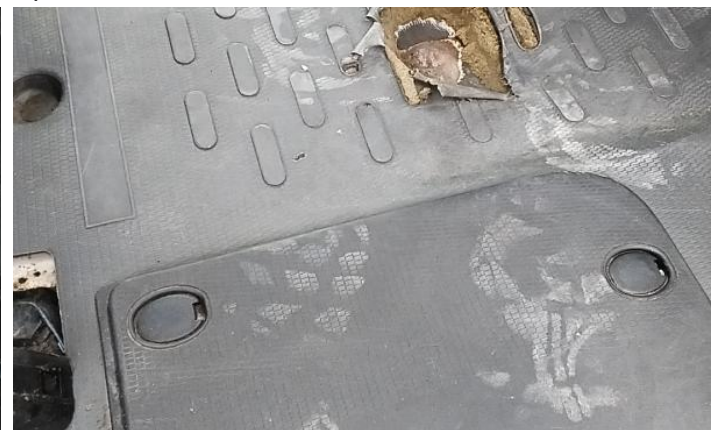
13: Seat Base Cover osf
Burn
Over 3mm

14: Carpets Front
Holed
Over 3mm
