VEHICLE INSPECTION REPORT

YH70LYJ

Ford Transit Custom 320 2.0 EcoBlue 130ps High Roof Leader Van

Non Runner

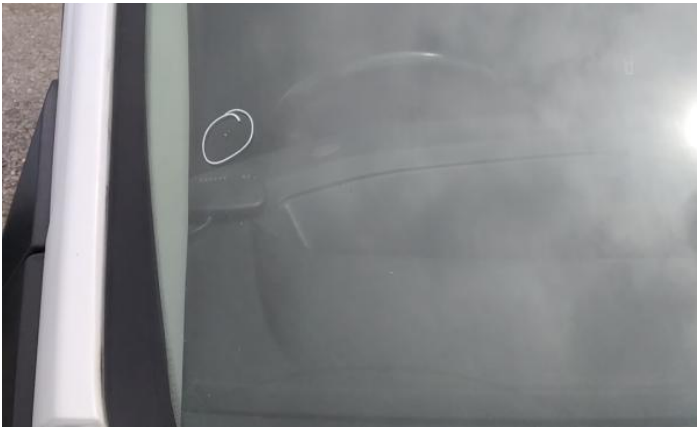
1: Screen Front
Chipped
UpTo 10mm

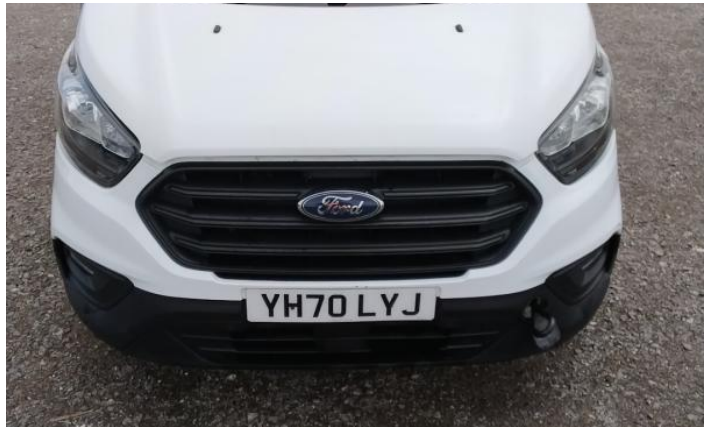
2: Bonnet
Chipped
Multiple Chips

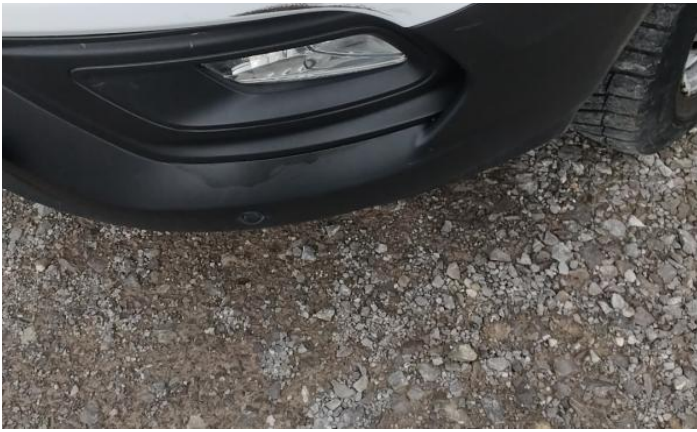
3: Bumper Front
Scratched
Over 100mm Thru Paint

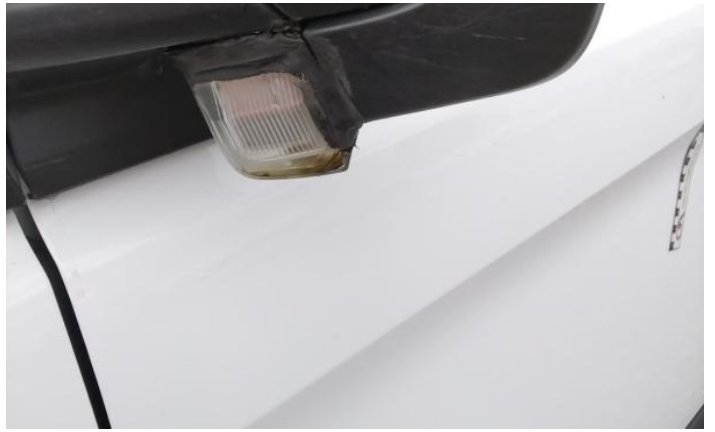
4: Door Mirror Assy nsf
Broken
Replace

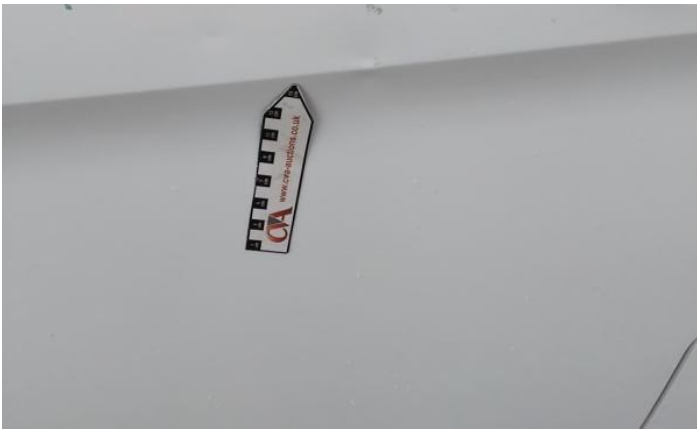
5: Door nsf
Dented
Over 30mm

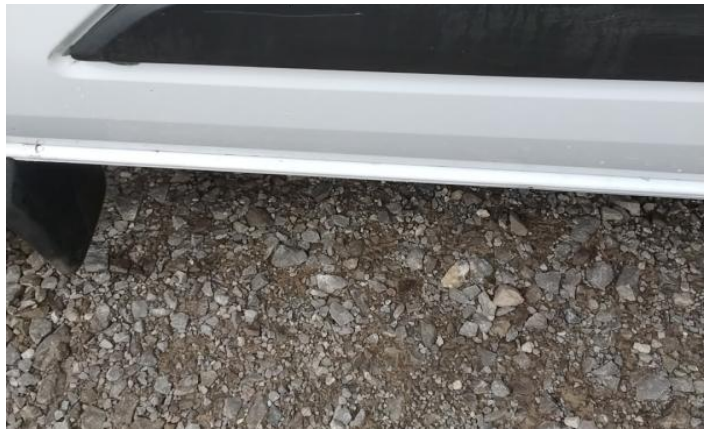
6: Door Moulding nsf
Scratched (Painted)
Over 25mm Thru Paint

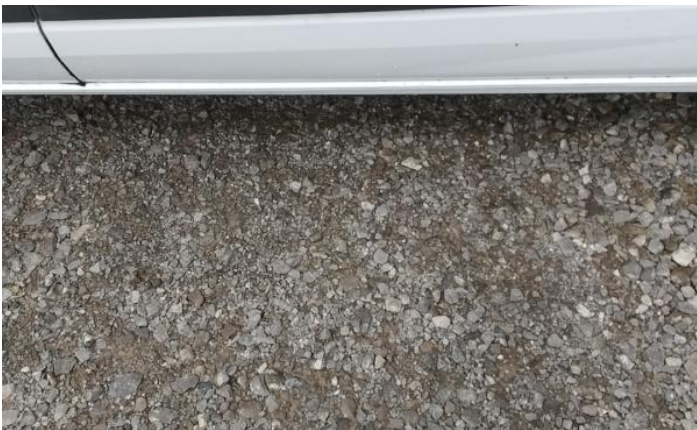
7: Door Moulding nsr
Scratched (Painted)
Over 25mm Thru Paint

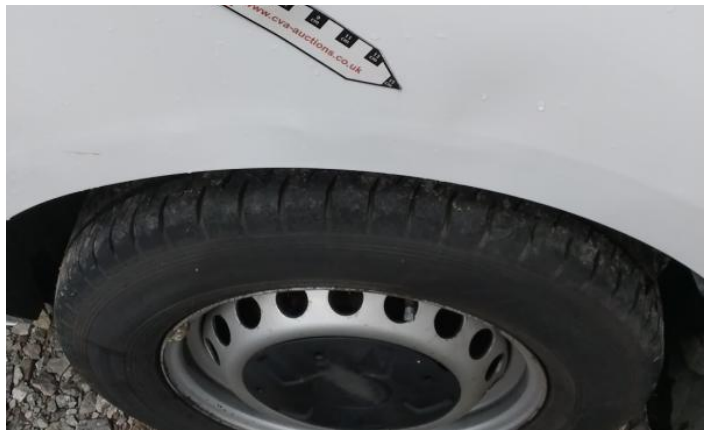
8: Qtr Panel osr
Dented
Over 30mm

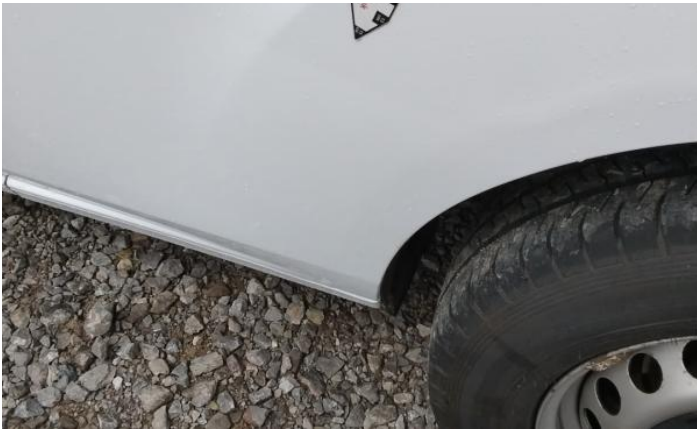
9: Qtr Panel nsr
Dented
Over 30mm

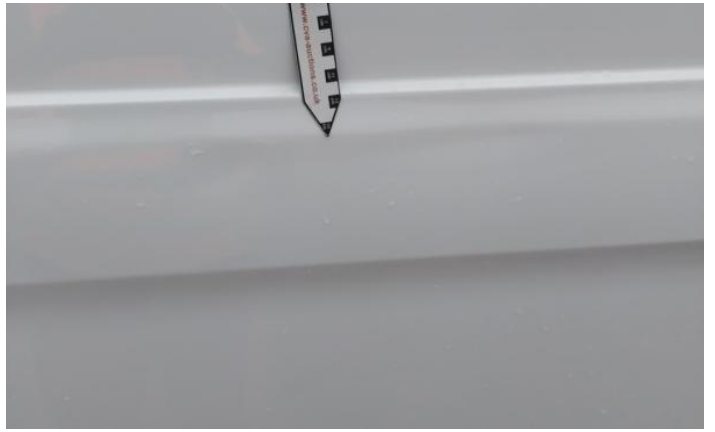
10: Qtr Panel osr
Dented
Over 30mm

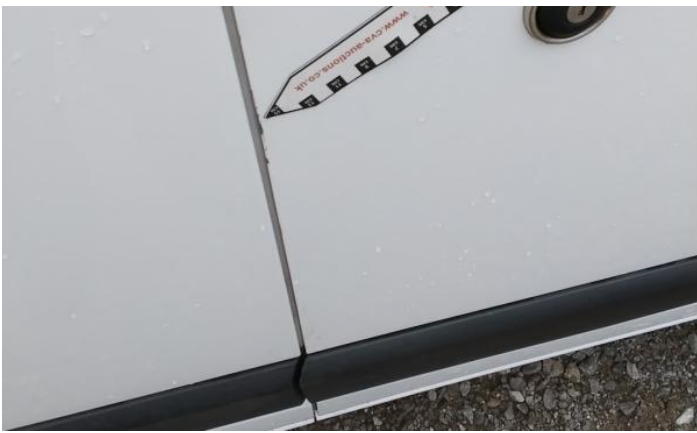
11: Door osf
Chipped
Multiple Chips

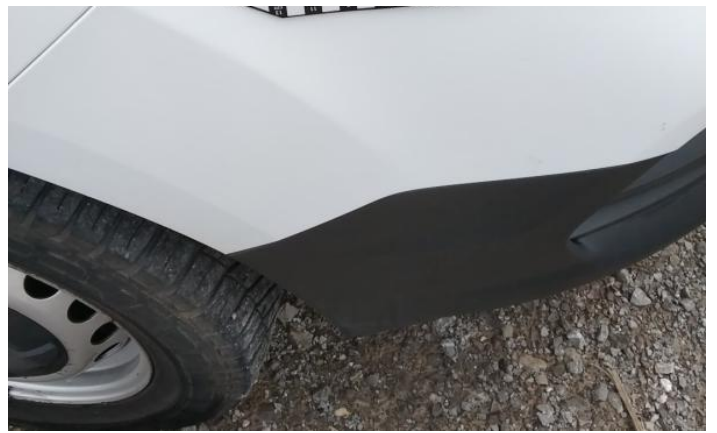
12: Bumper Front
Chipped
Multiple Chips

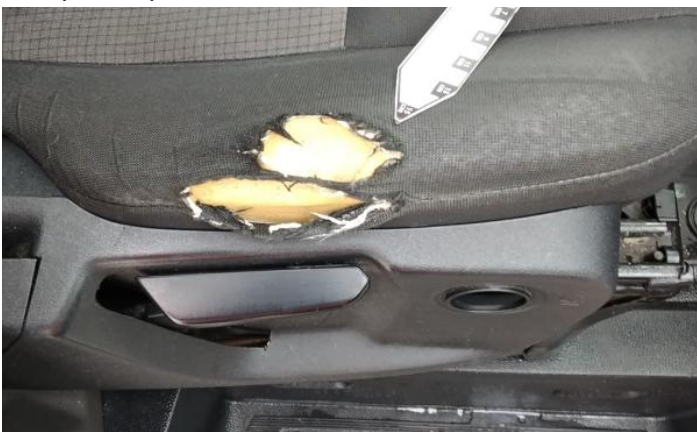
13: Seat Base Cover osf
Holed
Over 3mm

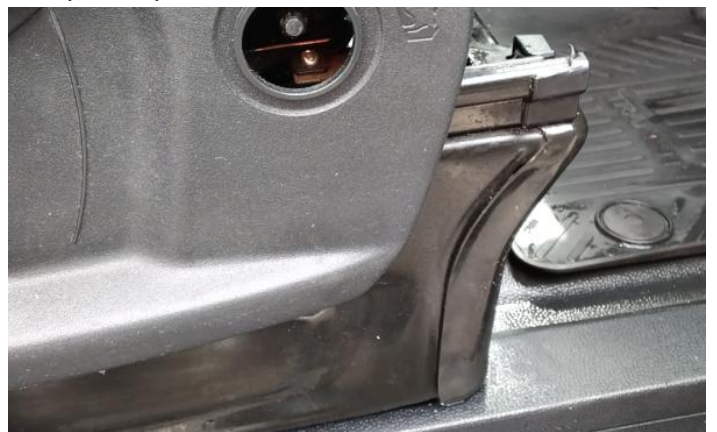
14: Seat Base Cover osr
Missing
Replace

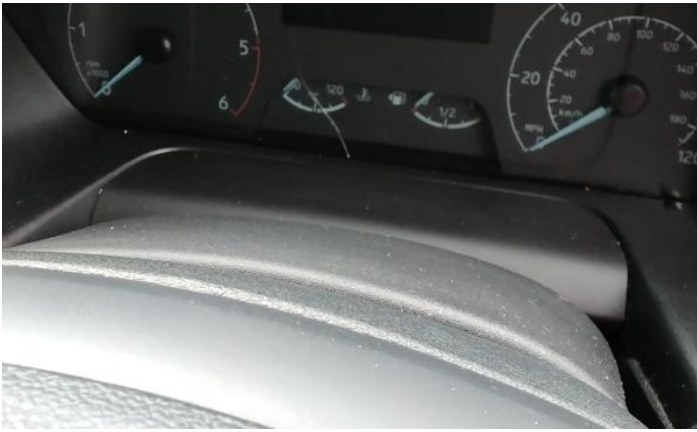
15: Centre Console Front
Broken
Replace
