VEHICLE INSPECTION REPORT

YF71VHM

Mercedes-Benz Sprinter 315 CDI

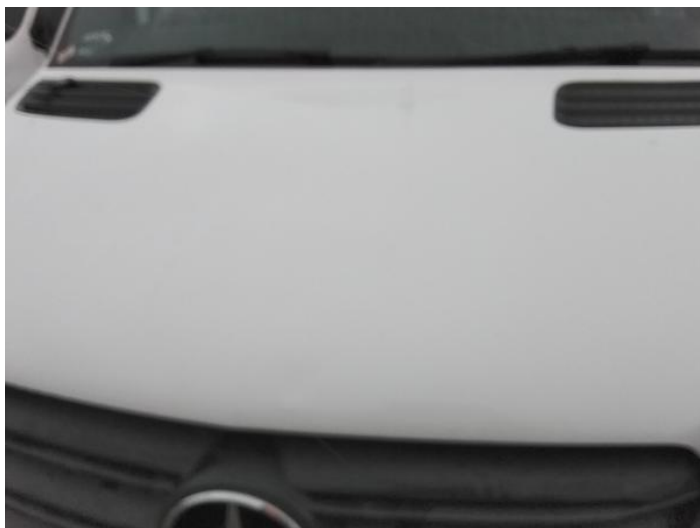
1: Bonnet
Chipped
Multiple Chips

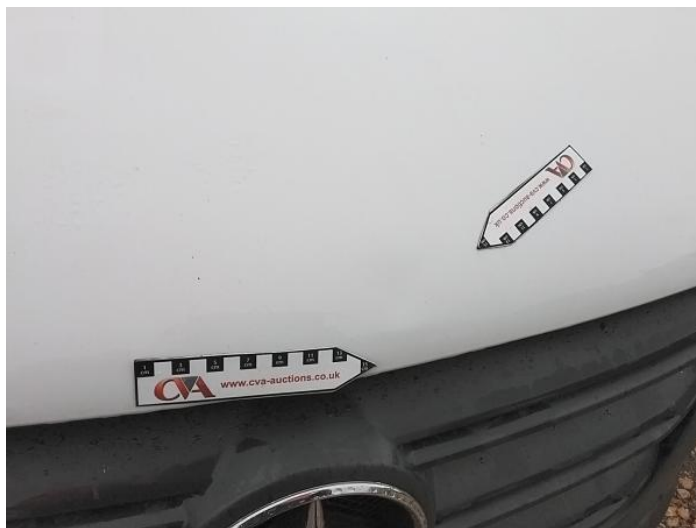
2: Bonnet
Dented
Over 30mm

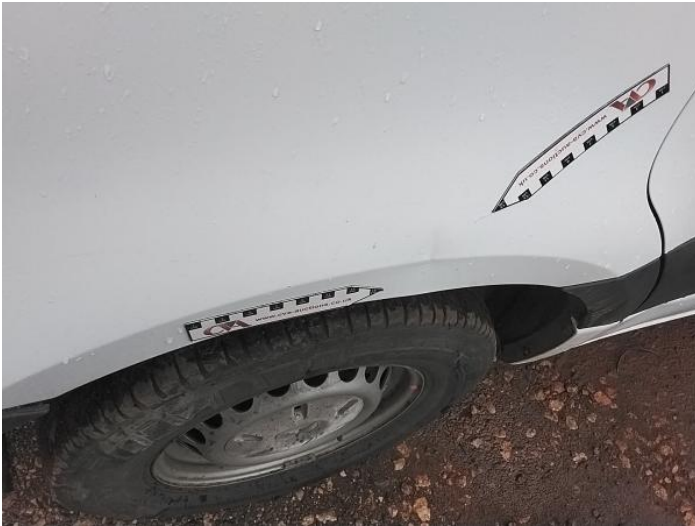
3: Wing nsf
Dented
Over 30mm

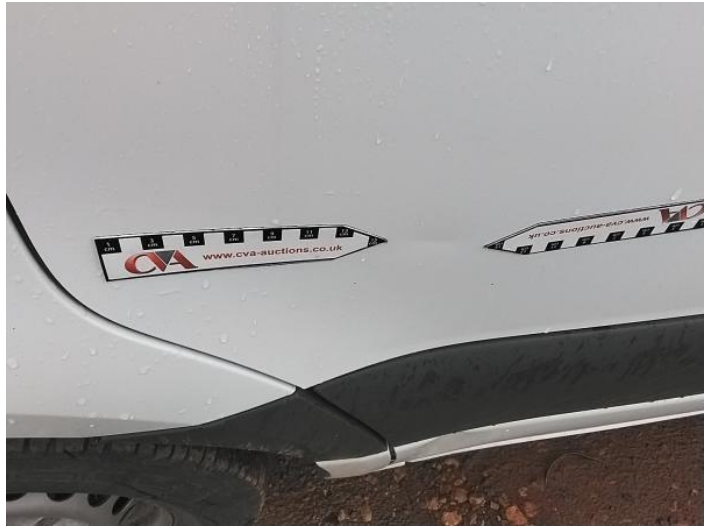
4: Door nsf
Dented
Over 30mm

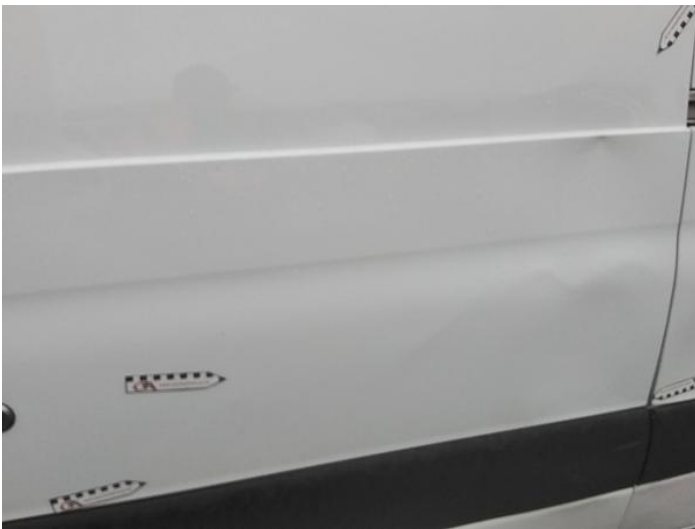
5: Qtr Panel nsr
Dented
Over 30mm

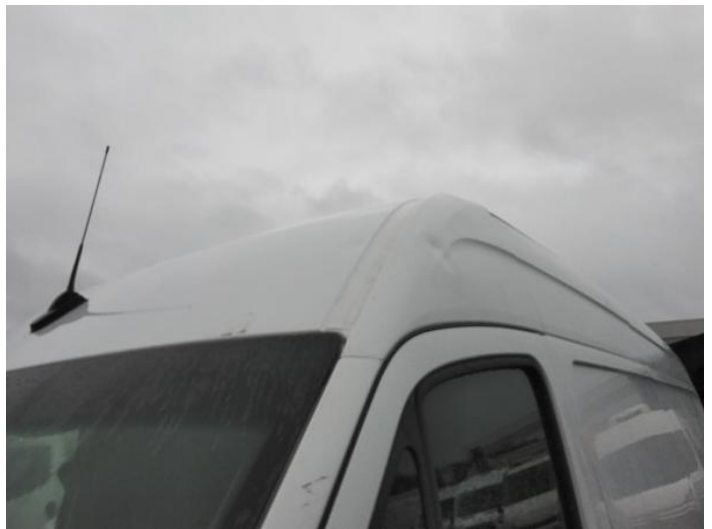
6: Roof
Dented
Over 30mm

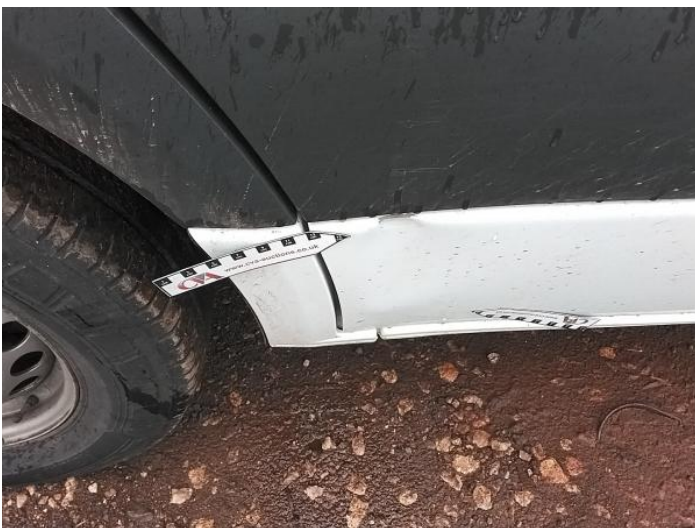
7: Door nsf
Dented
Over 30mm

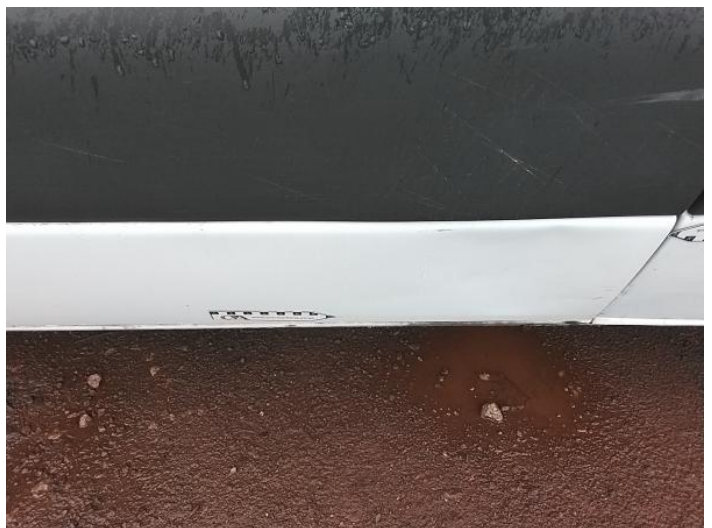
8: Qtr Panel nsr
Dented
Over 30mm

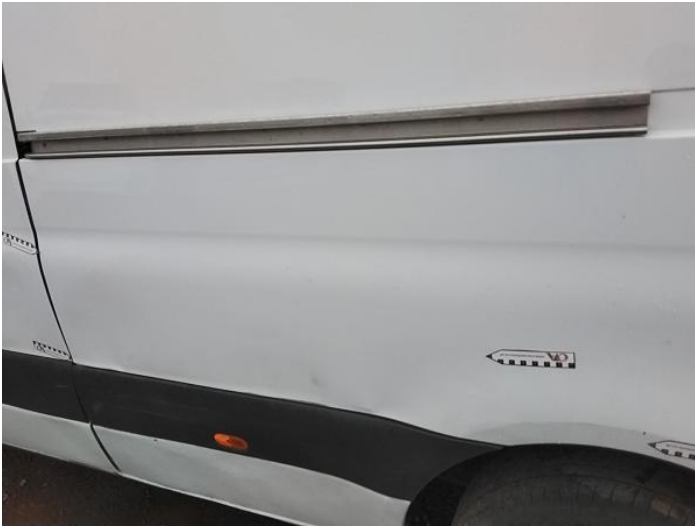
9: Qtr Panel nsr
Dented
Over 30mm

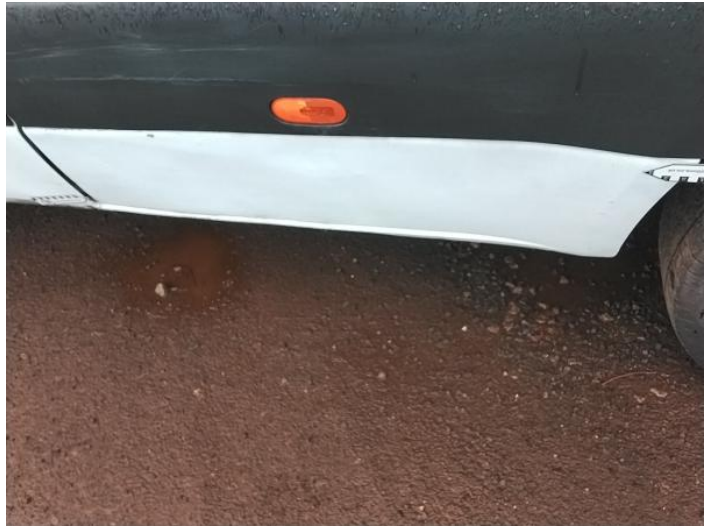
10: Qtr Panel nsr
Dented
Over 30mm

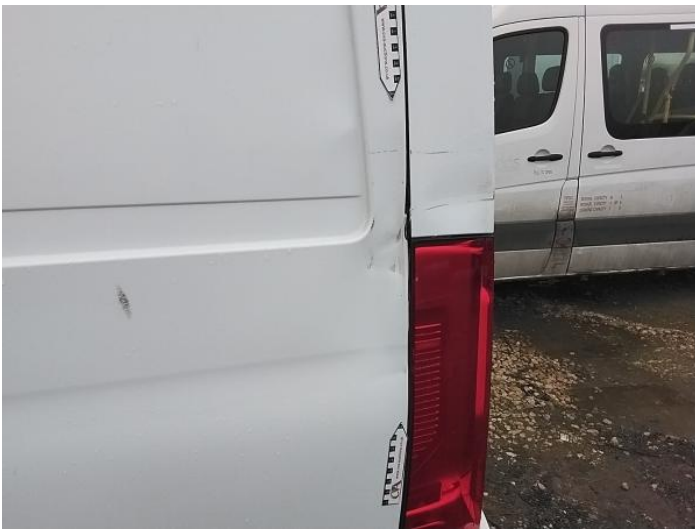
11: Qtr Panel nsr
Dented
Over 30mm

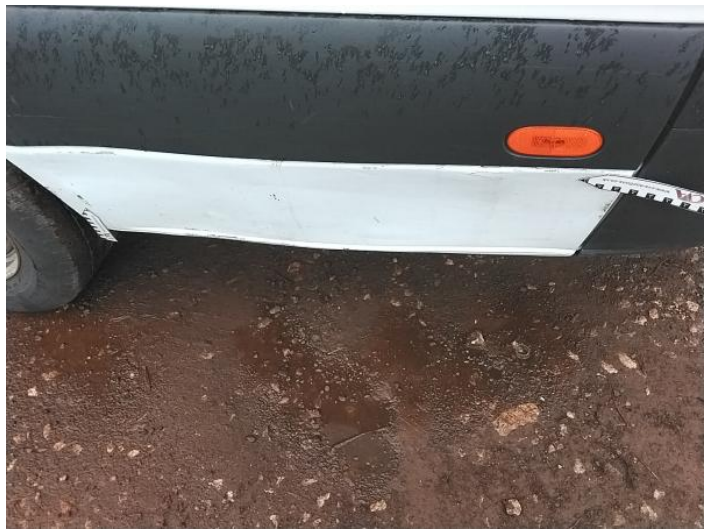
12: Qtr Panel nsr
Dented
Over 30mm

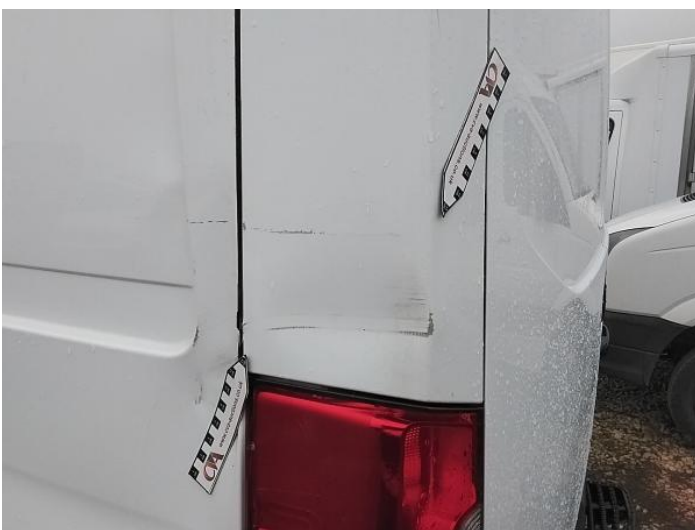
13: C Post ns
Dented
Over 30mm

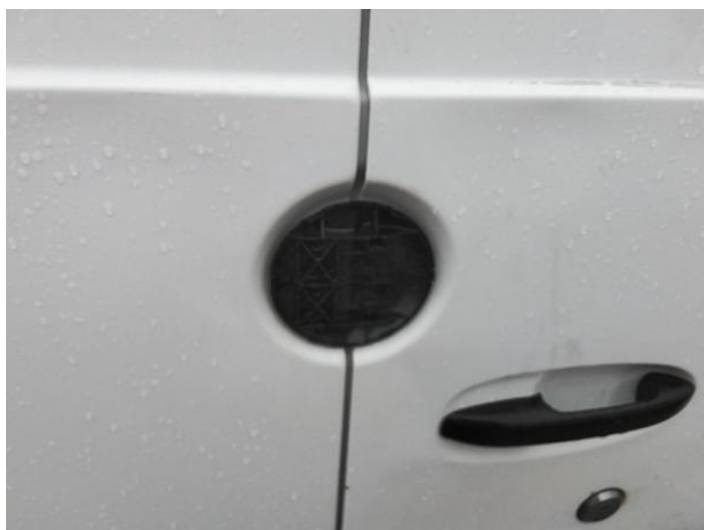
14: Badgedecal Rear
Broken
Replace

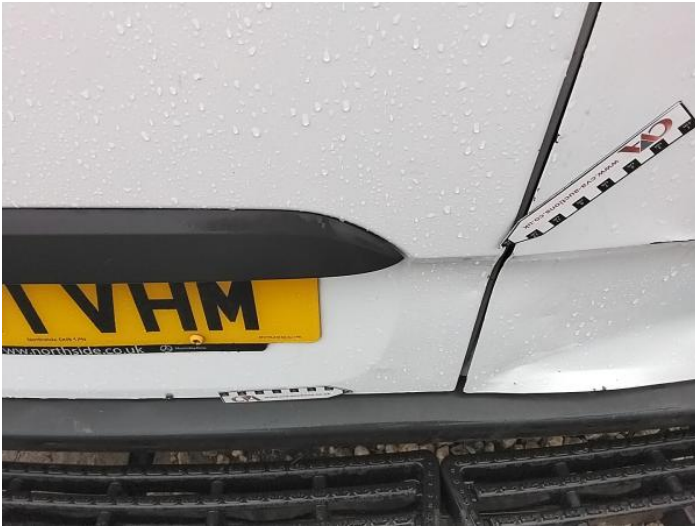
15: Door nsr
Dented
Over 30mm

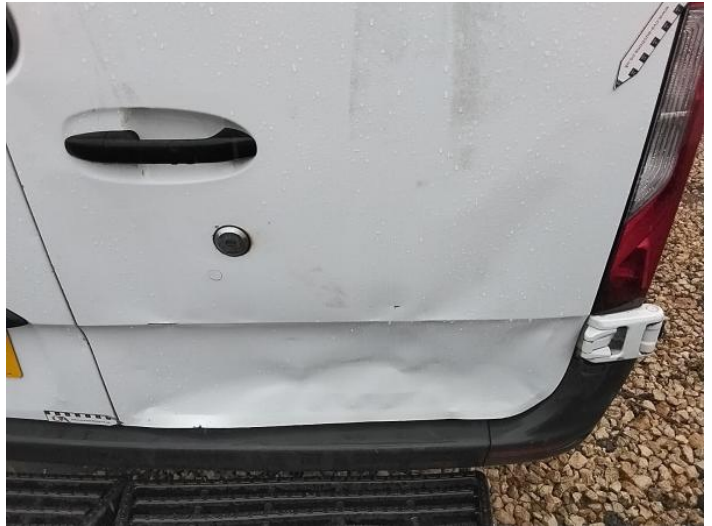
16: Door osr
Dented
Over 30mm

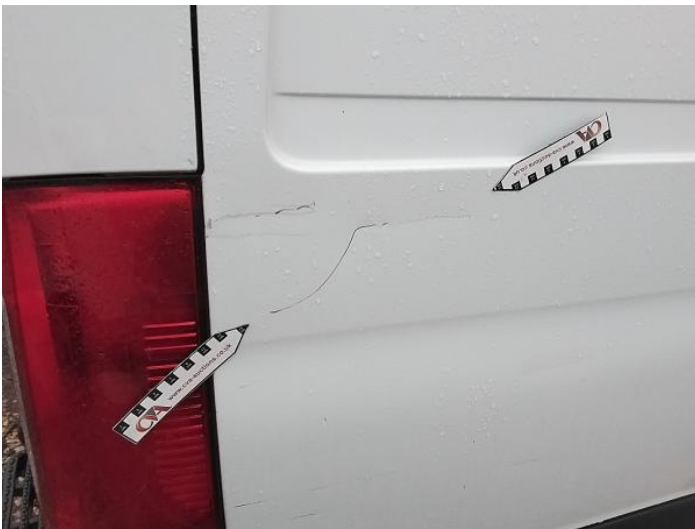
17: Qtr Panel osr
Dented
Over 30mm

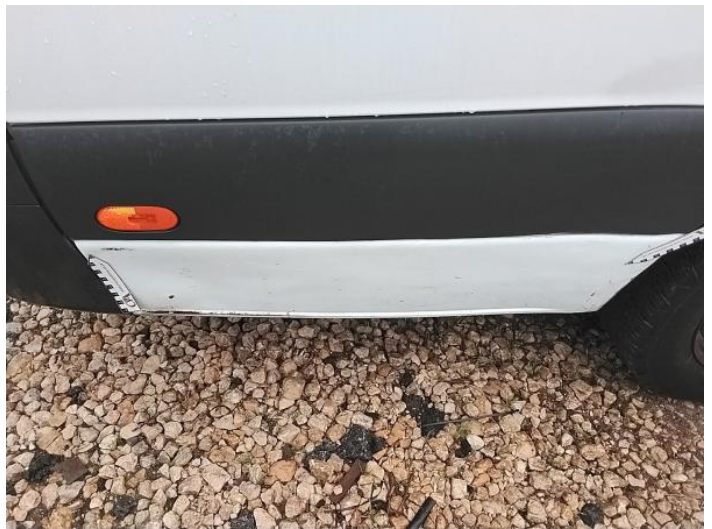
18: Qtr Panel osr
Dented
Over 30mm

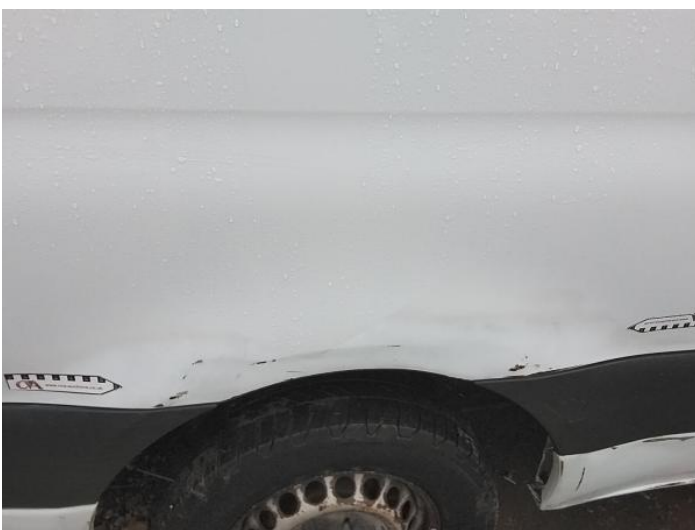
19: Qtr Panel osr
Dented
Over 30mm

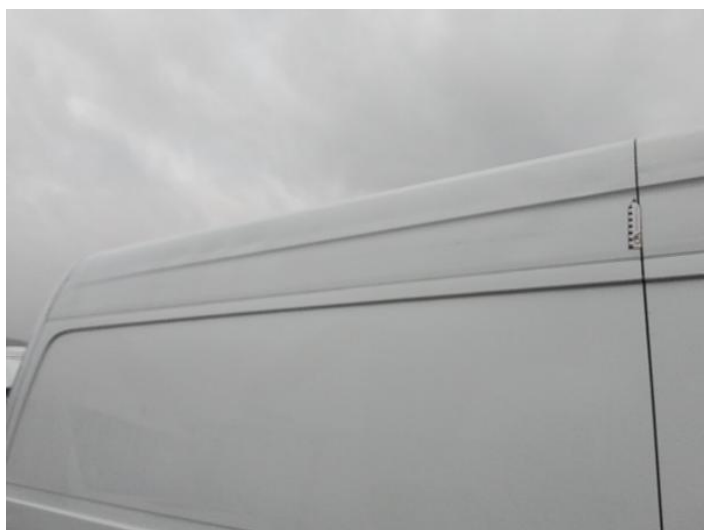
20: Qtr Panel osr
Dented
Over 30mm

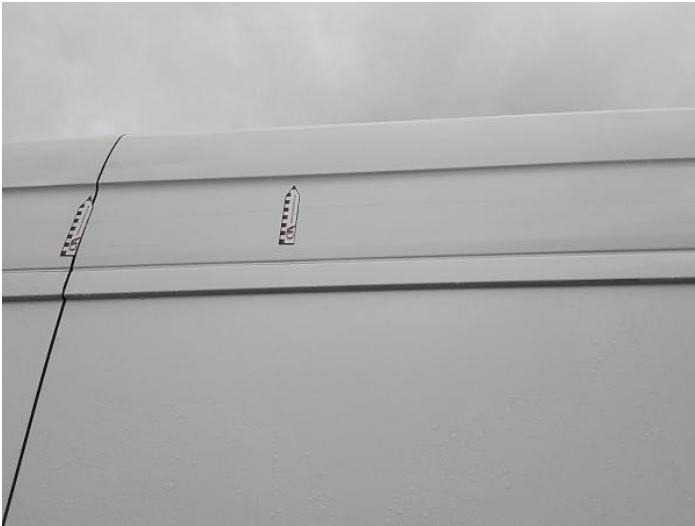
21: Qtr Panel osr
Dented
Over 30mm

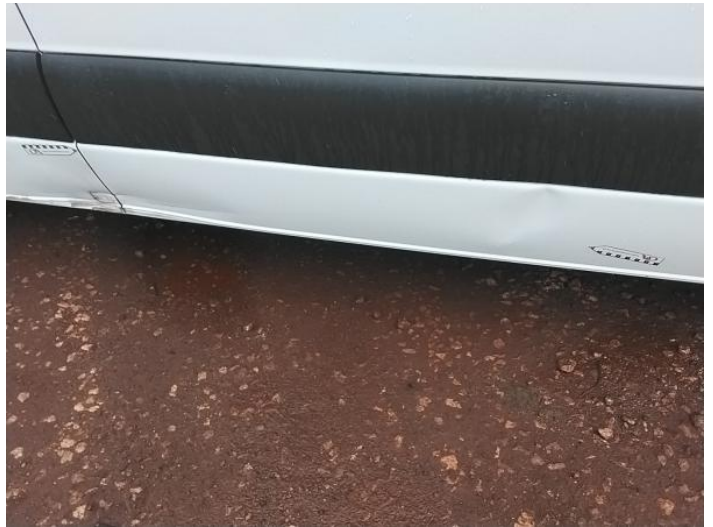
24: Qtr Panel osr
Dented
Over 30mm

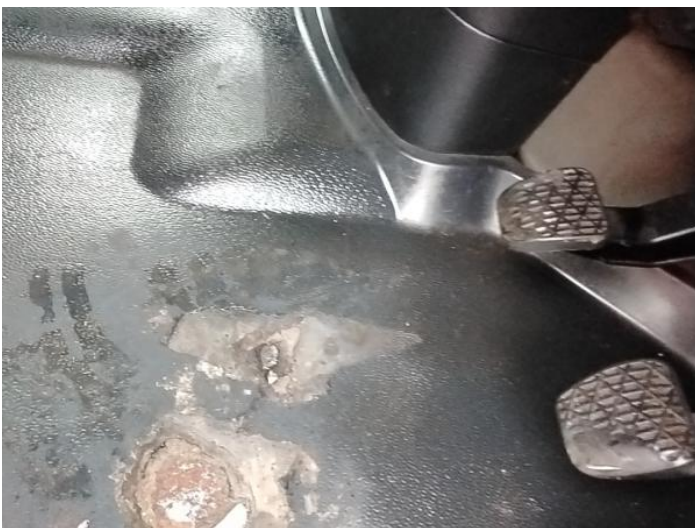
25: Carpets Front
Holed
Over 3mm

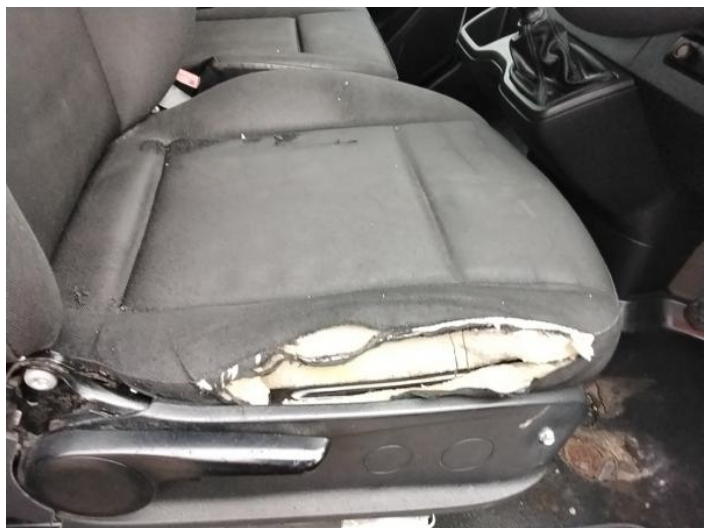
26: Seat Base Cover osf
Holed
Over 3mm

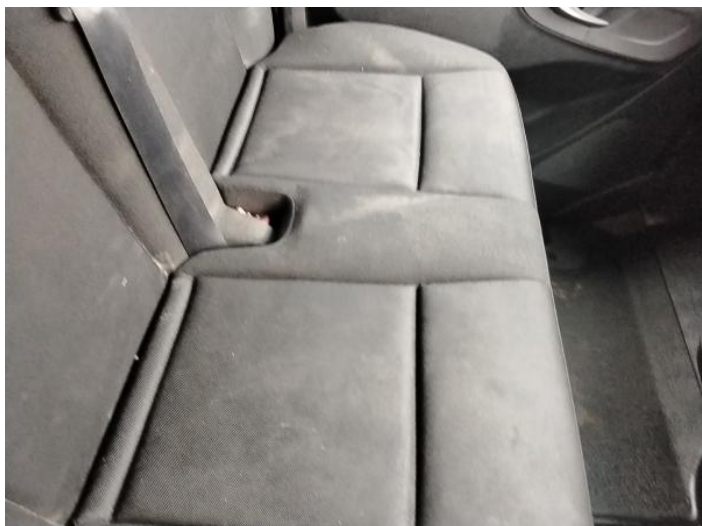
27: Seat Base Cover nsf
Soiled
Heavy
