VEHICLE INSPECTION REPORT

MF16XPS

Vauxhall Vivaro 2900 1.6 CDTI BITURBO 120PS ECOFLEX

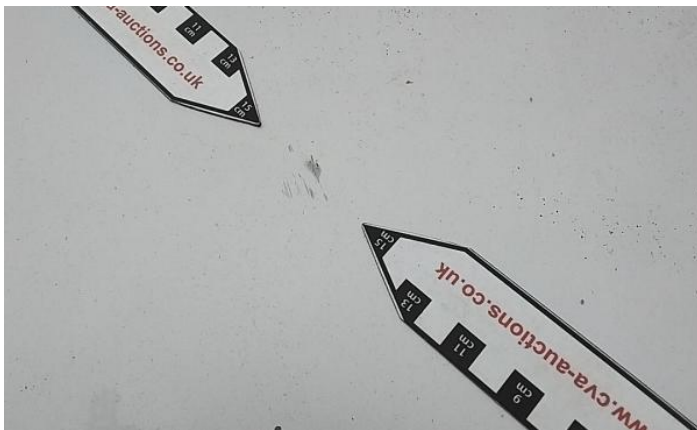
1: Bonnet
Dented
With Paint Damage

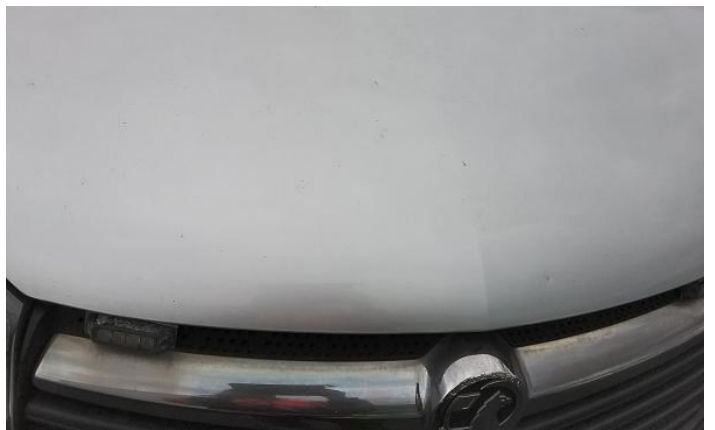
2: Bonnet
Chipped
Multiple Chips

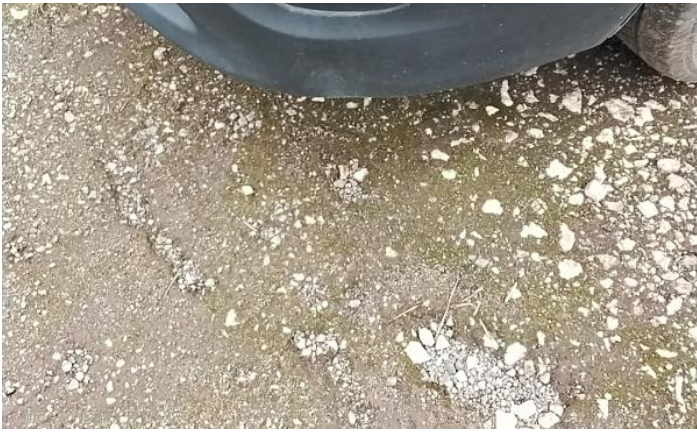
3: Bumper Front
Dented
Over 30mm

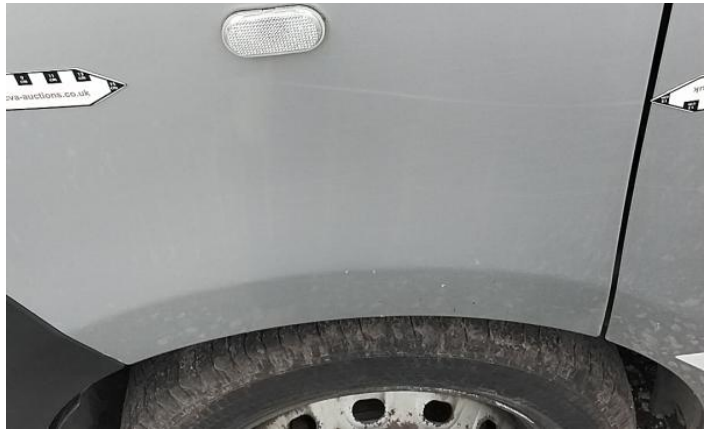
4: Wing nsf
Scratched
Over 25mm Thru Paint

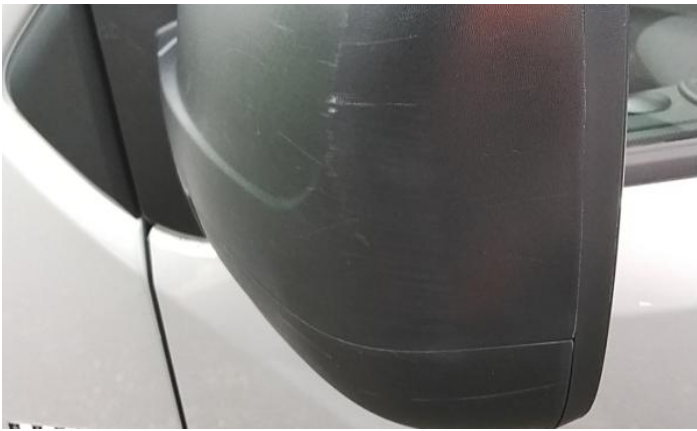
5: Door Mirror Assy nsf
Scuffed (Unpainted)
UpTo 100mm

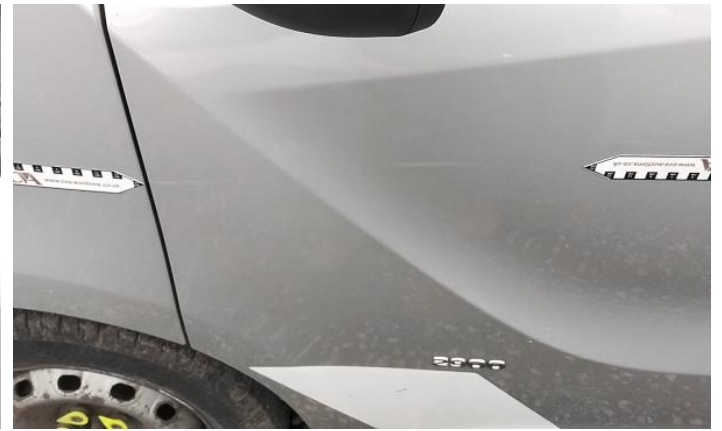
6: Door nsf
Scratched
Over 25mm Thru Paint

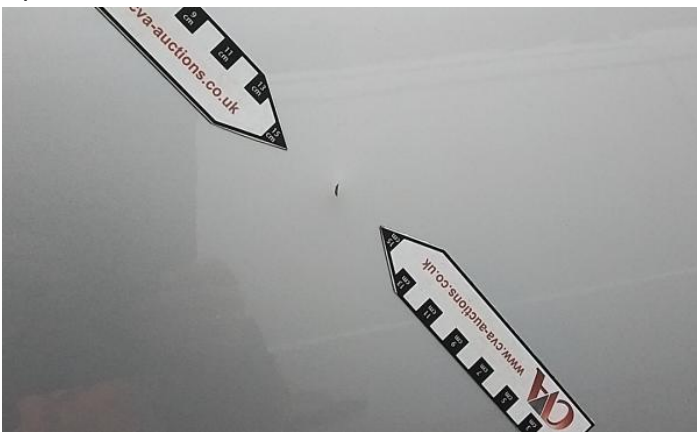
7: Qtr Panel nsr
Dented
With Paint Damage

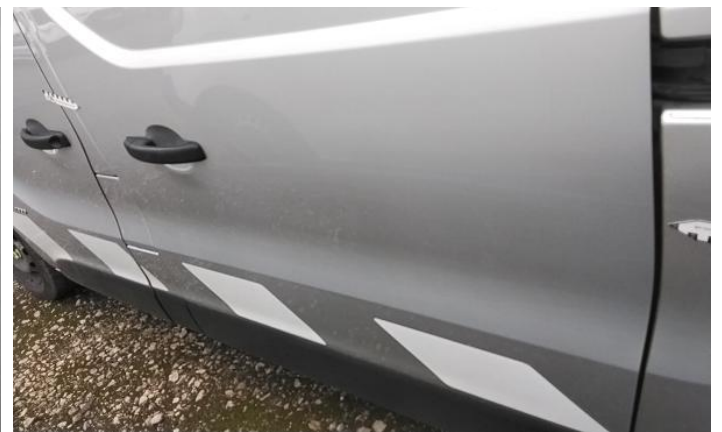
8: Qtr Panel nsr
Scratched
Over 25mm Thru Paint

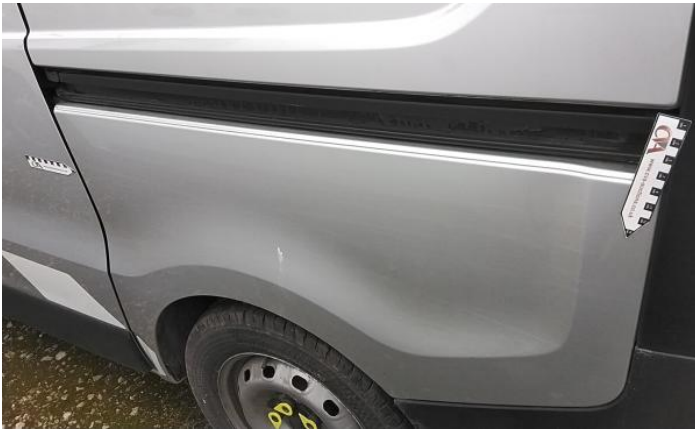
9: Qtr Panel nsr
Scratched
Over 25mm Thru Paint

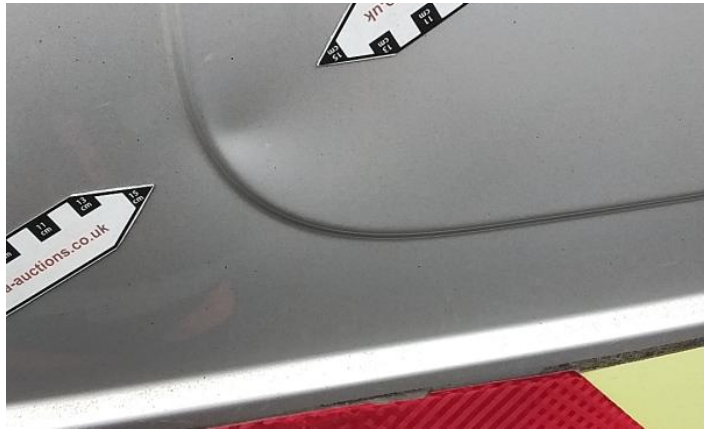
10: Door osr
Dented
Over 30mm

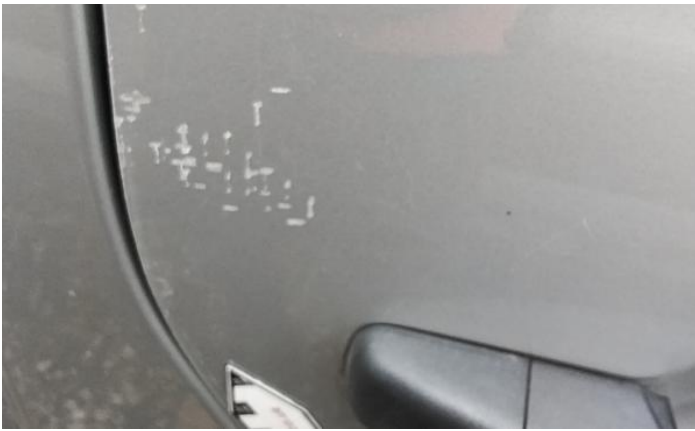
11: Door osf
Scratched
Over 25mm Thru Paint

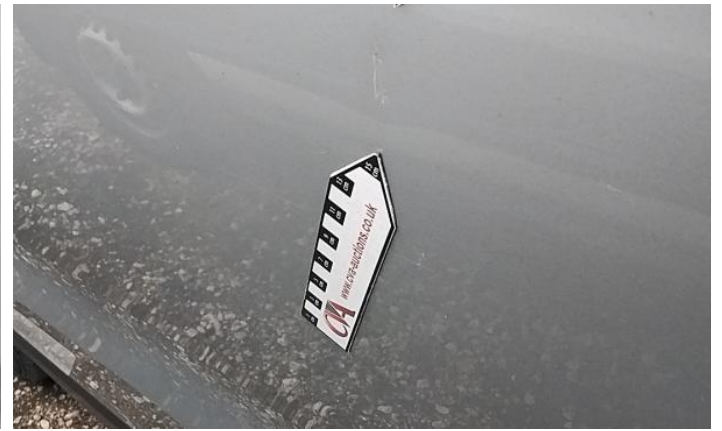
12: Qtr Panel osr
Dented
With Paint Damage

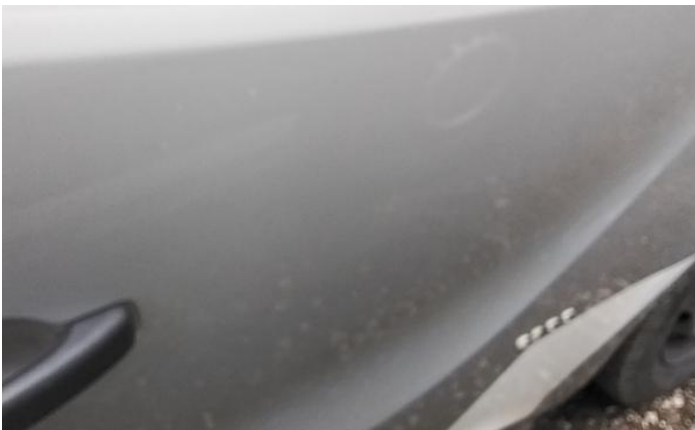
13: Door osf
Chipped
Multiple Chips

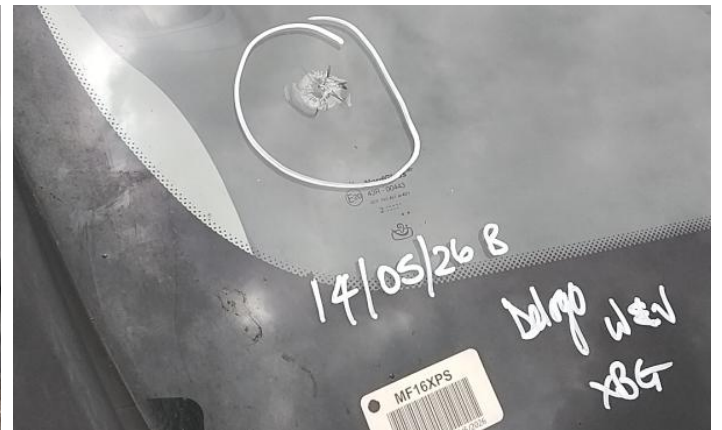
14: Screen Front
Cracked
Replace

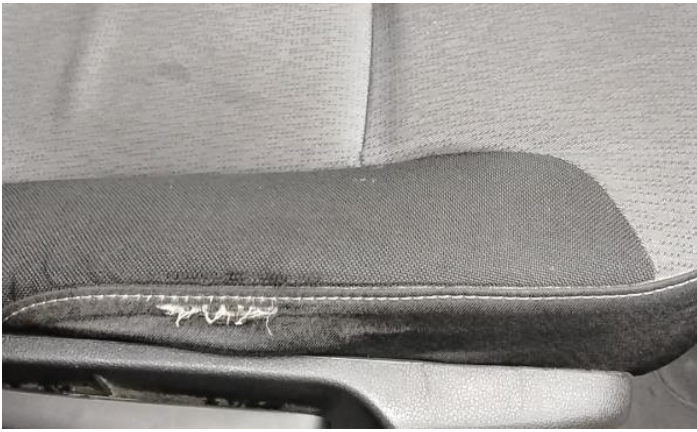
15: Seat Base Cover of
Torn
Over 3mm
