VEHICLE INSPECTION REPORT

PJ70KPT

Mercedes-Benz Sprinter 314 CDI

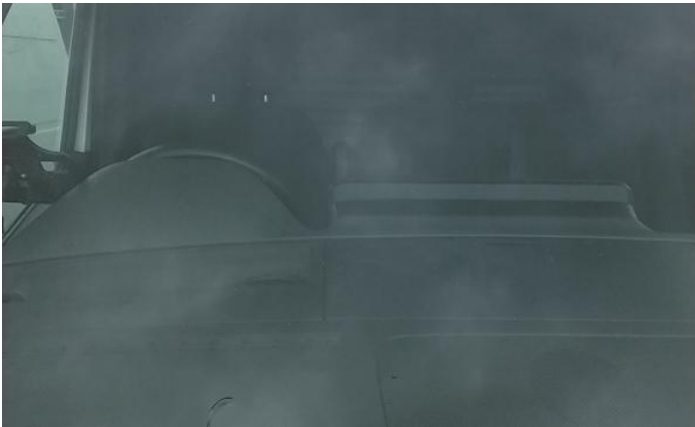
1: Screen Front
Cracked
Replace

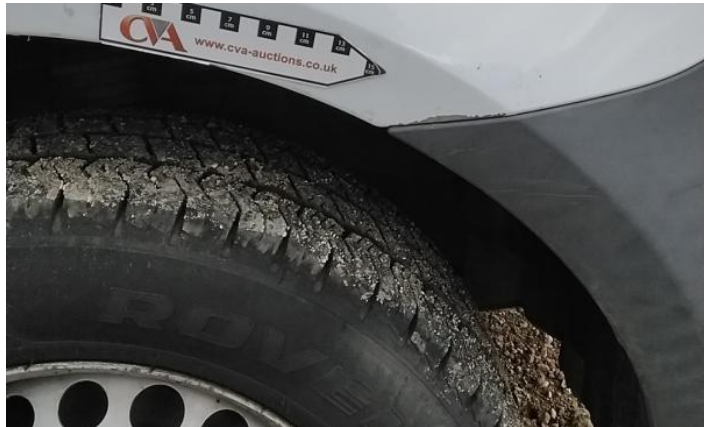
2: Wing of
Scratched
Over 25mm Thru Paint

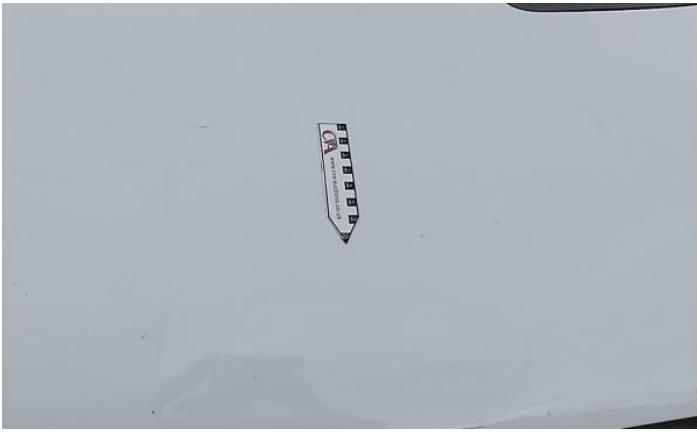
3: Bonnet
Dented
With Paint Damage

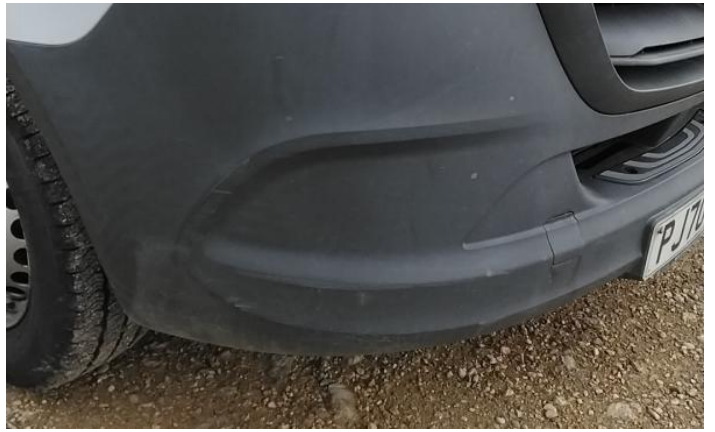
4: Bumper Front Moulding
Scuffed (Unpainted)
Over 100mm

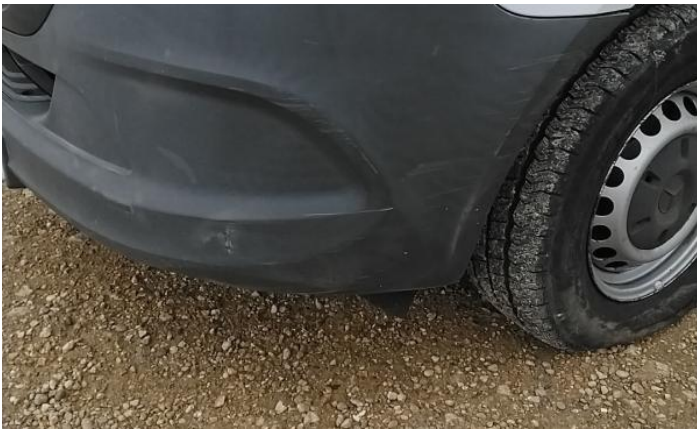
5: Bumper Front Moulding
Scuffed (Unpainted)
Over 100mm

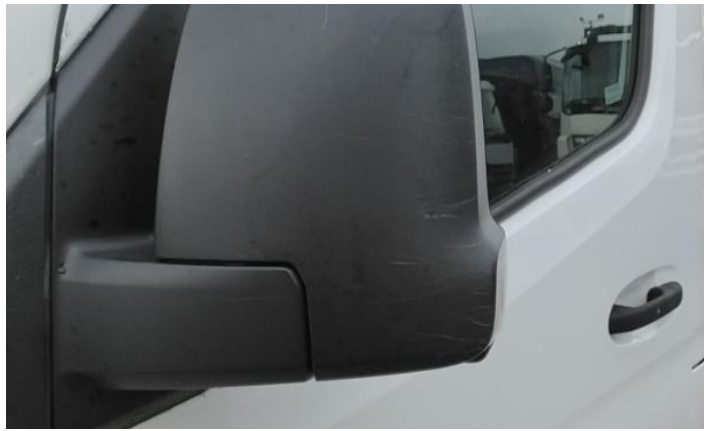
6: Door Mirror Assy nsf
Scuffed (Unpainted)
Over 100mm

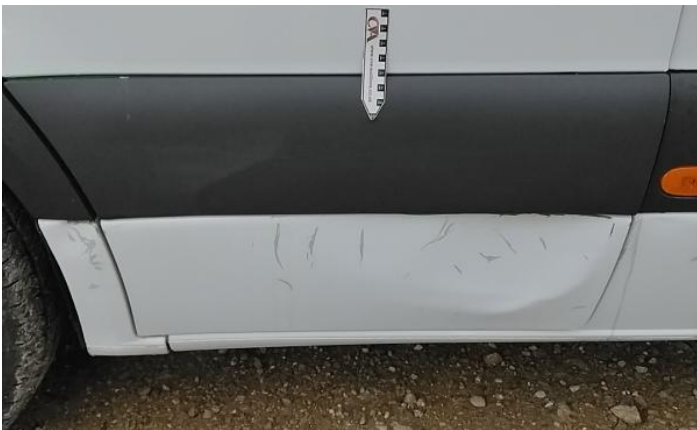
7: Door nsf
Dented
With Paint Damage

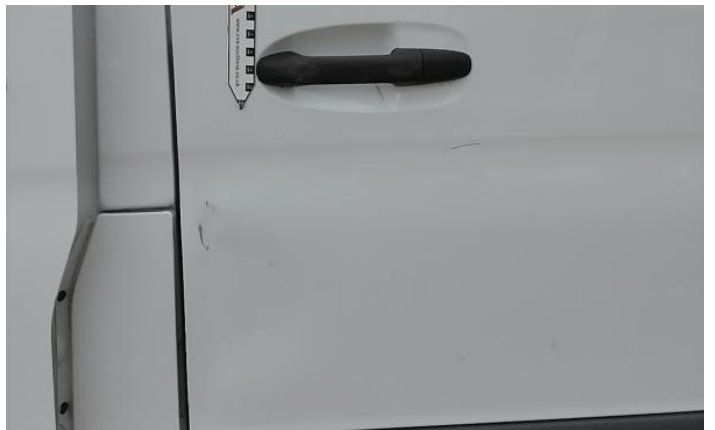
8: Door nsr
Dented
With Paint Damage

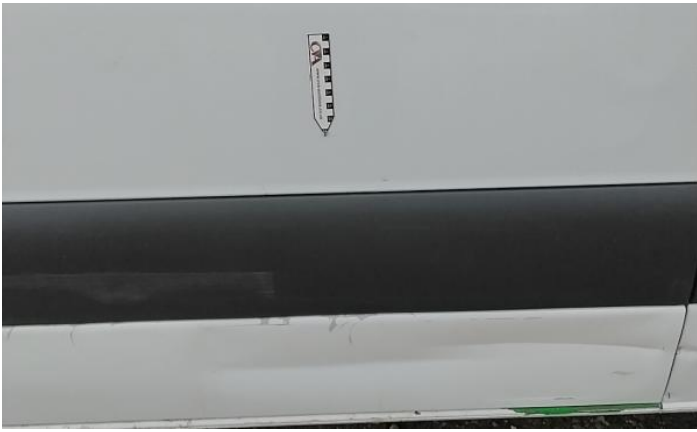
9: Door nsr
Dented
Over 30mm

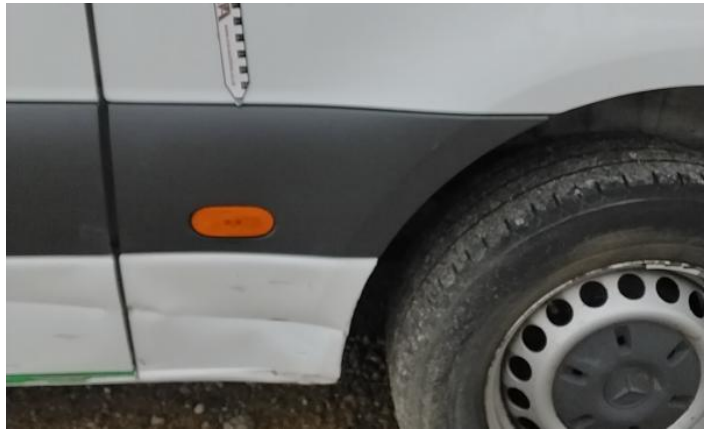
10: Qtr Panel nsr
Dented
With Paint Damage

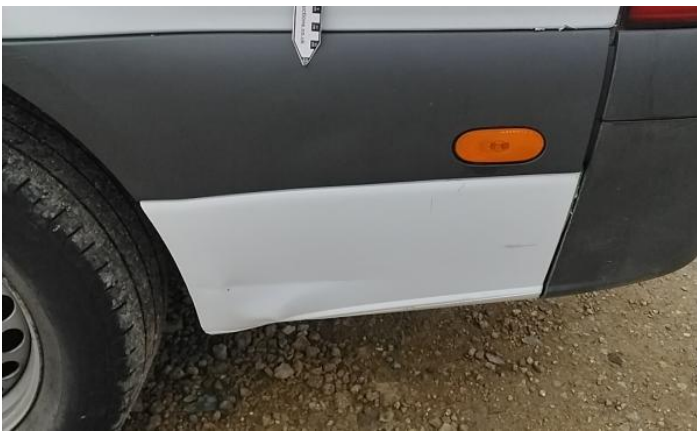
11: Qtr Panel nsr
Dented
With Paint Damage

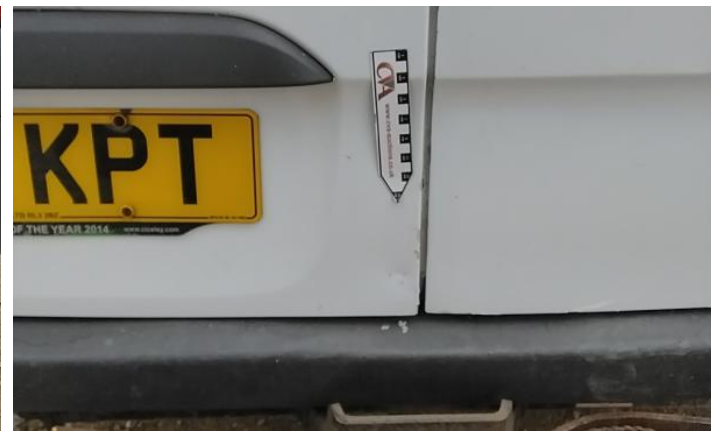
12: Door nsr
Dented
Between 10mm + 30mm

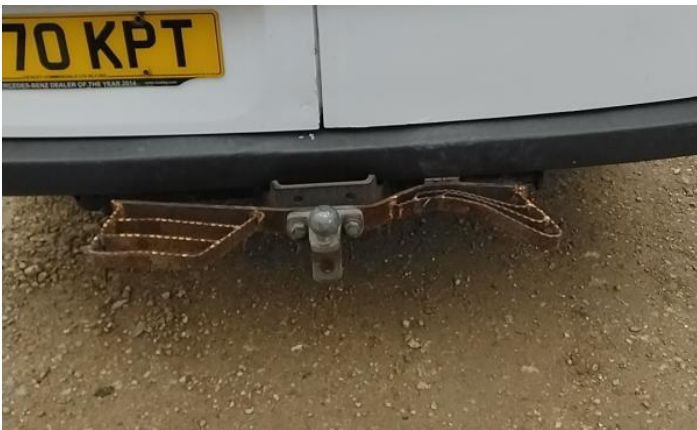
13: Bumper Rear Moulding
Scuffed (Unpainted)
Over 100mm

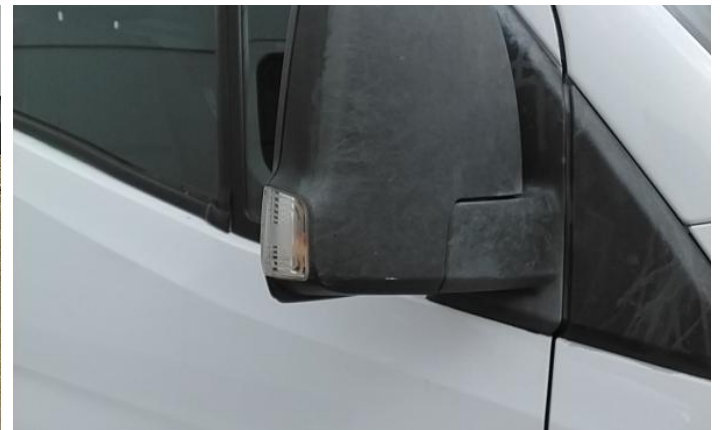
14: Door Mirror Assy of
Scuffed (Unpainted)
UpTo 100mm

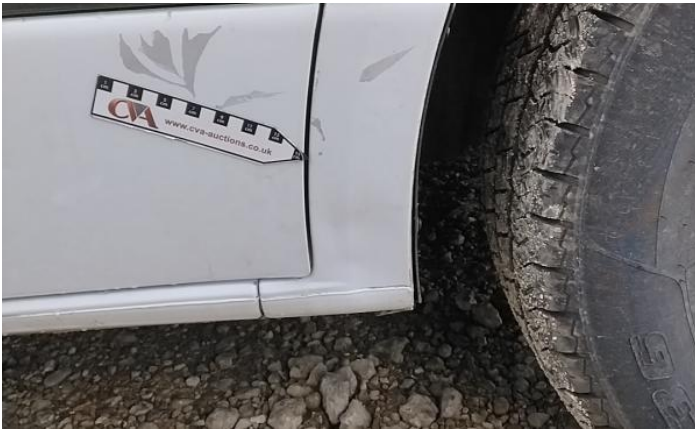
15: Wing of
Dented
Between 10mm + 30mm

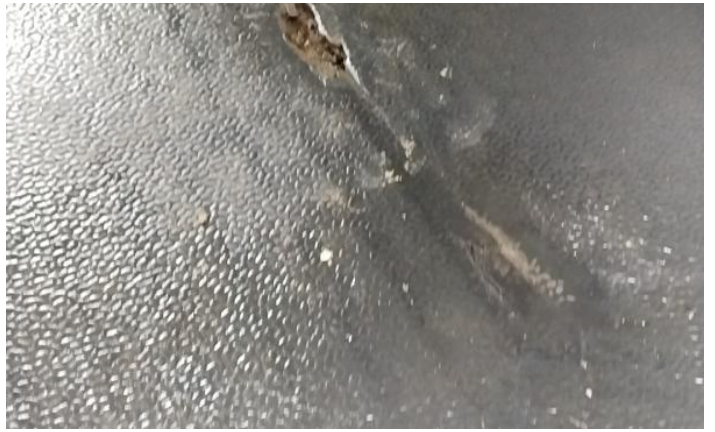
16: Carpets Front
Holed
Over 3mm
