COMMERCIAL VEHICLE AUCTIONS LTD
THE UK'S MOST ESTABLISHED COMMERCIAL VEHICLE AUCTIONEERS

VEHICLE INSPECTION REPORT

PJ70KRZ

Mercedes-Benz Sprinter 314 CDI

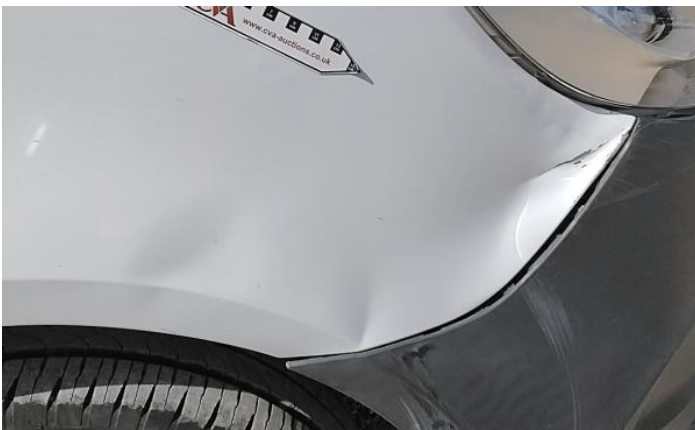
1: Wing osf
Dented
With Paint Damage

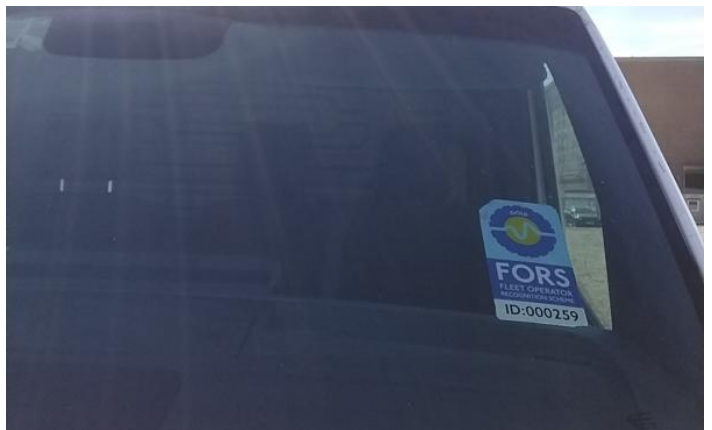
2: Screen Front
Chipped
Over 10mm

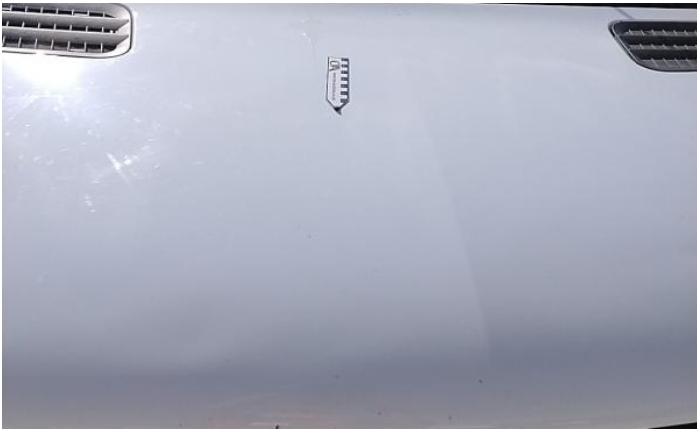
3: Bonnet
Chipped
Multiple Chips

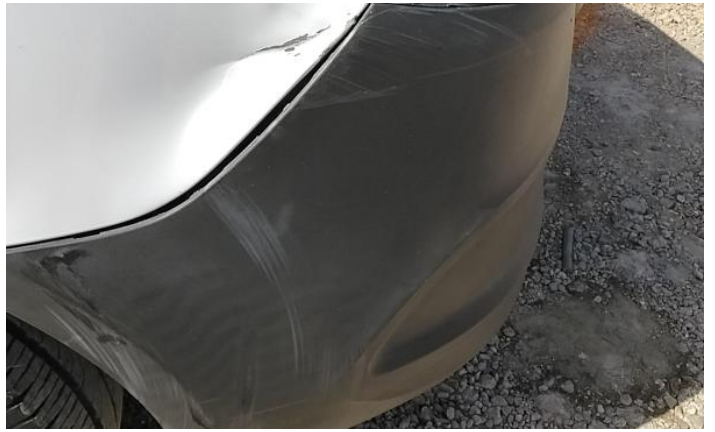
4: Bumper Front Moulding
Scuffed (Unpainted)
Over 100mm

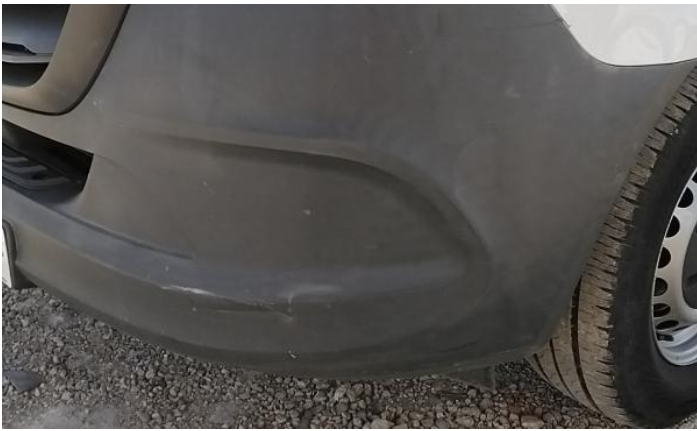
5: Bumper Front Moulding
Scuffed (Unpainted)
Over 100mm

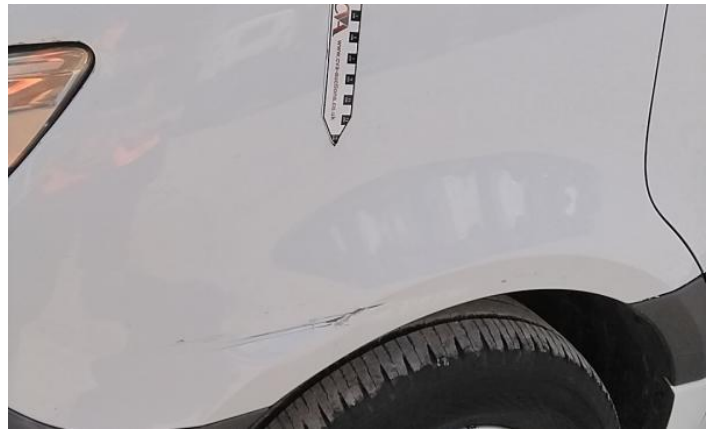
6: Wing nsf
Dented
With Paint Damage

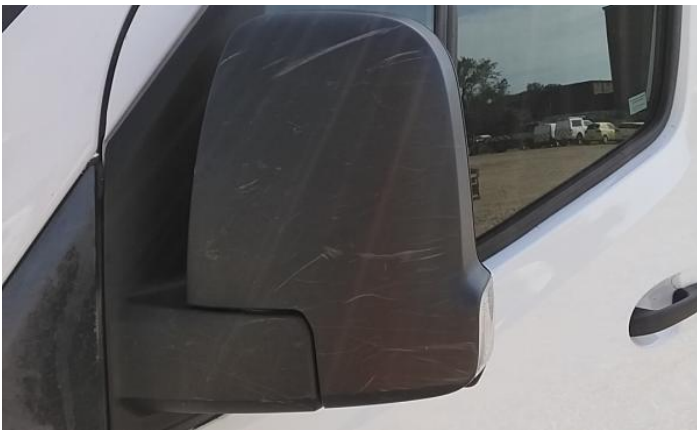
7: Door Mirror Assy nsf
Scuffed (Unpainted)
Over 100mm

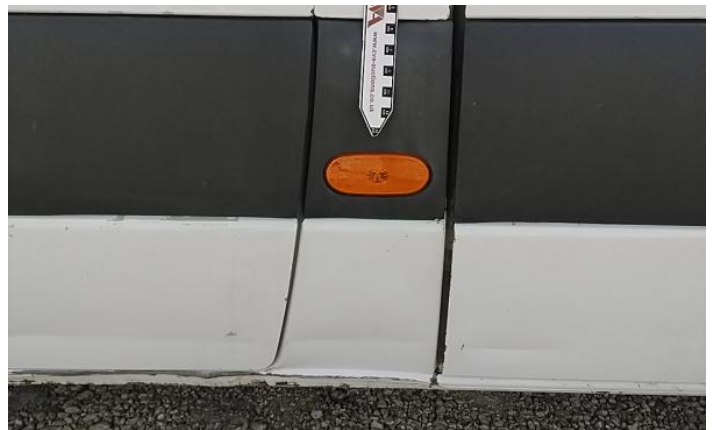
8: B Post ns
Dented
With Paint Damage

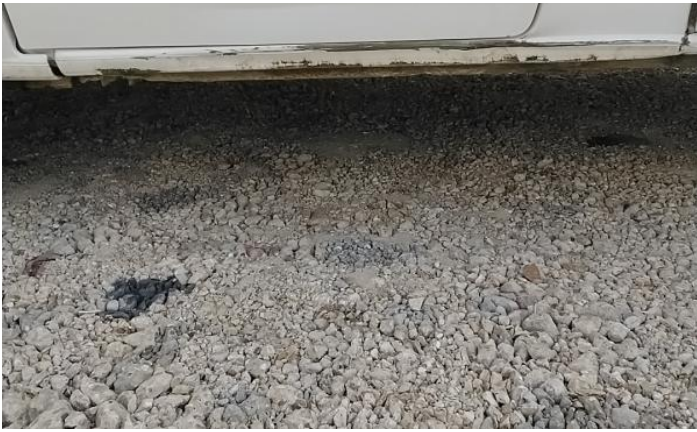
9: Sill ns
Dented
With Paint Damage

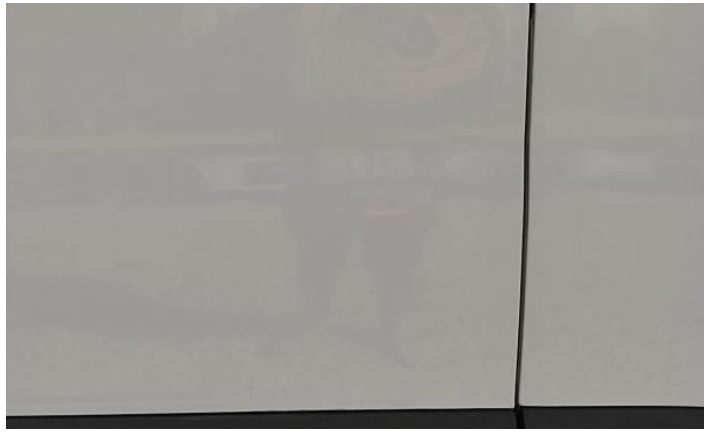
10: Door nsr
Dented
Over 30mm

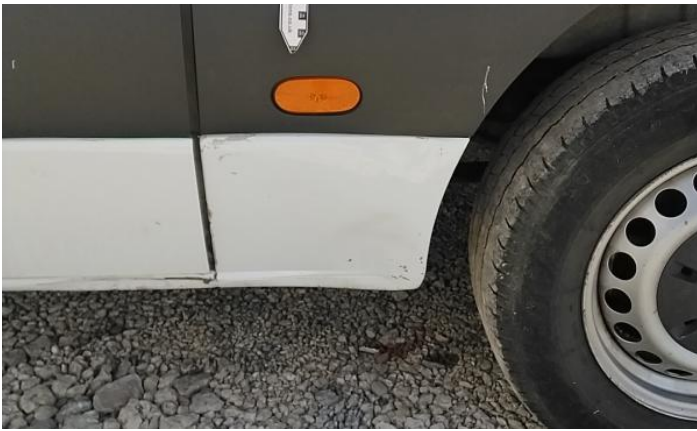
11: Qtr Panel nsr
Dented
Between 10mm + 30mm

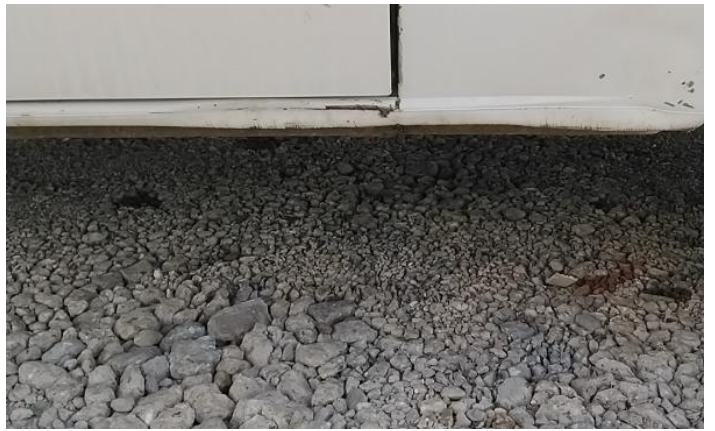
12: Sill ns
Dented
With Paint Damage

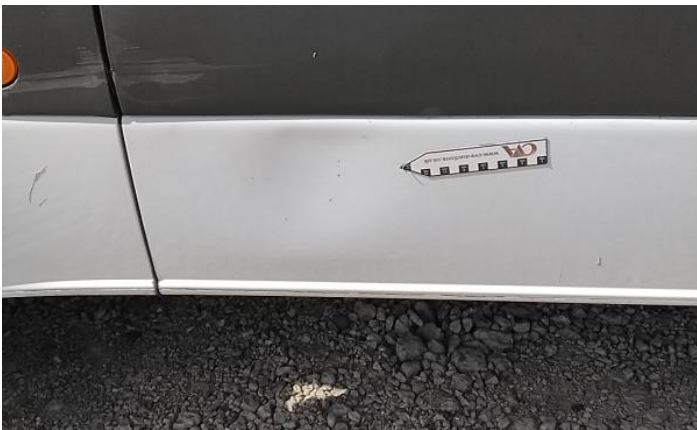
13: Qtr Panel osr
Dented
Between 10mm + 30mm

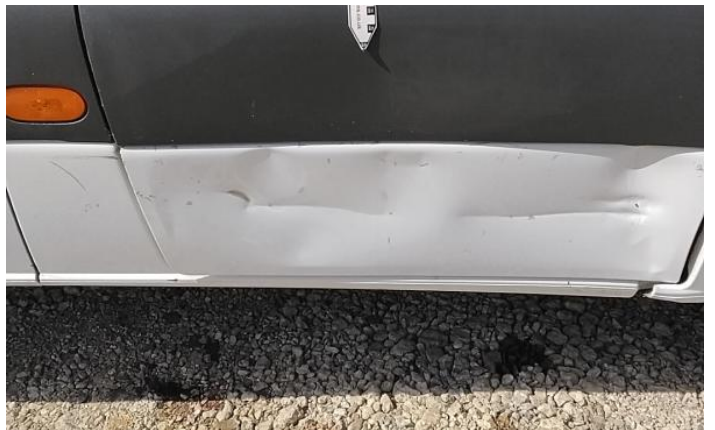
14: Door osf
Dented
With Paint Damage

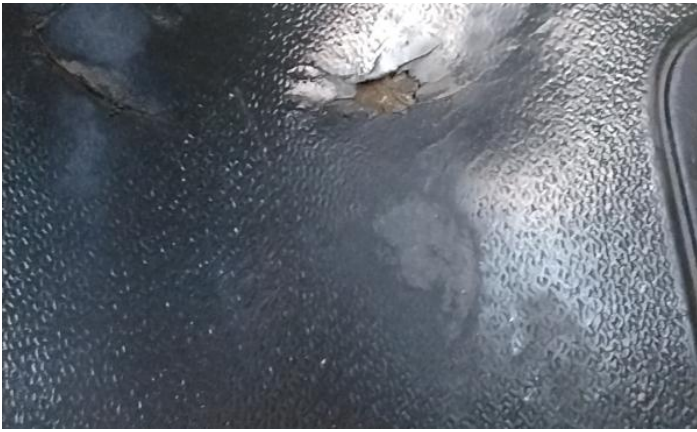
15: Carpets Front
 Holed
 Over 3mm
