COMMERCIAL VEHICLE AUCTIONS LTD
THE UK'S MOST ESTABLISHED COMMERCIAL VEHICLE AUCTIONEERS

VEHICLE INSPECTION REPORT

PJ19RFN

Mercedes-Benz Sprinter 316 CDI

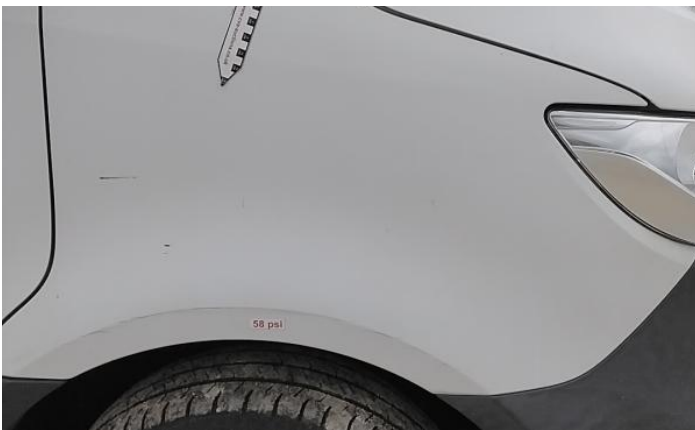
1: Wing of
Scratched
Over 25mm Thru Paint

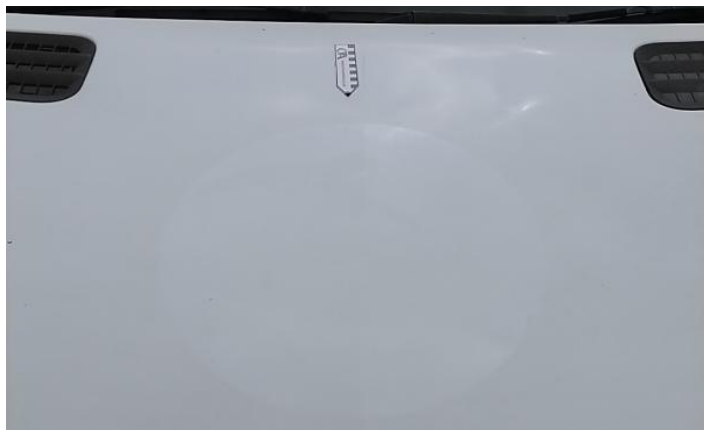
2: Bonnet
Chipped
Multiple Chips

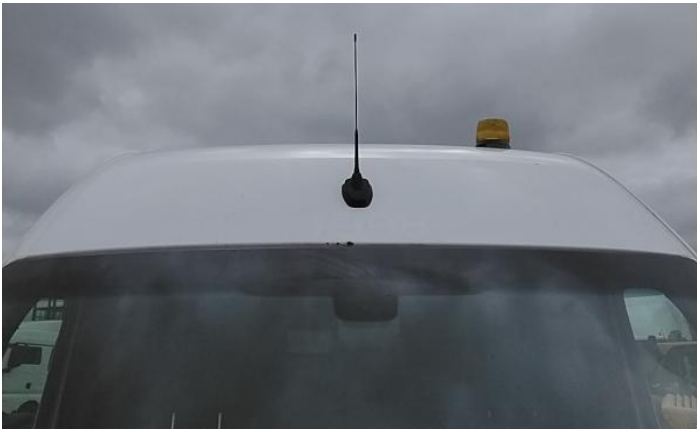
3: Roof
Rusted
Over 5mm

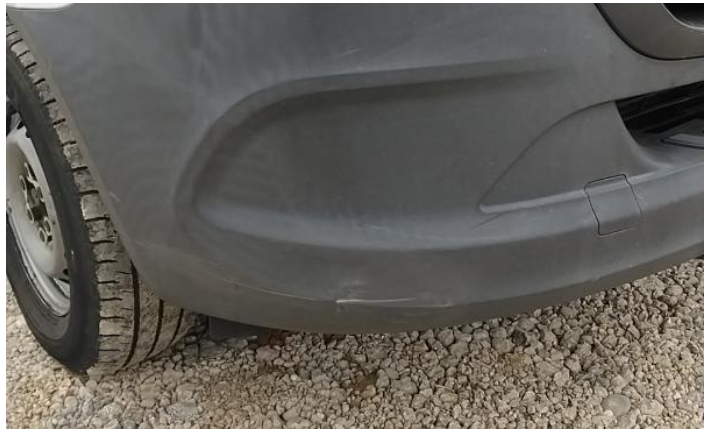
4: Bumper Front Moulding
Scuffed (Unpainted)
Over 100mm

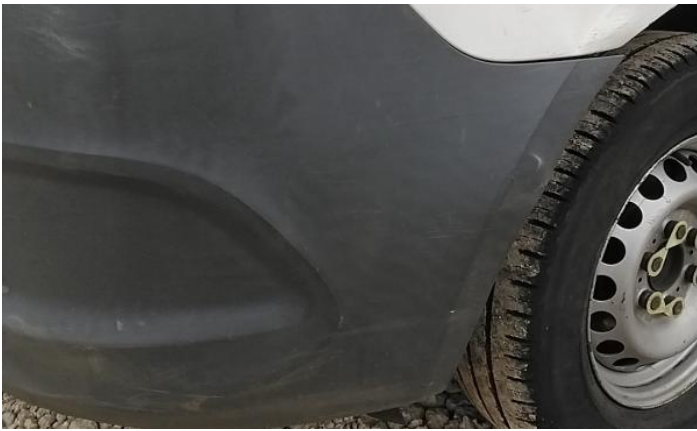
5: Bumper Front Moulding
Scuffed (Unpainted)
Over 100mm

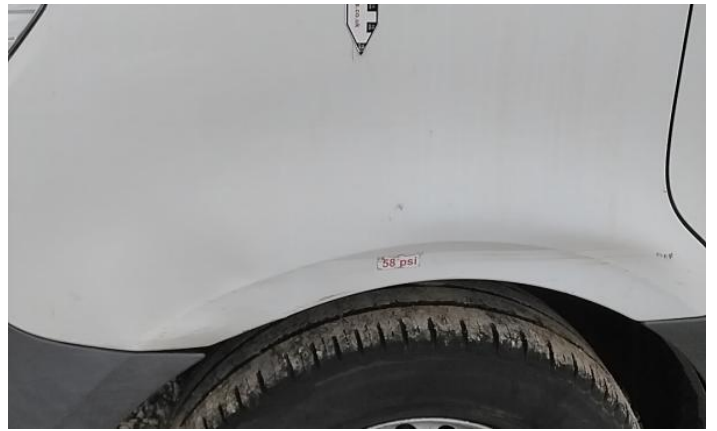
6: Wing nsf
Dented
With Paint Damage

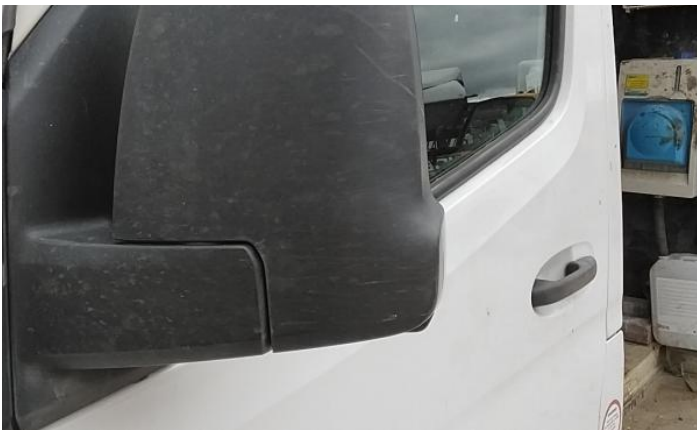
7: Door Mirror Assy nsf
Scuffed (Unpainted)
Over 100mm

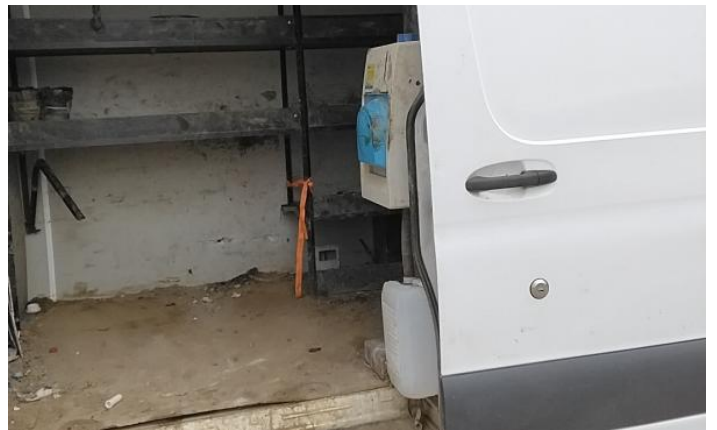
8: Handle Outer osr
Broken
Replace

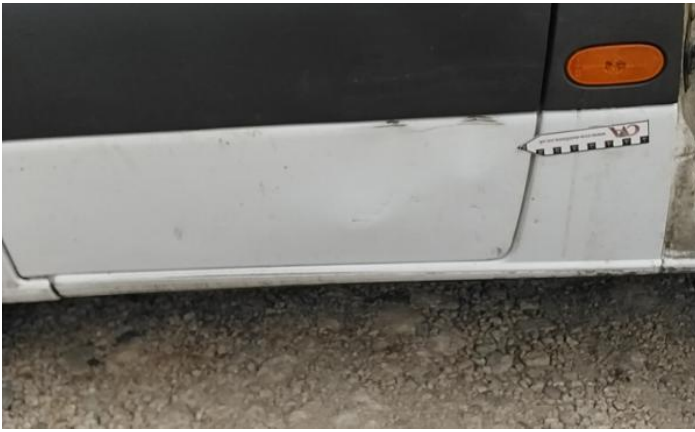
9: Door nsf
Dented
With Paint Damage

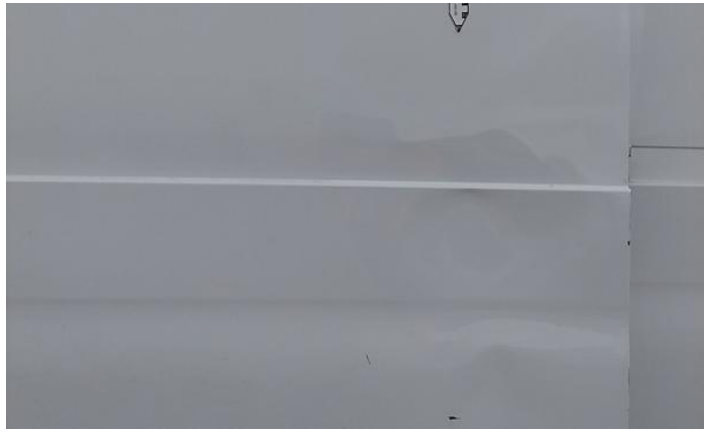
10: Door nsr
Dented
Over 30mm

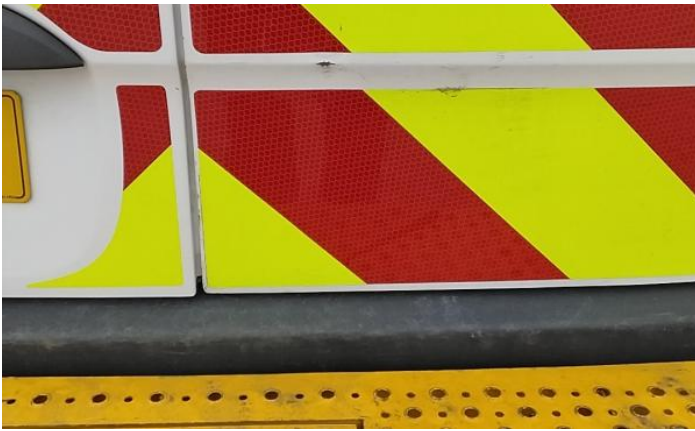
11: Door osr
Dented
With Paint Damage

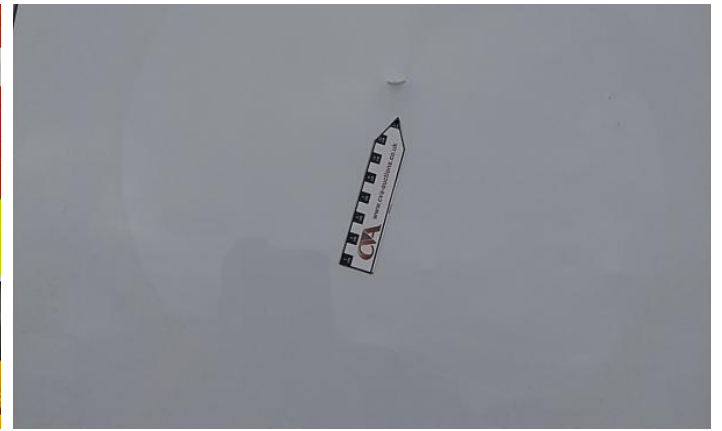
12: Door osr
Dented
With Paint Damage

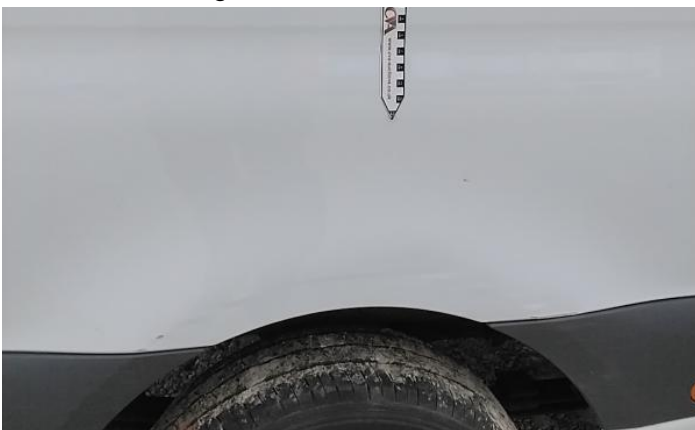
13: Qtr Panel osr
Dented
With Paint Damage

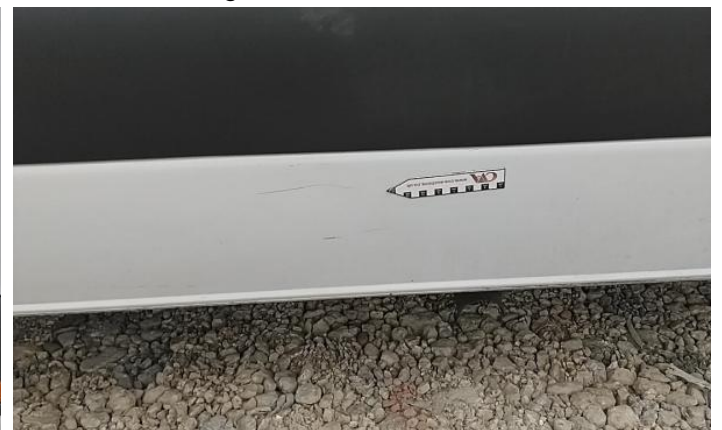
14: Qtr Panel osr
Dented
Between 10mm + 30mm

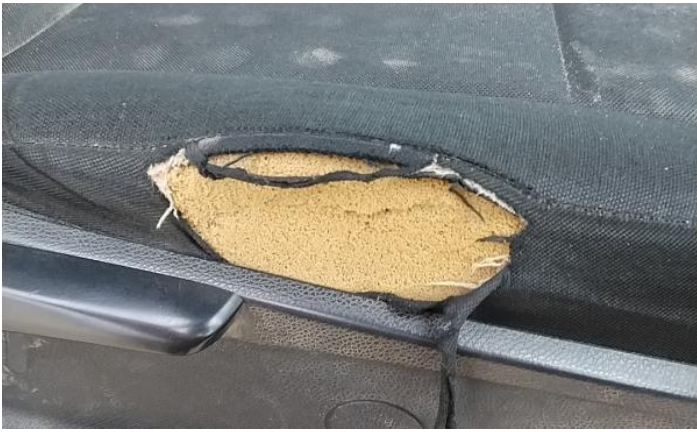
15: Seat Base Cover of
Holed
Over 3mm
