# VEHICLE INSPECTION REPORT

**RE70LBP**

## Iveco Eurocargo 75-160

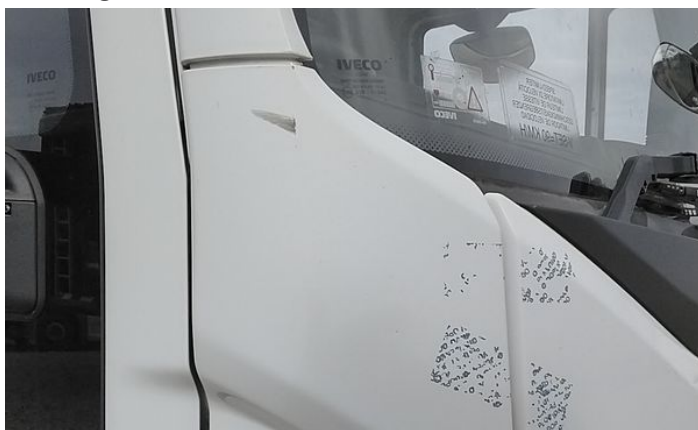
1: Wing osf  
Scratched  
Over 25mm Not Thru Paint

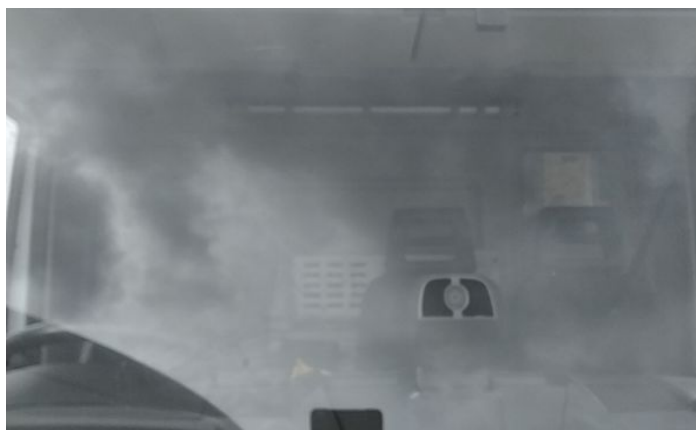
2: Screen Front  
Chipped  
UpTo 10mm

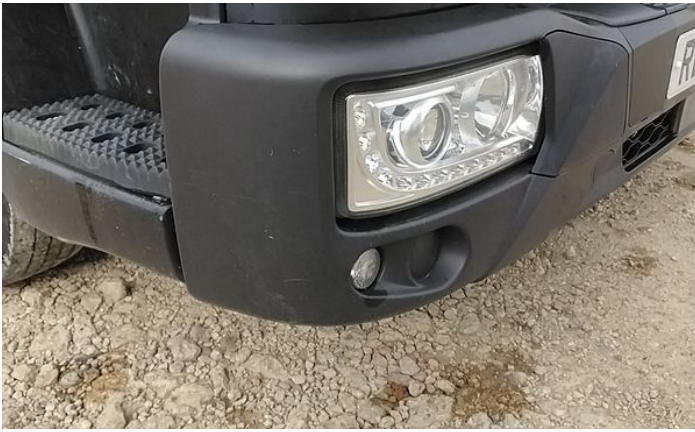
3: Bumper Front Moulding  
Scuffed (Unpainted)  
UpTo 100mm

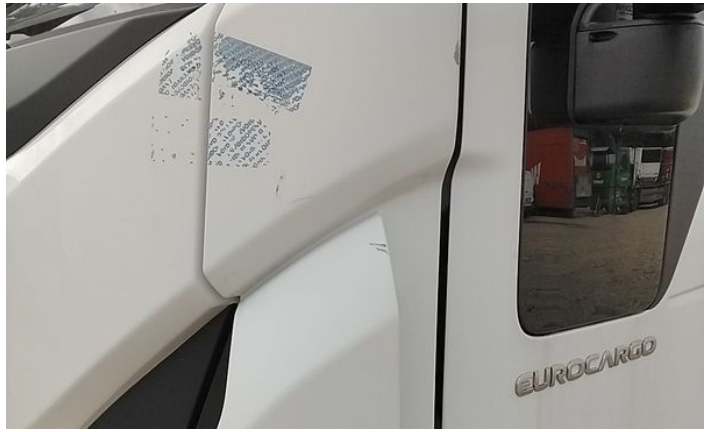
4: Wing nsf  
Scratched  
Over 25mm Not Thru Paint

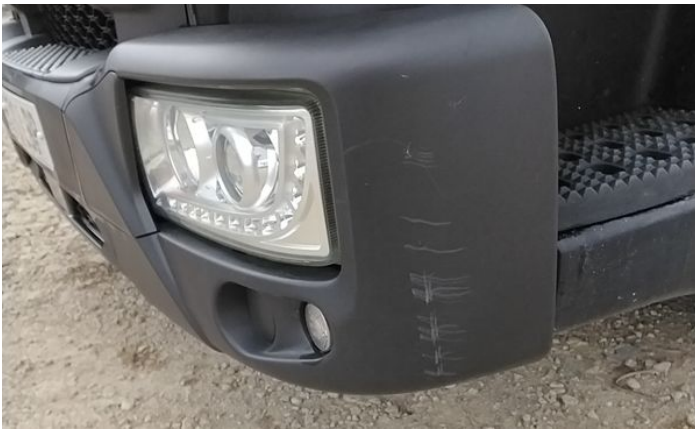
5: Bumper Front Moulding  
Scuffed (Unpainted)  
Over 100mm

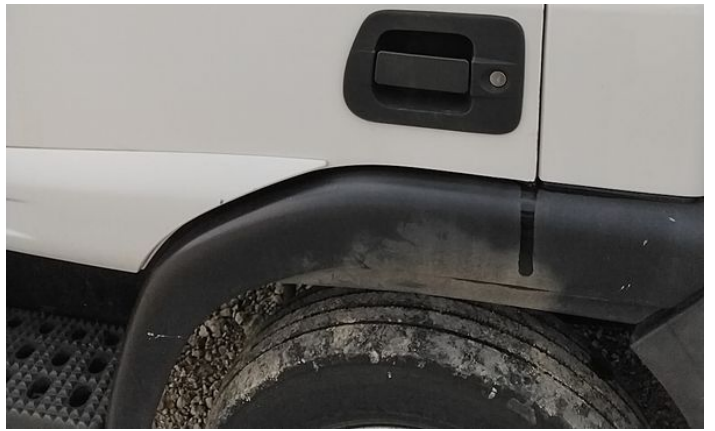
6: Door nsf  
Scratched  
Over 25mm Not Thru Paint

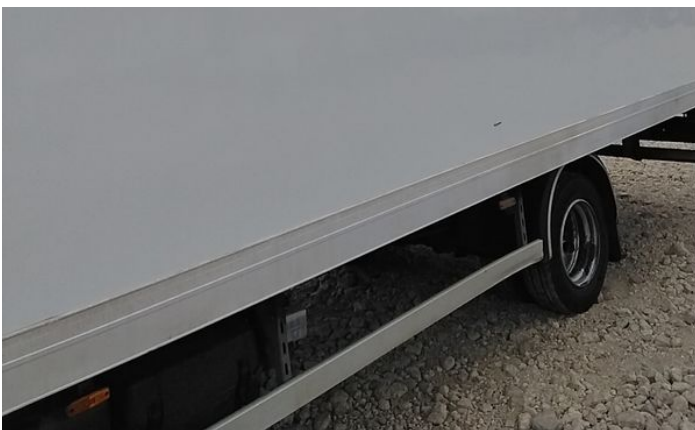
7: Qtr Panel nsr  
Scratched  
Over 25mm Not Thru Paint

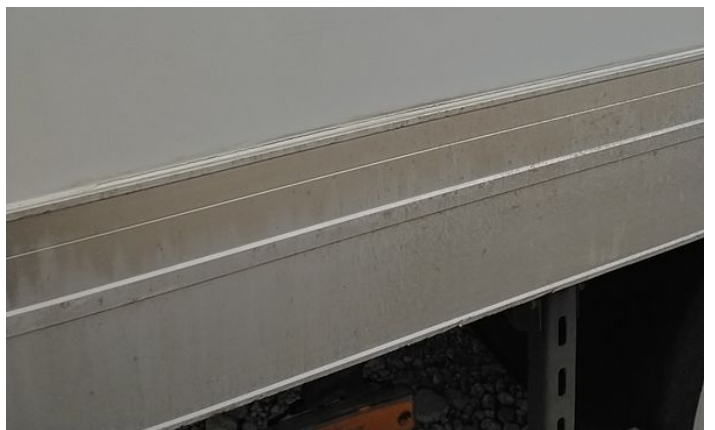
8: Qtr Panel nsr  
Scratched  
Over 25mm Thru Paint

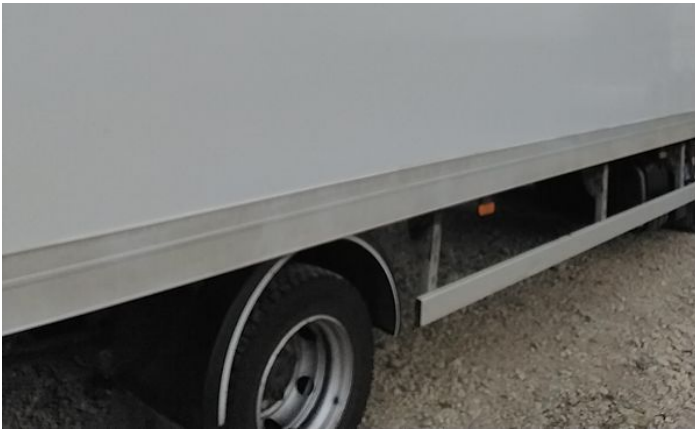
9: Qtr Panel osr  
 Scratched  
 Over 25mm Not Thru Paint

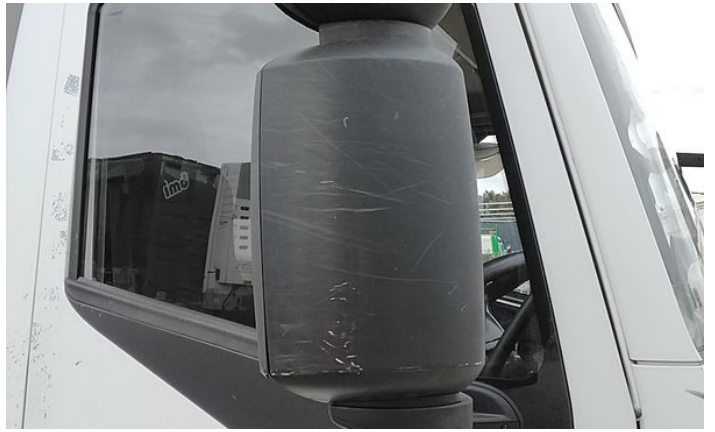
10: Door Mirror Assy osf  
 Scuffed (Unpainted)  
 Over 100mm

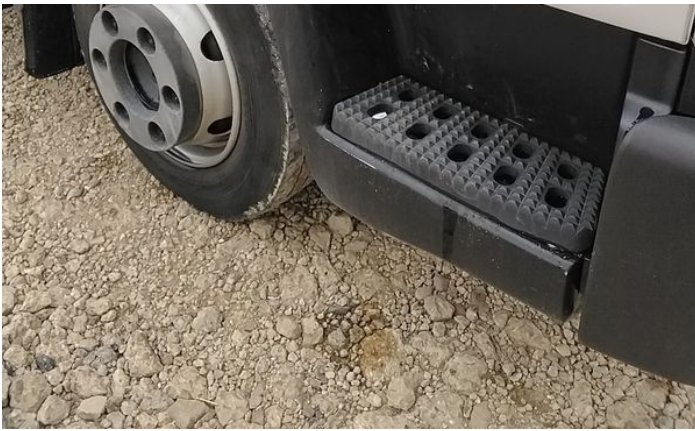
11: Wing Front Arch Extension os  
 Scuffed (Unpainted)  
 UpTo 100mm

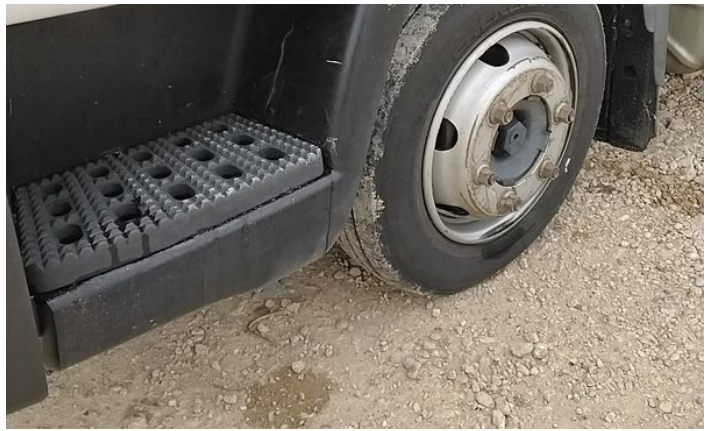
12: Wing Front Arch Extension ns  
 Scuffed (Unpainted)  
 UpTo 100mm
