VEHICLE INSPECTION REPORT

PJ20ZGA

Mercedes-Benz Sprinter 314 CDI

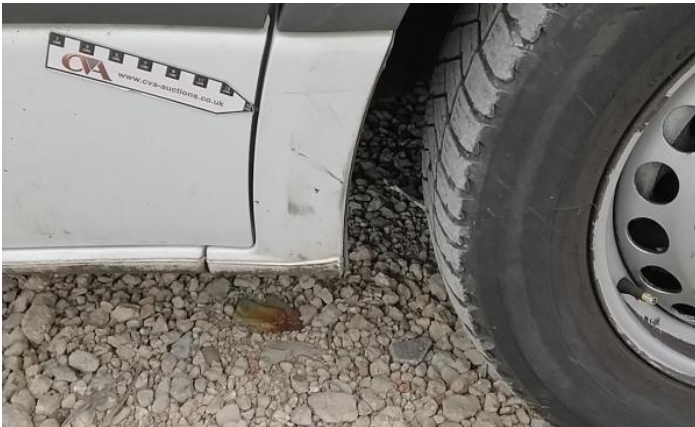
1: Wing of
Scratched
Over 25mm Not Thru Paint

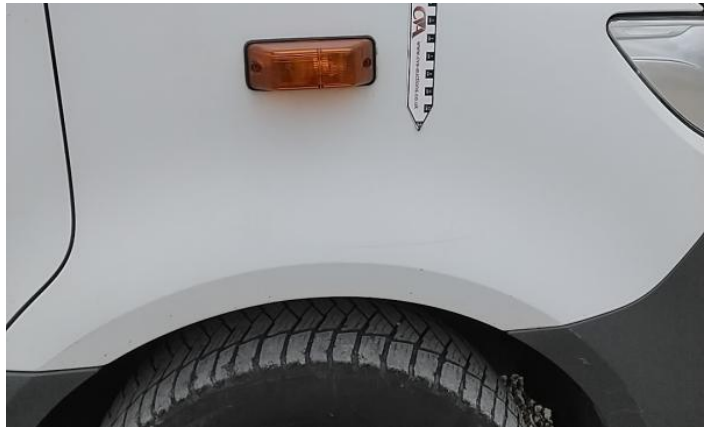
2: Wing of
Scratched
Over 25mm Not Thru Paint

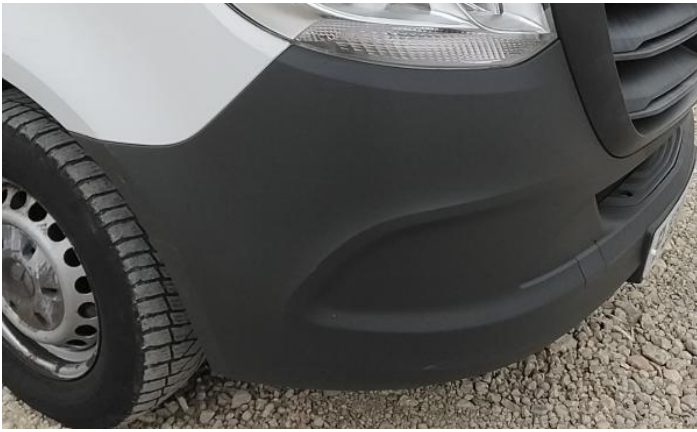
3: Bumper Front Moulding
Scuffed (Unpainted)
UpTo 100mm

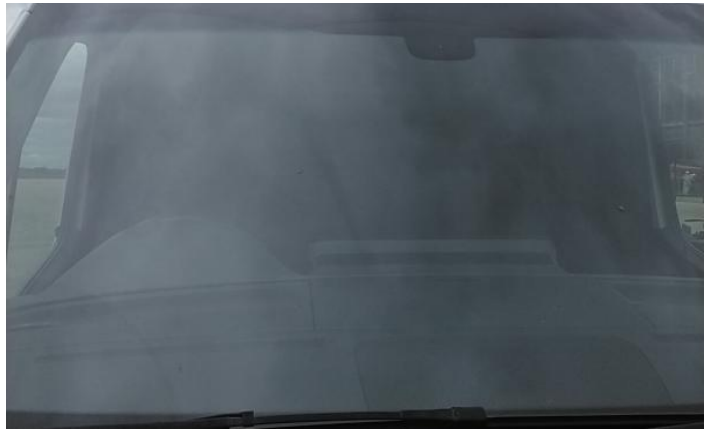
4: Screen Front
Chipped
Over 10mm

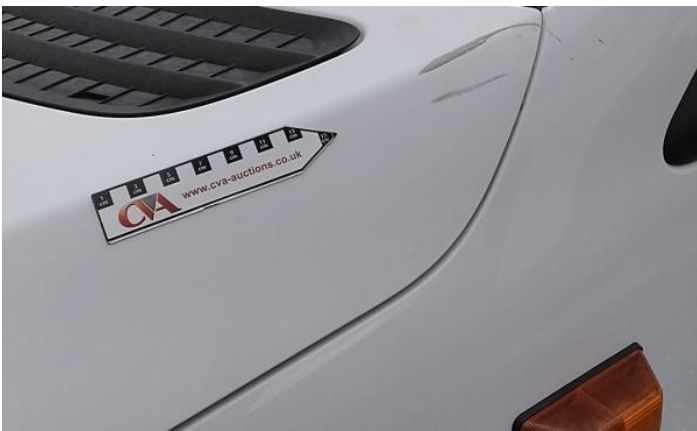
5: Bonnet
Scratched
Over 25mm Not Thru Paint

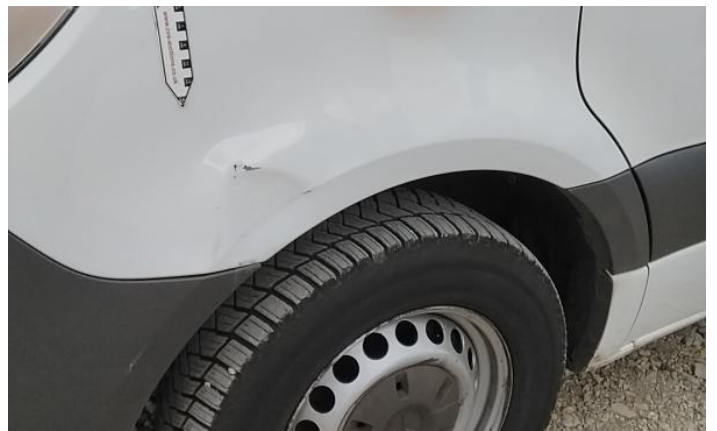
6: Wing nsf
Dented
With Paint Damage

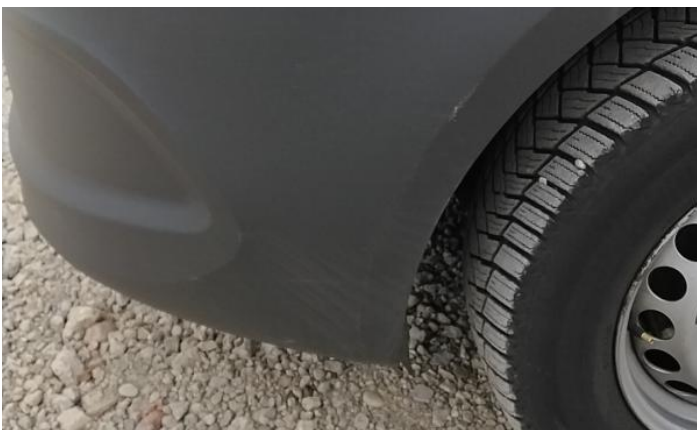
7: Bumper Front Moulding
Scuffed (Unpainted)
UpTo 100mm

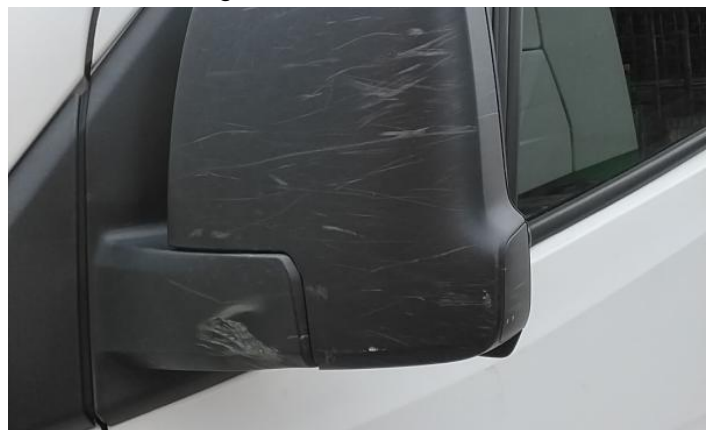
8: Door Mirror Assy nsf
Scuffed (Unpainted)
Over 100mm

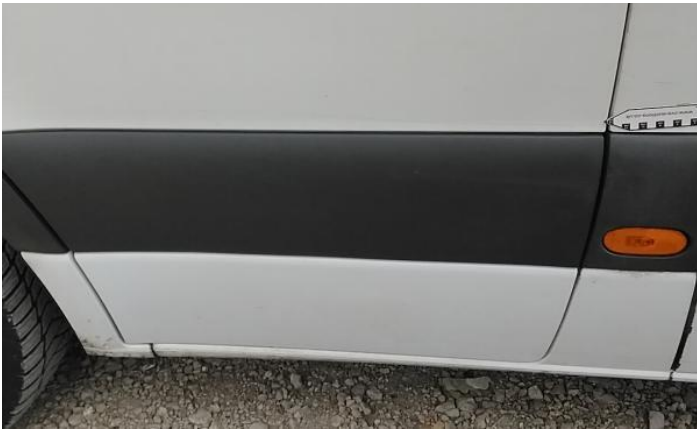
9: Door nsf
Scratched
Over 25mm Not Thru Paint

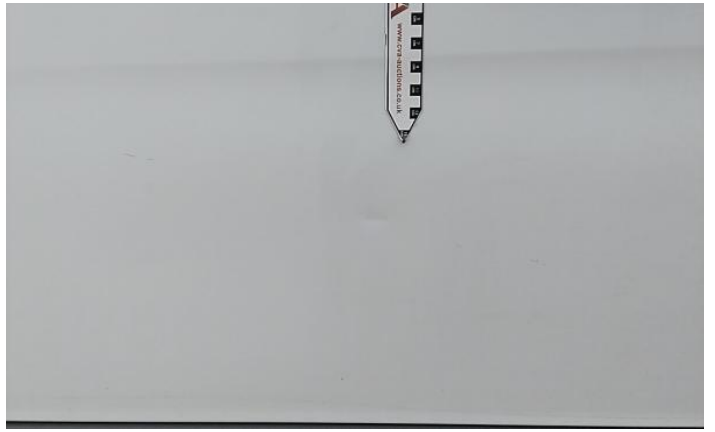
10: Door nsf
Dented
Over 2 Up To 10mm

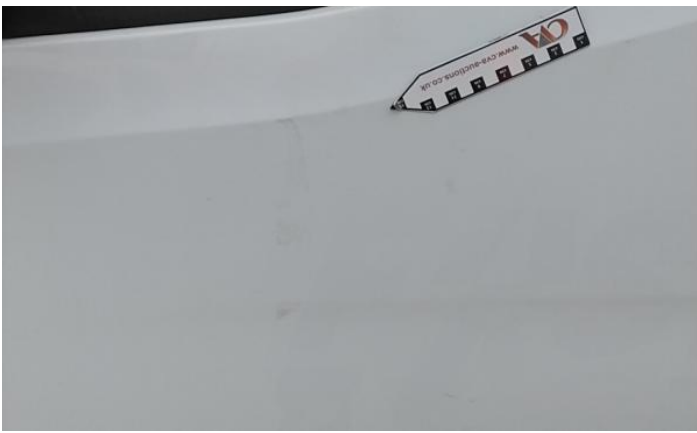
11: Door nsf
Dented
Over 2 Up To 10mm

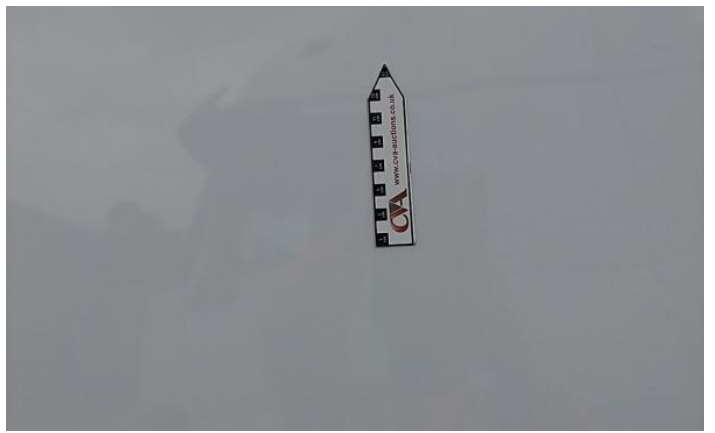
12: Door nsr
Dented
With Paint Damage

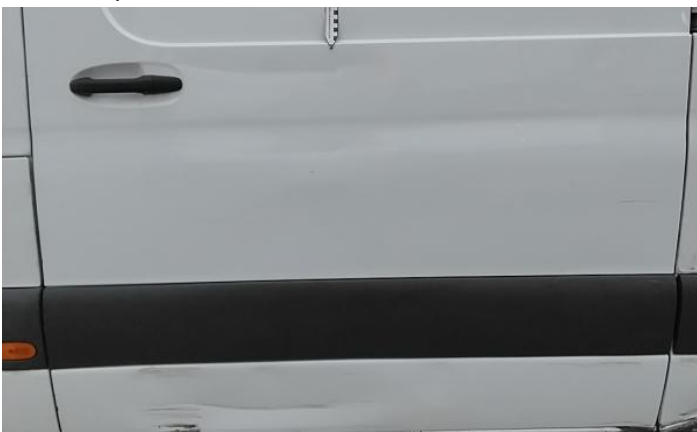
13: Door nsr
Dented
Over 30% Of Panel

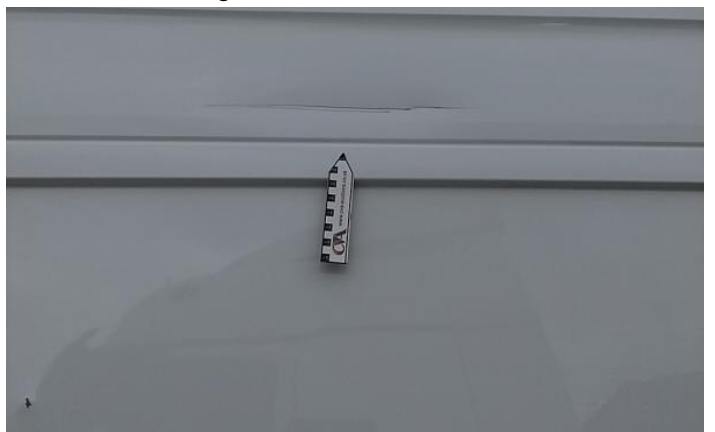
14: Door nsr
Dented
With Paint Damage

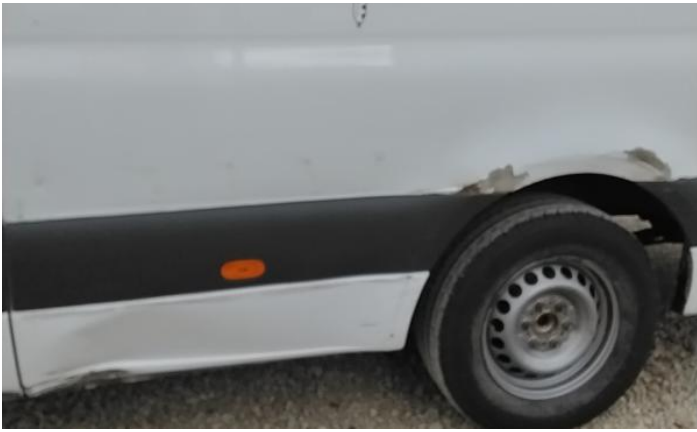
15: Qtr Panel nsr
Dented
With Paint Damage

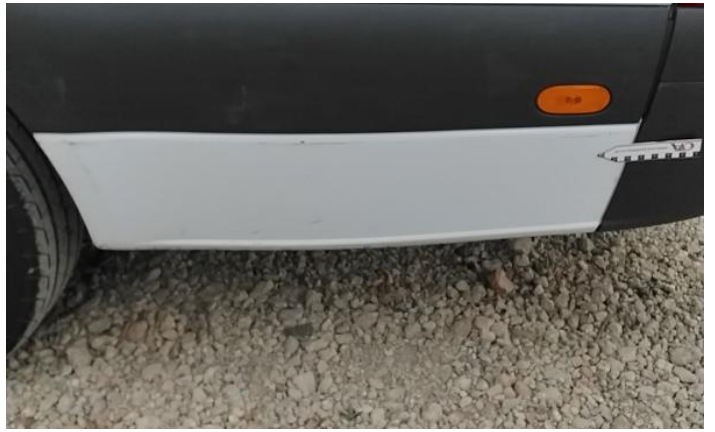
16: Qtr Panel nsr
Scratched
Over 25mm Thru Paint

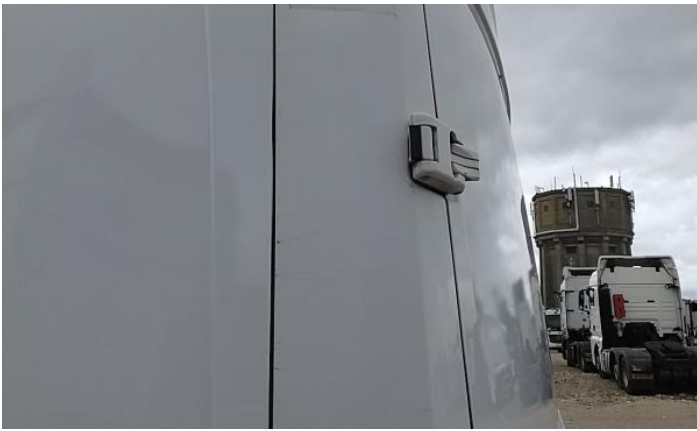
17: Qtr Panel nsr
Dented
With Paint Damage

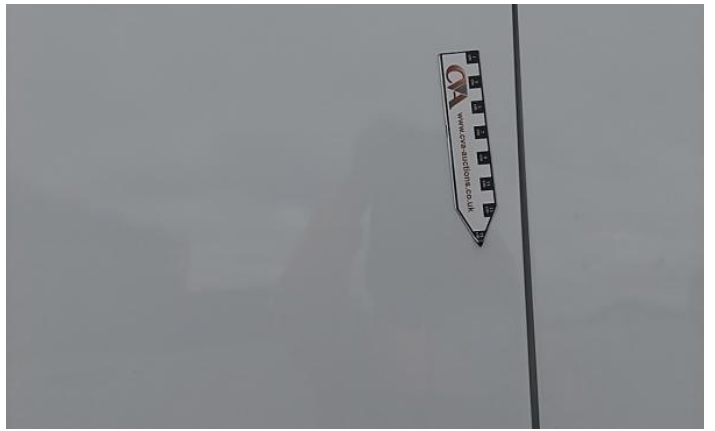
18: Door nsr
Dented
Between 10mm + 30mm

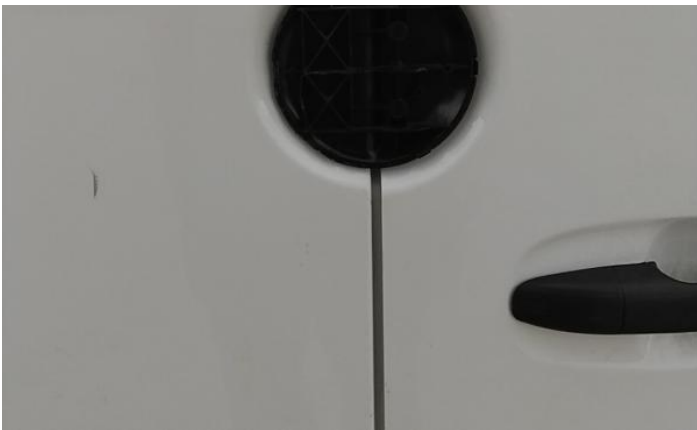
19: Badgedecal Rear
Missing
Replace

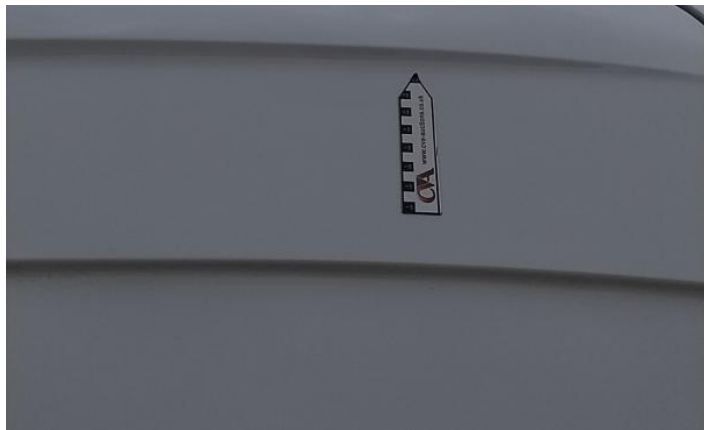
20: Door osr
Dented
Between 10mm + 30mm

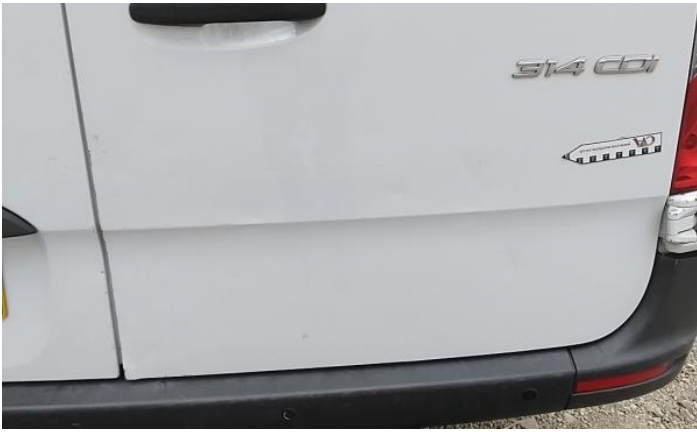
21: Door osr
Dented
Over 30mm

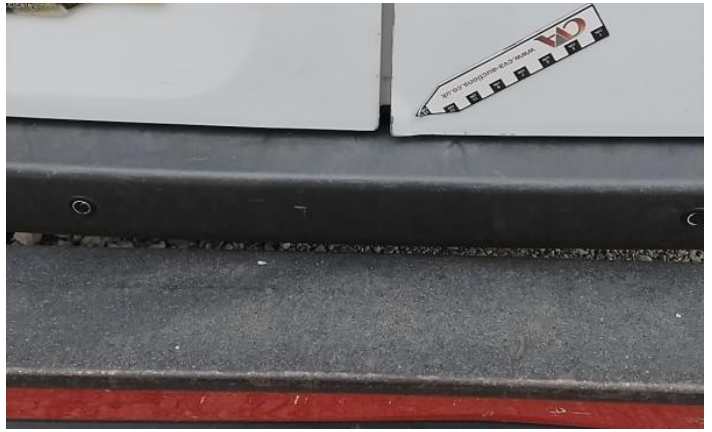
22: Door osr
Dented
With Paint Damage

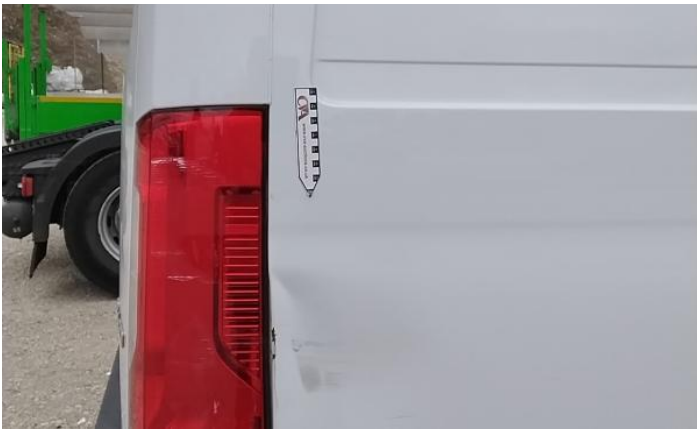
23: Qtr Panel osr
Dented
With Paint Damage

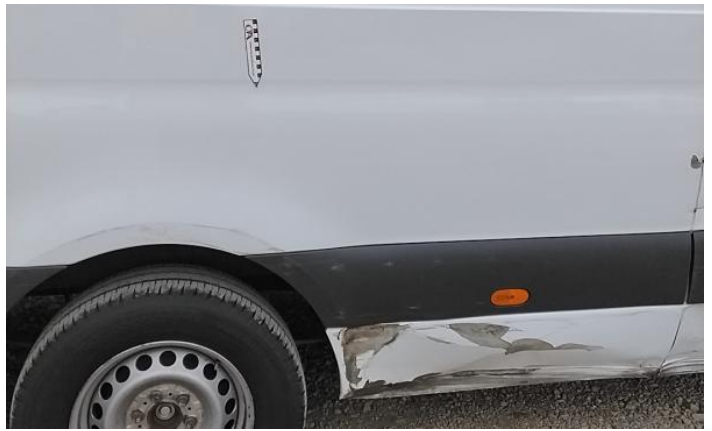
24: Qtr Panel osr
Dented
With Paint Damage

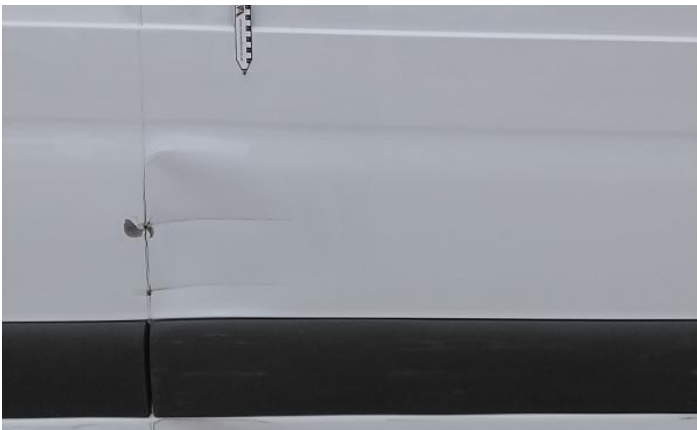
25: Qtr Panel osr
Dented
With Paint Damage

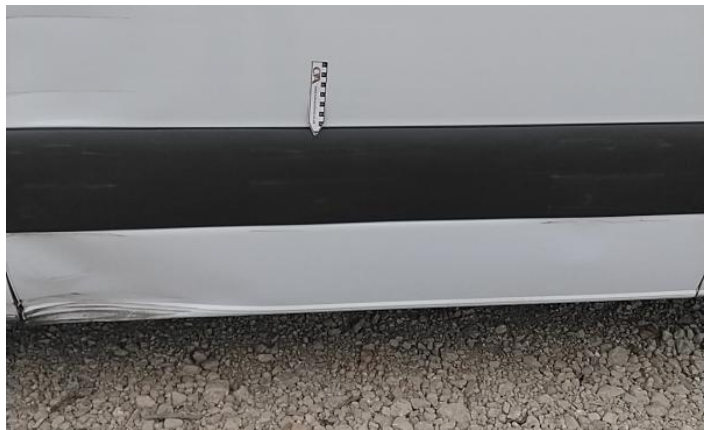
26: Qtr Panel Moulding os
Scuffed (Unpainted)
Over 100mm

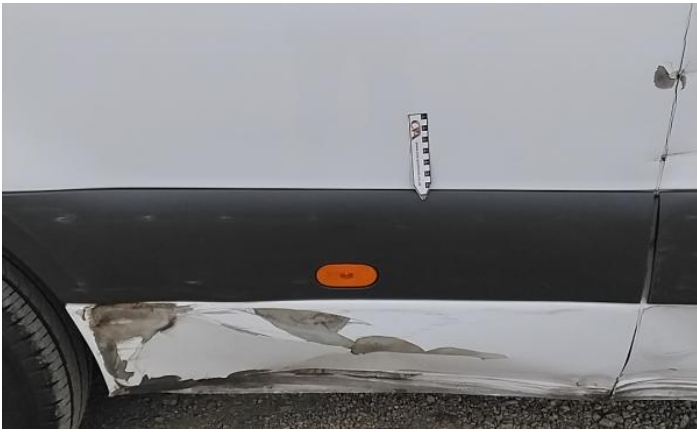
27: Qtr Panel Moulding os
Scuffed (Unpainted)
Over 100mm

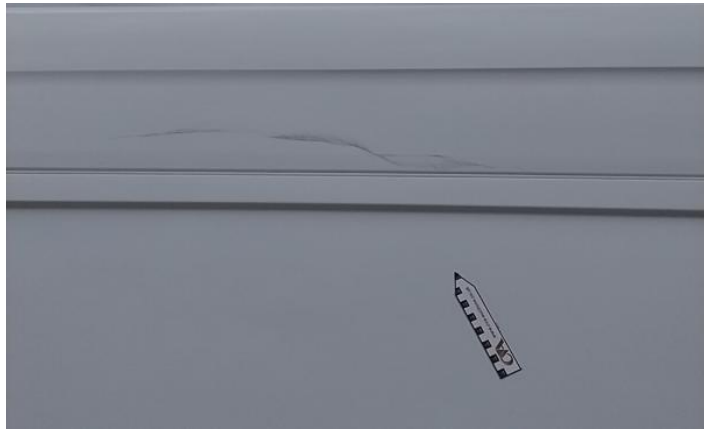
28: Qtr Panel osr
Scratched
Over 25mm Not Thru Paint

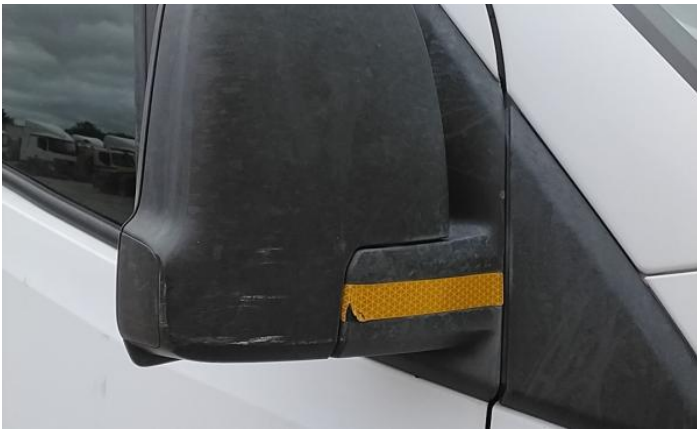
29: Door Mirror Assy osf
Scuffed (Unpainted)
UpTo 100mm

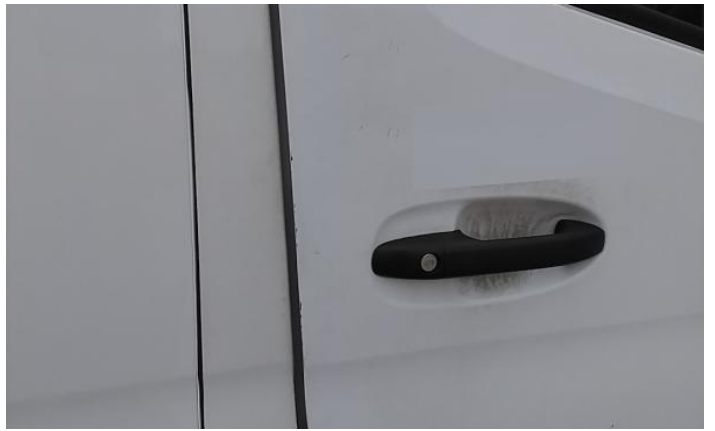
30: Door osf
Chipped
Edge Chip

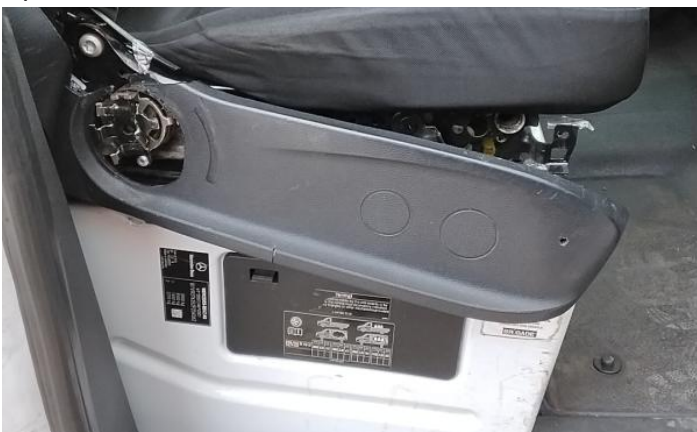
31: Seat Base Cover osf
Torn
Over 3mm
