VEHICLE INSPECTION REPORT

YF19FRL

Ford Transit Custom 320 2.0 TDCI 130PS

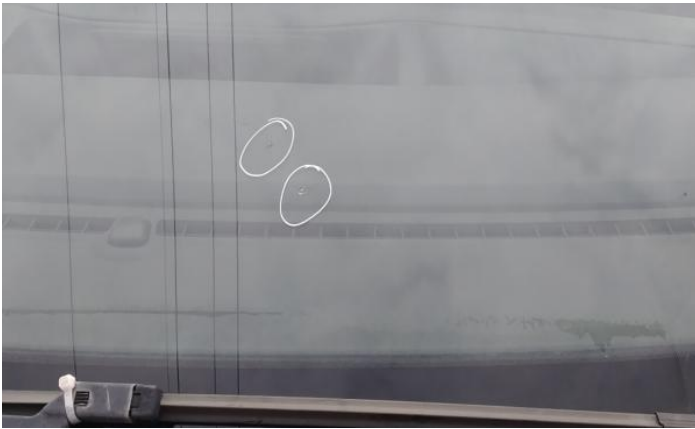
1: Screen Front
Cracked
Replace

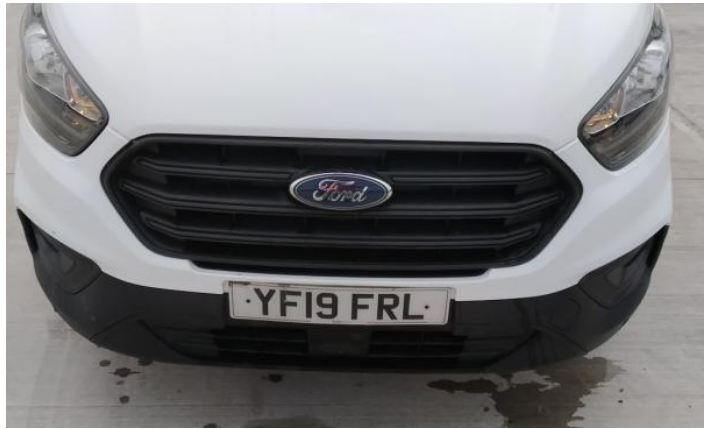
2: Bonnet
Chipped
Multiple Chips

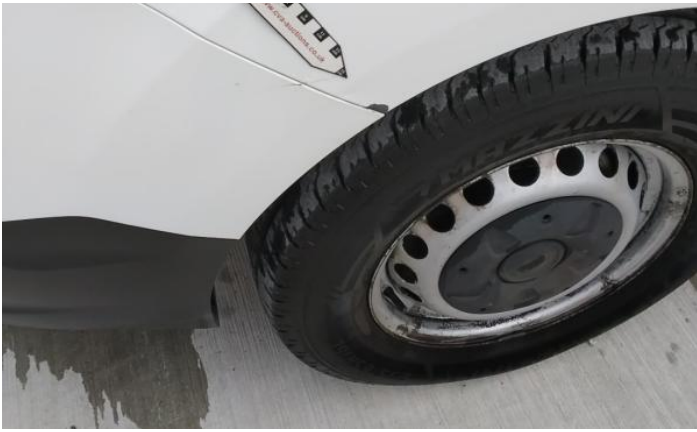
3: Wing nsf
Chipped
Over 5mm

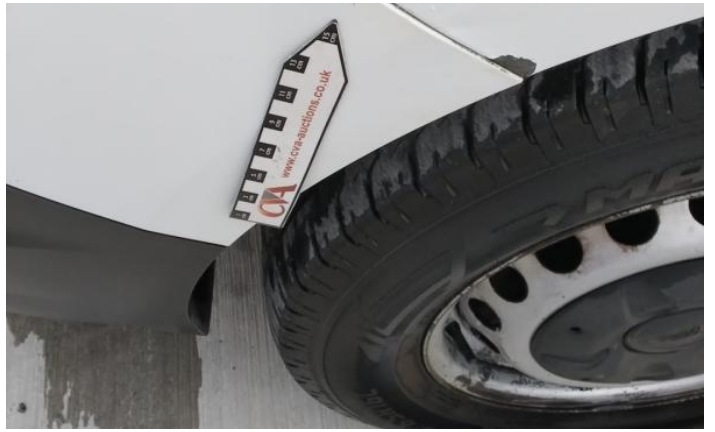
4: Bumper Front
Scratched
25 to 100mm Thru Paint

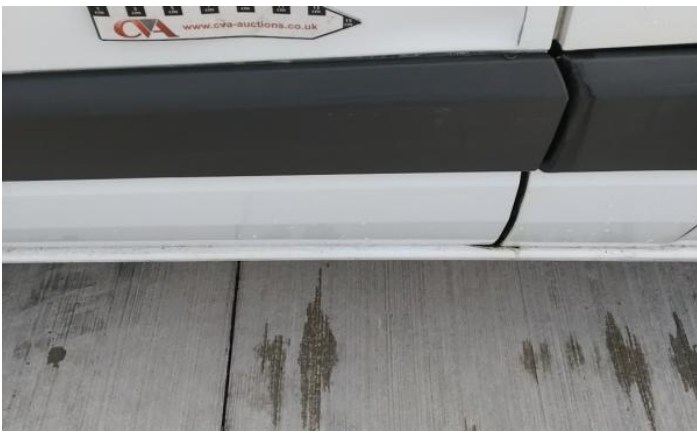
5: Door nsf
Dented
With Paint Damage

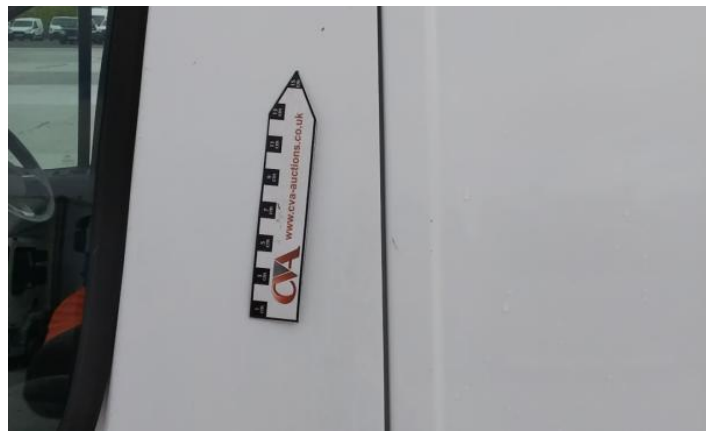
6: Door nsf
Chipped
Multiple Chips

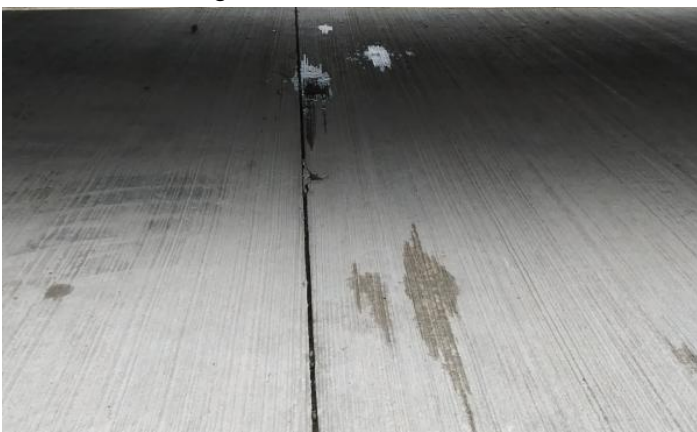
7: Sill ns
Dented
Over 30mm

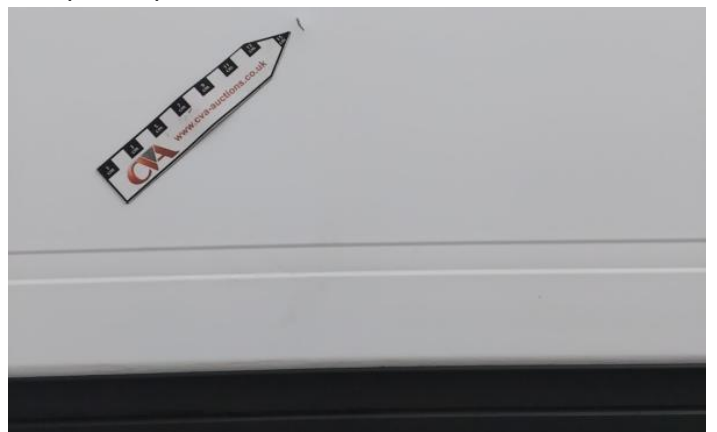
8: Qtr Panel nsr
Dented
With Paint Damage

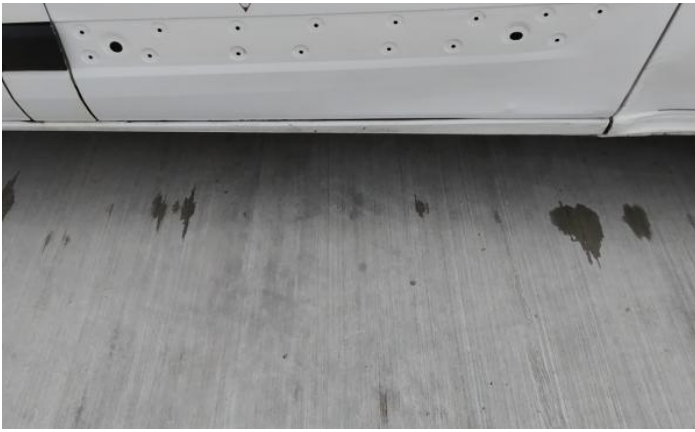
9: Qtr Panel Moulding ns
Missing
Replace

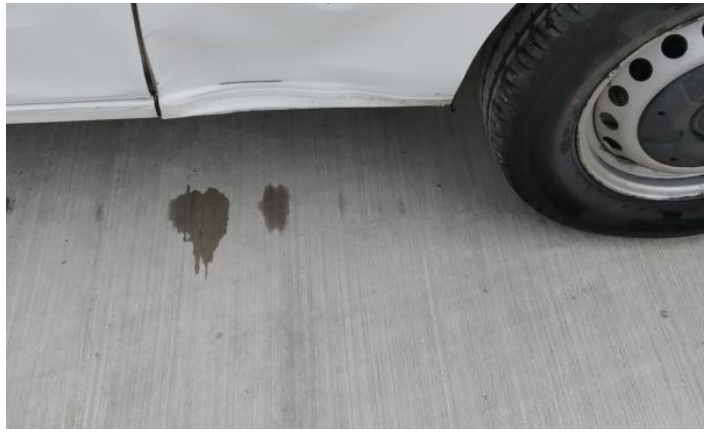
10: Qtr Panel nsr
Dented
Hail - Severe

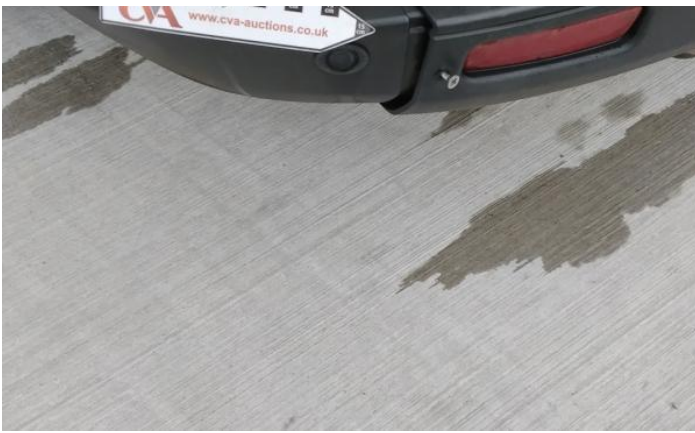
11: Bumper Rear
Insecure
Action Required

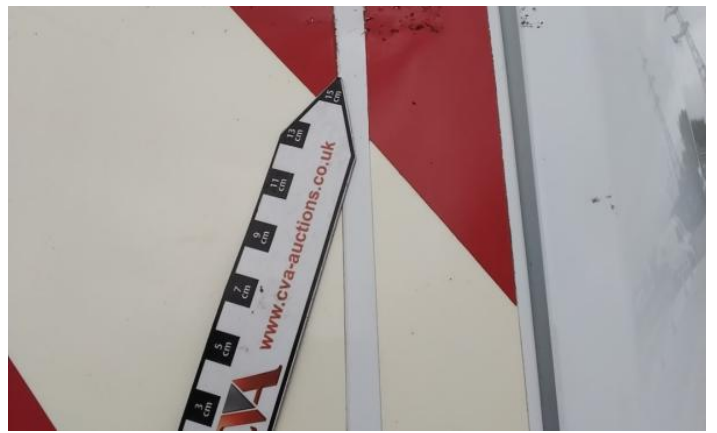
12: Door nsr
Dented
With Paint Damage

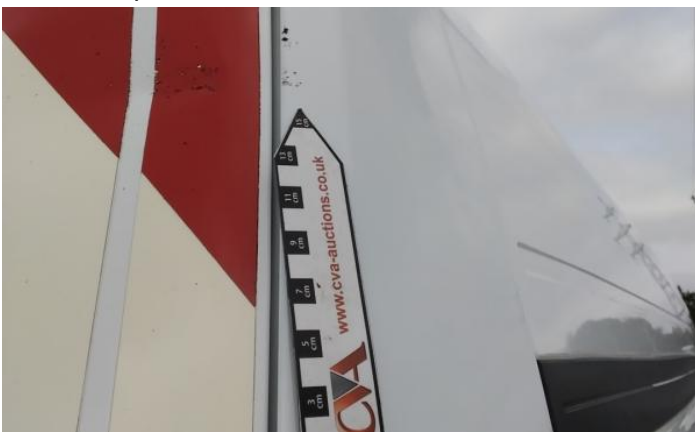
13: Qtr Panel Moulding os
Scratched (Painted)
Over 25mm Thru Paint

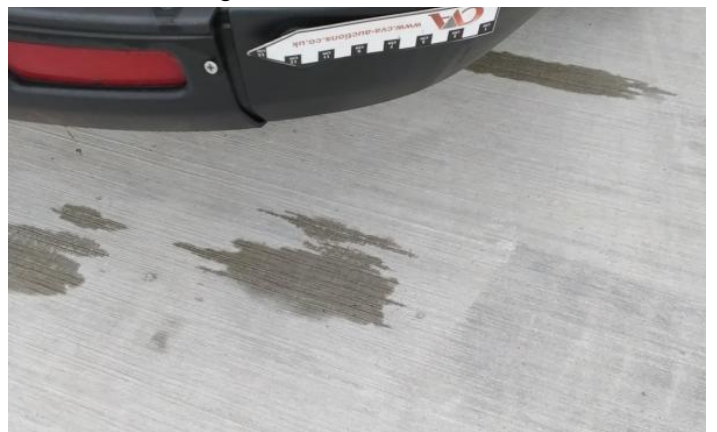
14: Bumper Rear
Insecure
Action Required

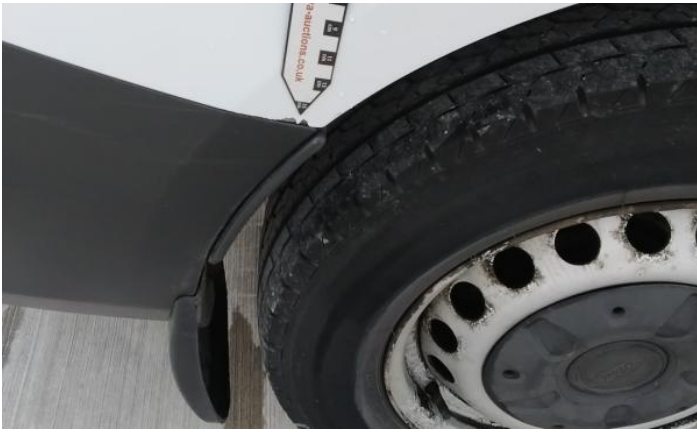
15: Qtr Panel osr
Chipped
Over 5mm

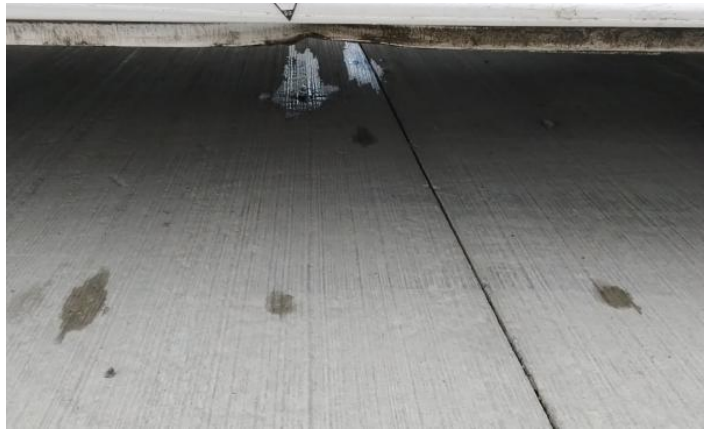
16: Sill os
Dented
Over 30mm

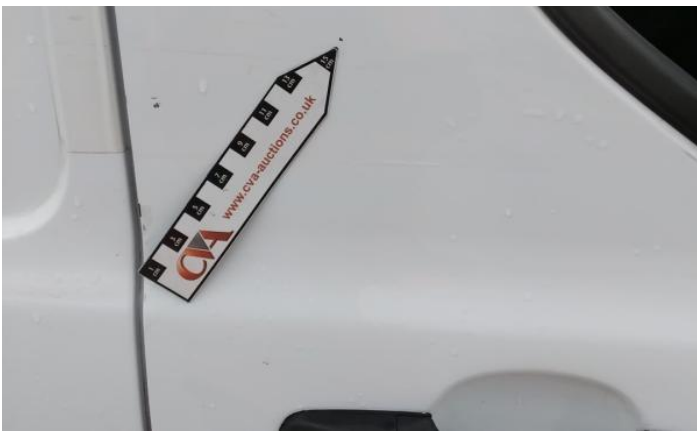
17: Door osf
Chipped
Multiple Chips

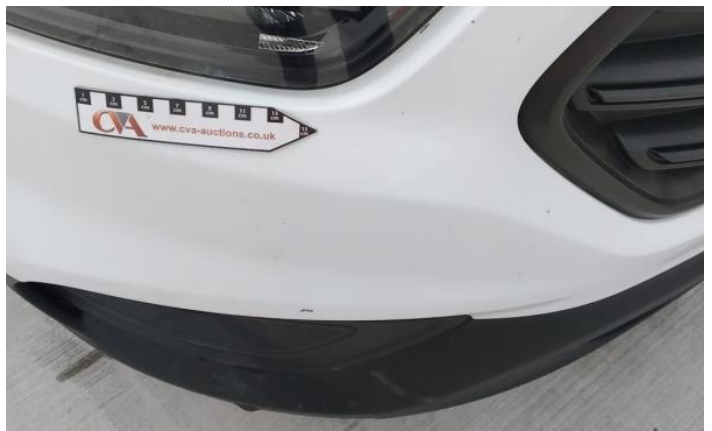
18: Bumper Front
Chipped
Multiple Chips

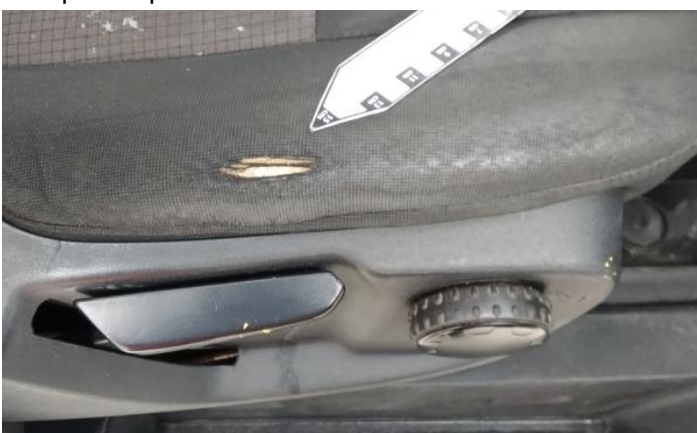
19: Seat Base Cover osf
Holed
Over 3mm

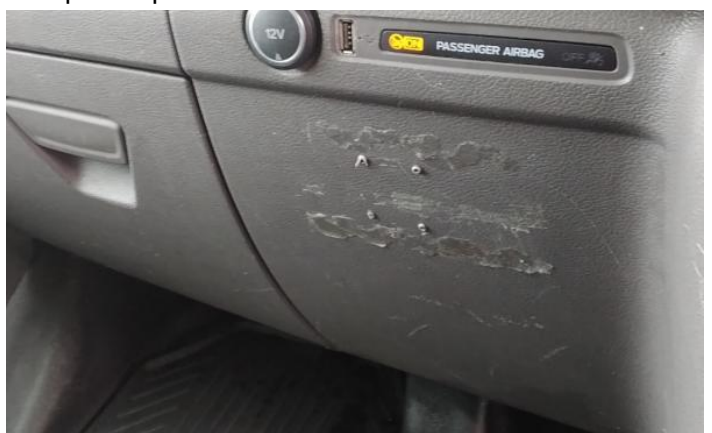
20: Centre Console Front
Holed
Over 3mm
