# VEHICLE INSPECTION REPORT

**PF70U00**

## Fiat Ducato 35 2.3 MULTI JET 140PS

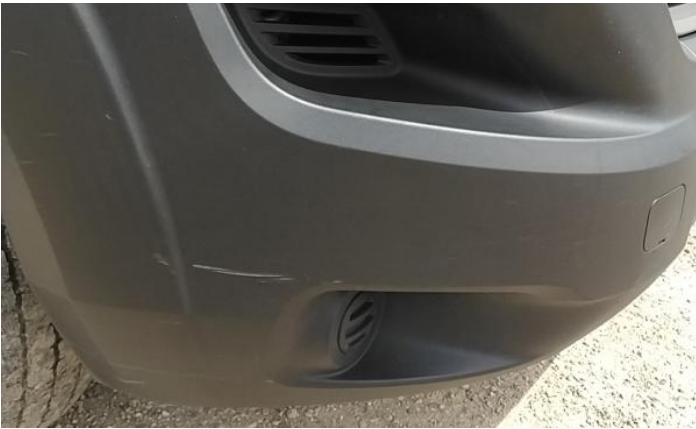
1: Bumper Front Moulding  
Scuffed (Unpainted)  
Over 100mm

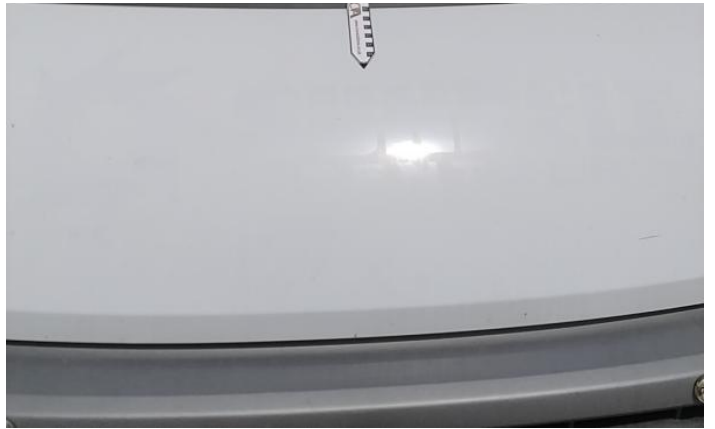
2: Bonnet  
Chipped  
Multiple Chips

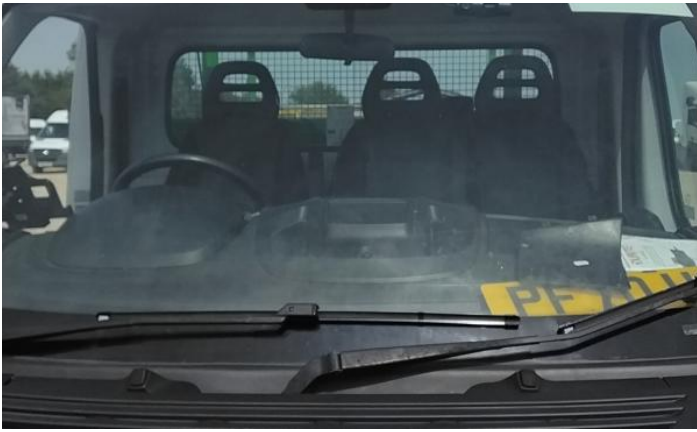
3: Screen Front  
Chipped  
Up To 10mm

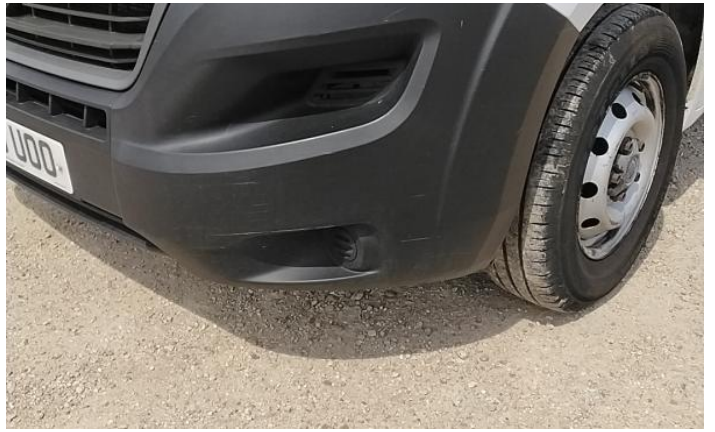
4: Bumper Front Moulding  
Scuffed (Unpainted)  
Over 100mm

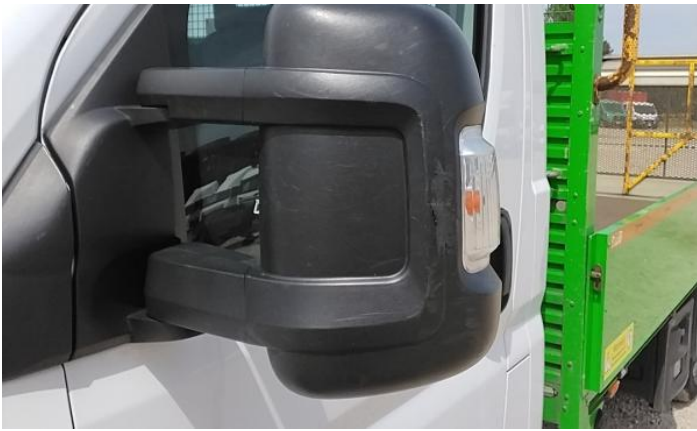
5: Door Mirror Assy nsf  
Scuffed (Unpainted)  
Over 100mm

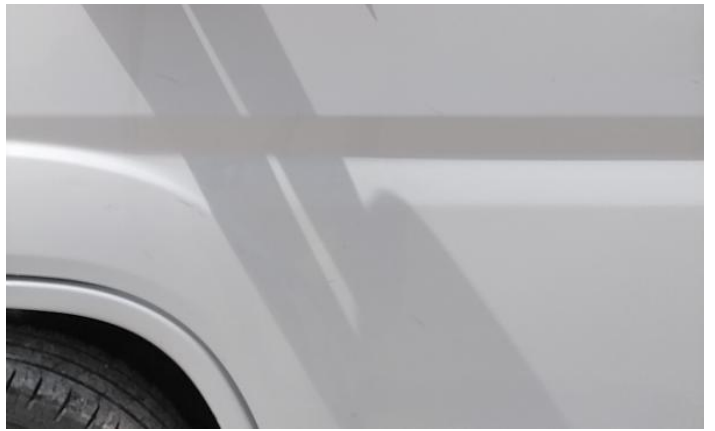
6: Door nsf  
Scatched  
Over 25mm Thru Paint

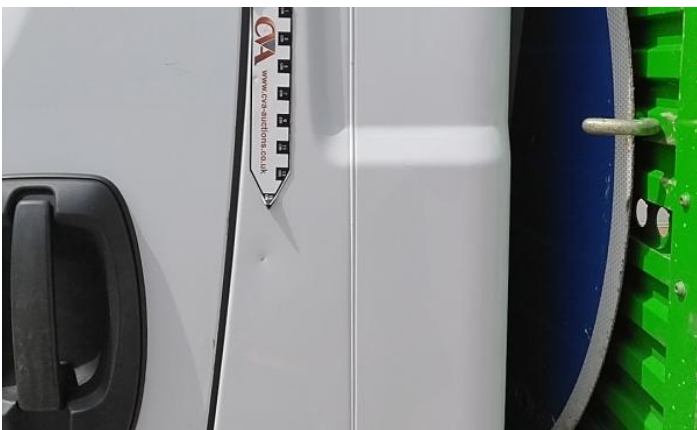
7: B Post ns  
Dented  
With Paint Damage

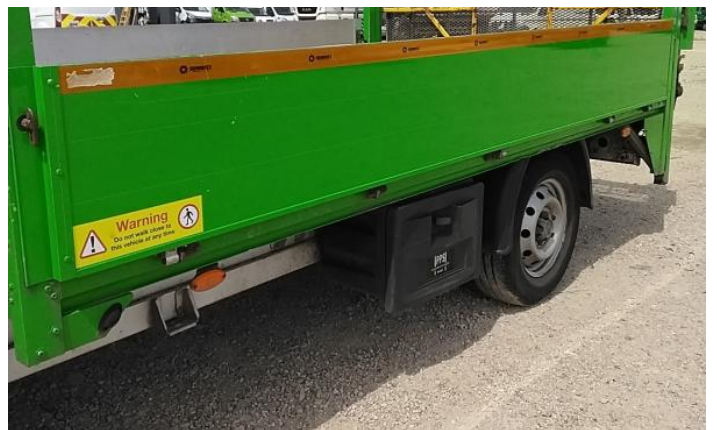
8: Qtr Panel nsr  
Scatched  
Over 25mm Thru Paint

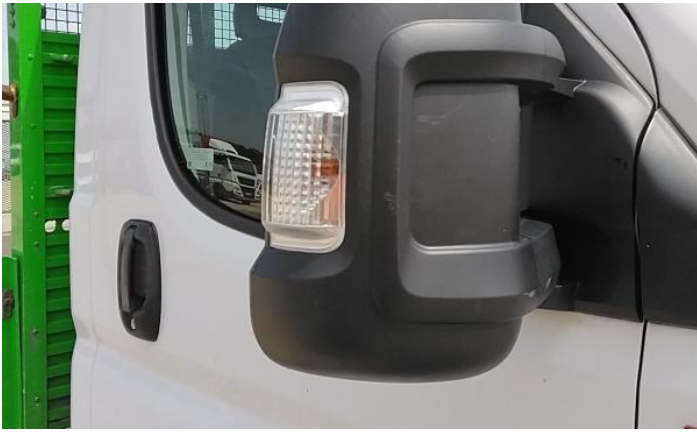
9: Door Mirror Assy osf  
Scuffed (Unpainted)  
Over 100mm

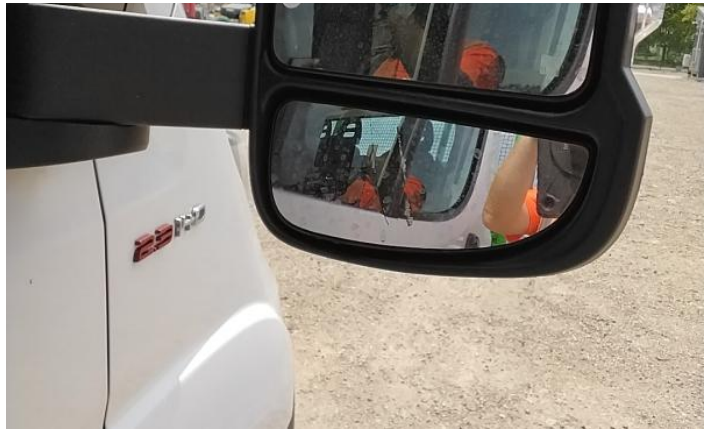
10: Door Mirror Glass os  
Broken  
Replace

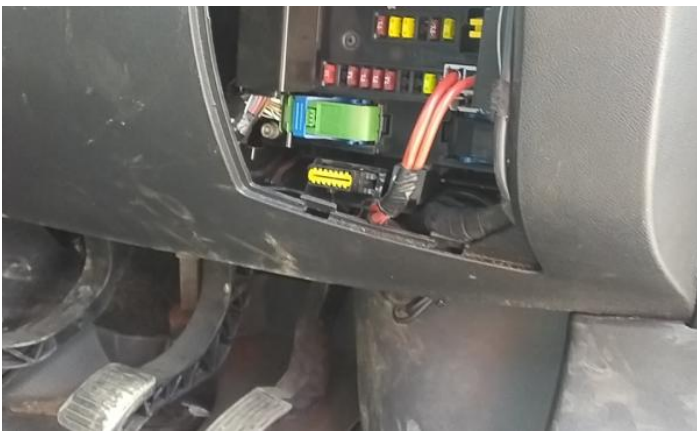
11: Centre Console Front  
Missing  
Replace

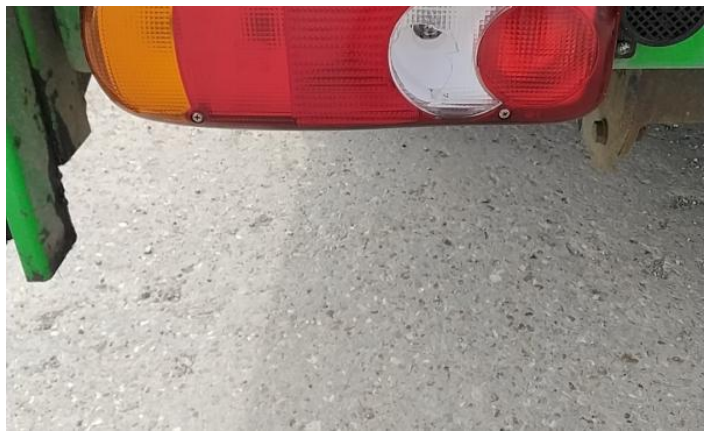
12: Lamp nsr  
Broken  
Replace

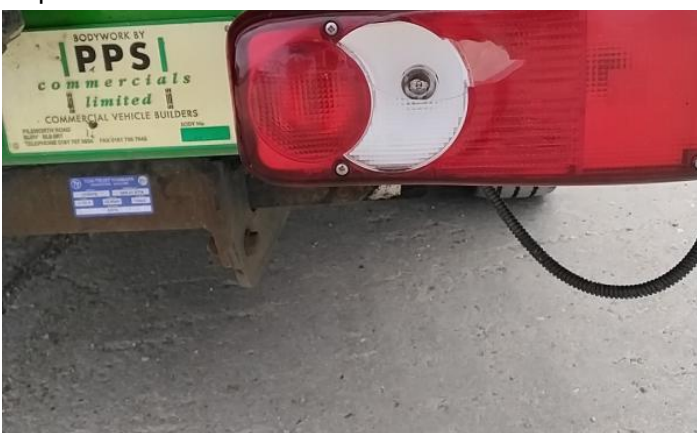
13: Fog Lamp osr  
Broken  
Replace
