# VEHICLE INSPECTION REPORT

**LF68WTZ**

## Ford Transit 350 2.0 TDCi 130ps

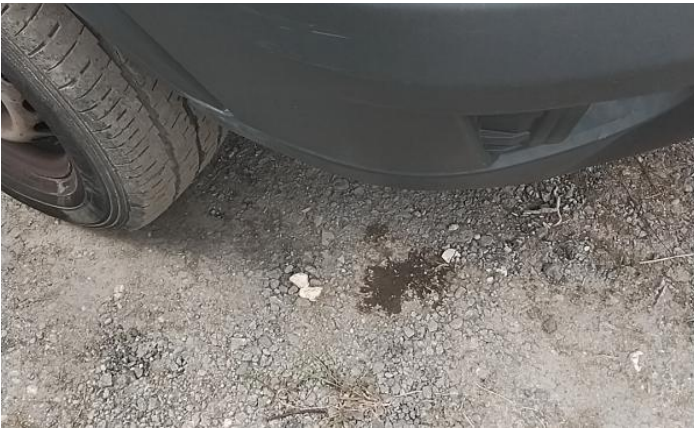
1: Bumper Front  
Scratched  
Over 100mm Thru Paint

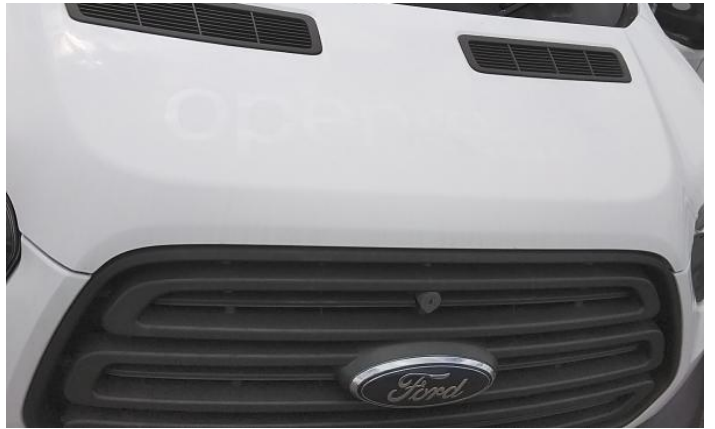
2: Bonnet  
Chipped  
Multiple Chips

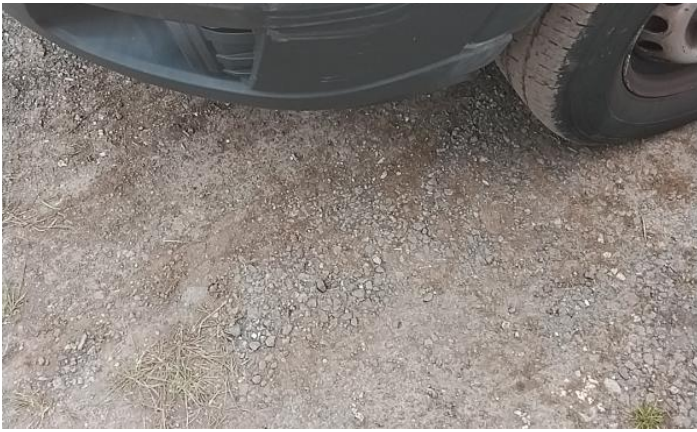
3: Bumper Front  
Scratched  
Over 100mm Thru Paint

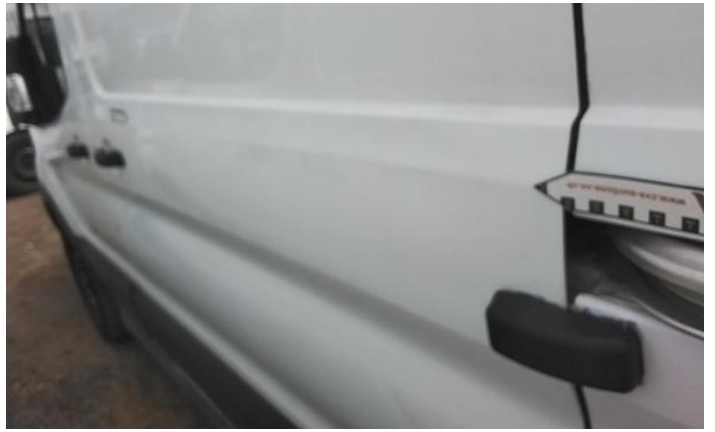
4: Qtr Panel nsr  
Dented  
Over 30mm

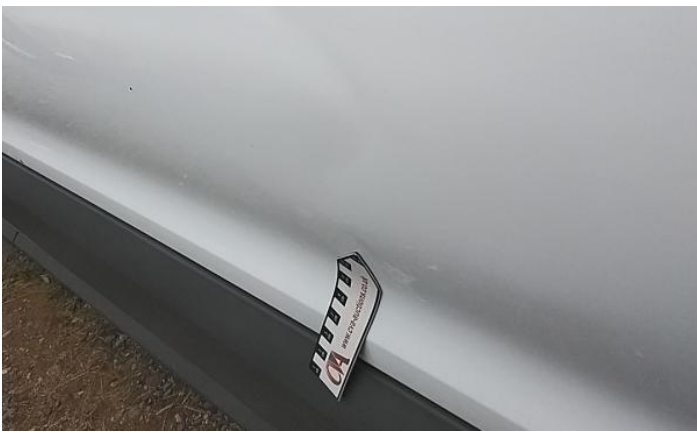
5: Qtr Panel nsr  
Dented  
Over 30mm

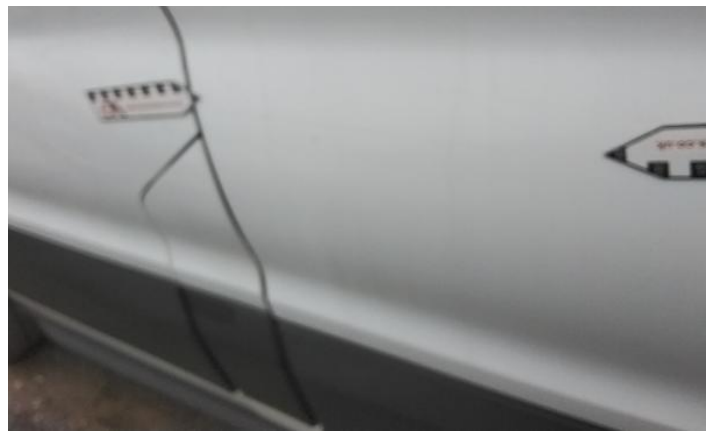
6: Qtr Panel nsr  
Scratched  
Over 25mm Thru Paint

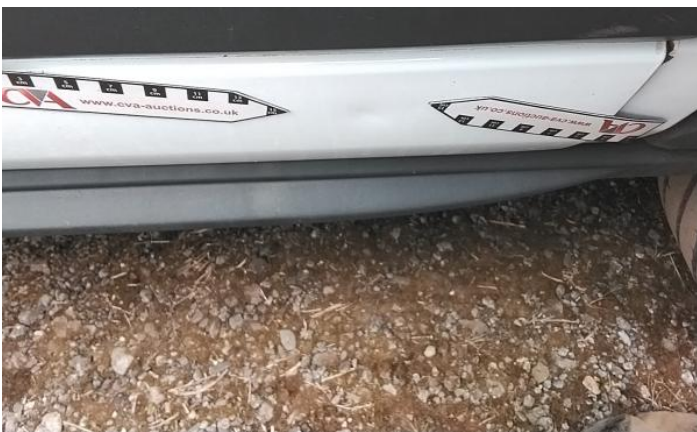
7: Qtr Panel nsr  
Dented  
Over 30mm

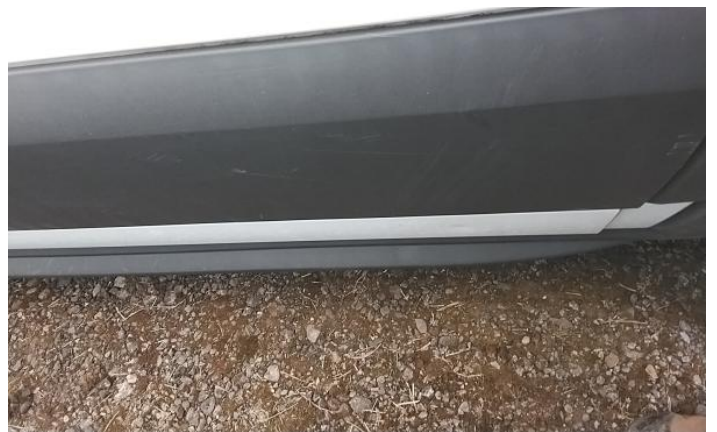
8: Qtr Panel Moulding ns  
Scuffed (Unpainted)  
Over 100mm

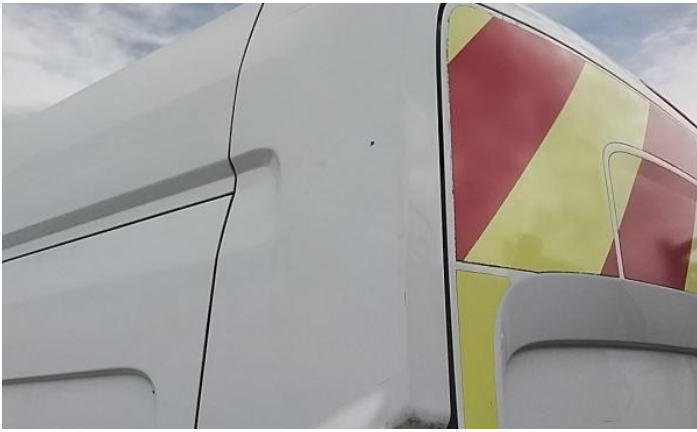
9: C Post ns  
Dented  
With Paint Damage

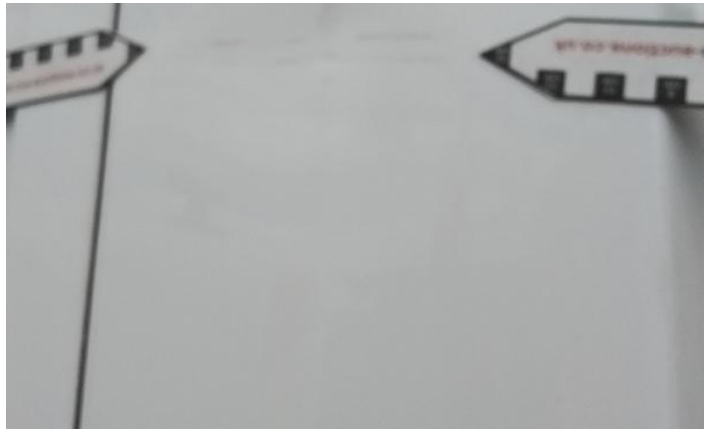
10: C Post ns  
Dented  
With Paint Damage

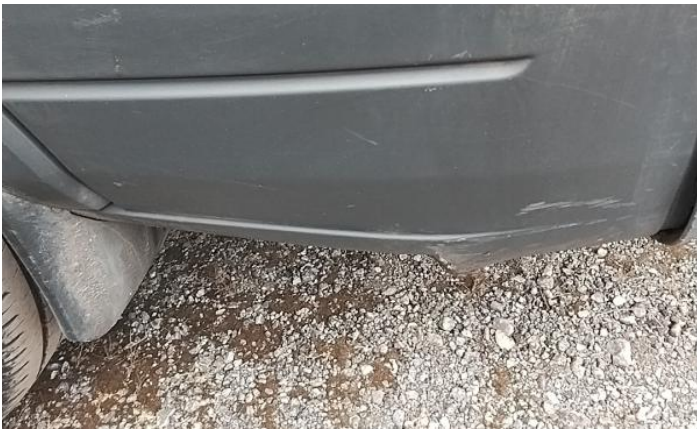
11: Qtr Panel Moulding ns  
Broken  
Replace

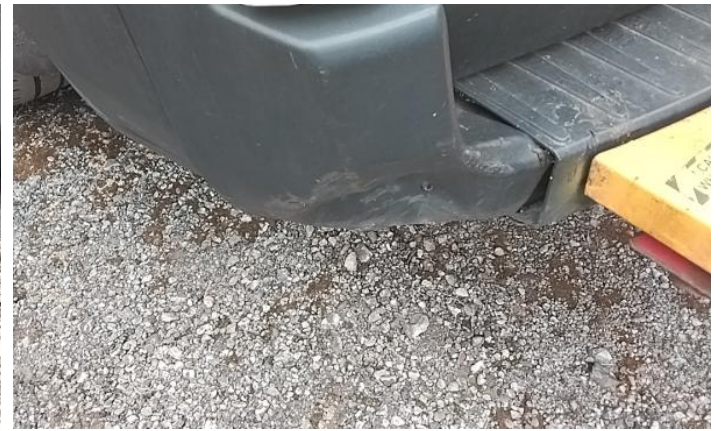
12: Bumper Rear Moulding  
Broken  
Replace

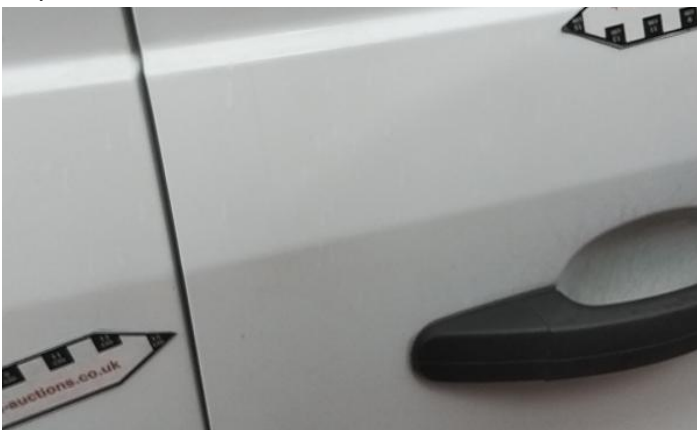
13: Door osr  
Dented  
Over 30mm

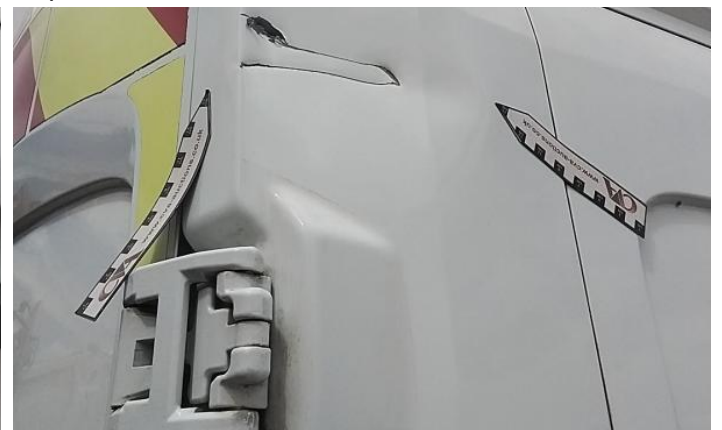
14: C Post os  
Dented  
With Paint Damage

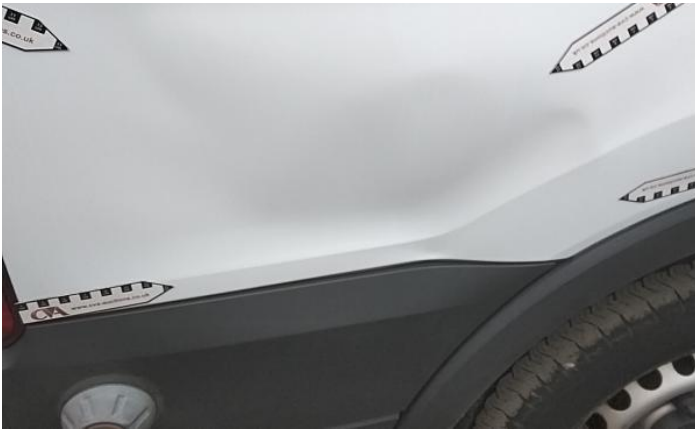
15: Qtr Panel osr  
Dented  
Over 30mm

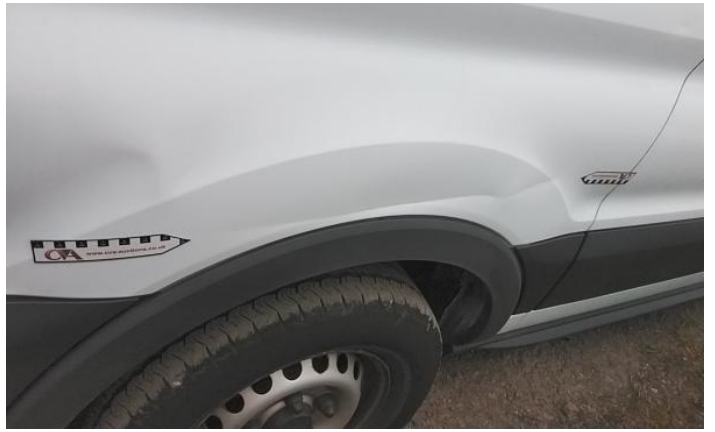
16: Qtr Panel osr  
Dented  
With Paint Damage

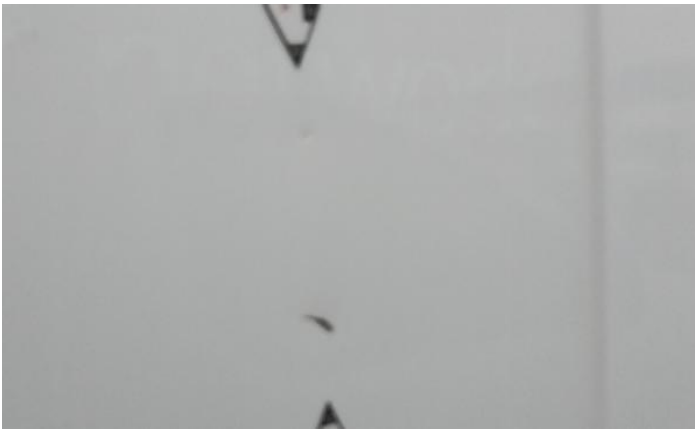
17: Qtr Panel osr  
Dented  
With Paint Damage

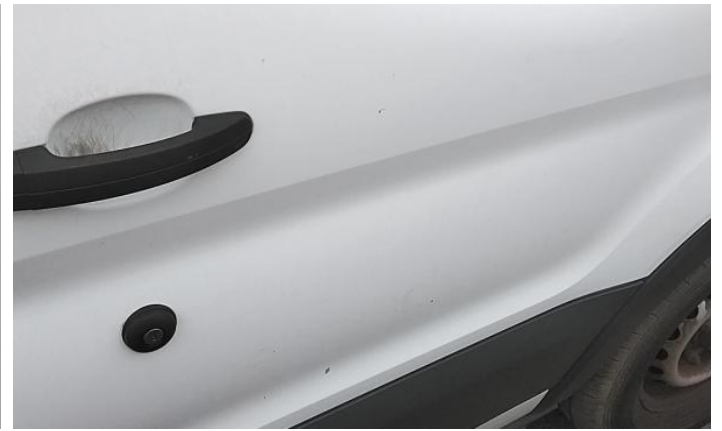
18: Door osf  
Chipped  
Multiple Chips

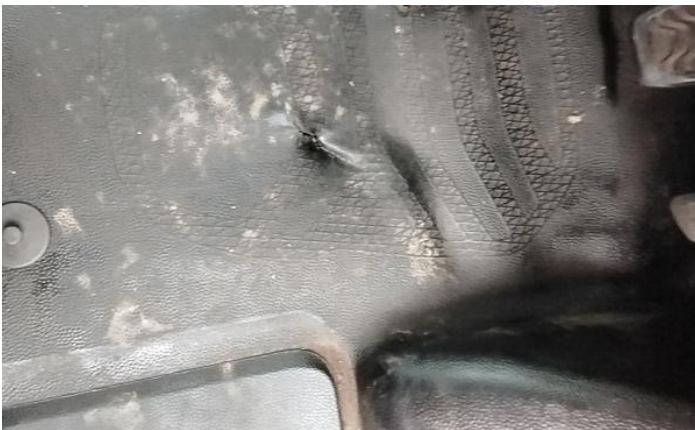
19: Carpets Front  
Holed  
Over 3mm

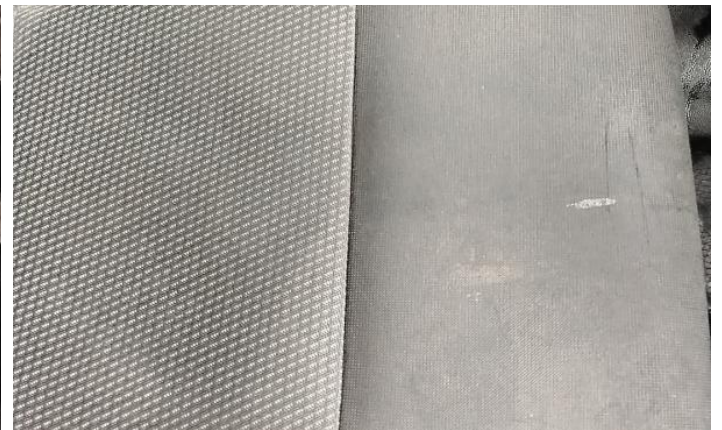
20: Seat Base Cover osf  
Soiled  
Heavy

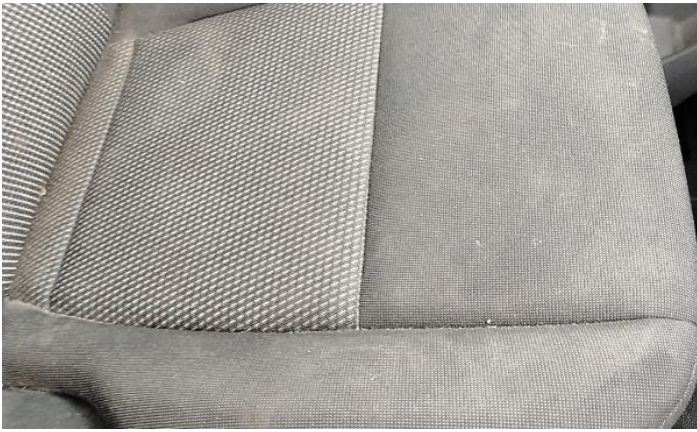
21: Seat Base Cover nsf  
 Soiled  
 Heavy
