# VEHICLE INSPECTION REPORT

**DK18HXJ**

## Daf LF 180

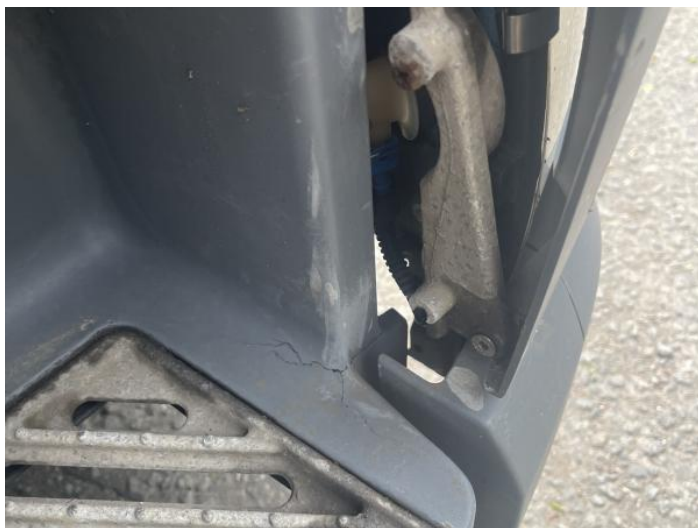
1: Door Moulding of  
Broken  
Replace

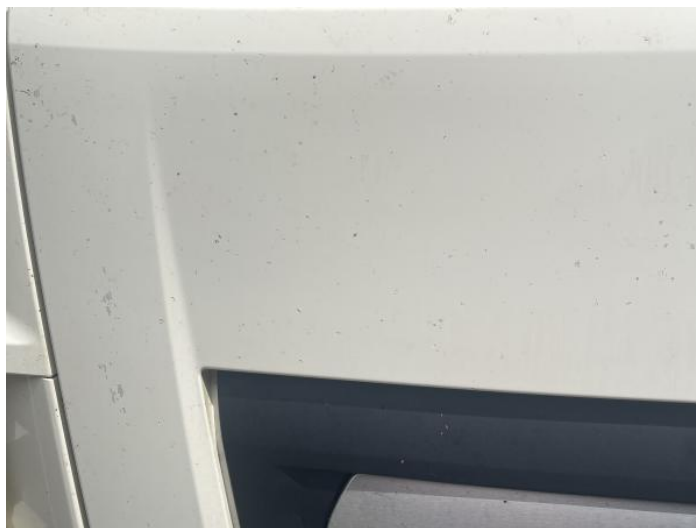
2: Bonnet  
Chipped  
Multiple Chips

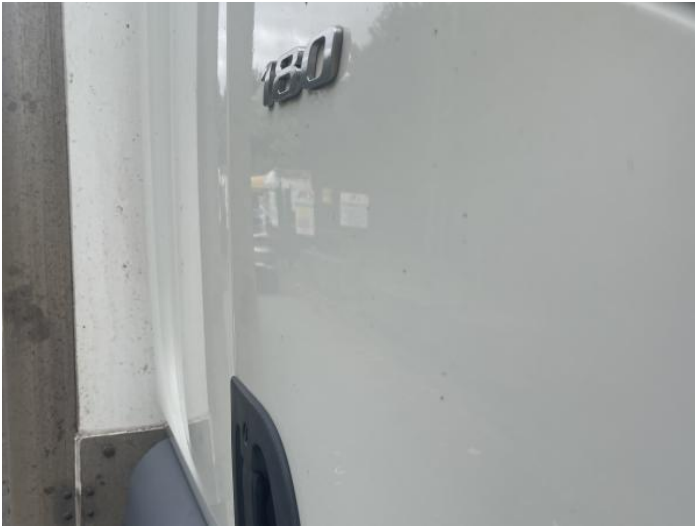
3: Door osf  
Dented  
Between 10mm + 30mm

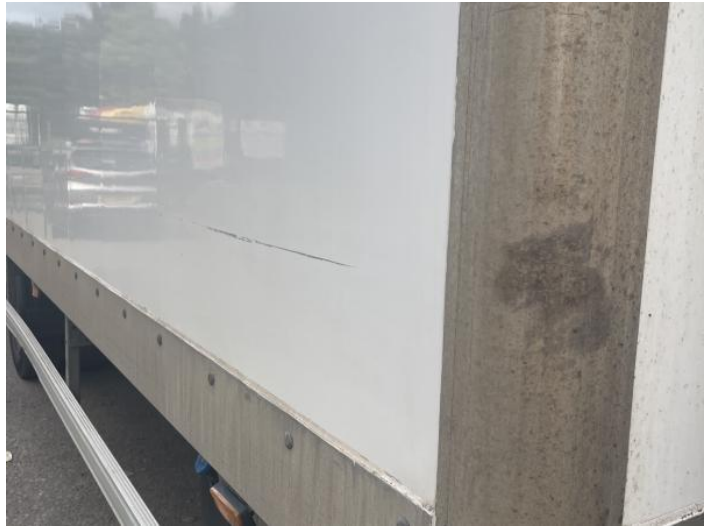
4: Qtr Panel osr  
Scratched  
Over 25mm Thru Paint

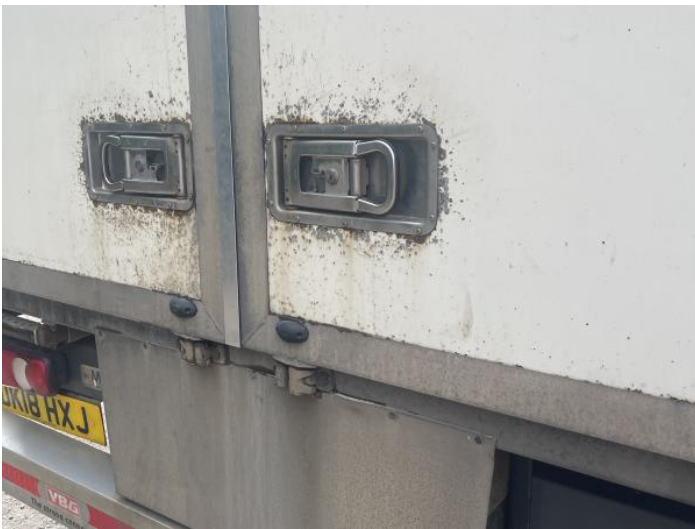
5: Tailgate  
Rusted  
Over 5mm

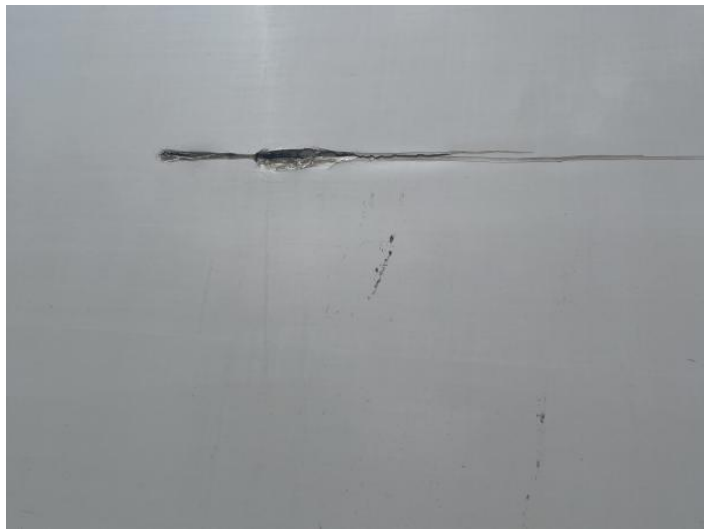
6: Qtr Panel nsr  
Hole  
Over 10mm

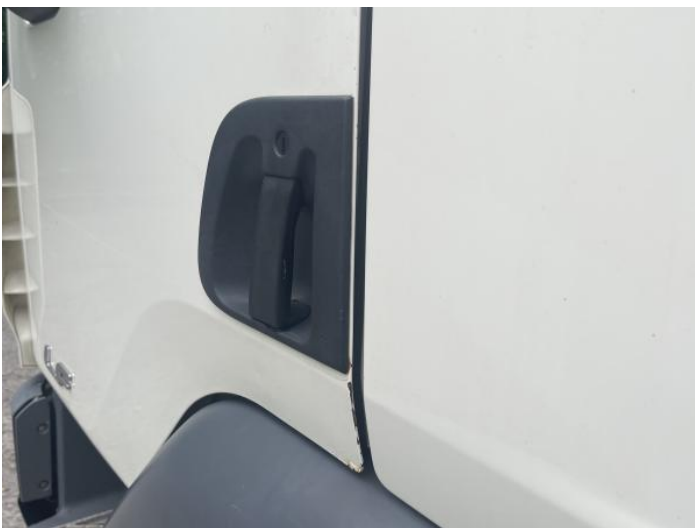
7: Door nsf  
Chipped  
Edge Chip

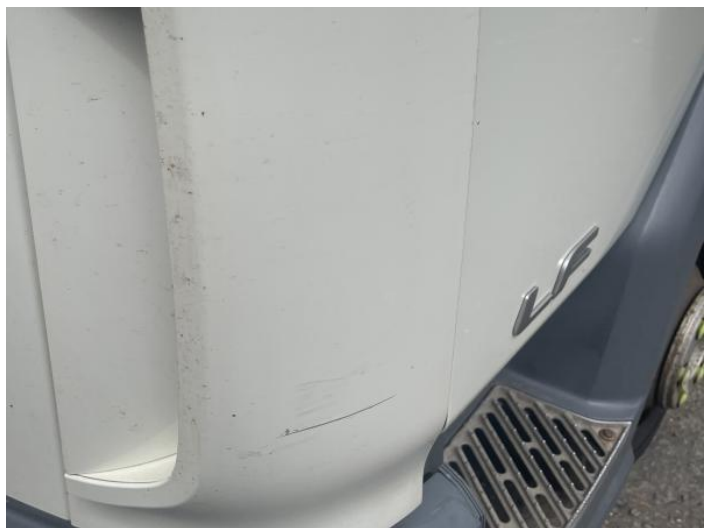
8: Wing nsf  
Scratched  
Over 25mm Thru Paint
