VEHICLE INSPECTION REPORT

OE71AMK

Man TGE 3.140

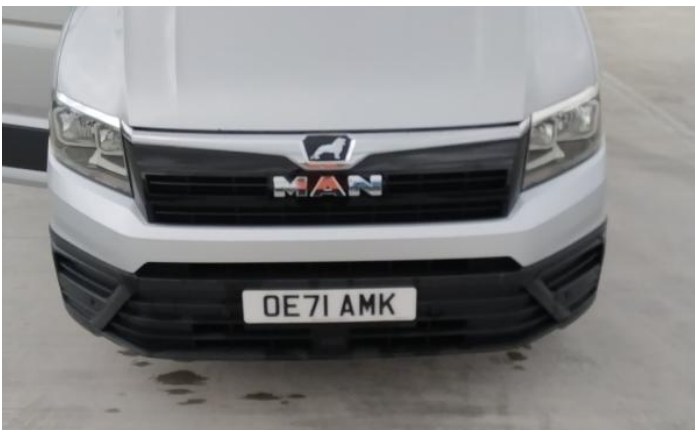
1: Bonnet
Chipped
Multiple Chips

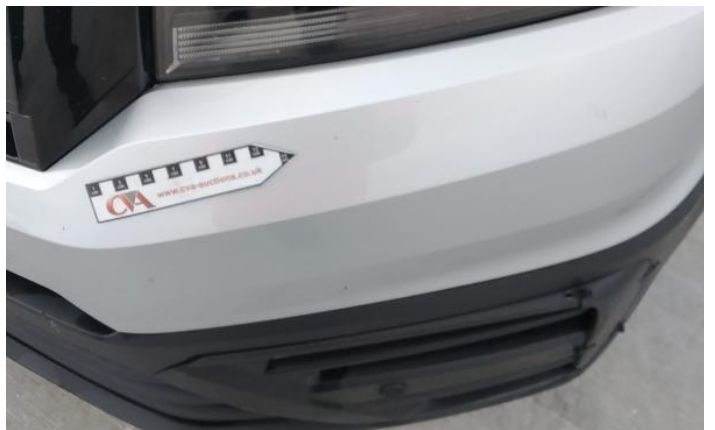
2: Bumper Front
Chipped
Multiple Chips

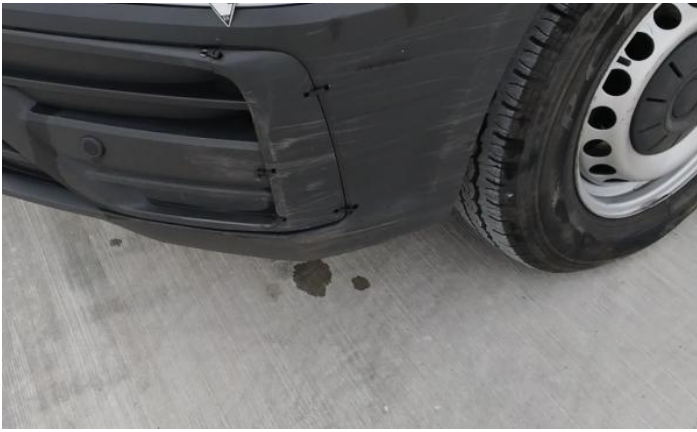
3: Bumper Front
Insecure
Action Required

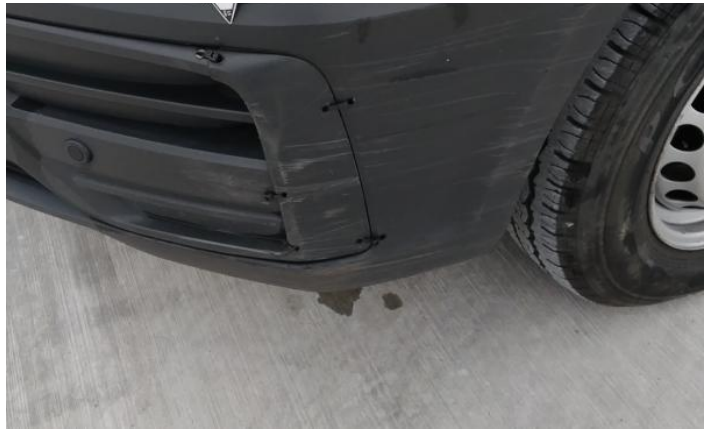
4: Bumper Front
Scratched
Over 100mm Thru Paint

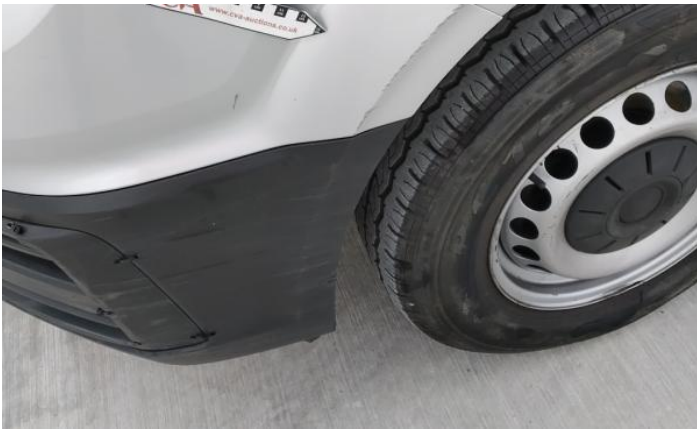
5: Bumper Front
Scratched
Over 100mm Thru Paint

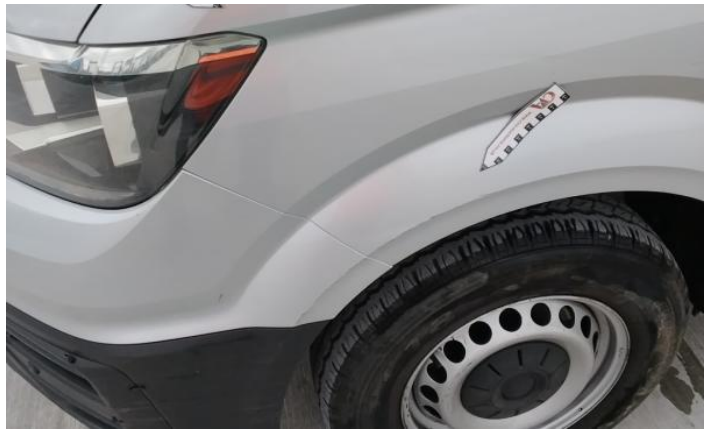
6: Wing nsf
Scratched
Over 25mm Thru Paint

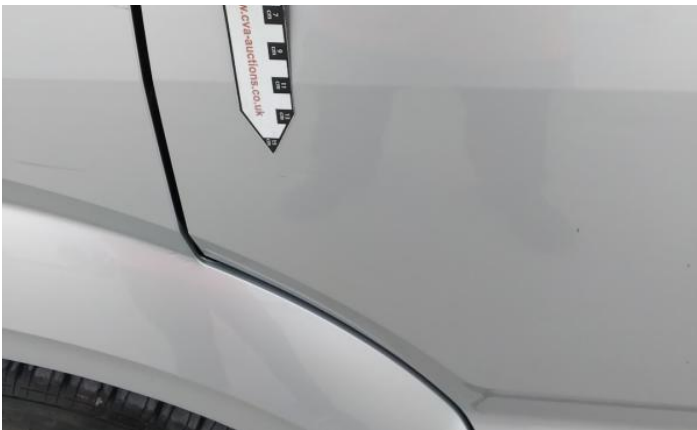
7: Door nsf
Scratched
Over 25mm Thru Paint

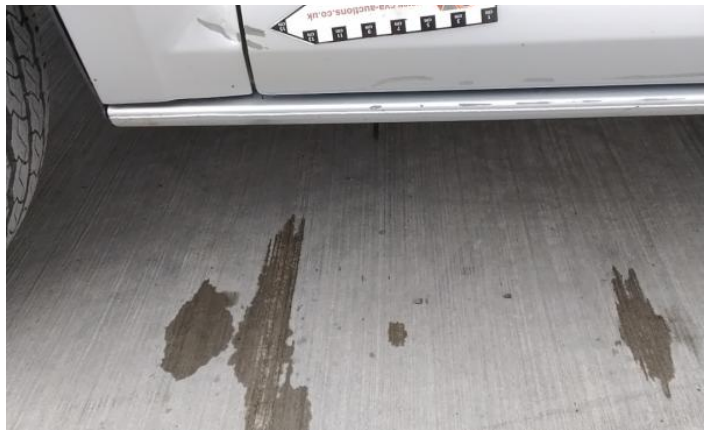
8: Door nsf
Dented
With Paint Damage

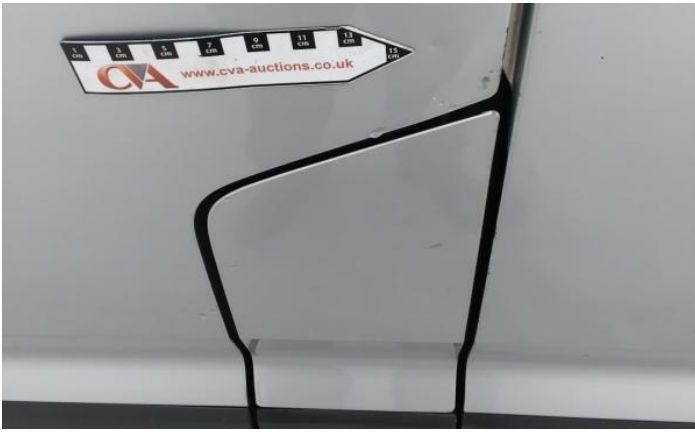
9: Door nsf
Dented
Over 30mm

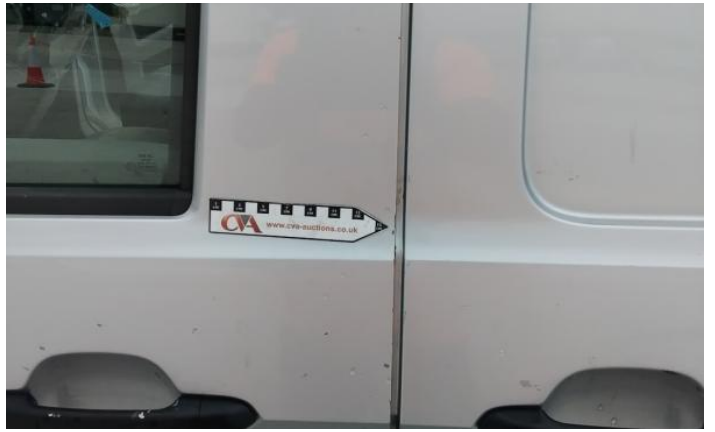
10: Door nsf
Chipped
Multiple Chips

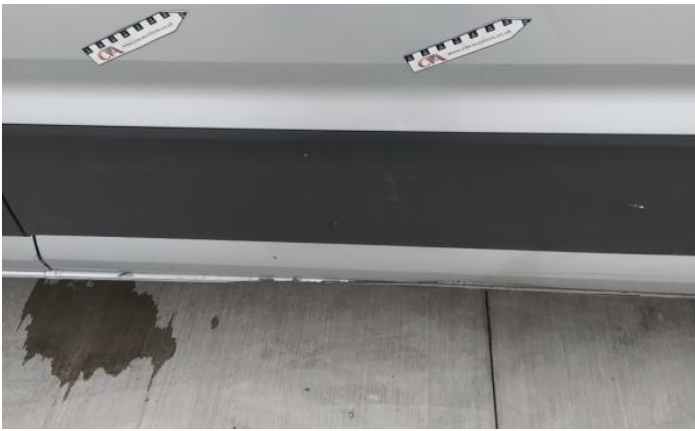
11: Qtr Panel nsr
Scratched
Over 25mm Thru Paint

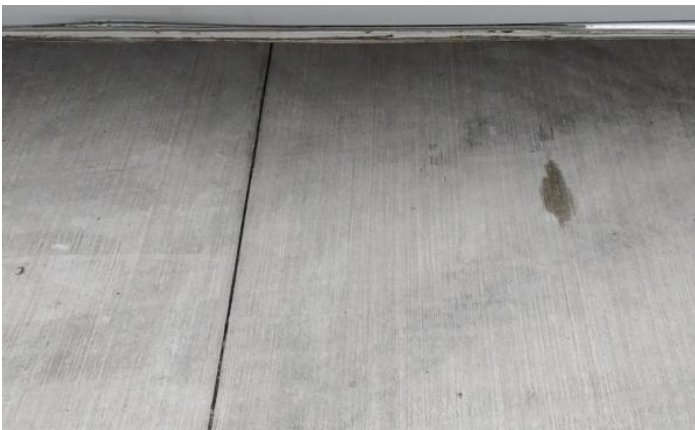
13: Qtr Panel nsr
Scratched
Over 25mm Thru Paint

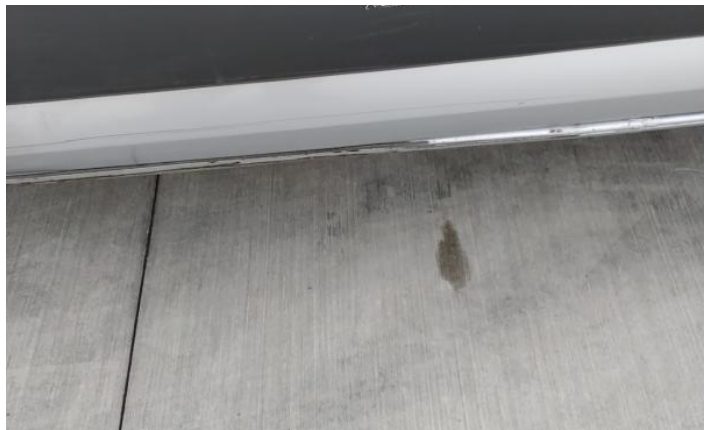
14: Qtr Panel Moulding ns
Scratched (Painted)
Over 25mm Thru Paint

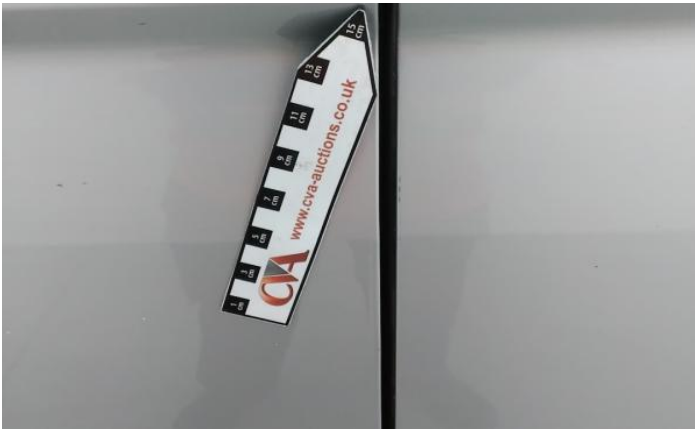
15: Qtr Panel nsr
Chipped
Over 5mm

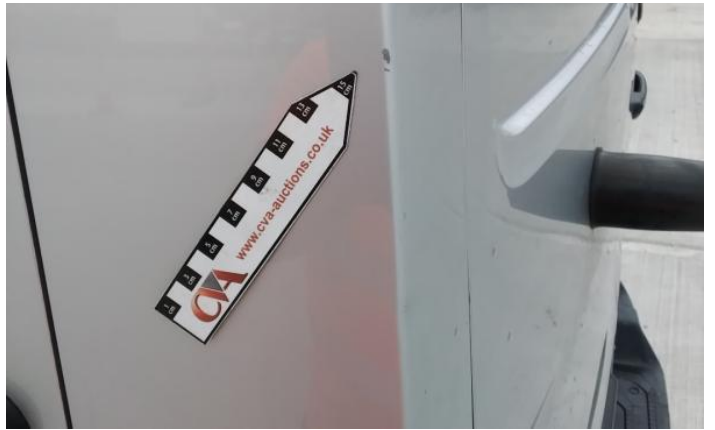
16: Panel Rear
Chipped
Over 5mm

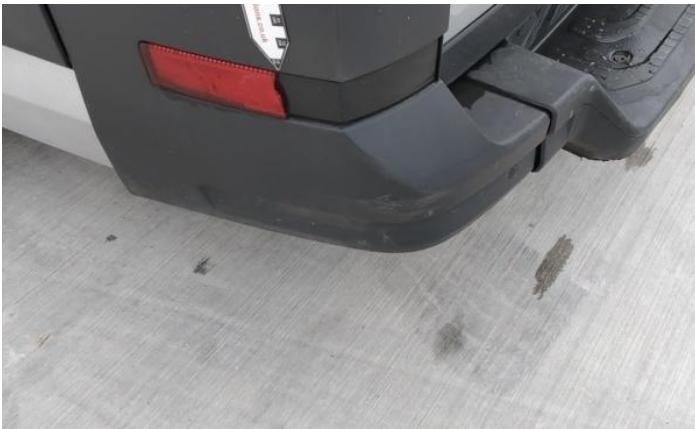
17: Reflector nsr
Broken
Replace

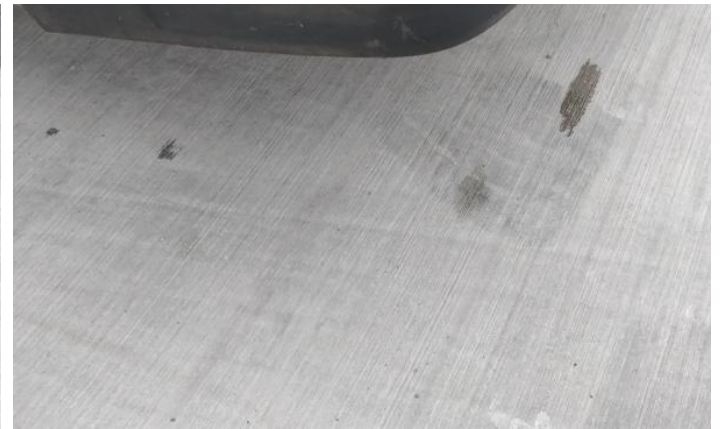
18: Bumper Rear
Scratched
Over 100mm Thru Paint

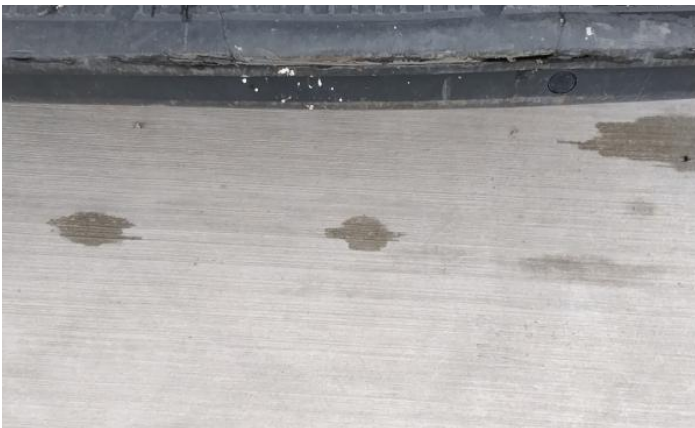
19: Bumper Rear
Cracked
Over 25mm

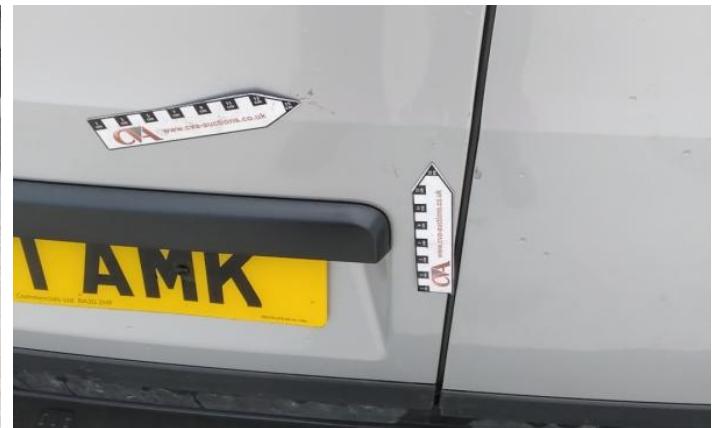
20: Door nsr
Dented
With Paint Damage

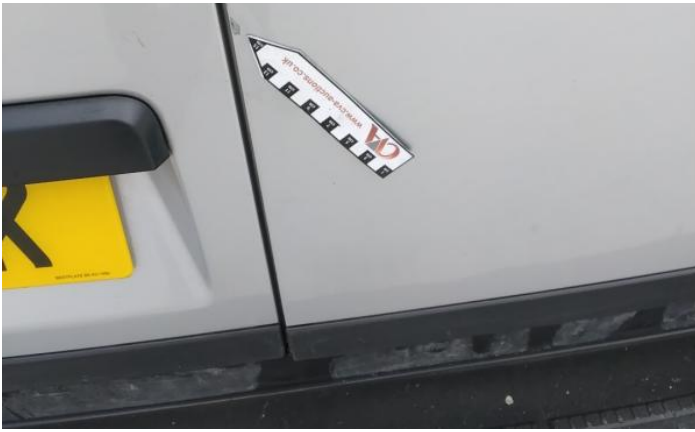
21: Door osr
Chipped
Over 5mm

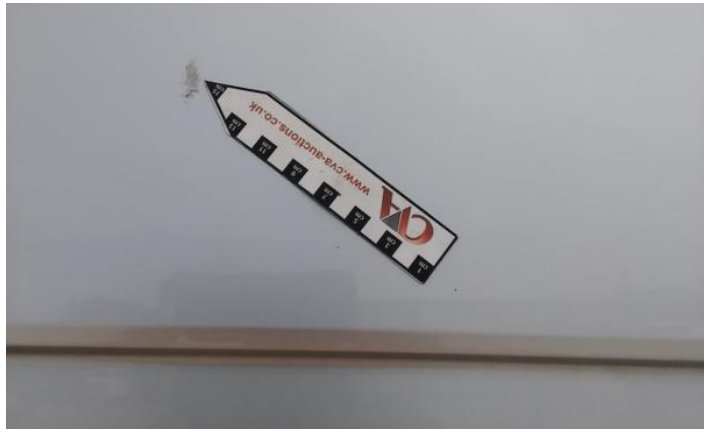
22: Door osr
Scratched
Over 25mm Thru Paint

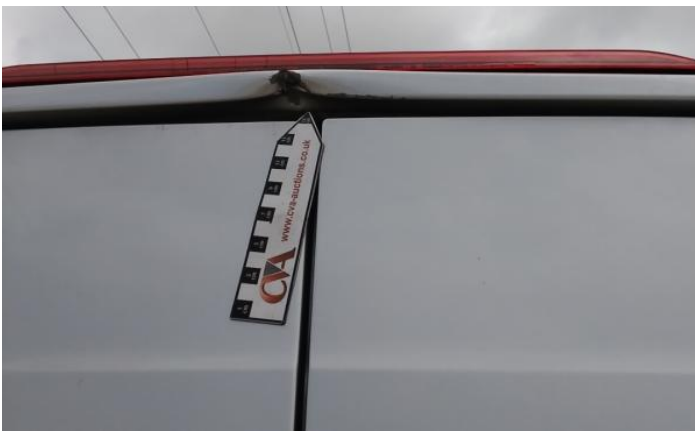
23: Panel Rear
Dented
Hail - Severe

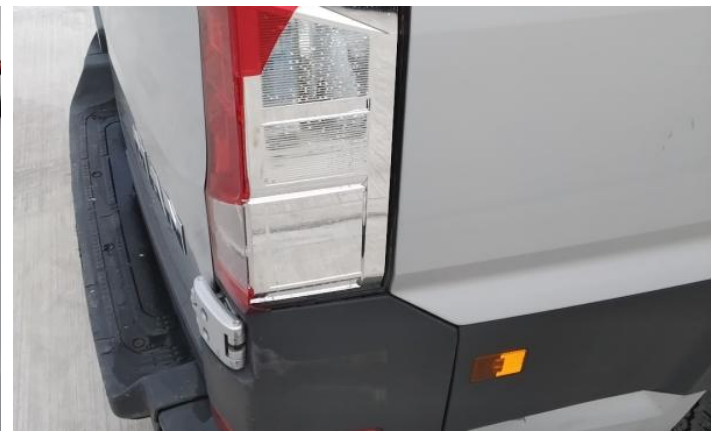
24: Lamp osr
Broken
Replace

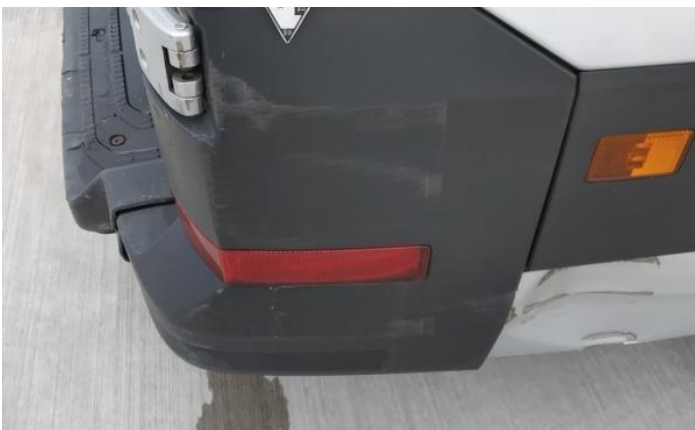
25: Bumper Rear
Scratched
Over 100mm Thru Paint

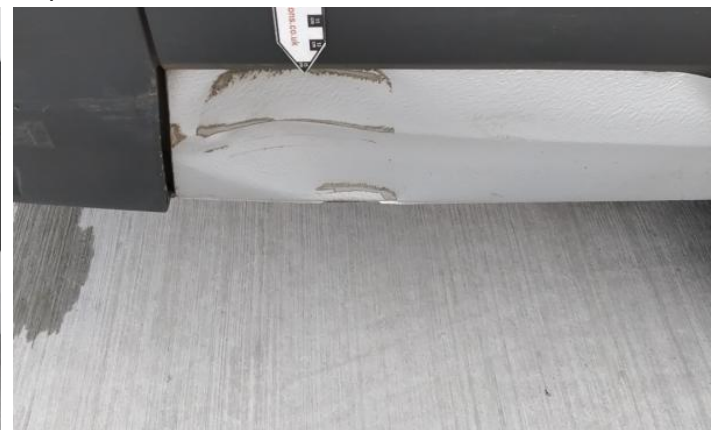
26: Qtr Panel osr
Dented
With Paint Damage

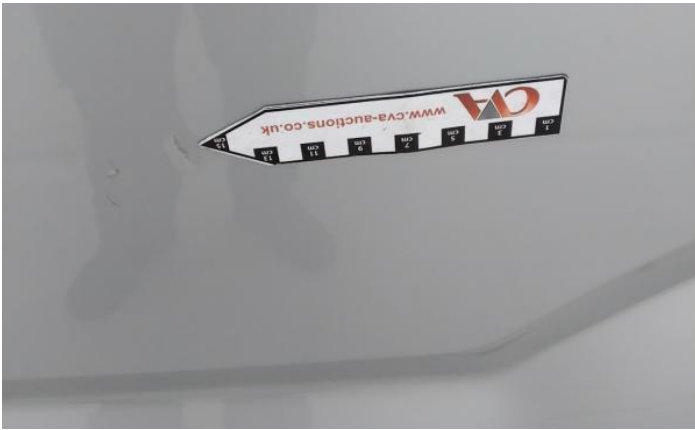
27: Qtr Panel osr
Scratched
Over 25mm Thru Paint

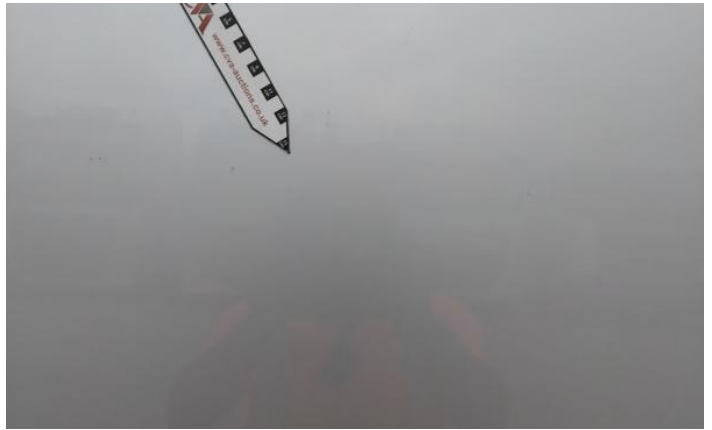
28: Qtr Panel osr
Scratched
Over 25mm Thru Paint

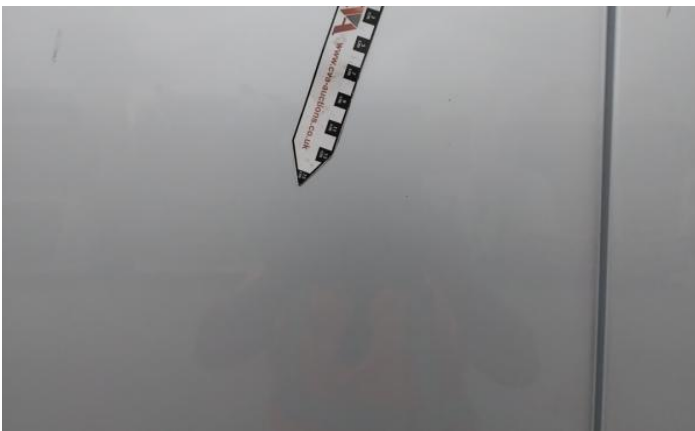
29: Qtr Panel osr
Scratched
Over 25mm Thru Paint

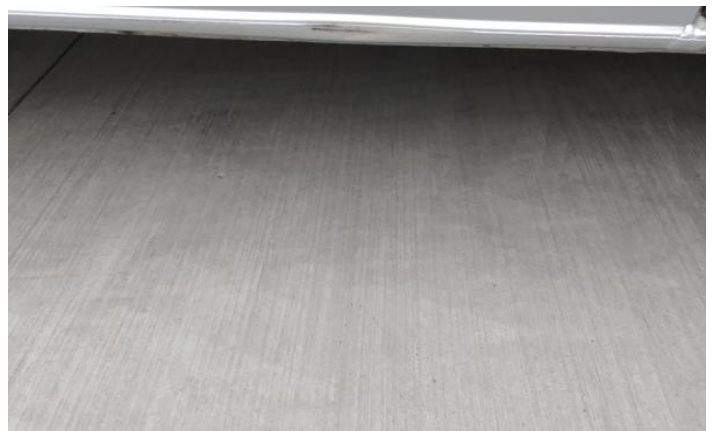
30: Sill os
Dented
With Paint Damage

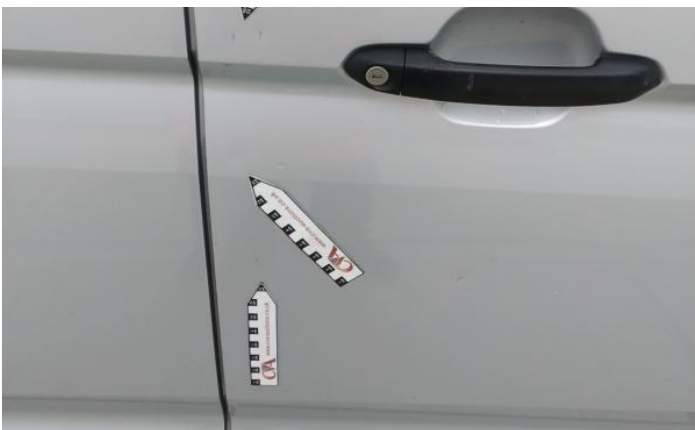
31: Door osf
Dented
With Paint Damage

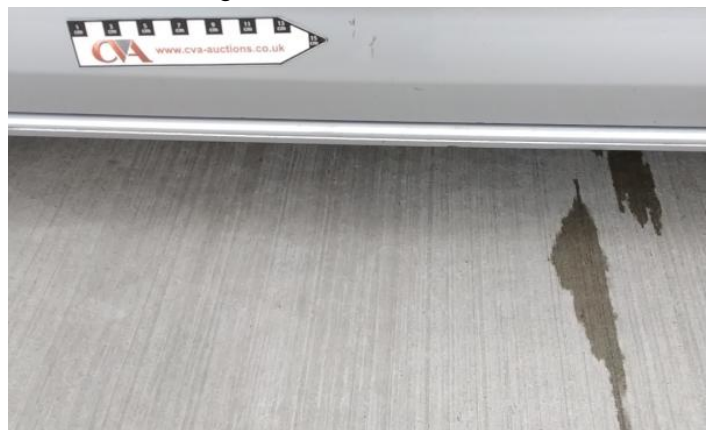
32: Door osf
Scratched
Over 25mm Thru Paint

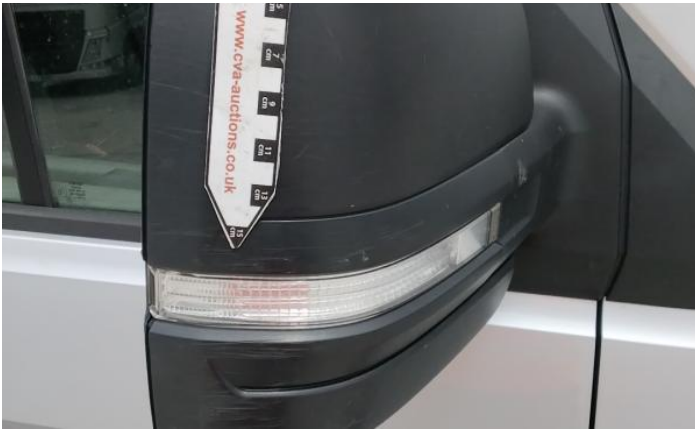
33: Door Mirror Assy osf
Scratched (Painted)
Over 25mm Thru Paint

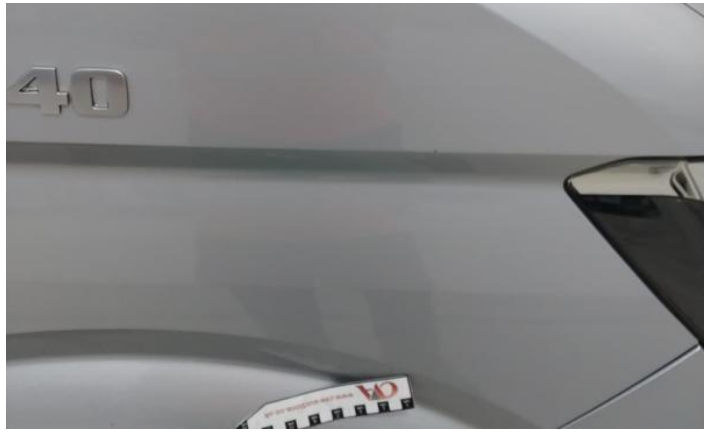
34: Wing osf
Chipped
Multiple Chips

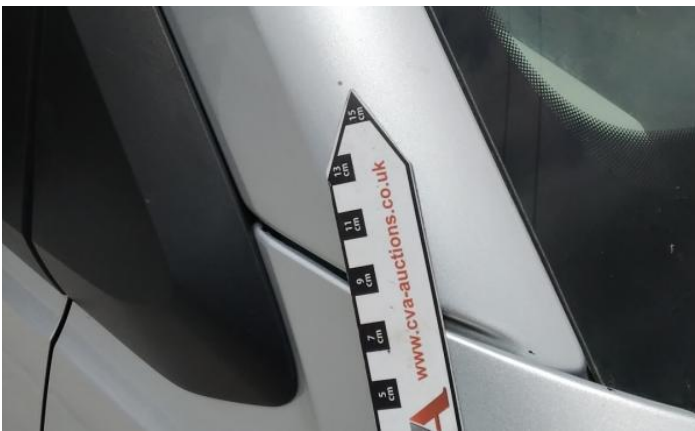
35: A Post os
Chipped
Over 5mm

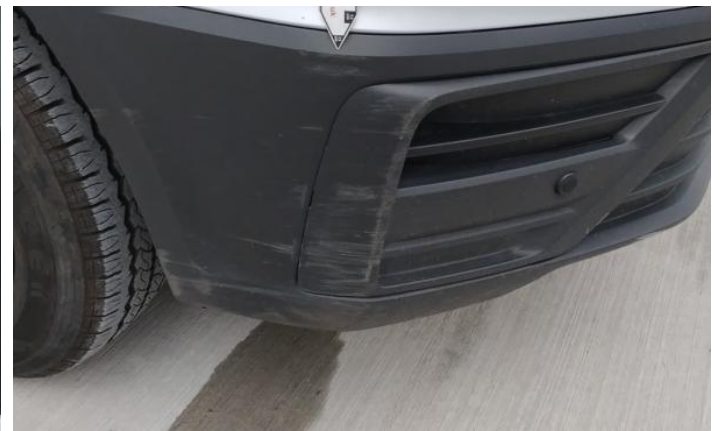
36: Bumper Front
Scratched
Over 100mm Thru Paint

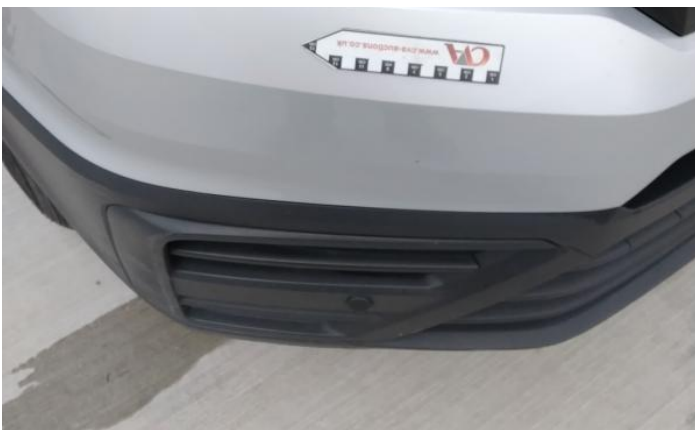
37: Bumper Front
Chipped
Multiple Chips

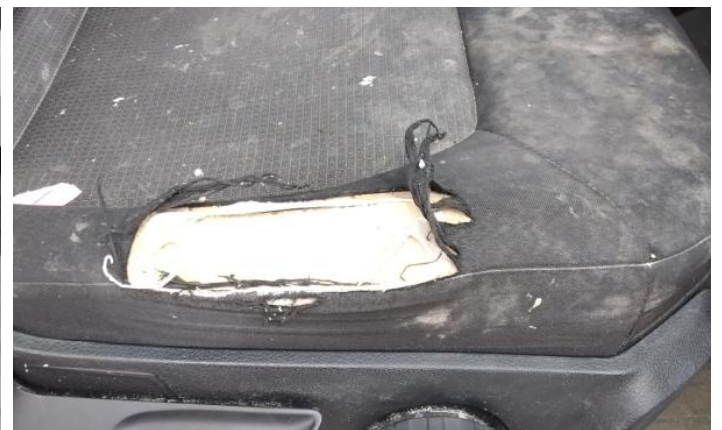
38: Seat Base Cover osf
Holed
Over 3mm

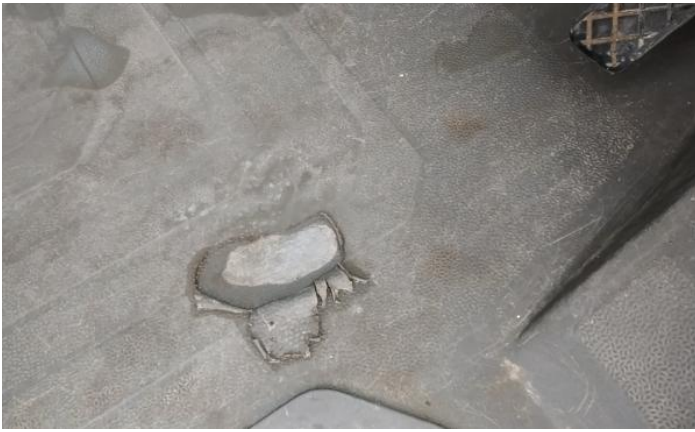
39: Carpets Front
Holed
Over 3mm

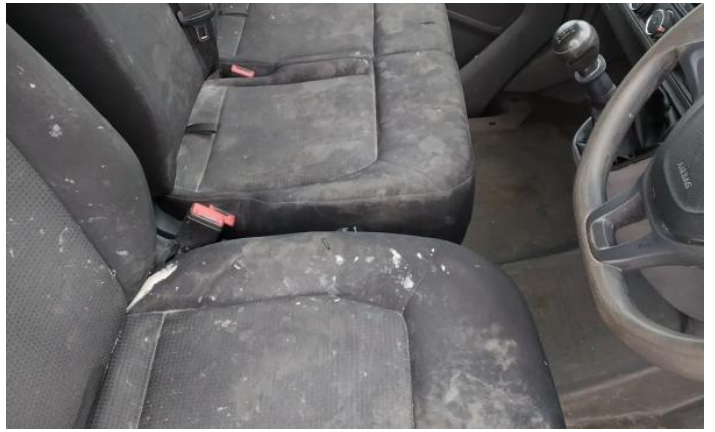
40: Seat Base Cover nsf
Soiled
Heavy

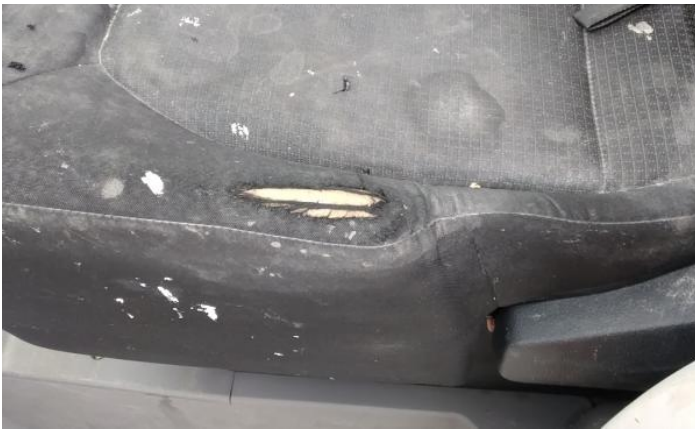
41: Seat Base Cover nsf
Holed
Over 3mm

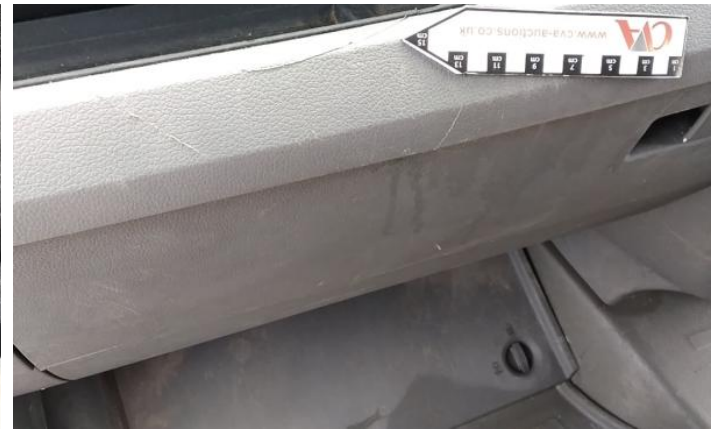
42: Centre Console Front
Scuffed
Over 25mm
