# VEHICLE INSPECTION REPORT

**URZ2750**

## Scania S 540

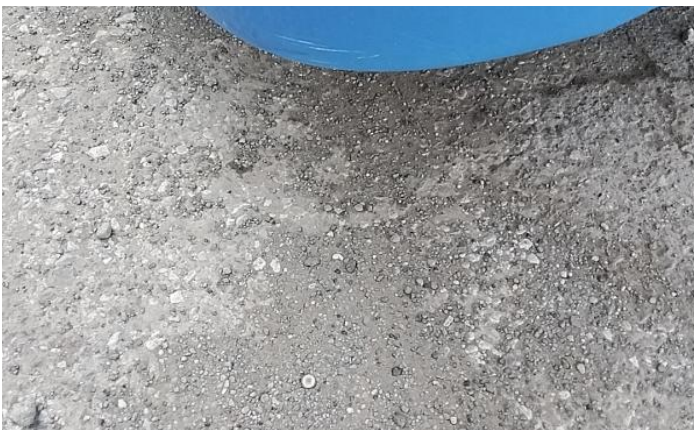
1: Bumper Front Moulding  
Scratched (Painted)  
Over 25mm Thru Paint

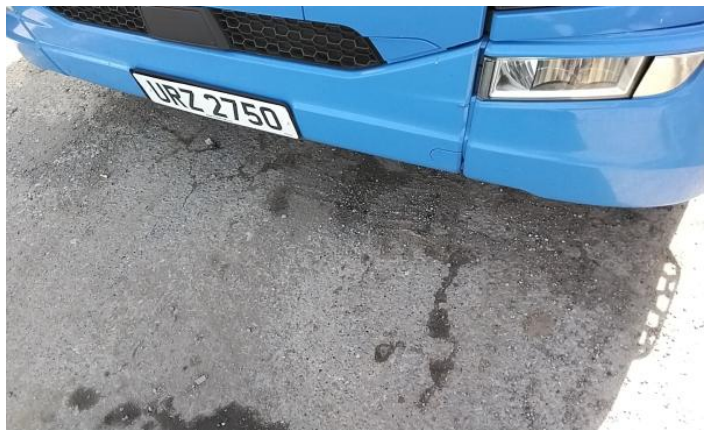
2: Bumper Front  
Chipped  
Multiple Chips

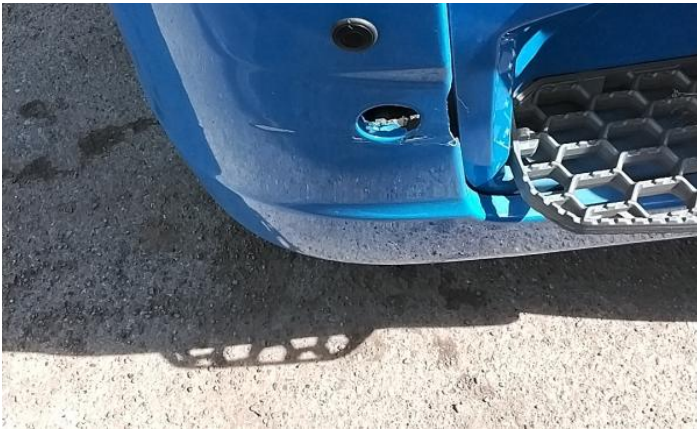
3: Bumper Front Moulding  
Scratched (Painted)  
Over 25mm Thru Paint

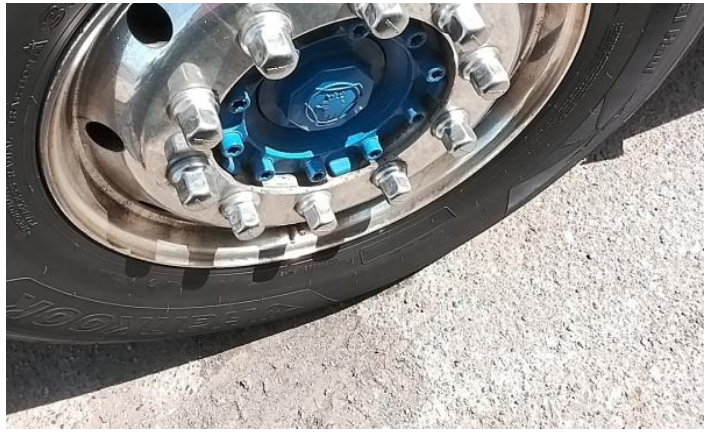
4: Wheel nsf  
Scratched  
Over 50mm

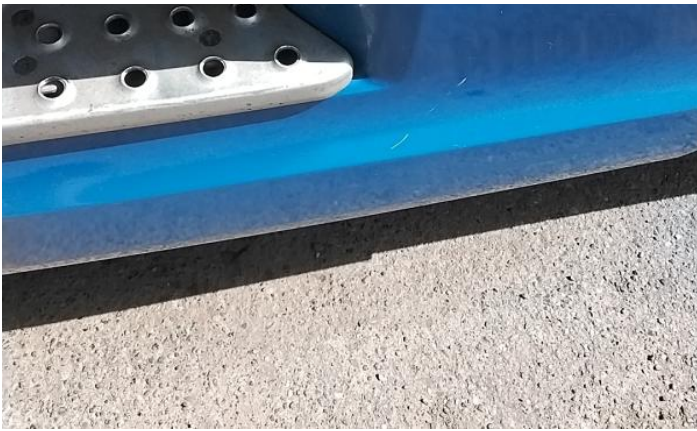
5: Qtr Panel Moulding ns  
Scratched (Painted)  
Over 25mm Thru Paint

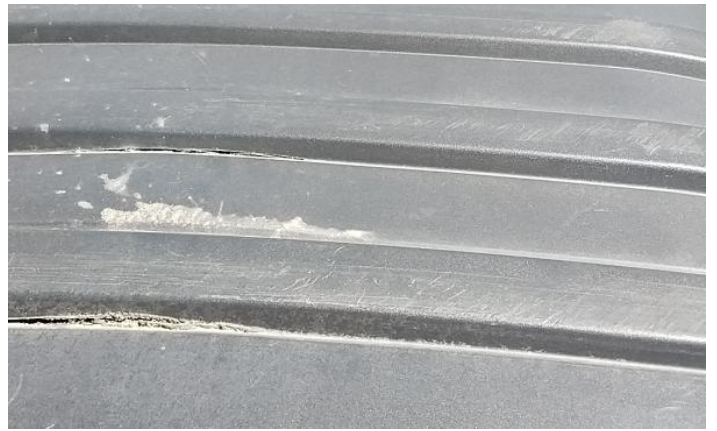
6: Qtr Panel Moulding ns  
Broken  
Replace

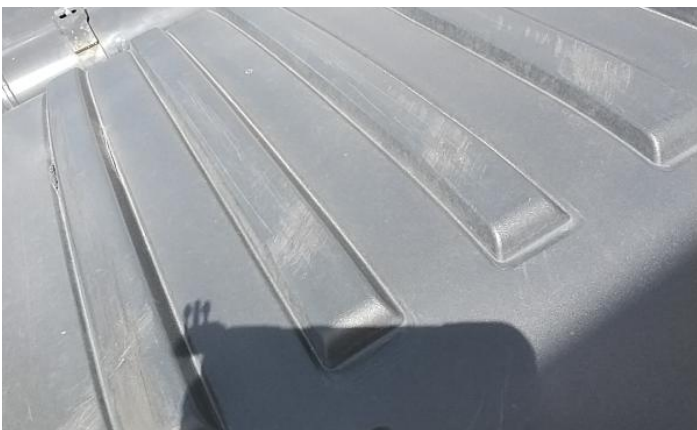
7: Qtr Panel Moulding os  
Broken  
Replace

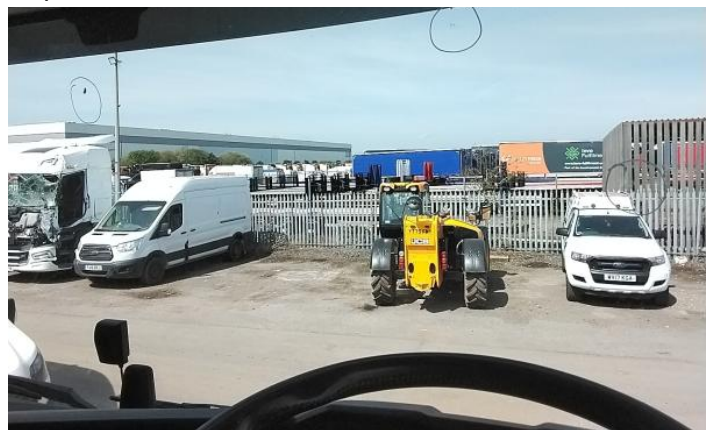
8: Screen Front  
Chipped  
Over 10mm

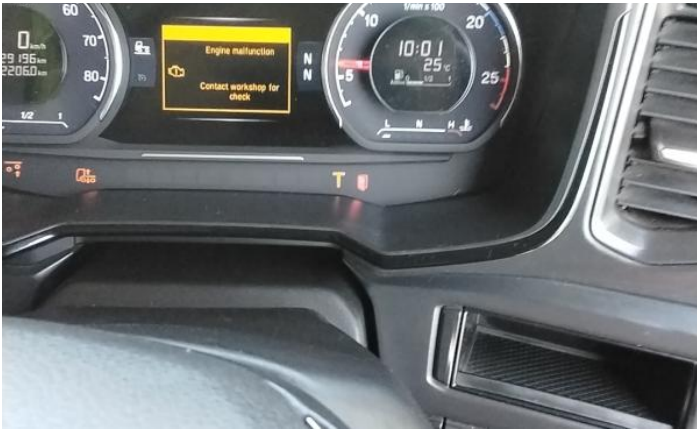
9: Dash Warning Lights  
 Displayed  
 No Action

<b>Carpet Condition</b>	OK	<b>Upholstery Condition</b>	OK
<b>Seat Condition</b>	OK	<b>Odour</b>	-
Engine Runs	OK	No Excessive Smoking	OK
EML light illuminated	Fault	DPF light illuminated	OK
ABS light illuminated	OK
