VEHICLE INSPECTION REPORT

AY18JVO

Mercedes-Benz Actros 1840

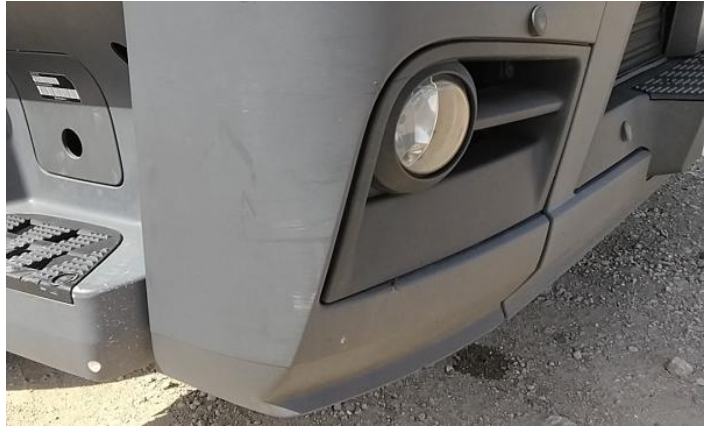
2: Bumper Front Moulding
Scuffed (Unpainted)
Over 100mm

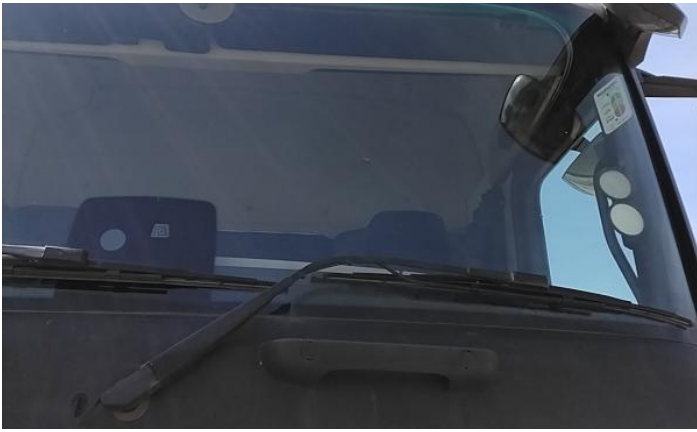
3: Screen Front
Chipped
Over 10mm

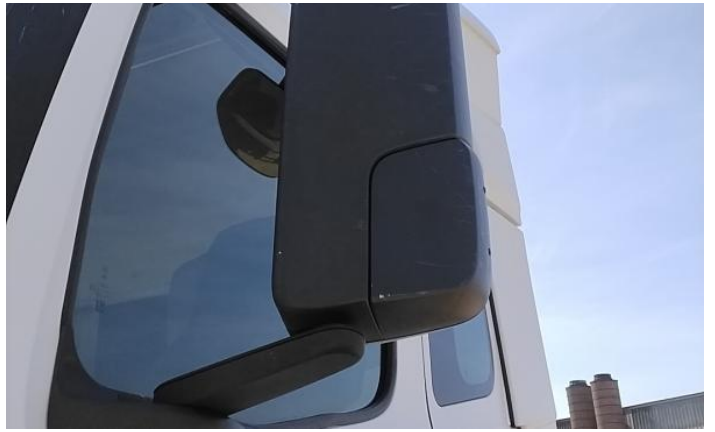
4: Door Mirror Assy nsf
Scuffed (Unpainted)
Over 100mm

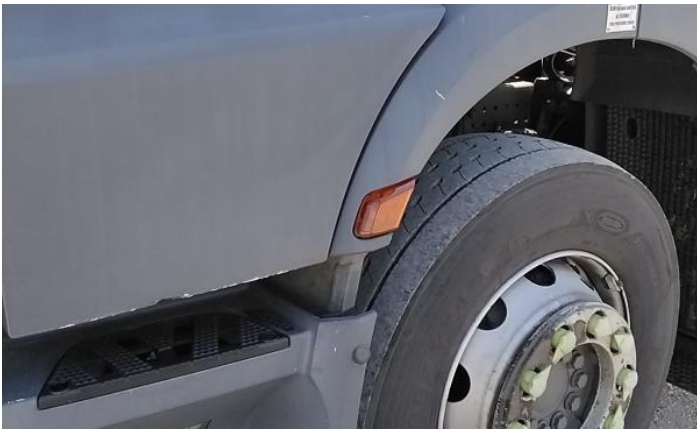
5: Wing Front Arch Extension ns
Scuffed (Unpainted)
Over 100mm

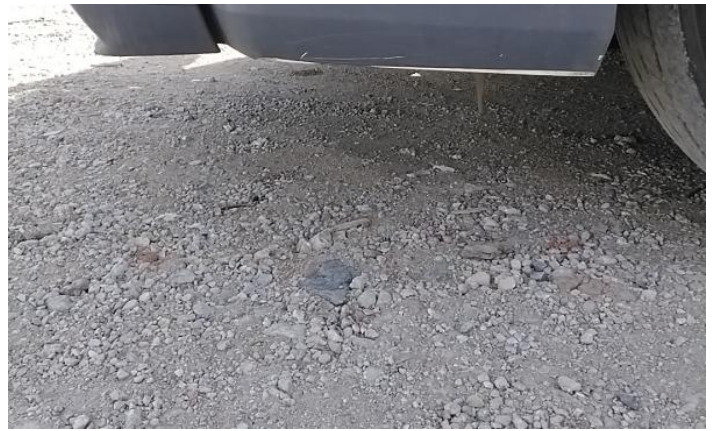
6: Wing Front Arch Extension ns
Scuffed (Unpainted)
Over 100mm

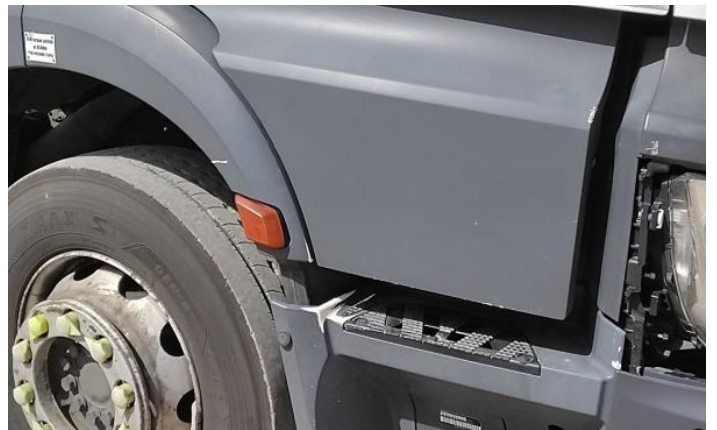
8: Wing Front Arch Extension os
Scuffed (Unpainted)
Over 100mm

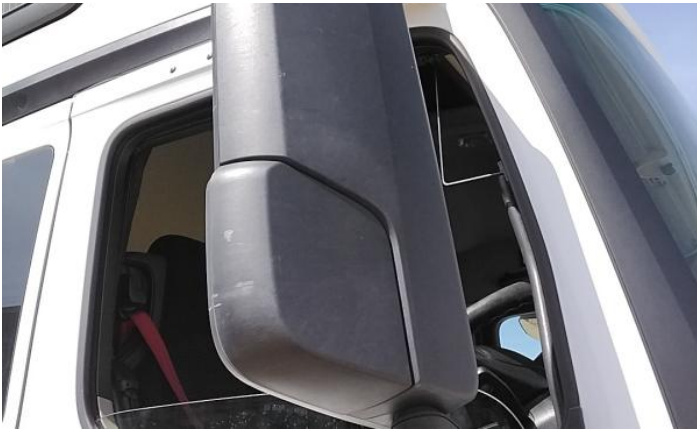
9: Door Mirror Assy osf
Scuffed (Unpainted)
Over 100mm

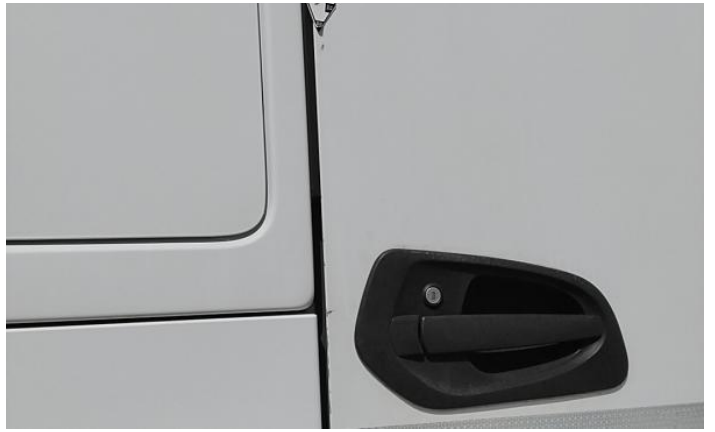
10: Door osf
Chipped
Edge Chip
