COMMERCIAL VEHICLE AUCTIONS LTD
THE UK'S MOST ESTABLISHED COMMERCIAL VEHICLE AUCTIONEERS

VEHICLE INSPECTION REPORT

AY18JVP

Mercedes-Benz Actros 1840

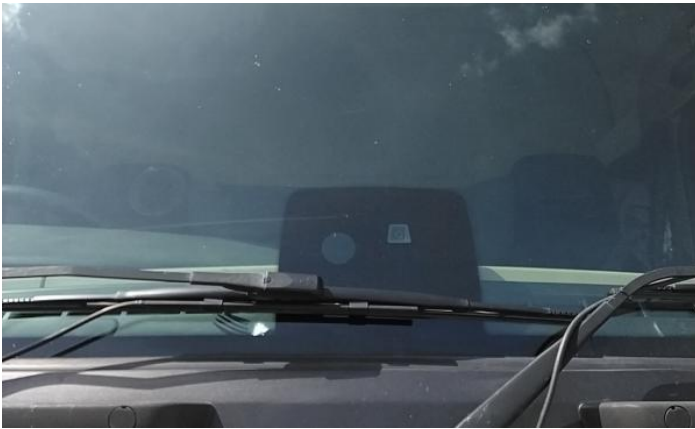
1: Screen Front
Chipped
UpTo 10mm

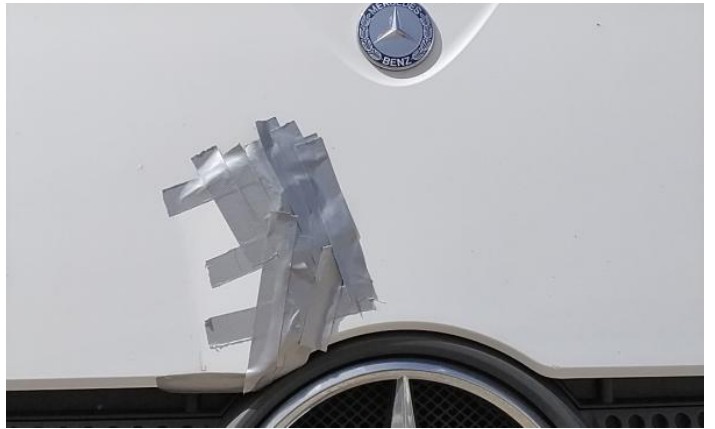
2: Bonnet
Cracked
Replace

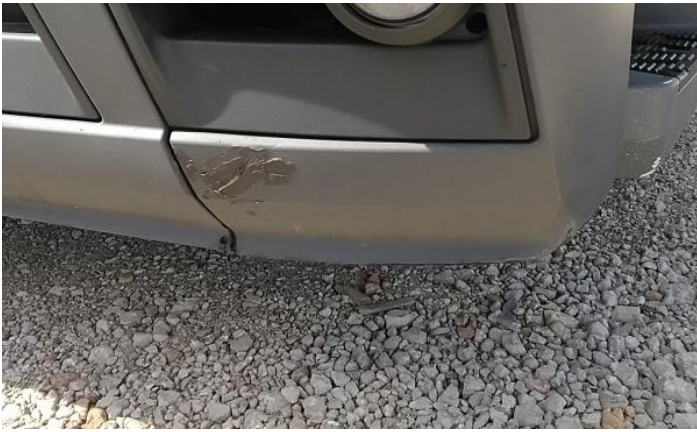
3: Bumper Front Moulding
Scuffed (Unpainted)
Over 100mm

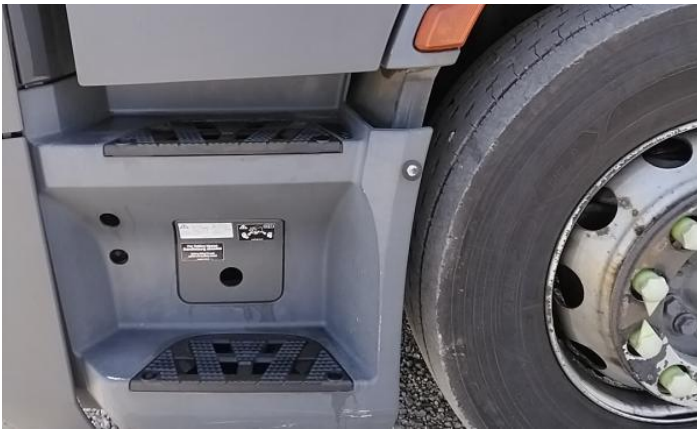
5: Wing Front Arch Extension ns
Scuffed (Unpainted)
Over 100mm

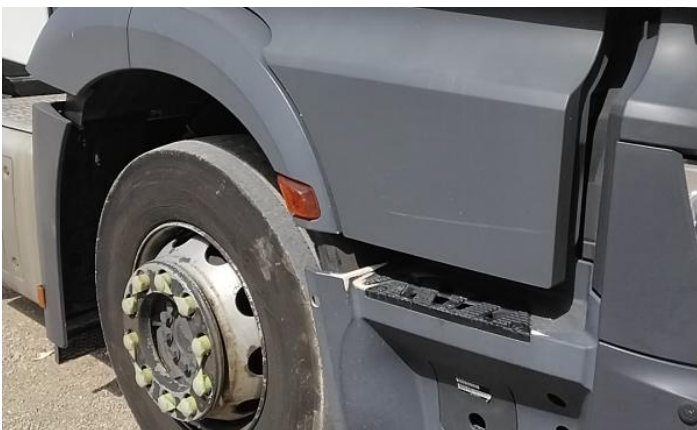
7: Wing Front Arch Extension os
Scuffed (Unpainted)
Over 100mm

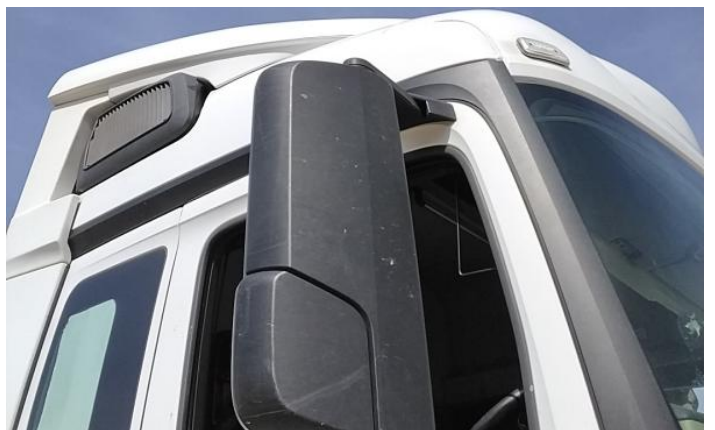
8: Door Mirror Assy osf
Scuffed (Unpainted)
Over 100mm
