VEHICLE INSPECTION REPORT

RV70DEU

Iveco Eurocargo 75-160

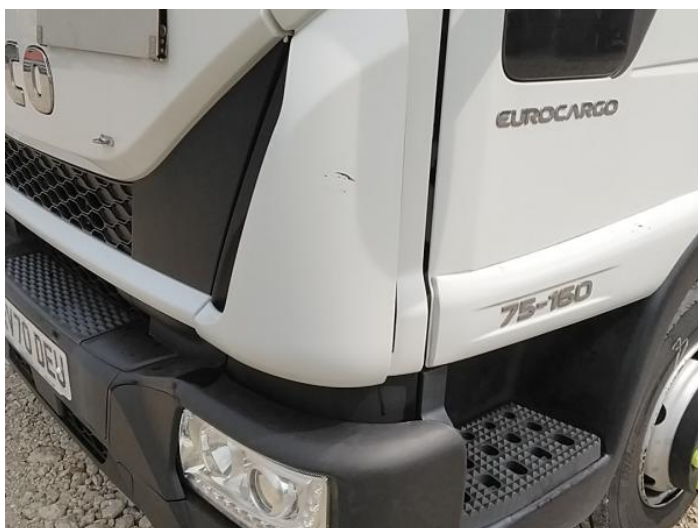
1: Moulding nsf Wing
Scratched (Painted)
Over 25mm Thru Paint

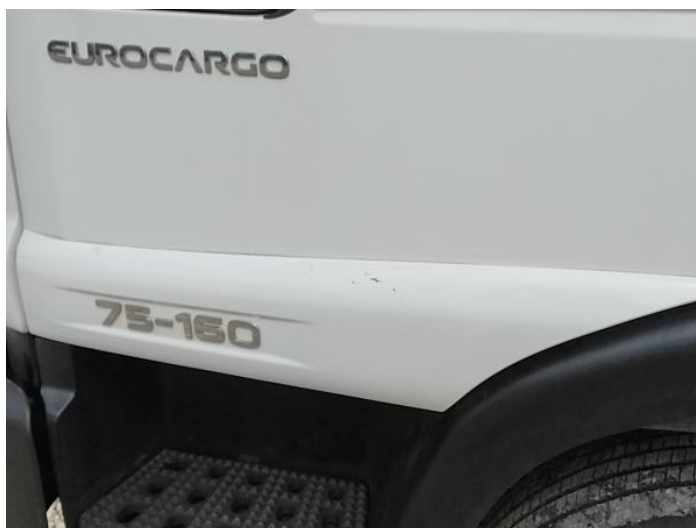
2: Door nsf
Scratched
Over 25mm Thru Paint

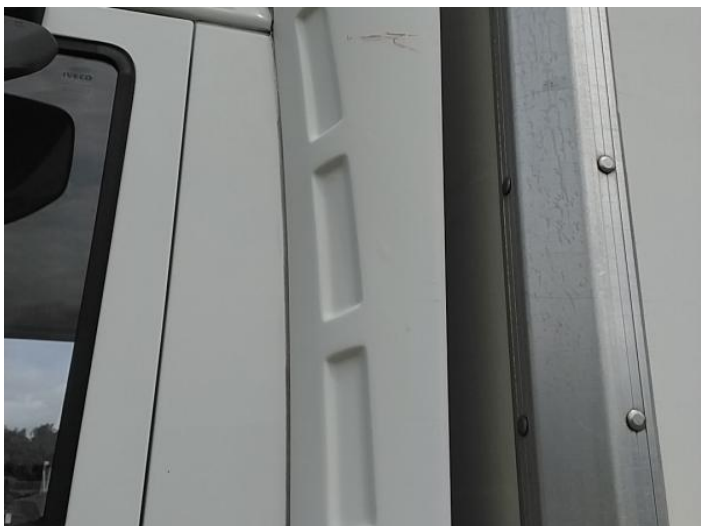
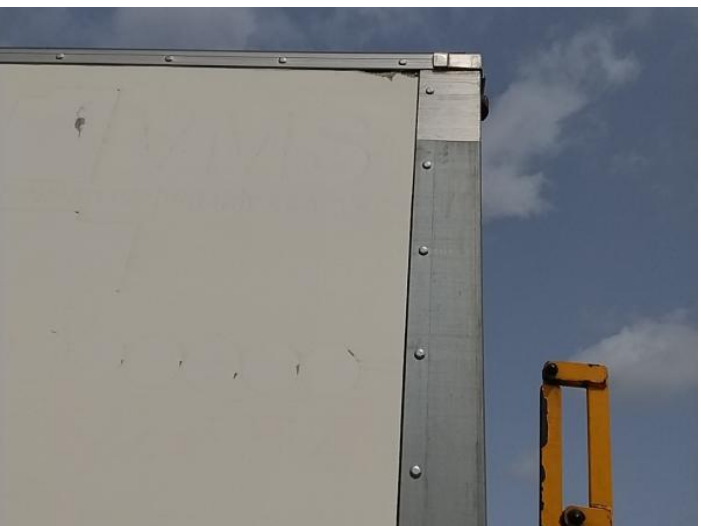
3: General Exterior
Soiled
Light

4: General Exterior
Soiled
Light

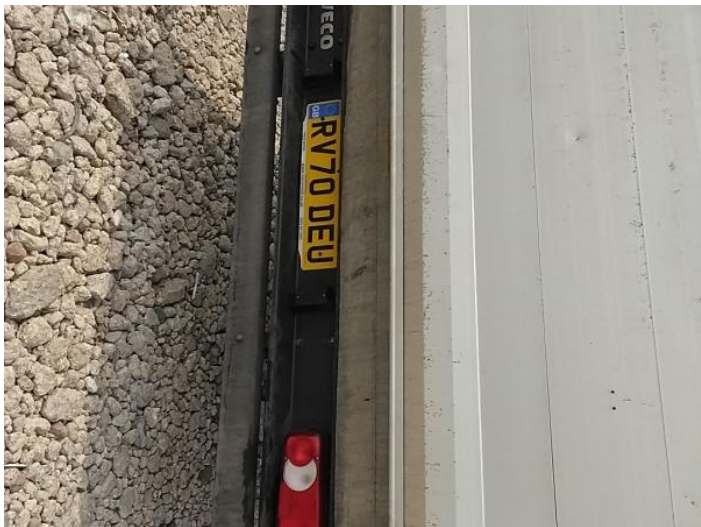
5: Bumper Rear
Rusted
Over 5mm
