VEHICLE INSPECTION REPORT

WX14AEP

Ford Transit 350 High Roof Van TDCi 125ps

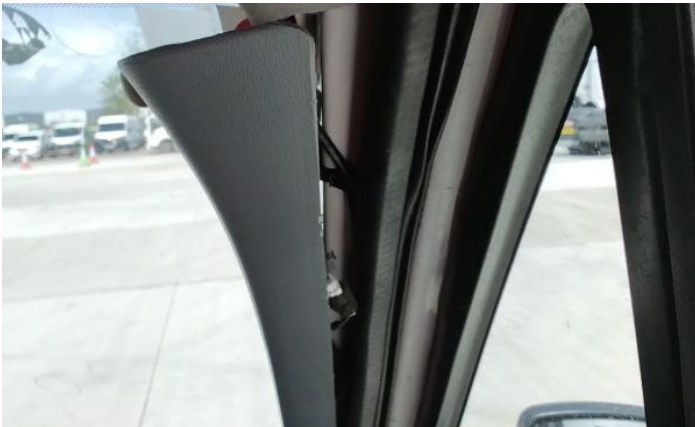
1: Fascia Trim
Damaged
Replace

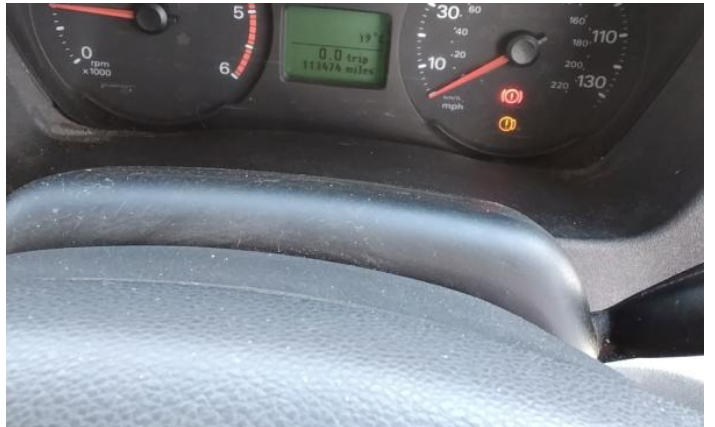
2: Dash Warning Lights
Displayed
No Action

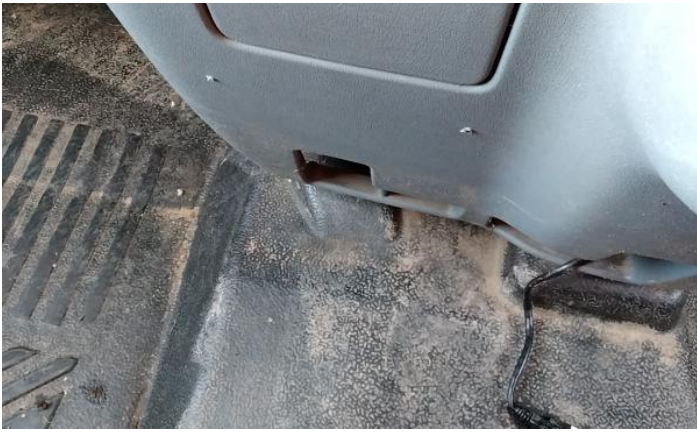
3: Centre Console Front
Holed
Over 3mm

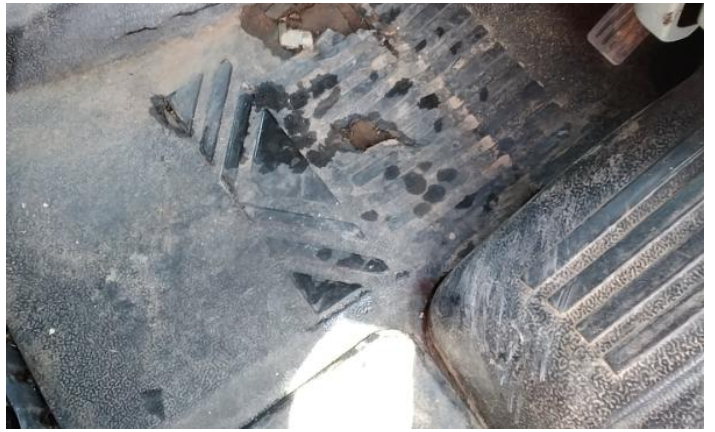
4: Carpets Front
Holed
Over 3mm

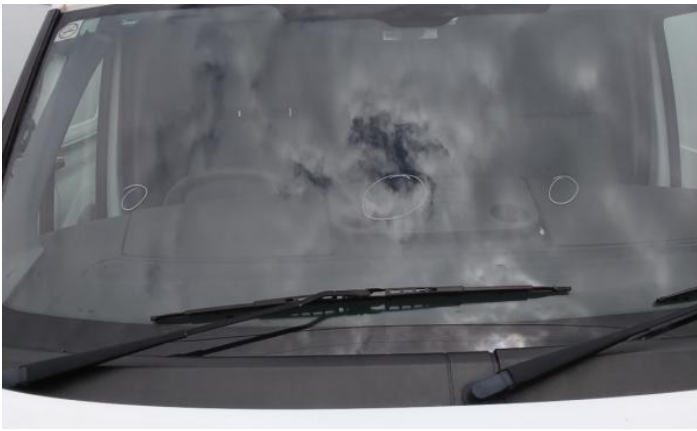
5: Screen Front
Chipped
Over 10mm

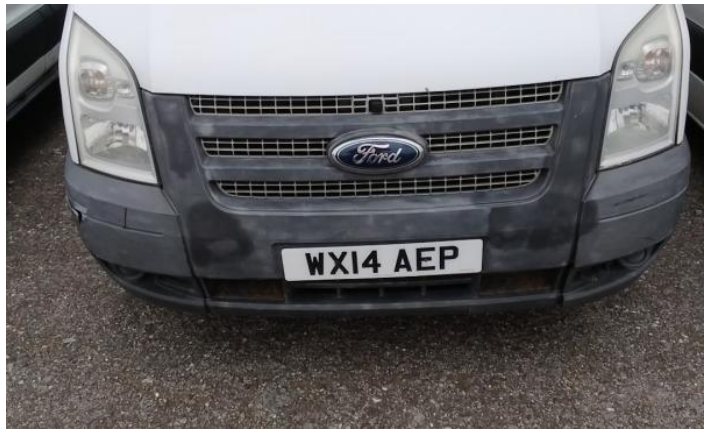
6: Bonnet
Chipped
Multiple Chips

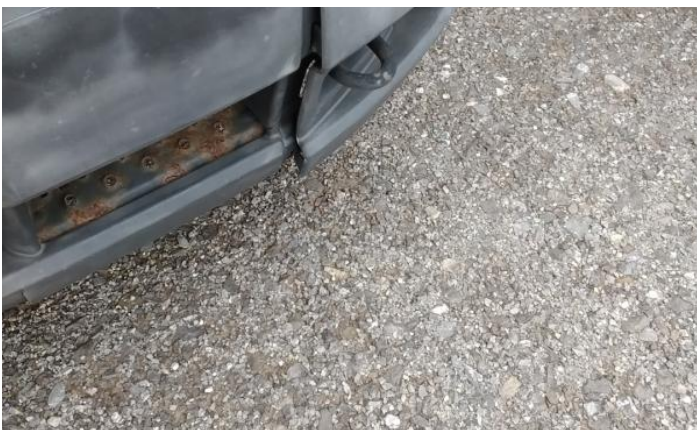
7: Bumper Front
Insecure
Action Required

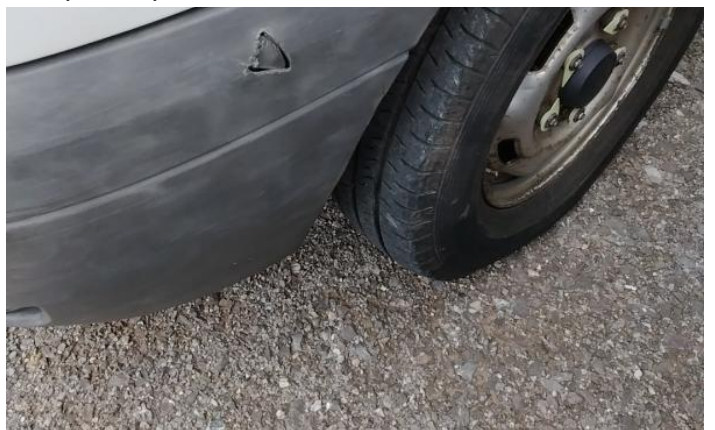
8: Bumper Front
Cracked
Over 25mm

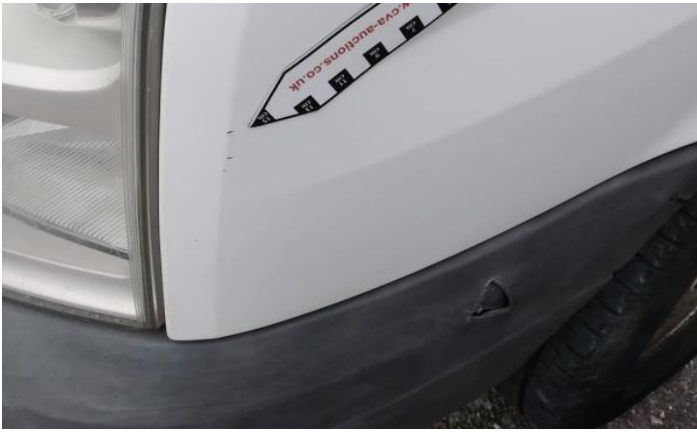
9: Wing nsf
Scratched
Over 25mm Thru Paint

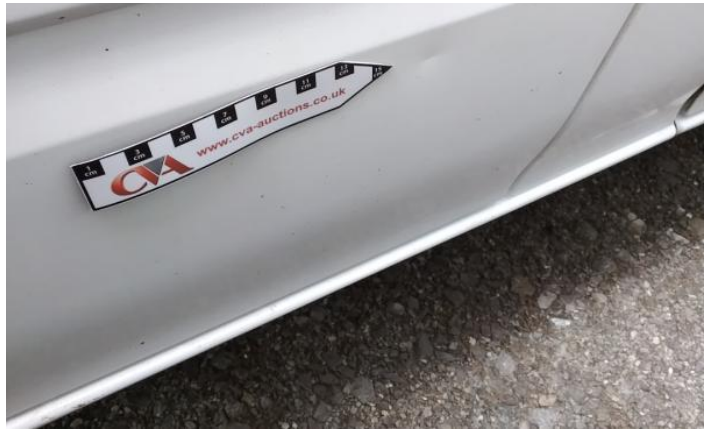
10: Door nsf
Dented
2 Or Less Up To 10mm

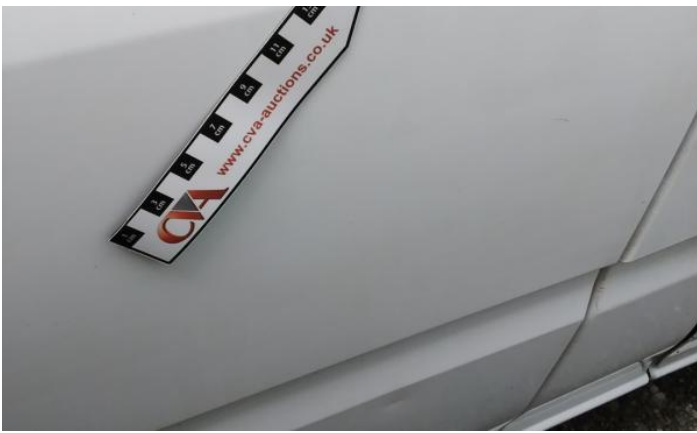
11: Door nsf
Chipped
Multiple Chips

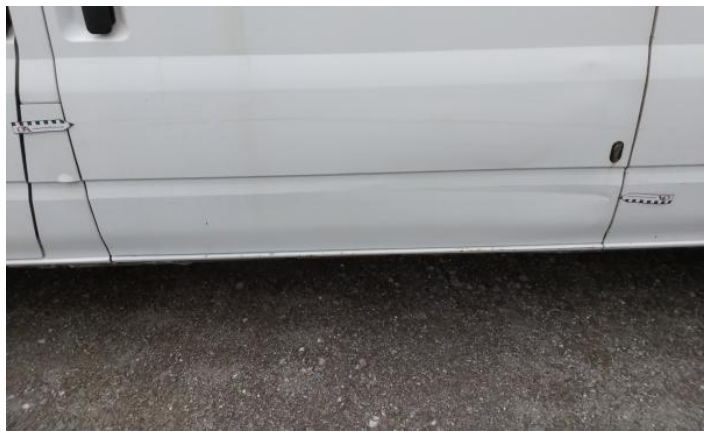
12: Qtr Panel osr
Scratched
Over 25mm Thru Paint

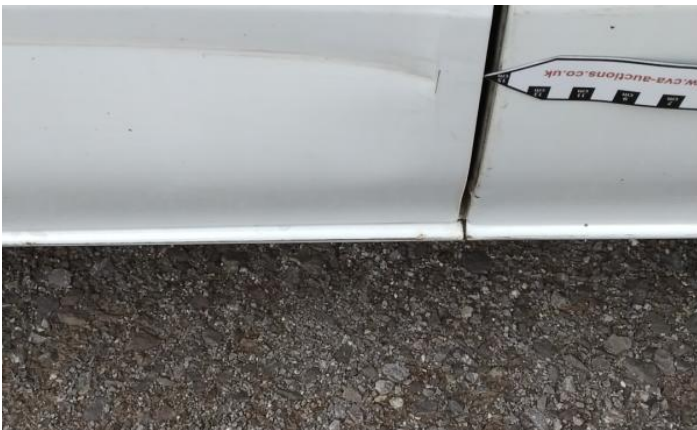
13: Qtr Panel nsr
Dented
With Paint Damage

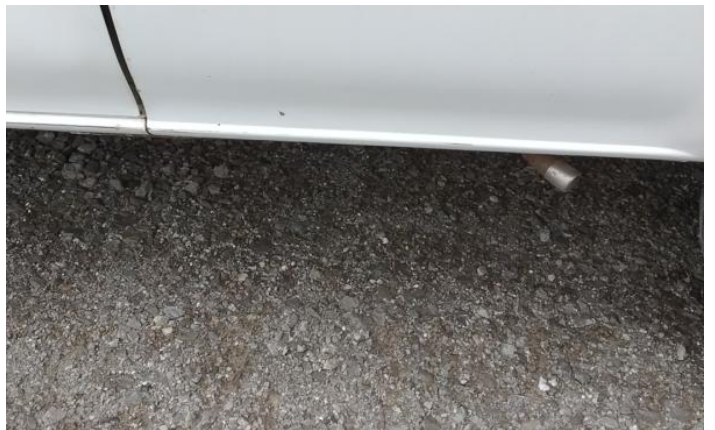
14: Qtr Panel nsr
Scratched
Over 25mm Thru Paint

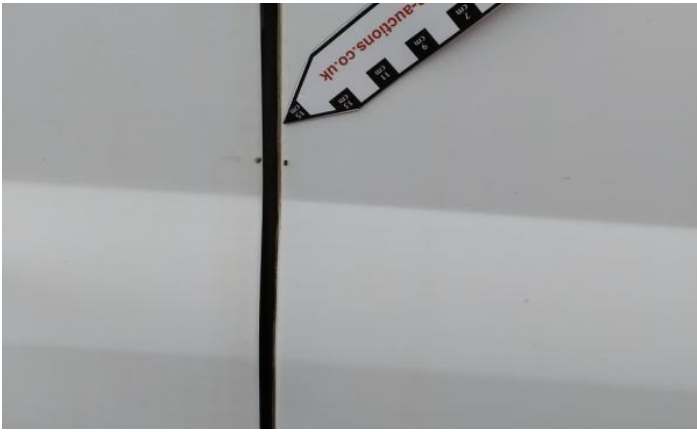
15: Qtr Panel nsr
Scratched
UpTo 25mm Thru Paint

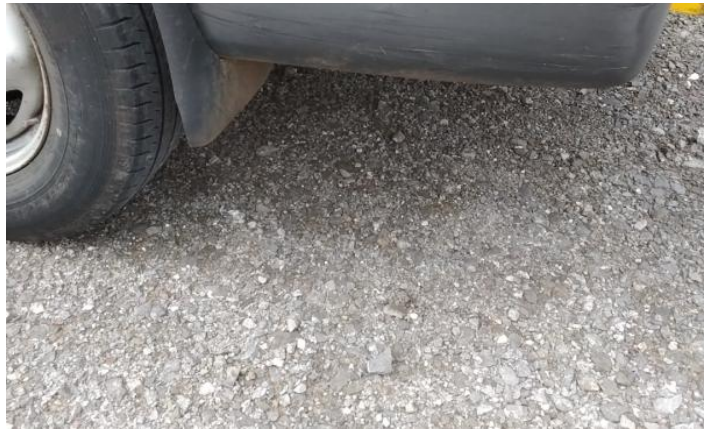
16: Bumper Rear
Scratched
Over 100mm Thru Paint

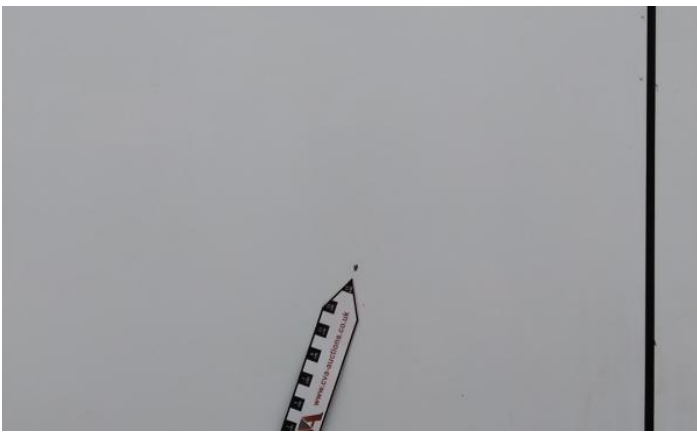
17: Door nsr
Scratched
UpTo 25mm Thru Paint

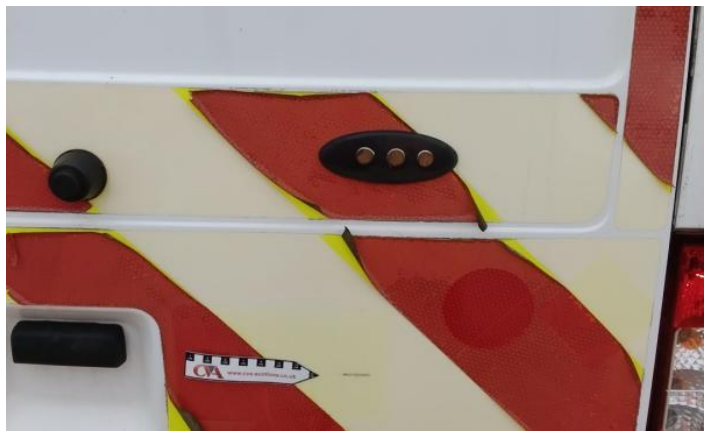
18: Door osr
Dented
With Paint Damage

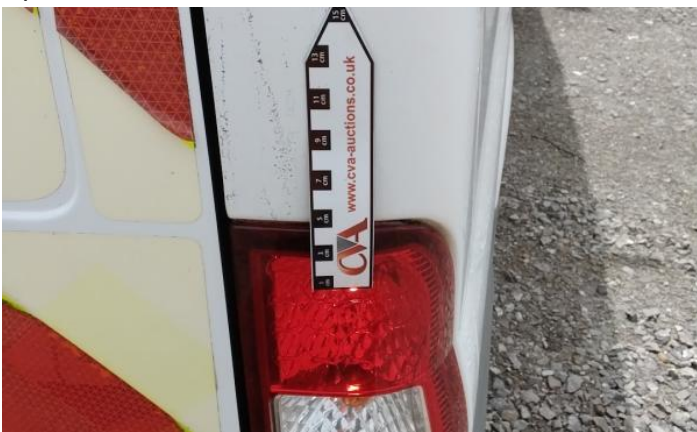
19: Panel Rear
Dented
With Paint Damage

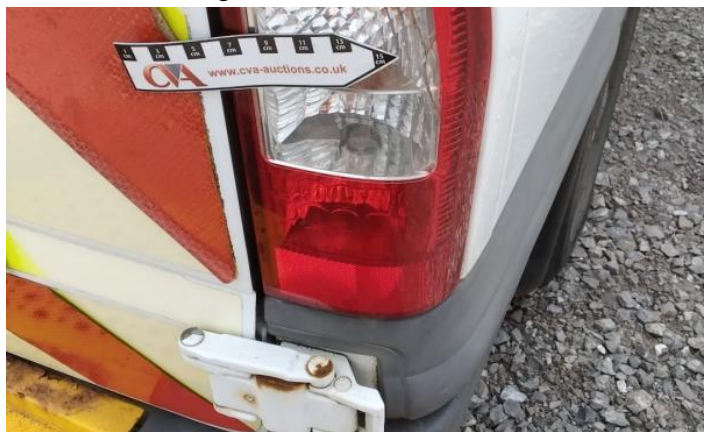
20: Lamp osr
Broken
Replace

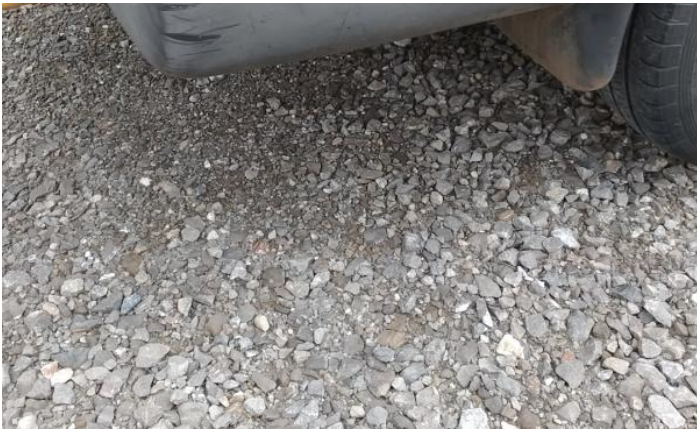
21: Bumper Rear
Scratched
Over 100mm Thru Paint

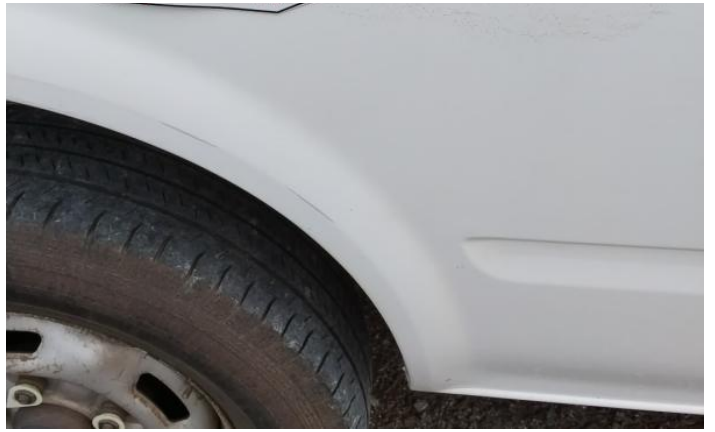
22: Qtr Panel osr
Scratched
Over 25mm Not Thru Paint

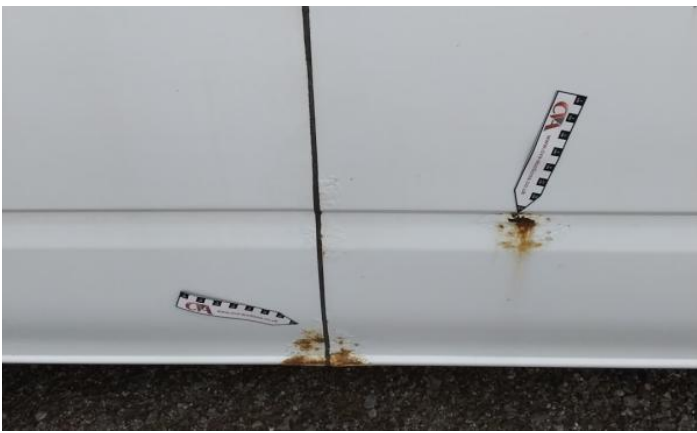
23: Qtr Panel osr
Rusted
Over 5mm

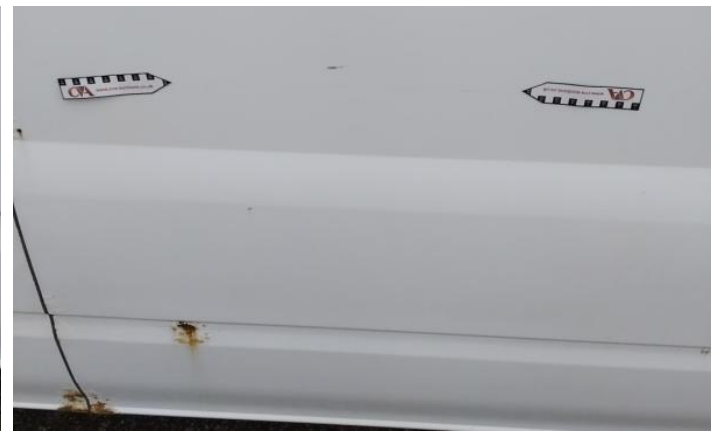
24: Qtr Panel osr
Scratched
Over 25mm Thru Paint

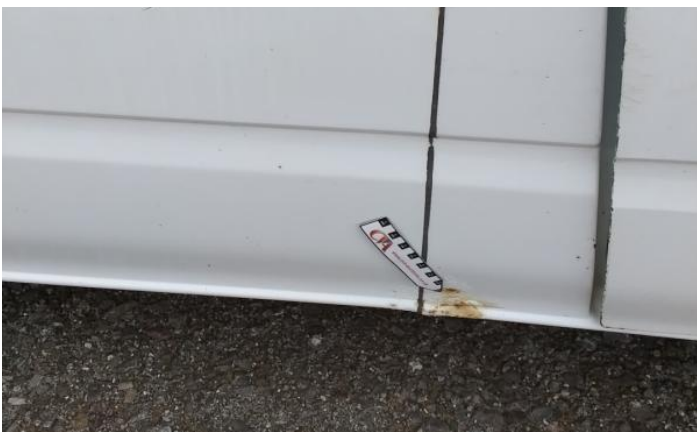
25: Qtr Panel osr
Rusted
Over 5mm

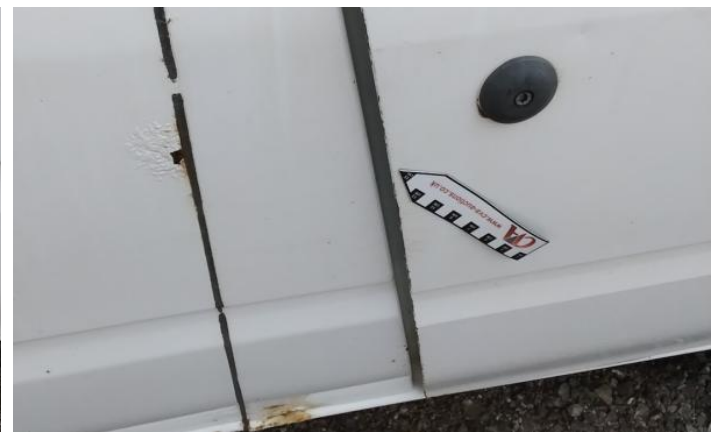
26: Door osf
Chipped
Multiple Chips

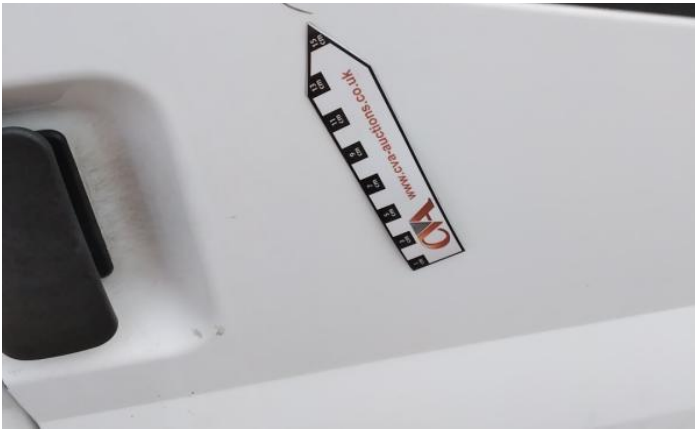
27: Door osf
Scratched
Over 25mm Thru Paint

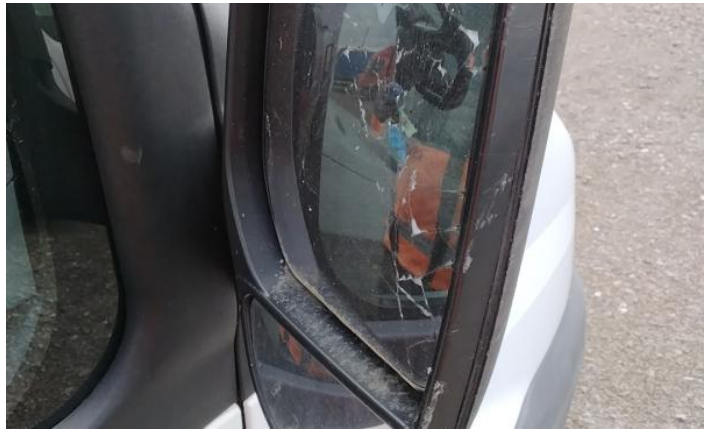
28: Door Mirror Glass os
Broken
Replace

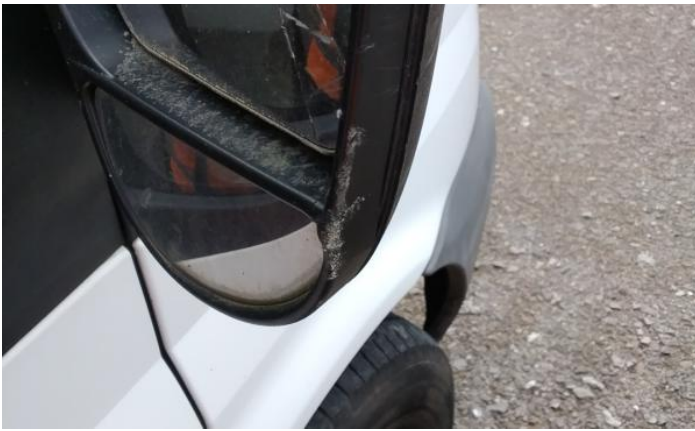
29: Door Mirror Assy osf
Broken
Replace

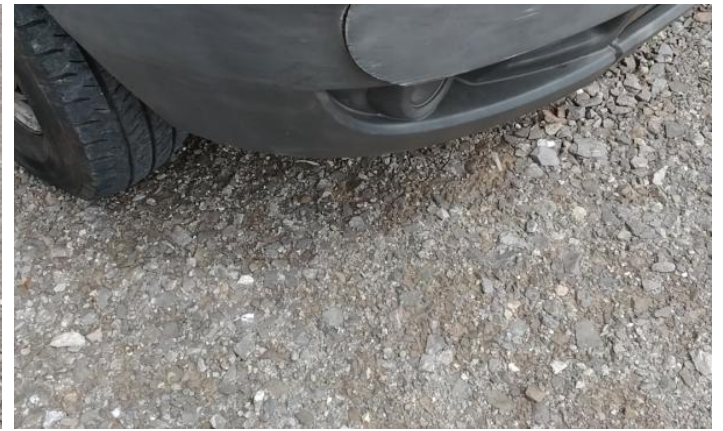
30: Bumper Front
Cracked
Over 25mm

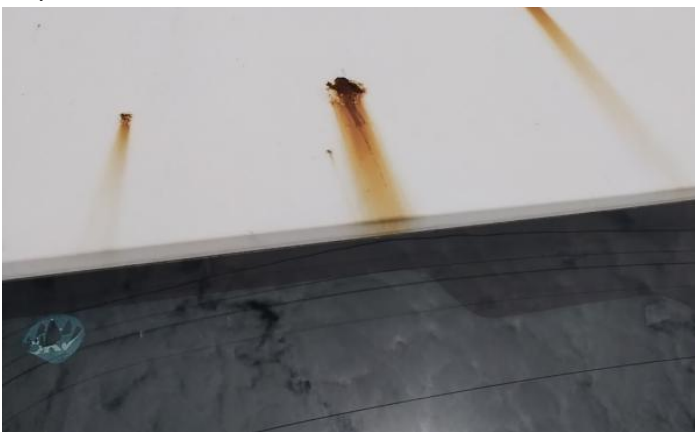
31: Roof
Rusted
Over 5mm
