VEHICLE INSPECTION REPORT

WX17GPZ

Isuzu D-Max 2.5TD Extended Cab 4x4

Non Runner

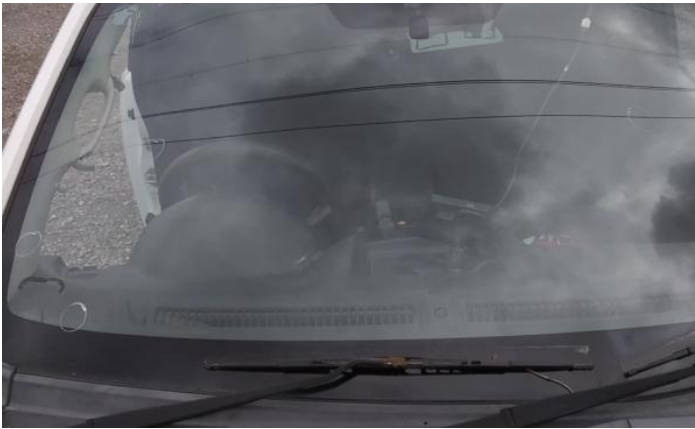
1: Screen Front
Chipped
Over 10mm

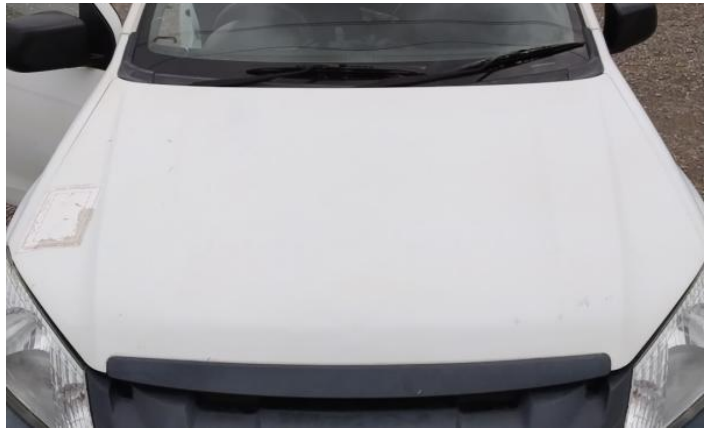
2: Bonnet
Chipped
Multiple Chips

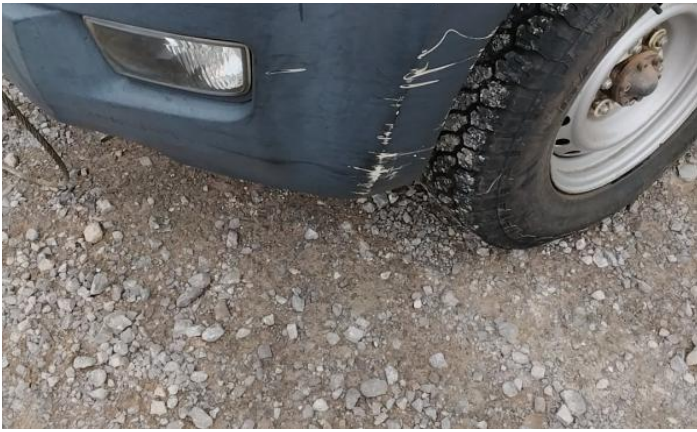
3: Bumper Front
Scratched
Over 100mm Thru Paint

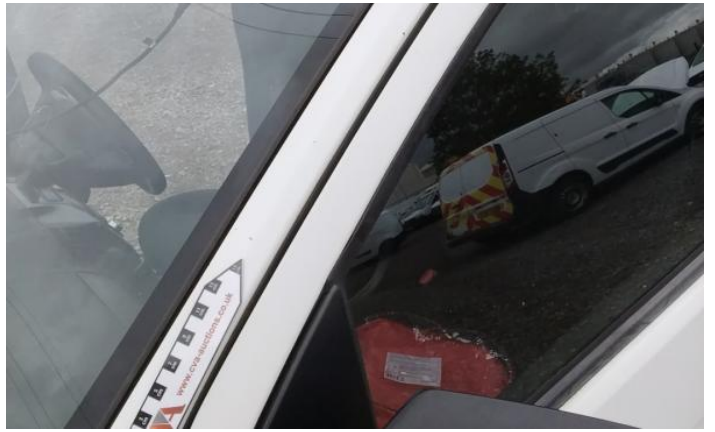
4: A Post ns
Rusted
UpTo 5mm

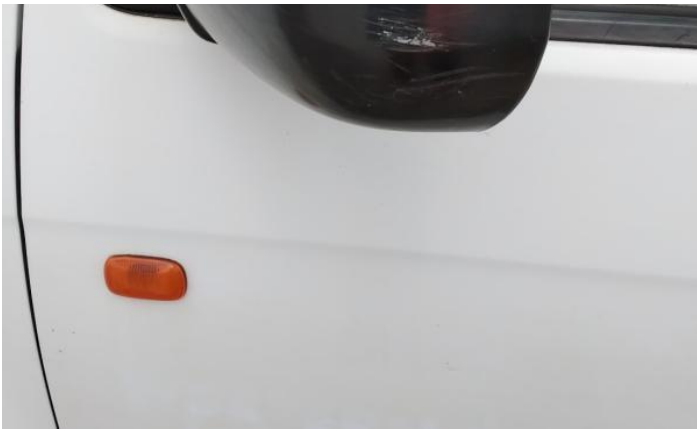
5: Door nsf
Scratched
Over 25mm Thru Paint

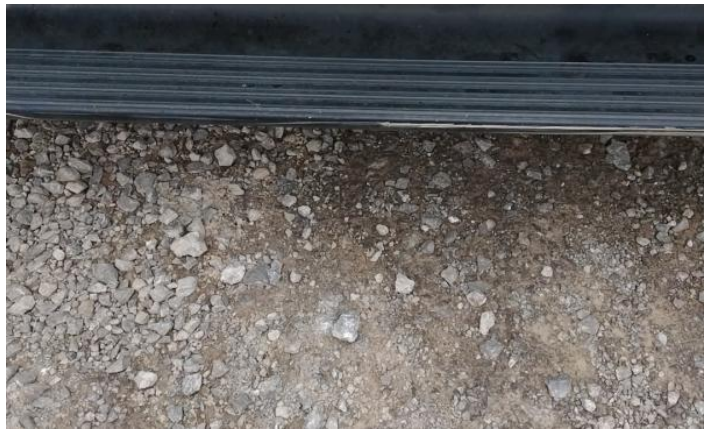
6: Sill ns
Dented
With Paint Damage

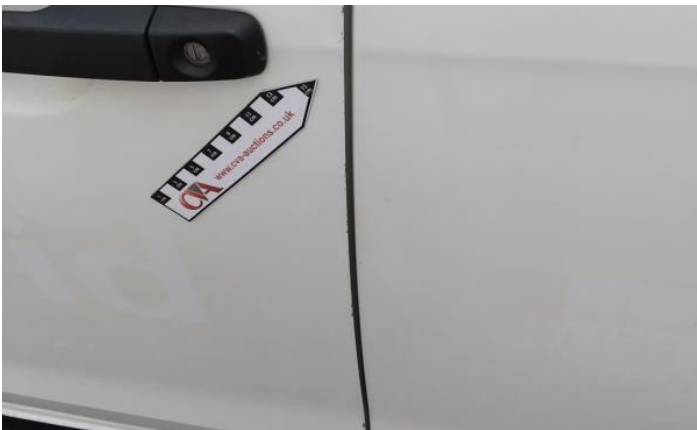
7: Door nsf
Chipped
Multiple Chips

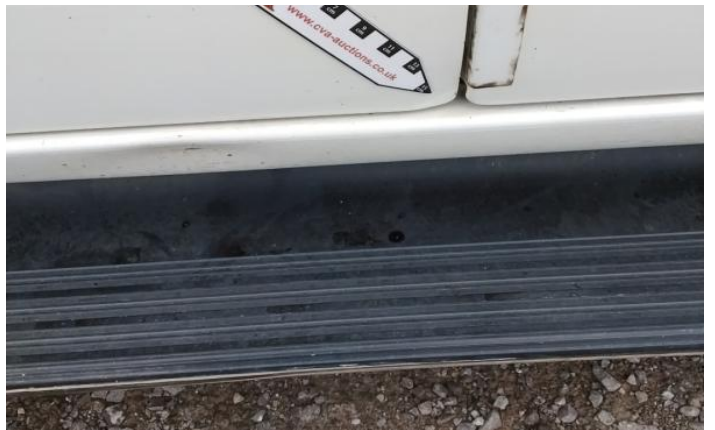
8: Door nsf
Dented
Between 10mm + 30mm

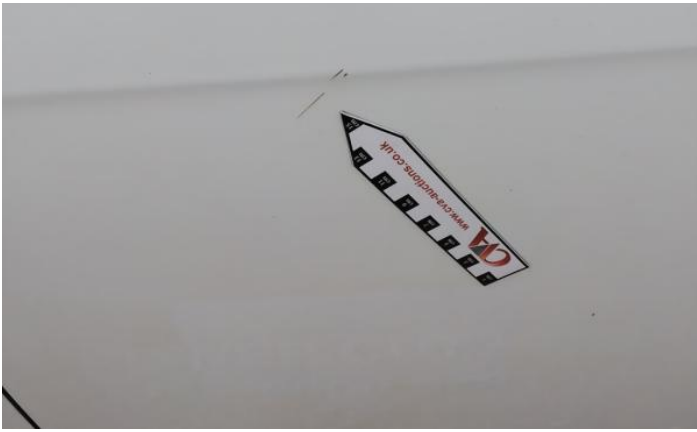
9: Qtr Panel nsr
Scratched
Over 25mm Thru Paint

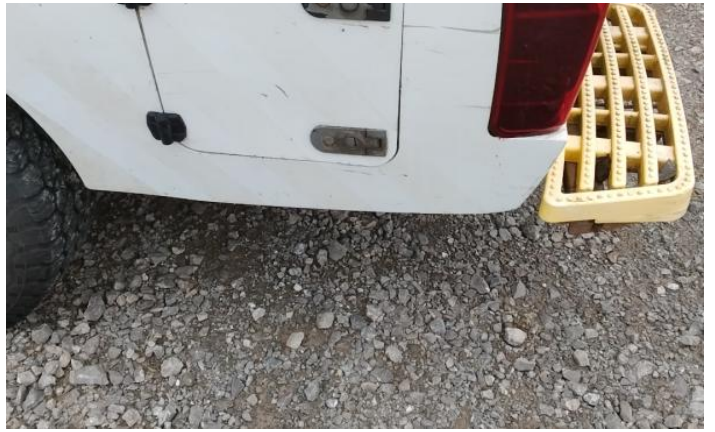
10: Qtr Panel nsr
Scratched
Over 25mm Thru Paint

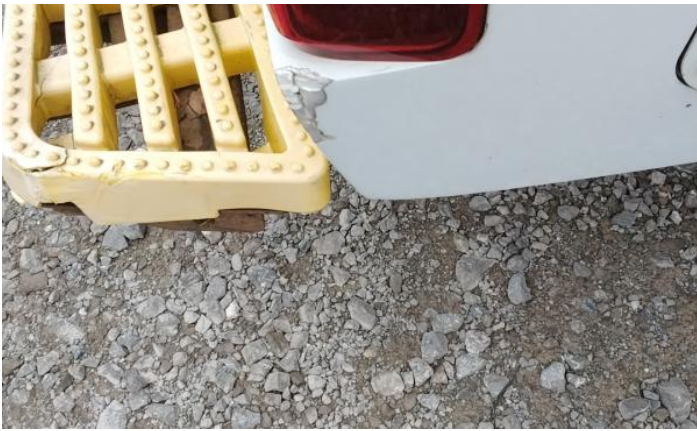
11: Panel Rear
Cracked
Replace

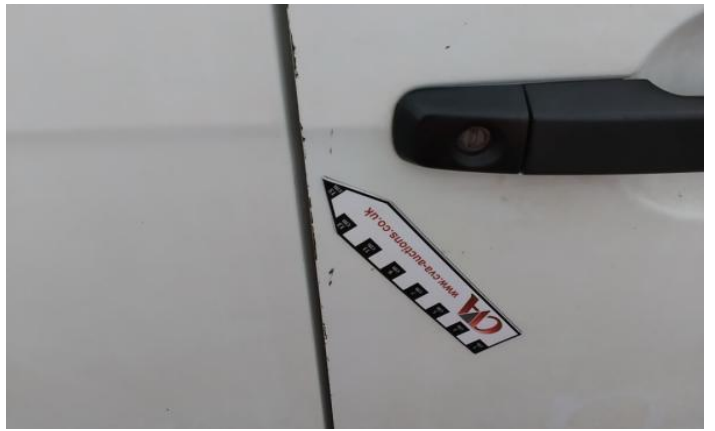
12: Door osf
Chipped
Multiple Chips

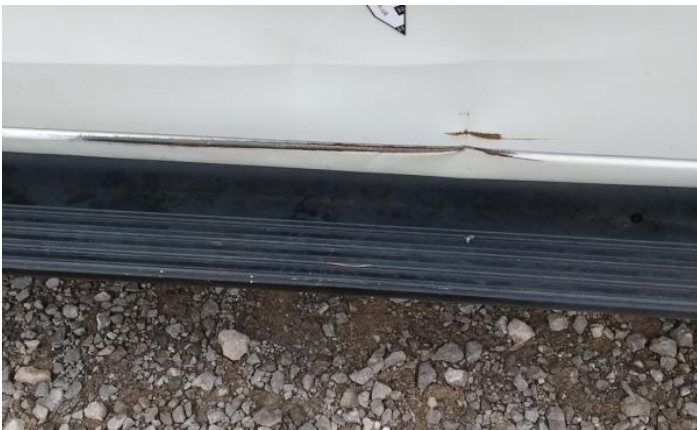
13: Door osf
Dented
Over 30mm

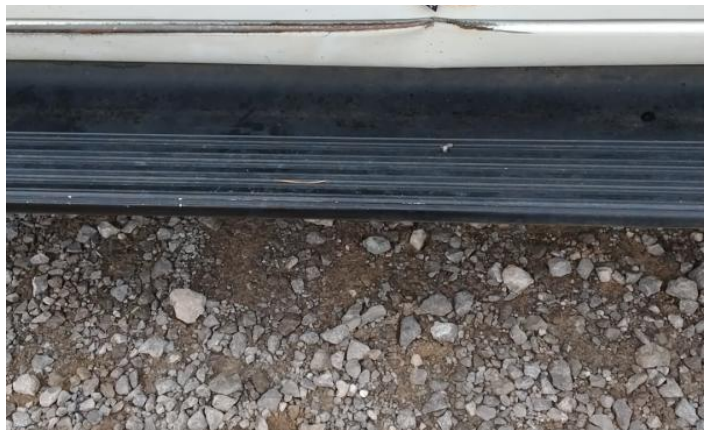
14: Sill os
Dented
With Paint Damage

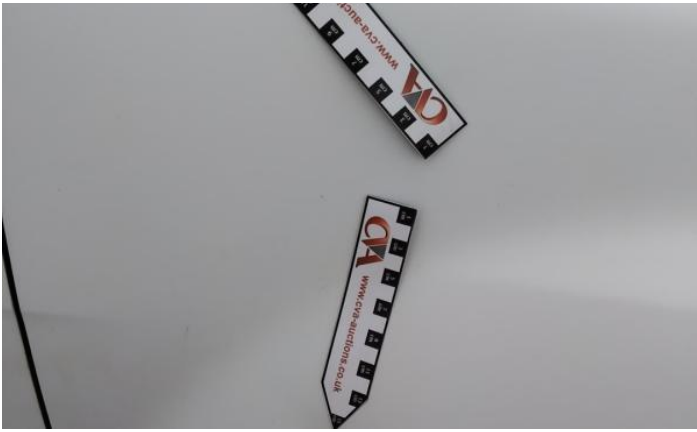
15: Wing of
Dented
With Paint Damage

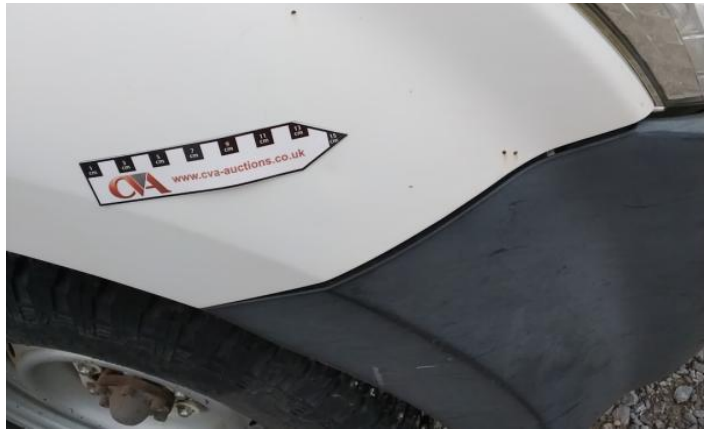
16: Wing of
Rusted
Over 5mm

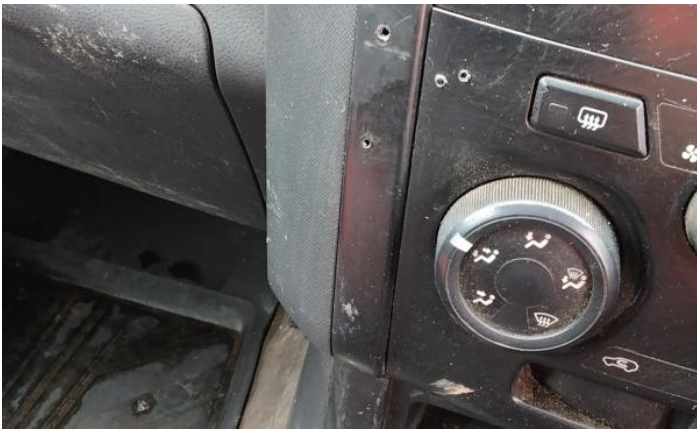
17: Centre Console Front
Holed
Over 3mm
