VEHICLE INSPECTION REPORT

WX17UTC

Isuzu D-Max 2.5TD

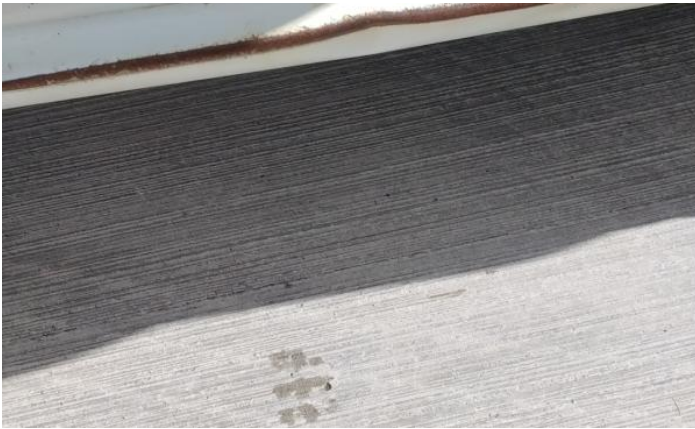
1: Sill os
Dented
Over 30mm

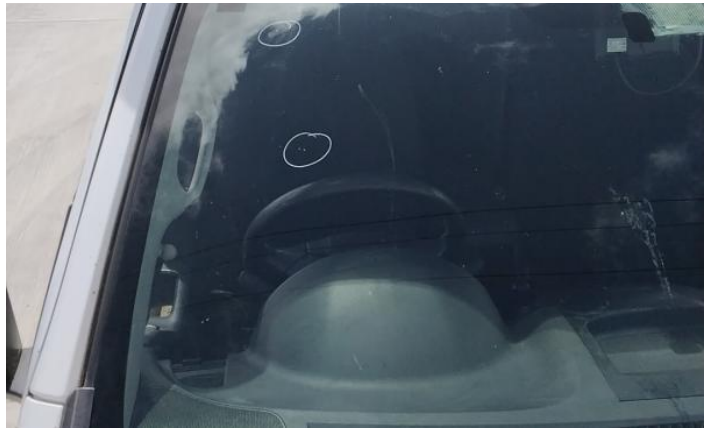
2: Screen Front
Chipped
Over 10mm

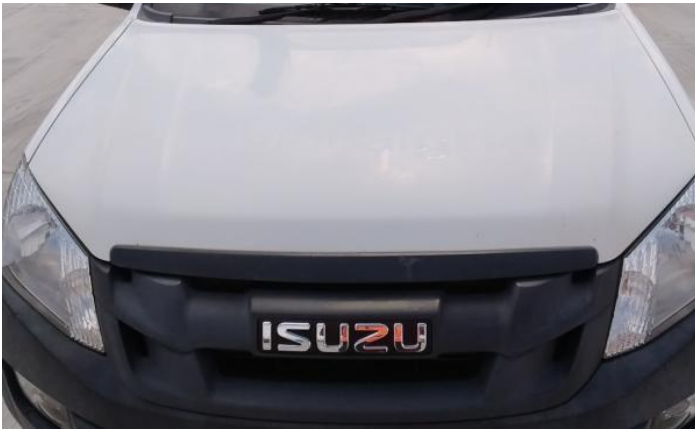
3: Bonnet
Chipped
Multiple Chips

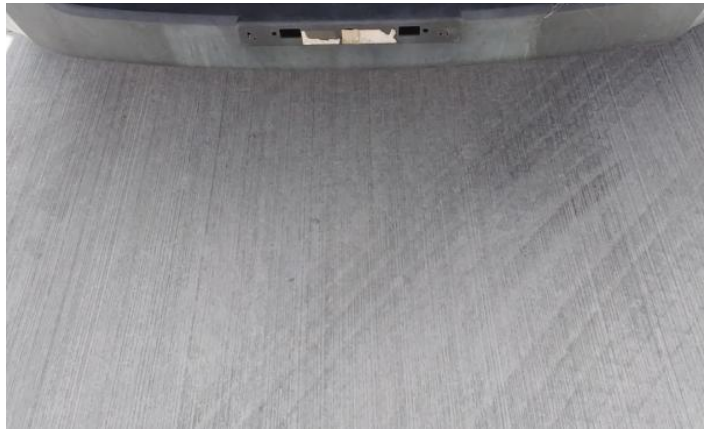
4: Number Plate Front
Missing
Replace

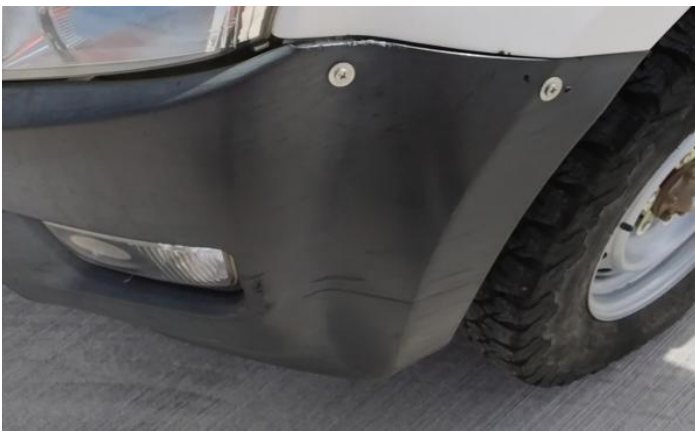
5: Bumper Front
Insecure
Action Required

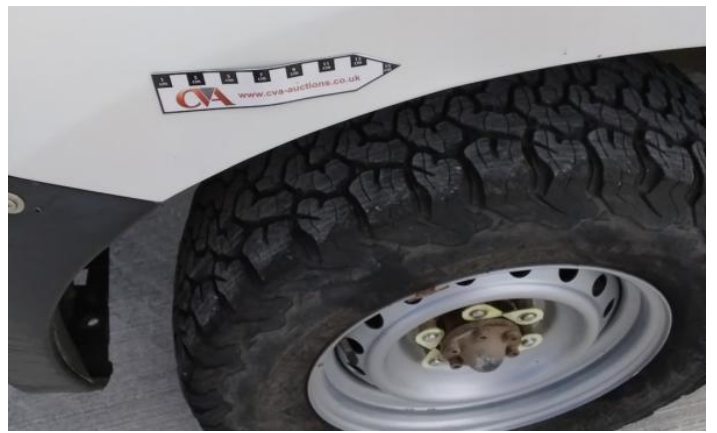
6: Wing nsf
Dented
Over 30mm

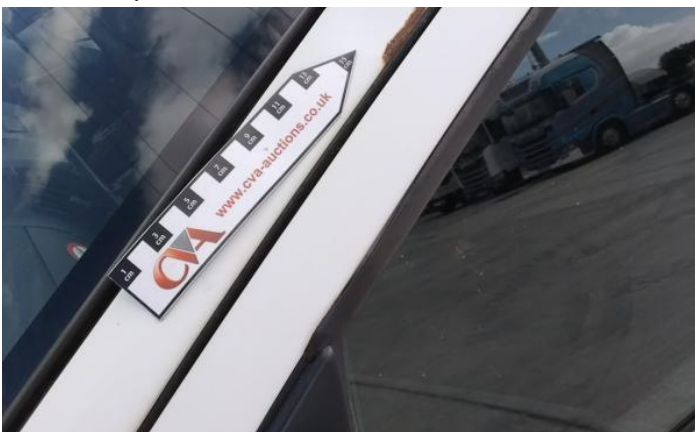
7: A Post ns
Rusted
Over 5mm

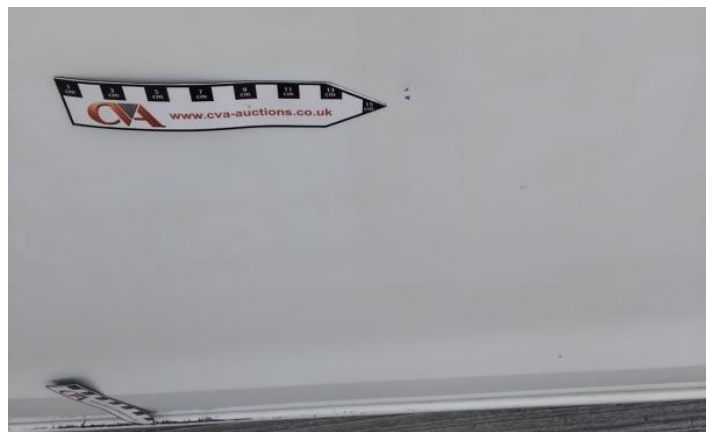
8: Door nsf
Scratched
Up To 25mm Thru Paint

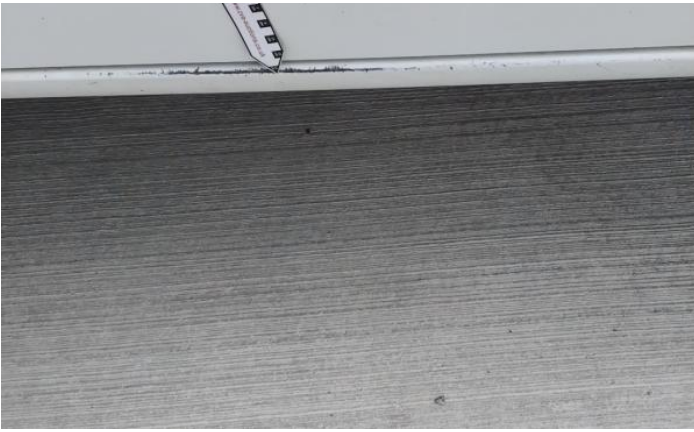
9: Sill ns
Scratched
Over 25mm Thru Paint

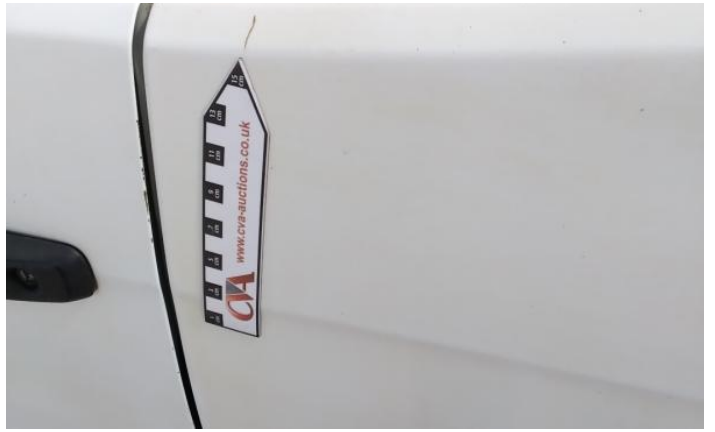
10: Qtr Panel nsr
Scratched
Rusted

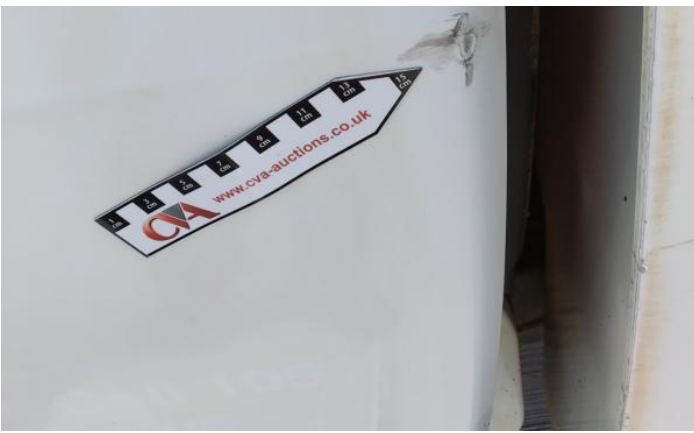
11: Qtr Panel nsr
Dented
With Paint Damage

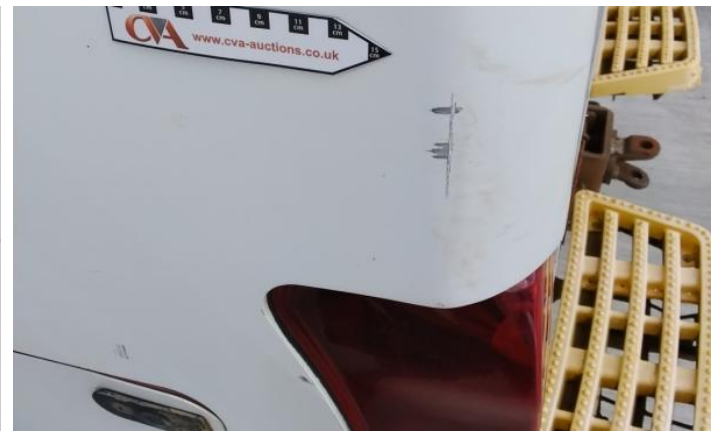
12: Qtr Panel nsr
Scratched
Over 25mm Thru Paint

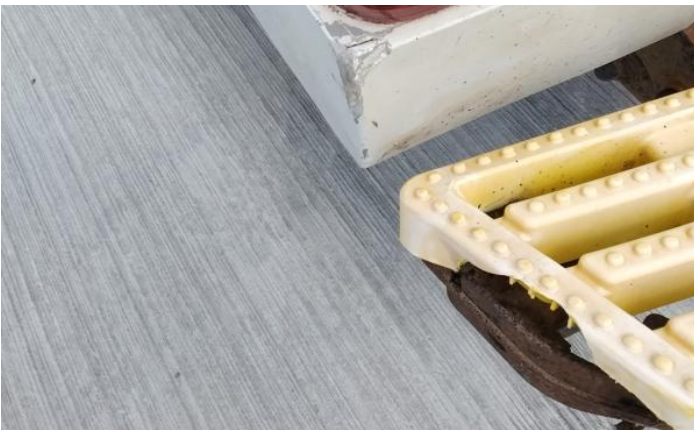
13: Panel Rear
Cracked
Replace

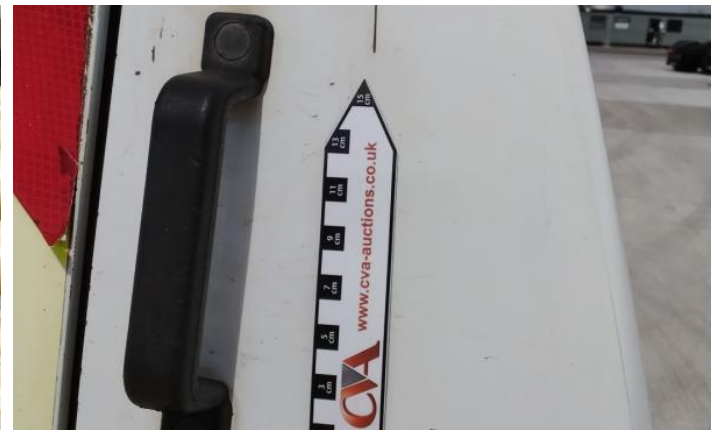
14: Panel Rear
Scratched
Over 25mm Thru Paint

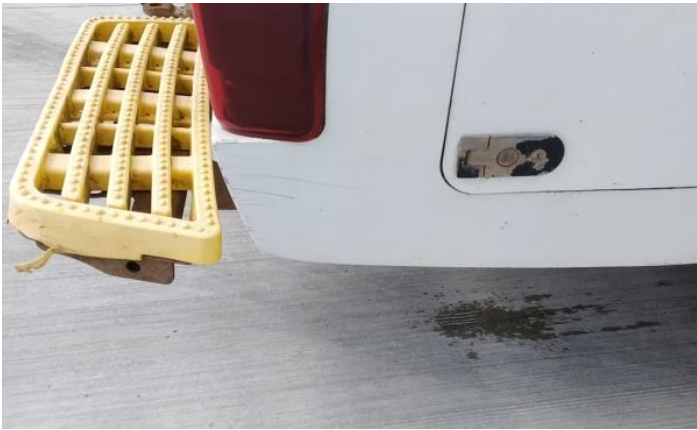
15: Qtr Panel osr
Scratched
Over 25mm Thru Paint

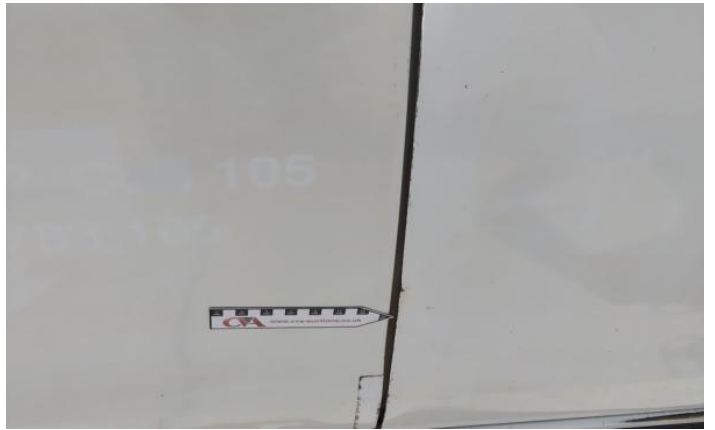
16: Door osf
Dented
With Paint Damage

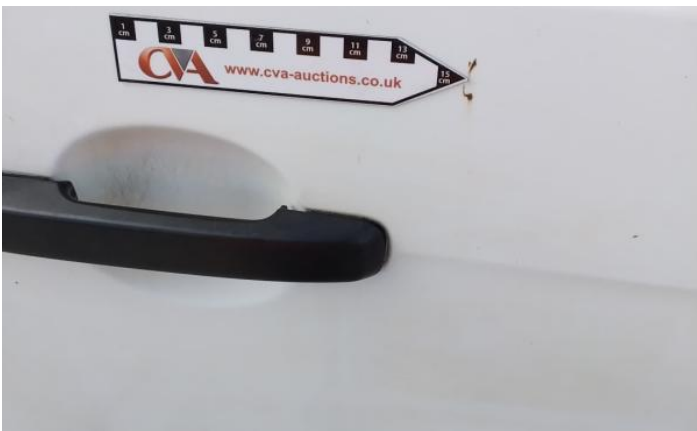
17: Door osf
Scratched
Rusted

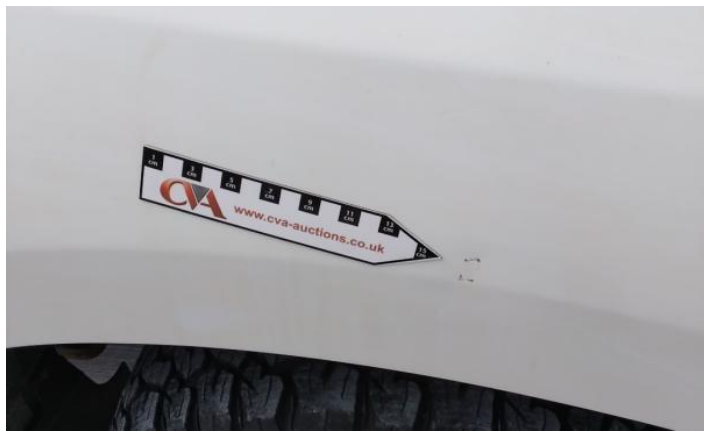
18: Wing osf
Dented
With Paint Damage

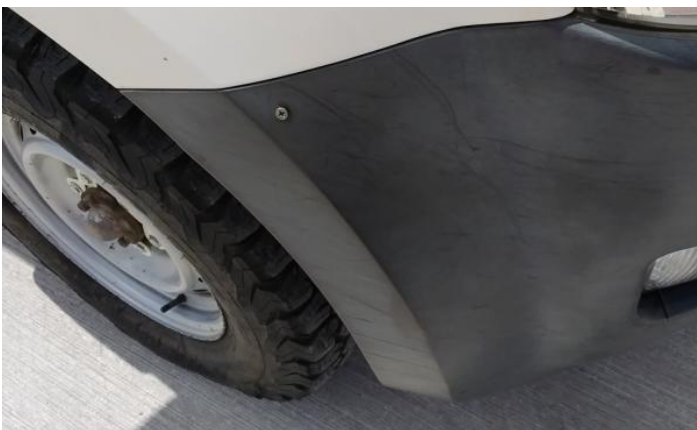
19: Bumper Front
Insecure
Action Required

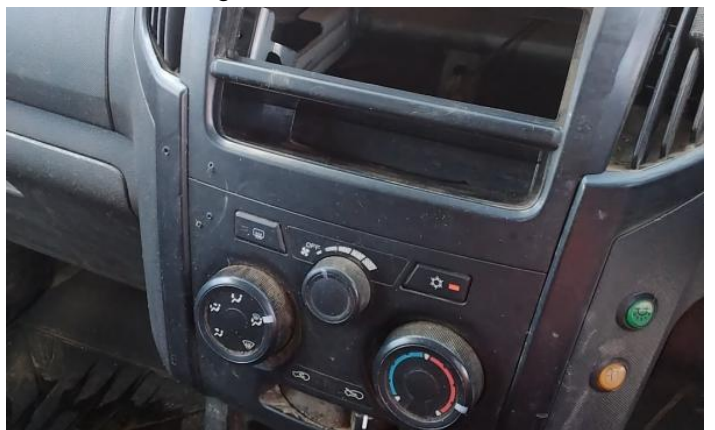
20: In Car Entertainment
Missing
Replace

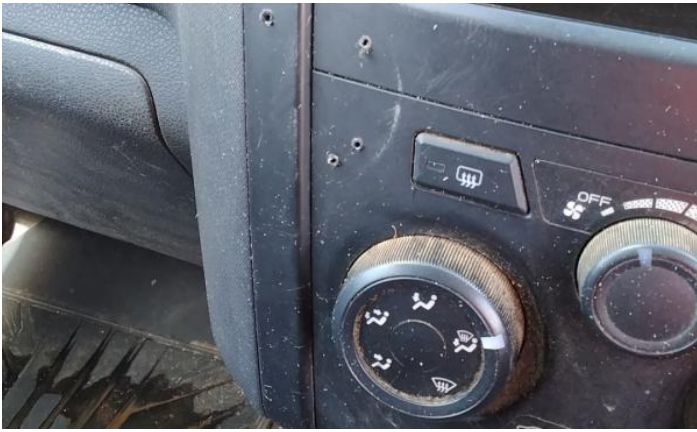
21: Centre Console Front
Holed
Over 3mm

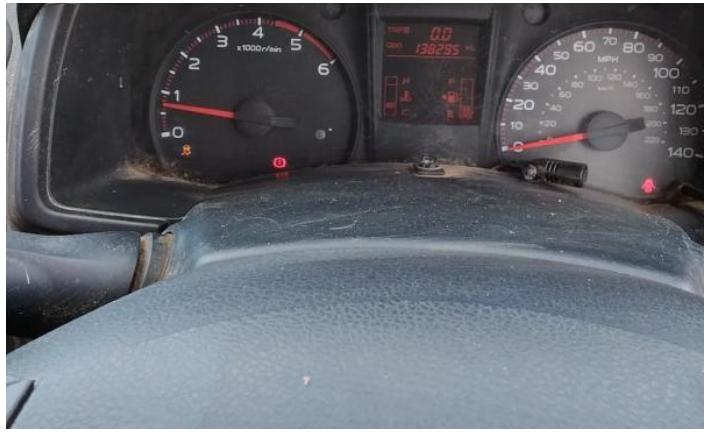
22: Dash Warning Lights
Displayed
No Action

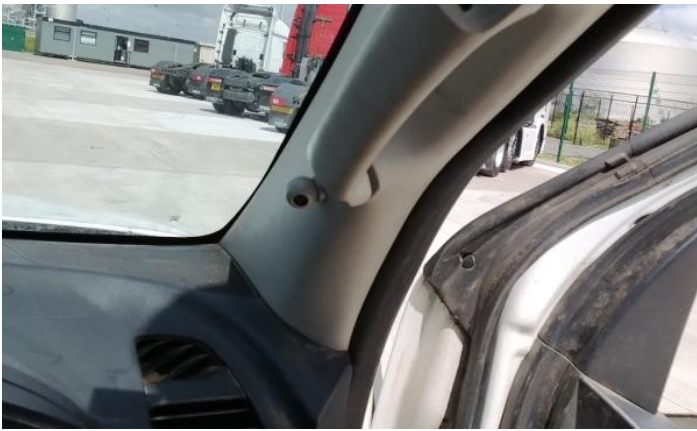
23: Fascia Trim
Missing
Replace
