## VEHICLE INSPECTION REPORT

**CV16XWG**

### Ford Transit 350 2.2 TDCI 155PS

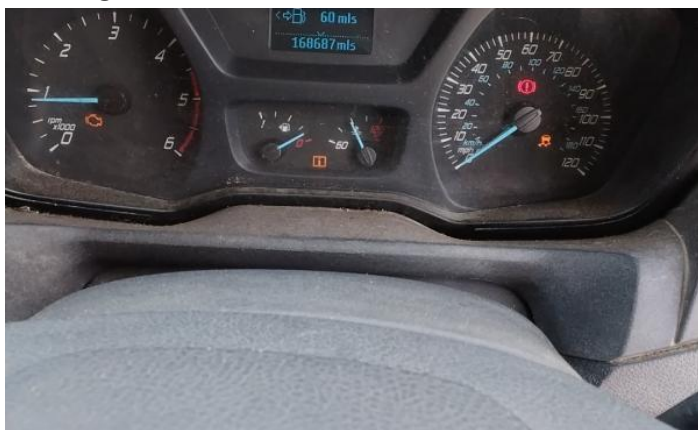
1: Dash Warning Lights  
Displayed  
No Action

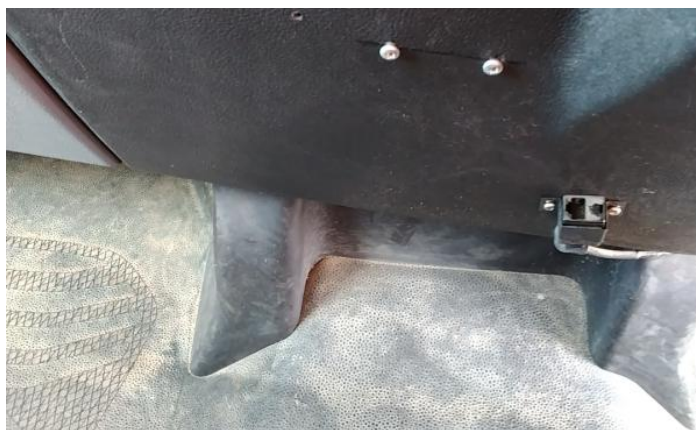
2: Centre Console Front  
Holed  
Over 3mm

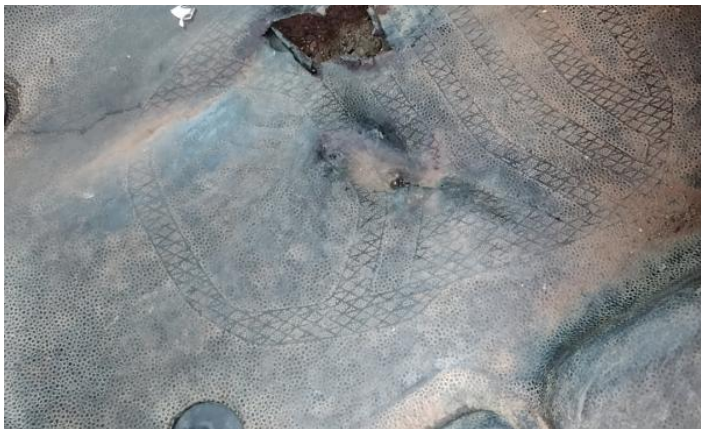
3: Carpets Front  
Holed  
Over 3mm

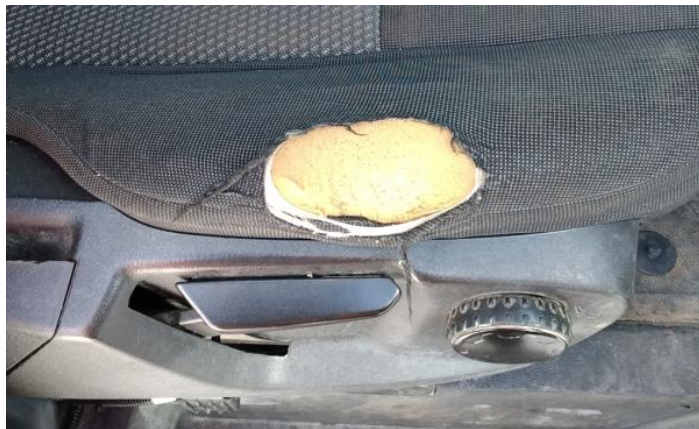
4: Seat Base Cover osf  
Holed  
Over 3mm

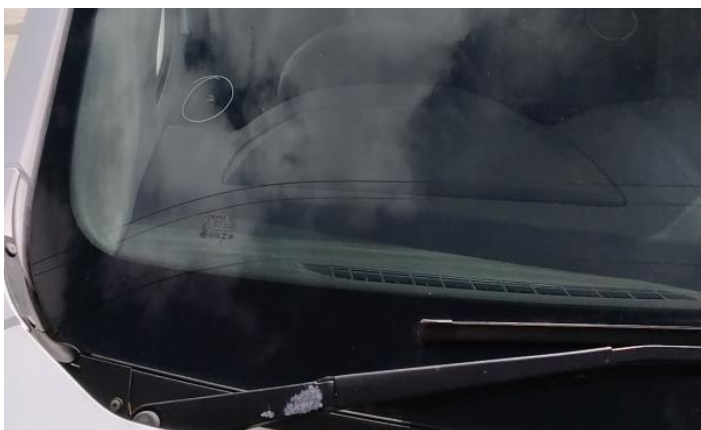
5: Screen Front  
Chipped  
Over 10mm

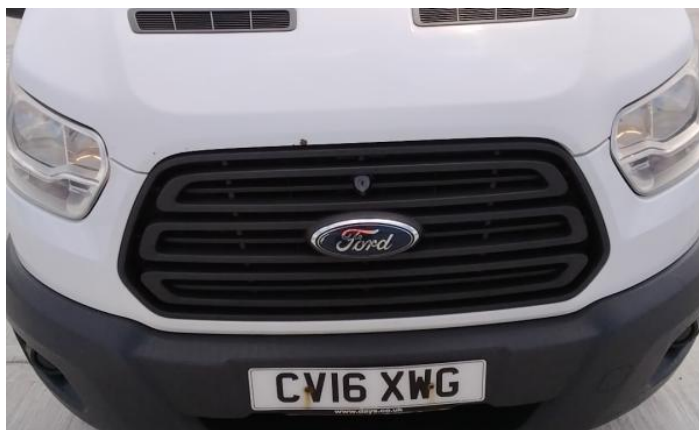
6: Bonnet  
Chipped  
Multiple Chips

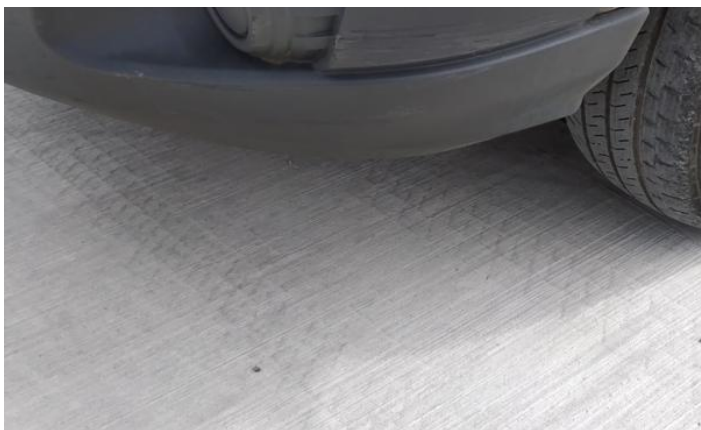
7: Bumper Front  
Scratched  
Over 100mm Thru Paint

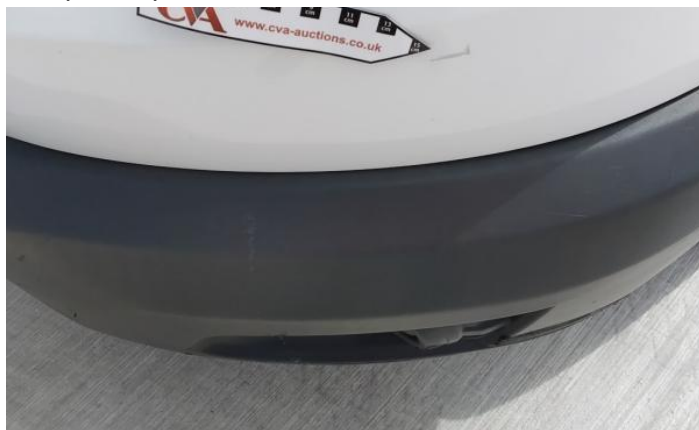
8: Bumper Front Moulding  
Scratched (Painted)  
Over 25mm Thru Paint

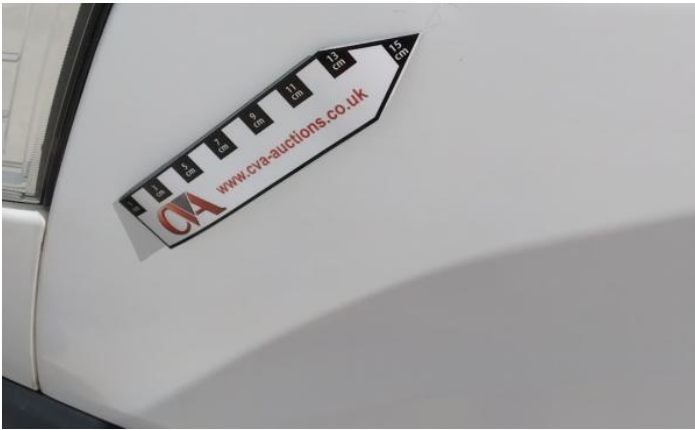
9: Wing nsf  
Scratched  
Over 25mm Thru Paint

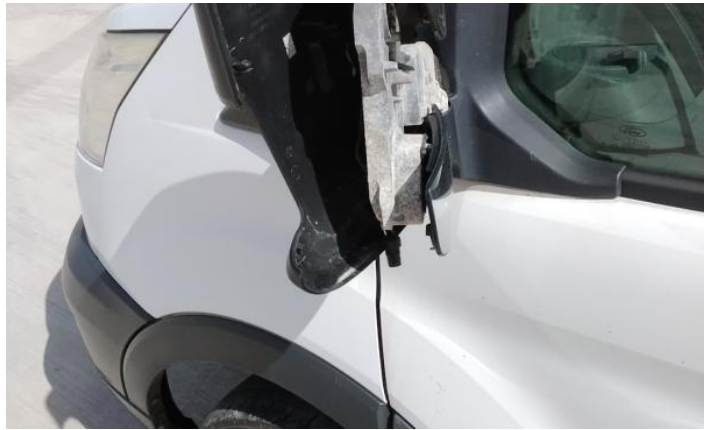
10: Door Mirror Assy nsf  
Broken  
Replace

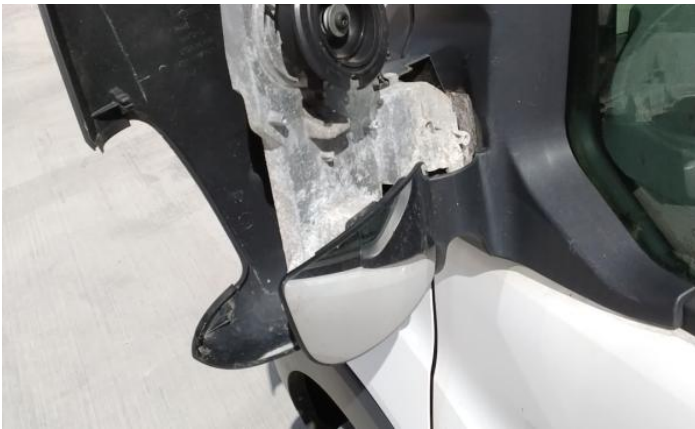
11: Door Mirror Glass ns  
Missing  
Replace

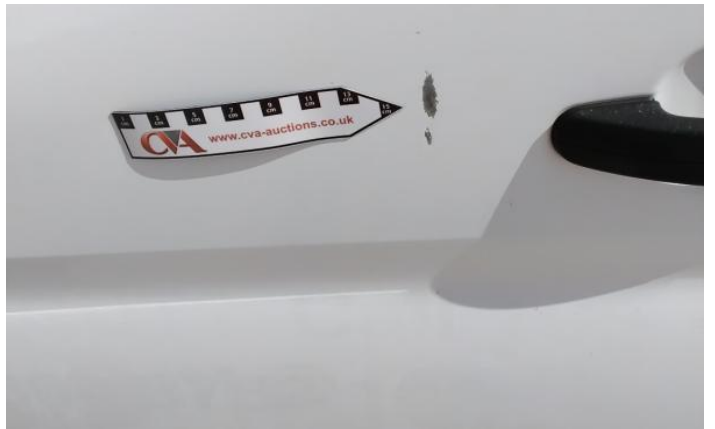
12: Door nsf  
Scratched  
Over 25mm Thru Paint

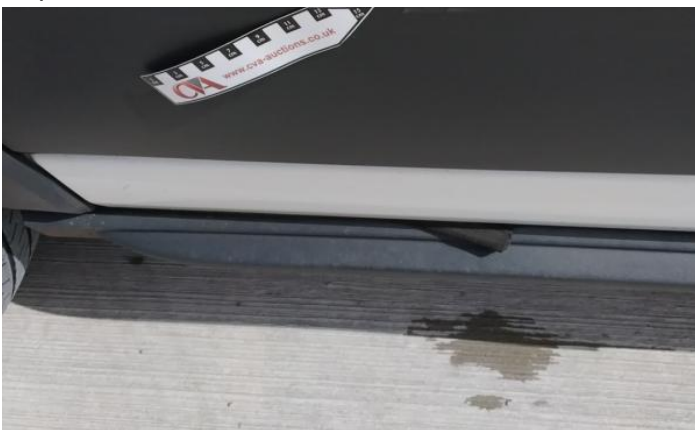
13: Door Moulding nsf  
Scratched (Painted)  
UpTo 25mm Thru Paint

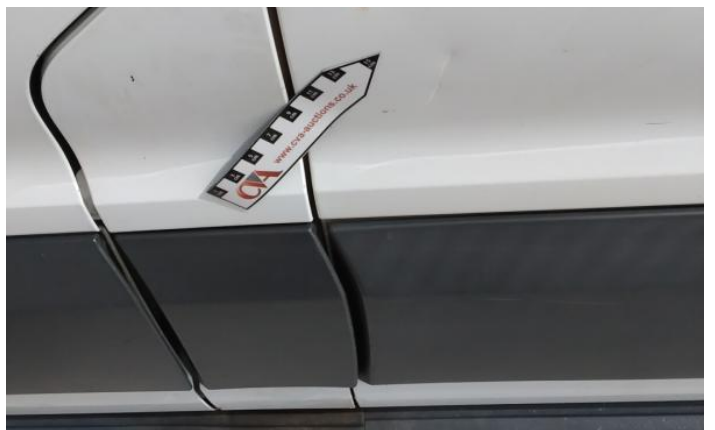
14: Qtr Panel nsr  
Scratched  
Over 25mm Thru Paint

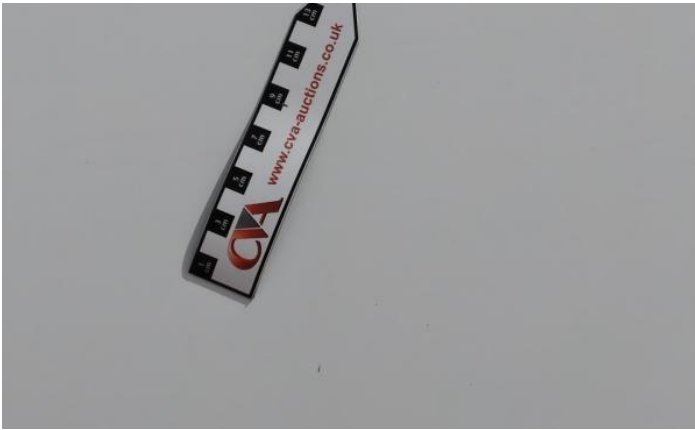
15: Qtr Panel nsr  
Scratched  
Over 25mm Thru Paint

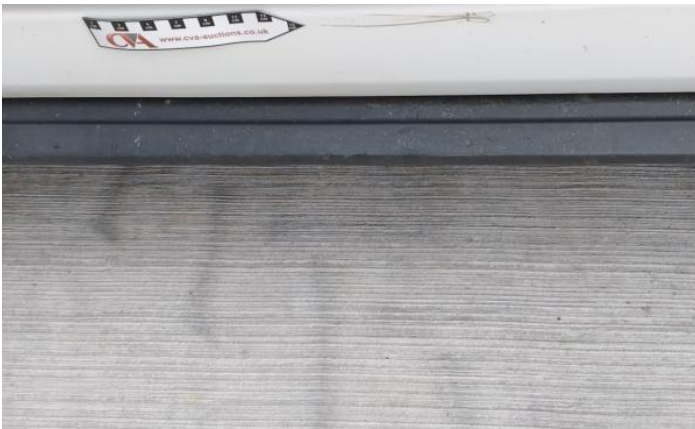
16: Qtr Panel nsr  
Dented  
Over 30mm

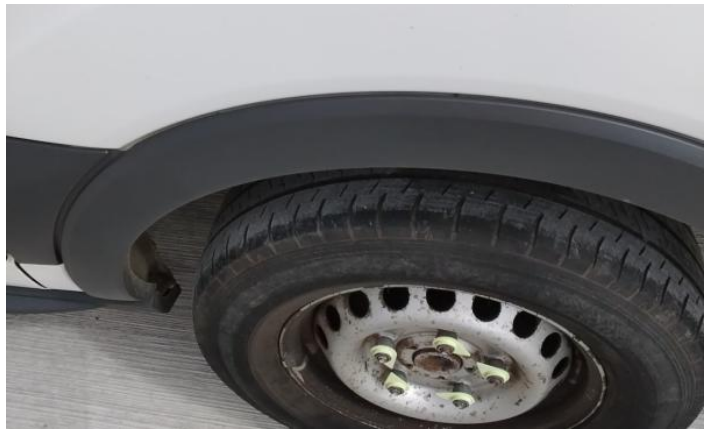
17: Qtr Panel nsr  
Scratched  
Over 25mm Thru Paint

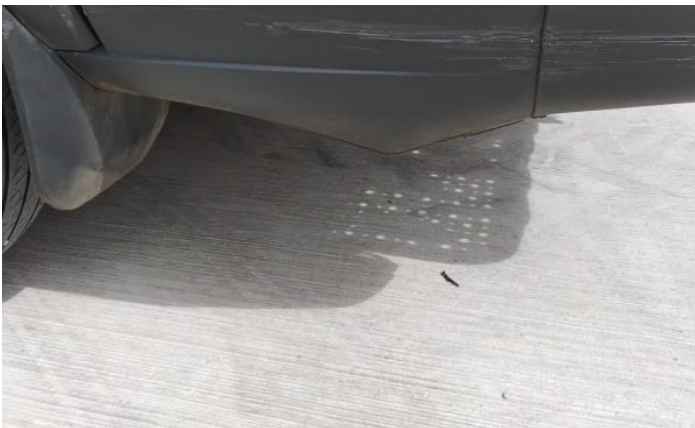
18: Qtr Panel nsr  
Scratched  
Over 25mm Not Thru Paint

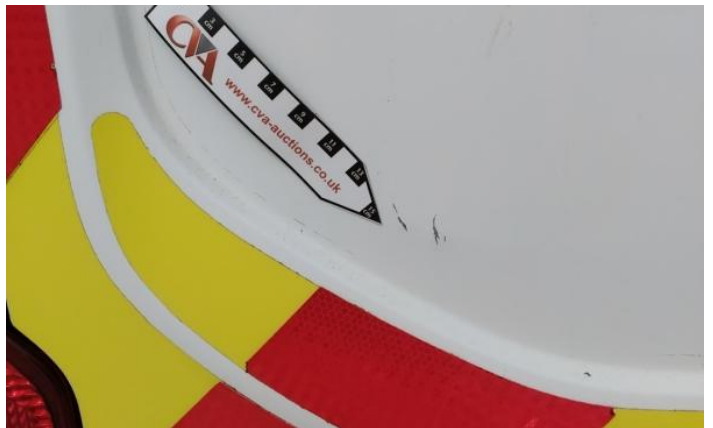
19: Bumper Rear  
Scratched  
Over 100mm Thru Paint

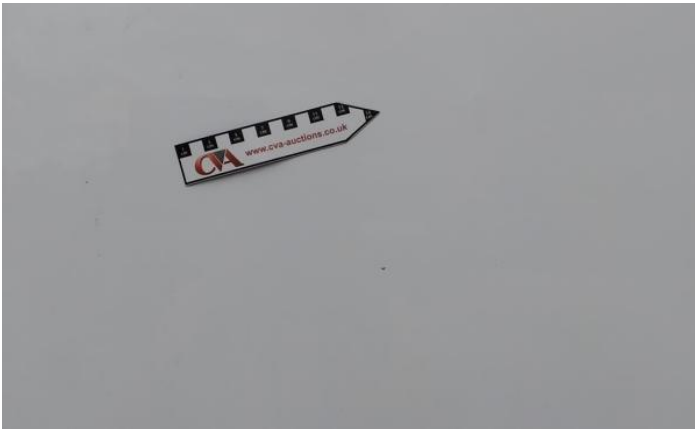
20: Door nsr  
Dented  
With Paint Damage

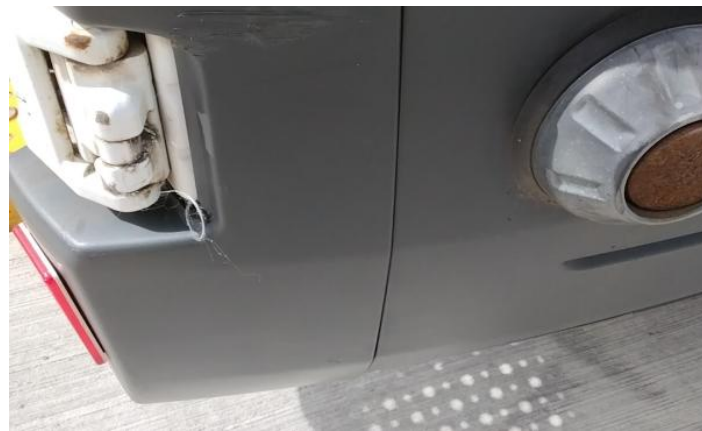
21: Door osr  
Dented  
Between 10mm + 30mm

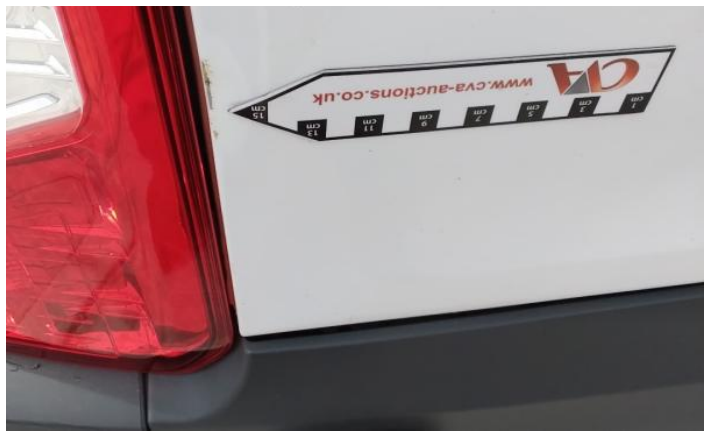
22: Door osr  
Scratched  
UpTo 25mm Thru Paint

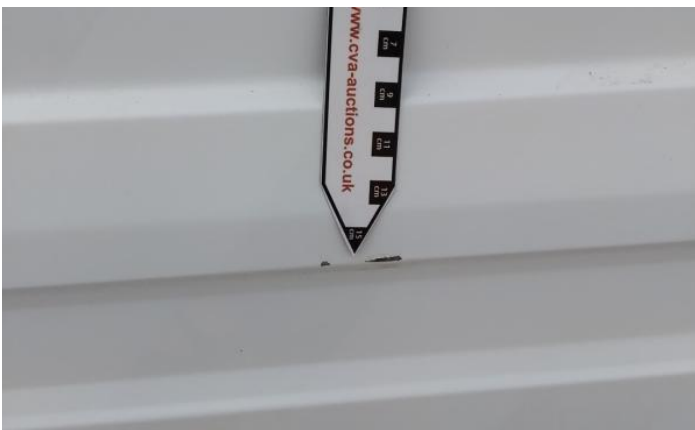
23: Bumper Rear  
Scratched  
25 to 100mm Thru Paint

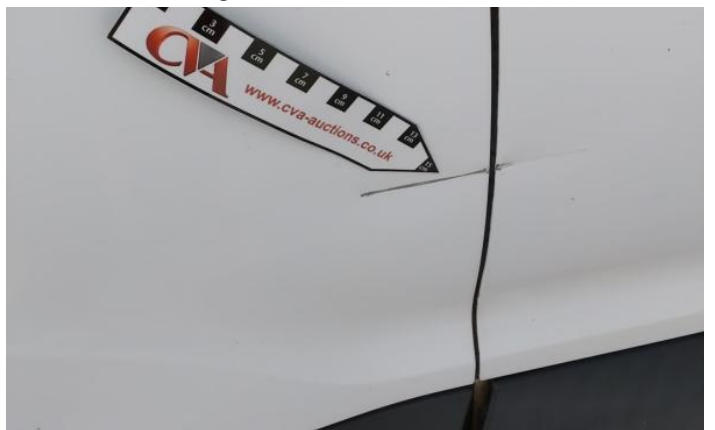
24: Qtr Panel osr  
Dented  
With Paint Damage
