VEHICLE INSPECTION REPORT

KX68BPU

Isuzu D-Max

WARNING LIGHTS ON DASH PALFINGER P 130 PLATFORM (YEAR 2018)

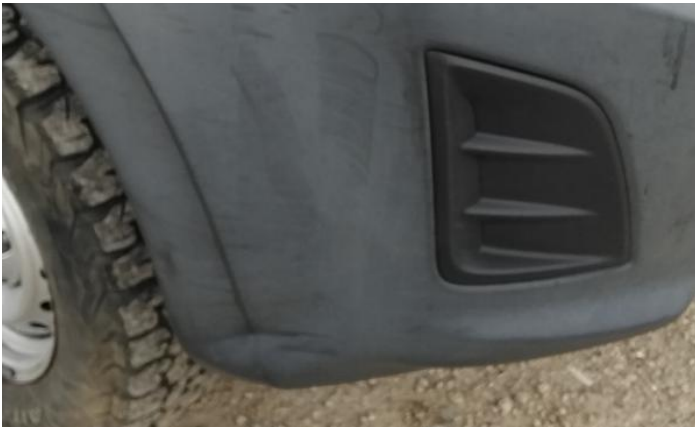
1: Bumper Front
Dented
Over 30mm

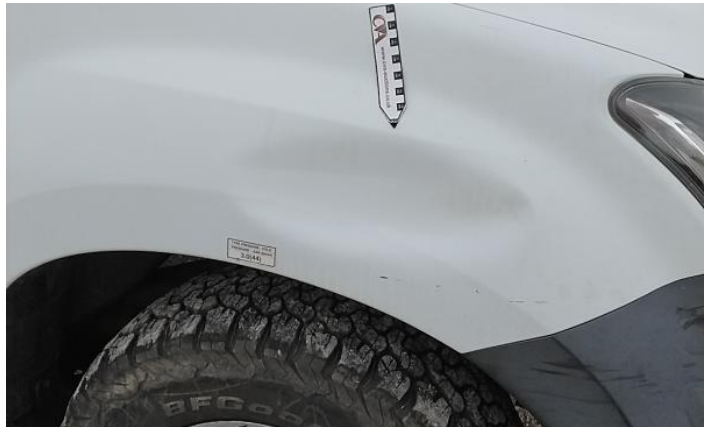
2: Wing of
Dented
Over 30mm

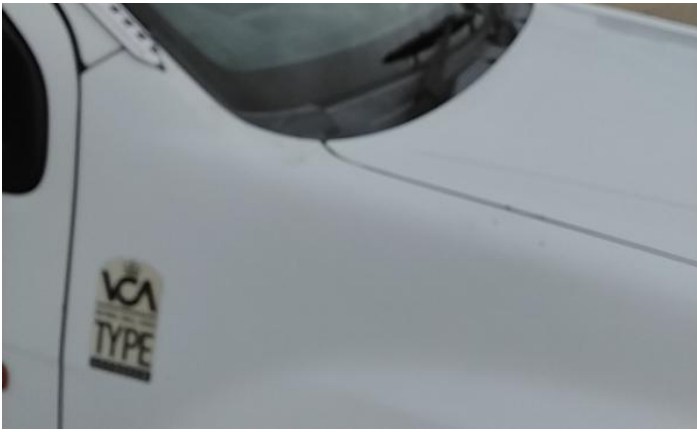
3: Wing osf
Chipped
Multiple Chips

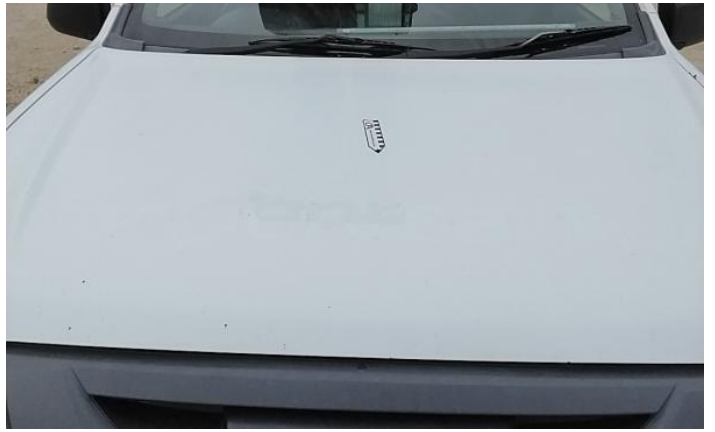
4: Bonnet
Chipped
Multiple Chips

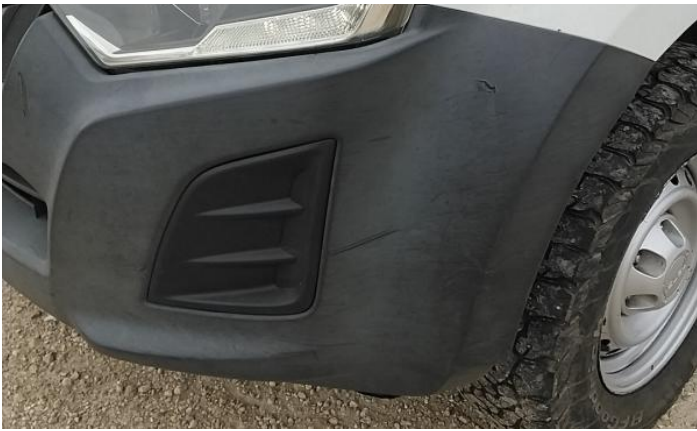
5: Bumper Front Moulding
Scuffed (Unpainted)
Over 100mm

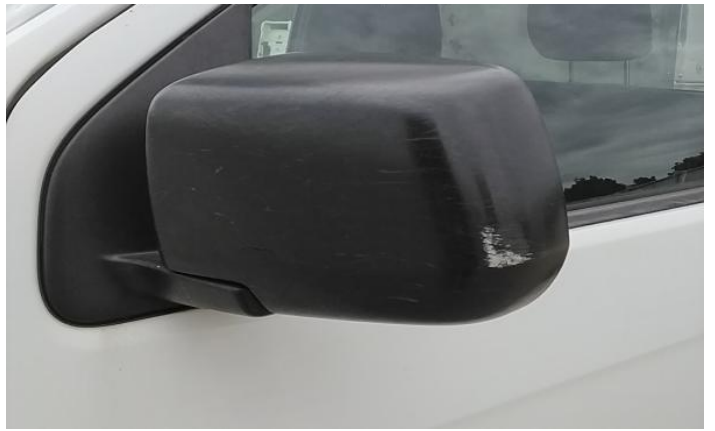
6: Door Mirror Assy nsf
Broken
Replace

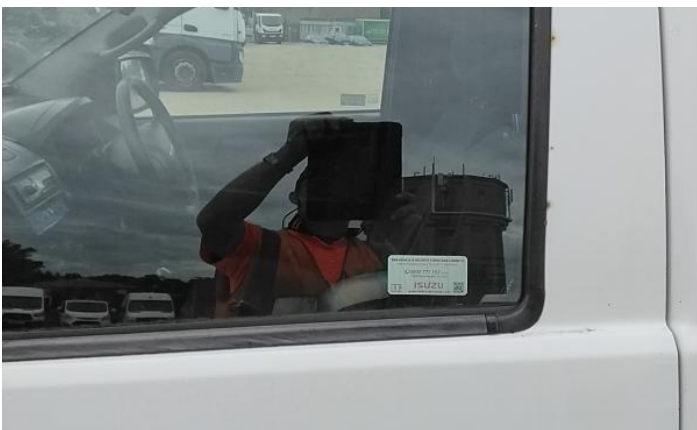
7: Door nsf
Chipped
1 To 5

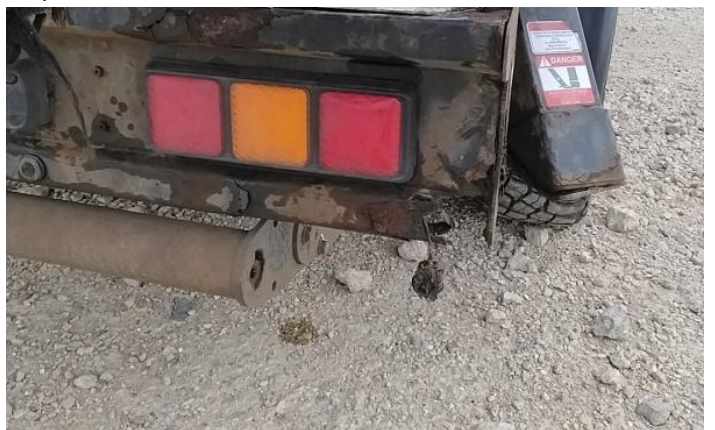
8: Bumper Rear
Hole
UpTo 25mm

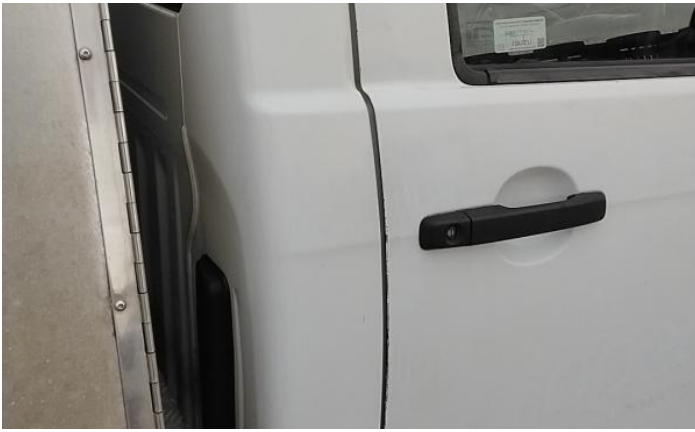
9: Door osf
Chipped
Edge Chip

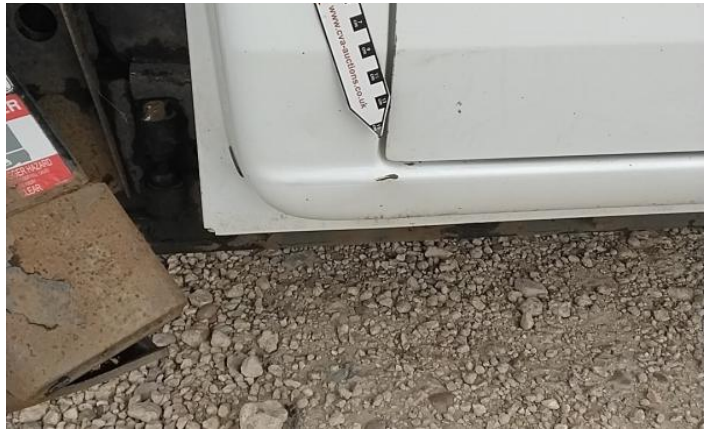
10: Sill os
Dented
With Paint Damage
