VEHICLE INSPECTION REPORT

MV68XYK

Ford Ranger XLT 2.2 TDCI

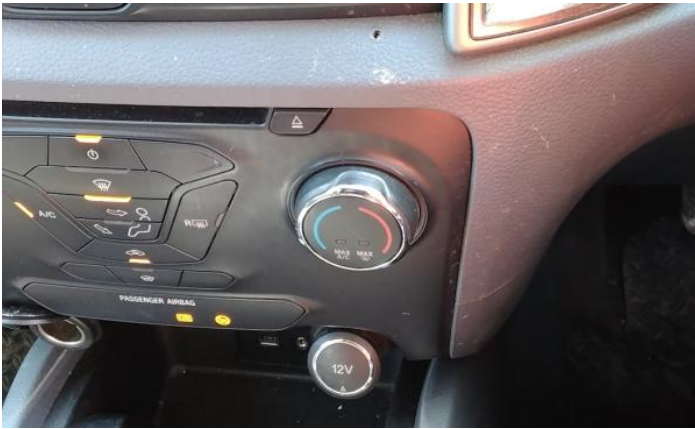
1: Centre Console Front
Holed
Up To 3mm

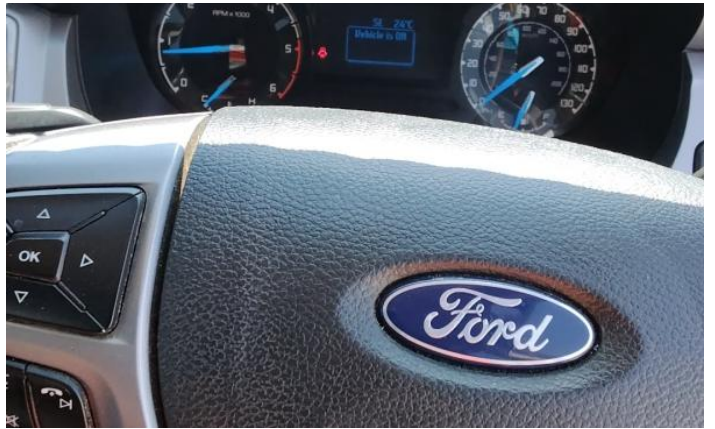
2: Dash Warning Lights
Displayed
No Action

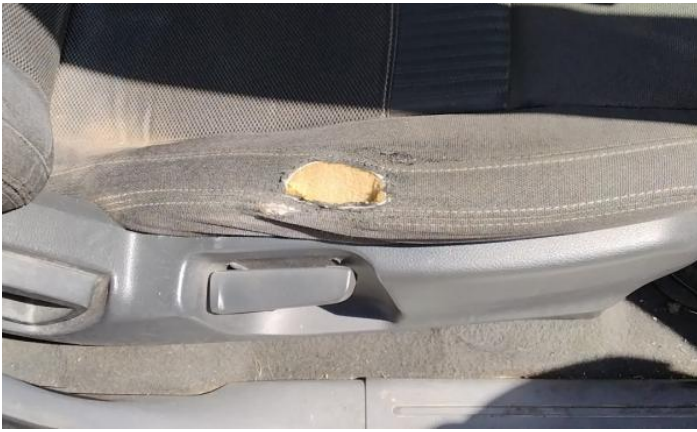
3: Seat Base Cover of
Holed
Over 3mm

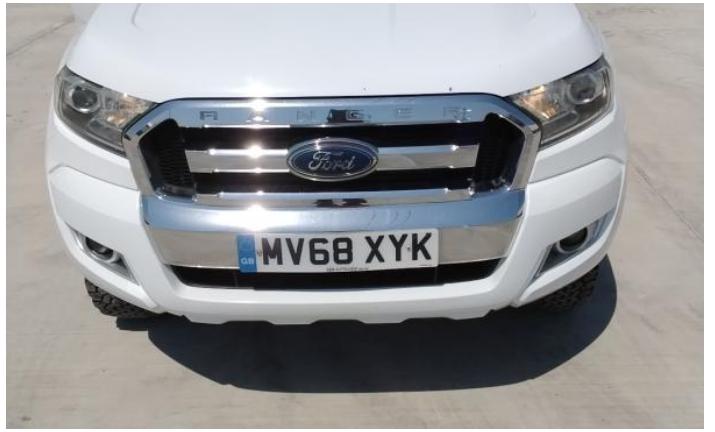
4: Bonnet
Chipped
Multiple Chips

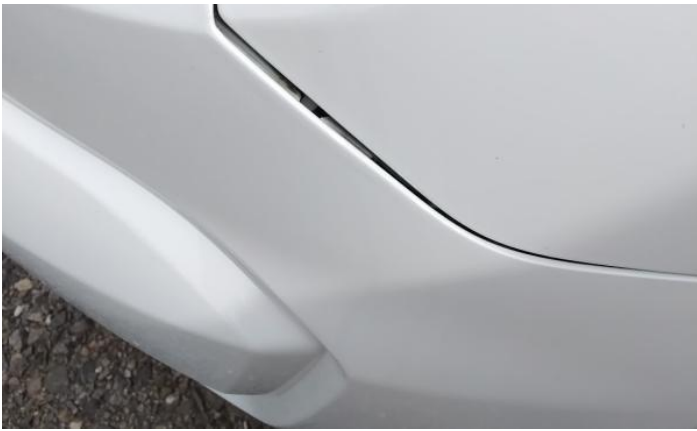
5: Bumper Front
Insecure
Action Required

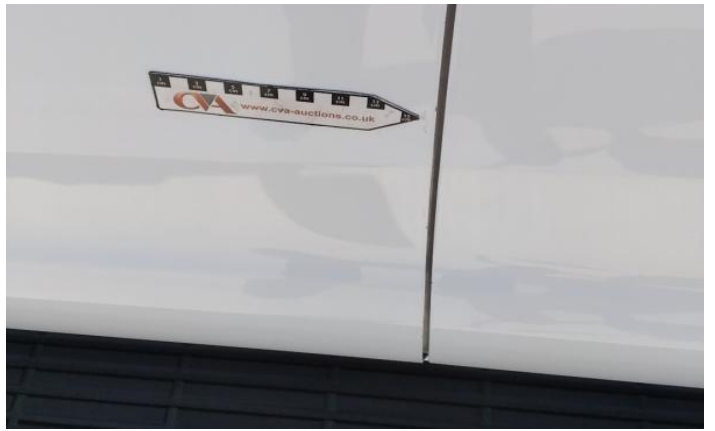
6: Door nsf
Dented
With Paint Damage

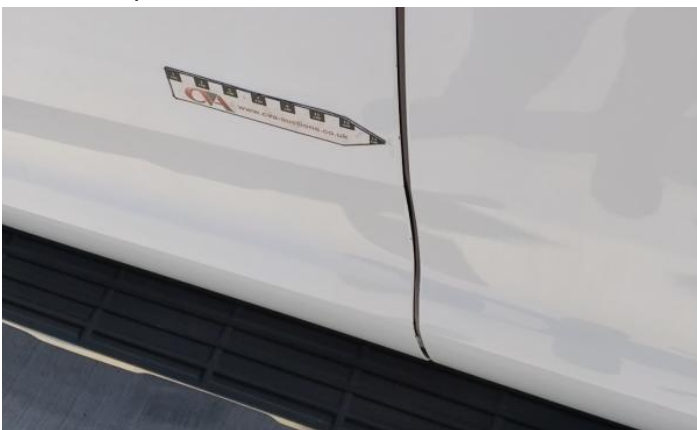
7: Door nsf
Chipped
Multiple Chips

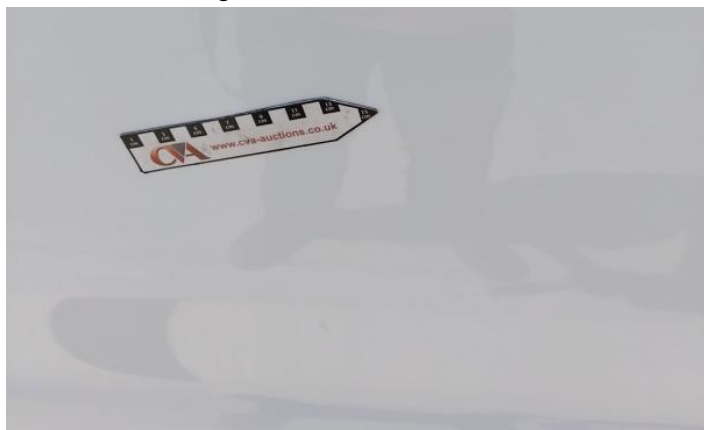
8: Qtr Panel nsr
Scratched
Over 25mm Thru Paint

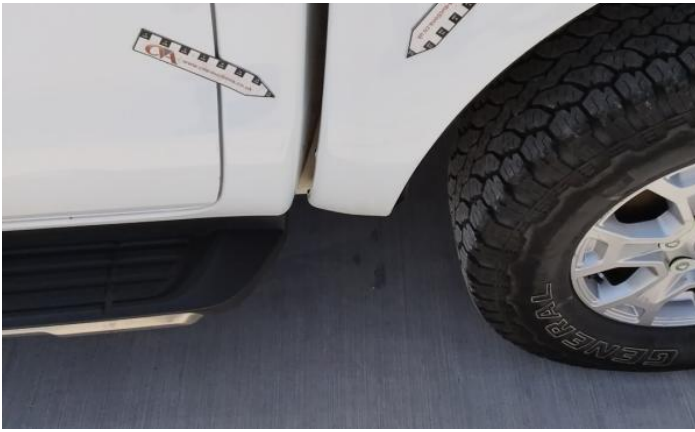
9: Qtr Panel nsr
Scratched
Over 25mm Thru Paint

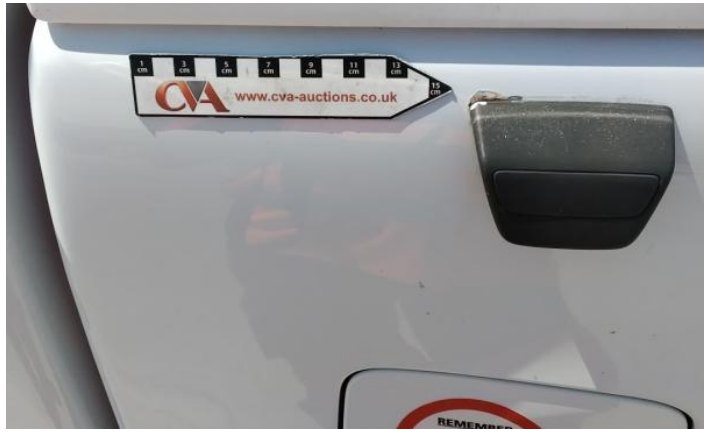
10: Qtr Panel nsr
Chipped
Over 5mm

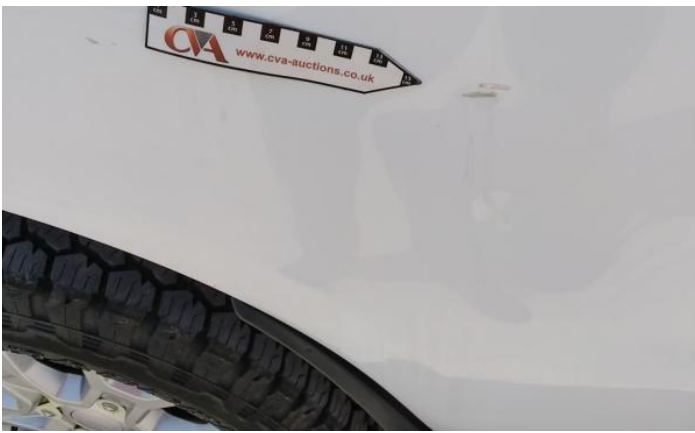
11: Qtr Panel nsr
Dented
With Paint Damage

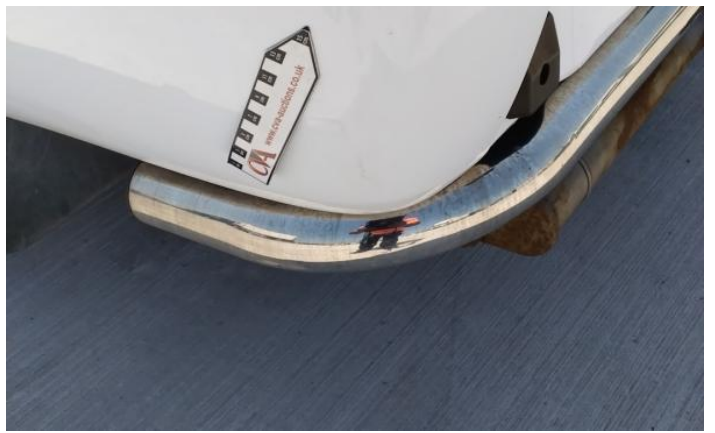
12: Panel Rear
Dented
With Paint Damage

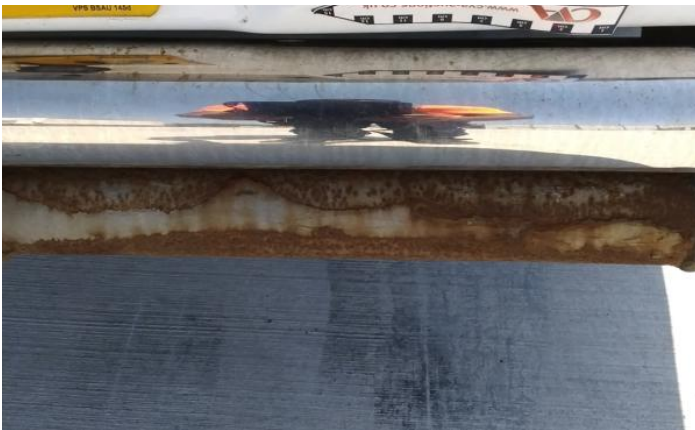
13: Panel Rear
Scratched
Over 25mm Thru Paint

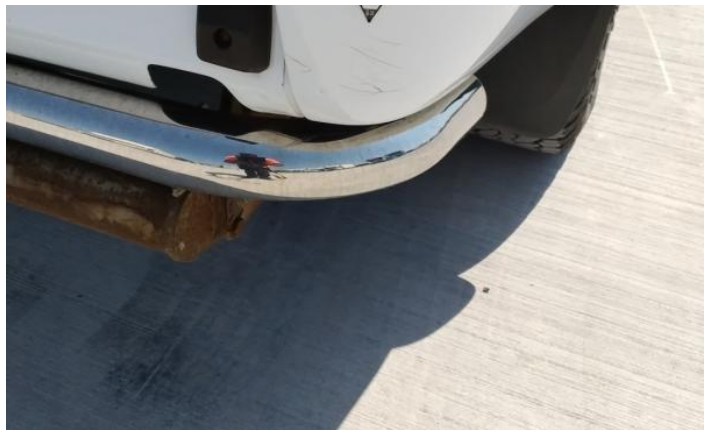
14: Panel Rear
Scratched
Over 25mm Thru Paint

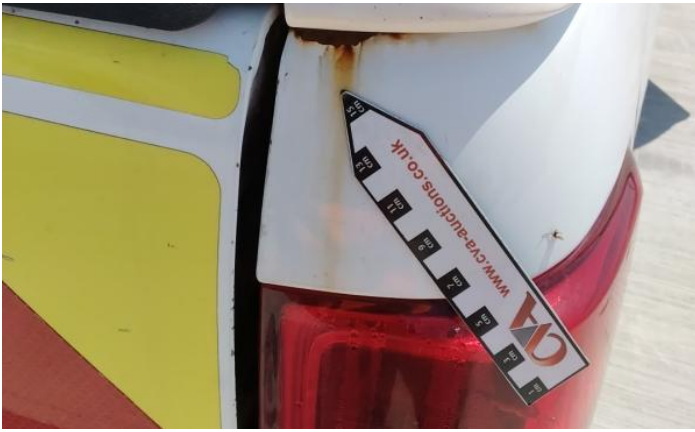
15: Panel Rear
Rusted
Over 5mm

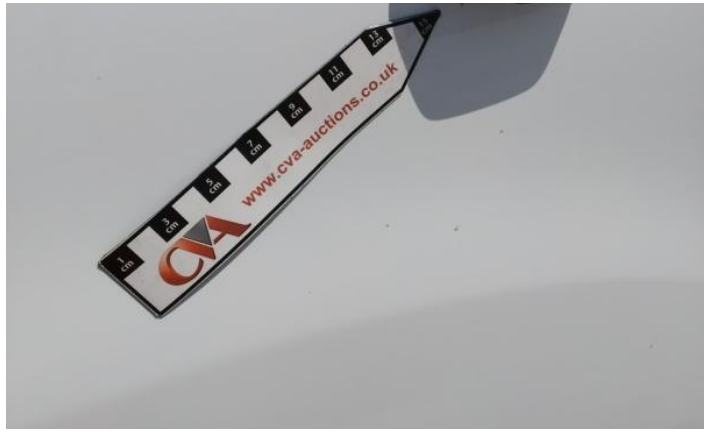
16: Qtr Panel osr
Scratched
Over 25mm Thru Paint

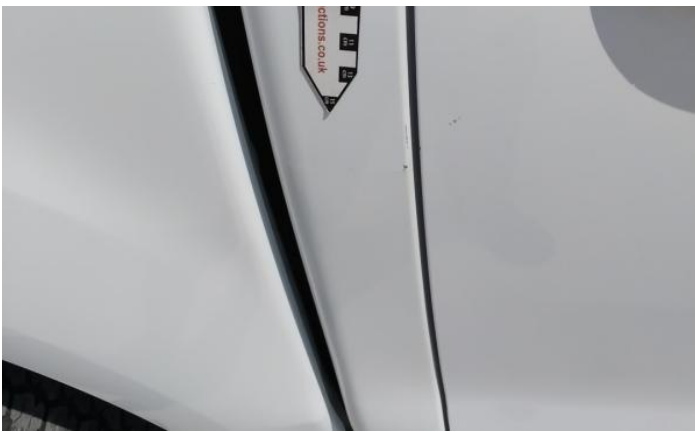
17: Qtr Panel osr
Poor Previous Repair
Paint Flake

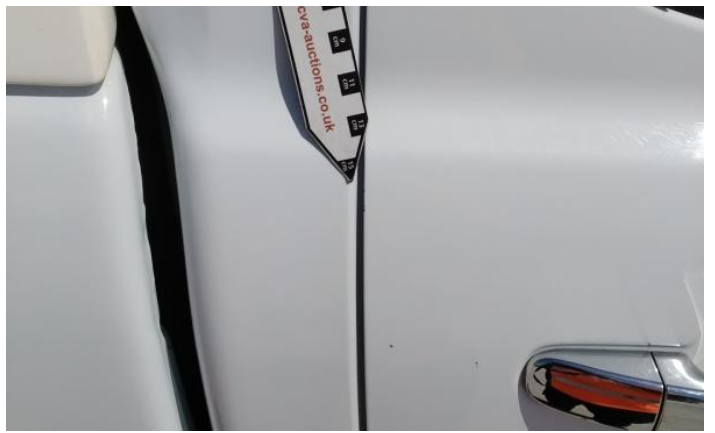
18: Qtr Panel osr
Chipped
Multiple Chips

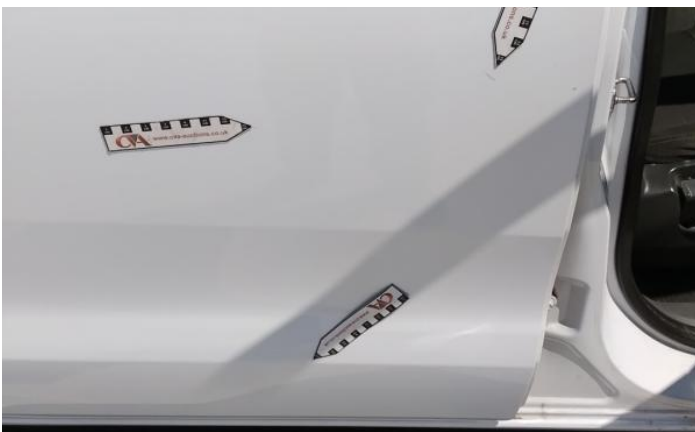
19: Qtr Panel osr
Scratched
Over 25mm Thru Paint

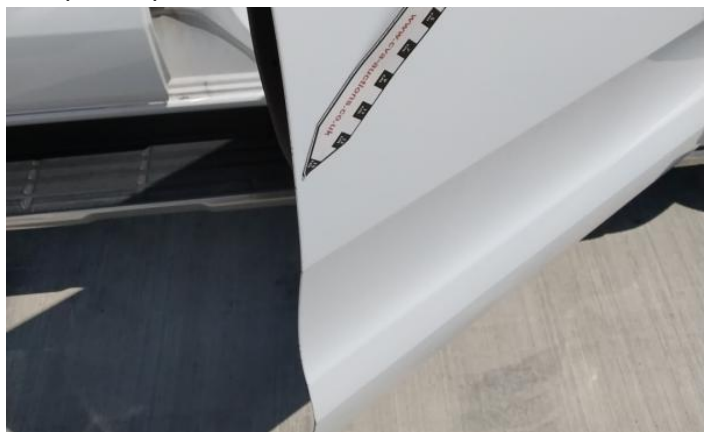
20: Door osf
Chipped
Multiple Chips

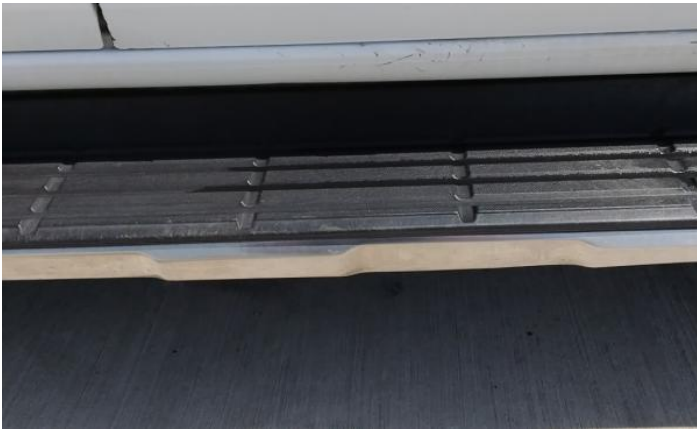
21: Door osf
Dented
Over 2 UpTo 10mm

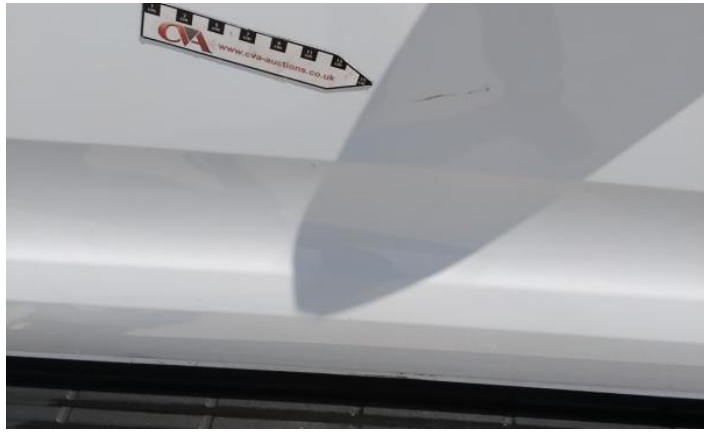
22: Door osf
Scratched
Over 25mm Thru Paint

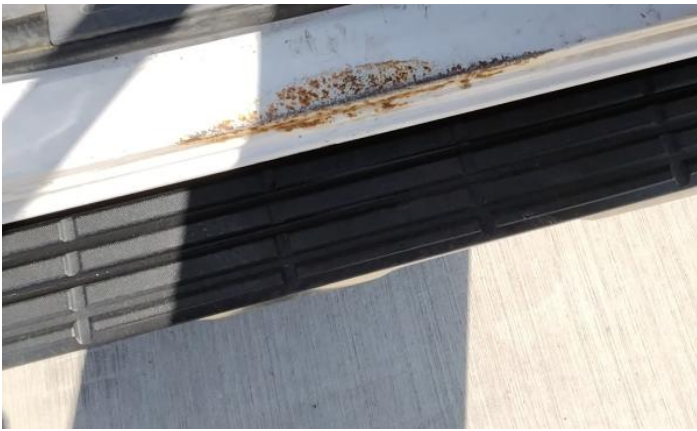
23: C Post os
Rusted
Over 5mm

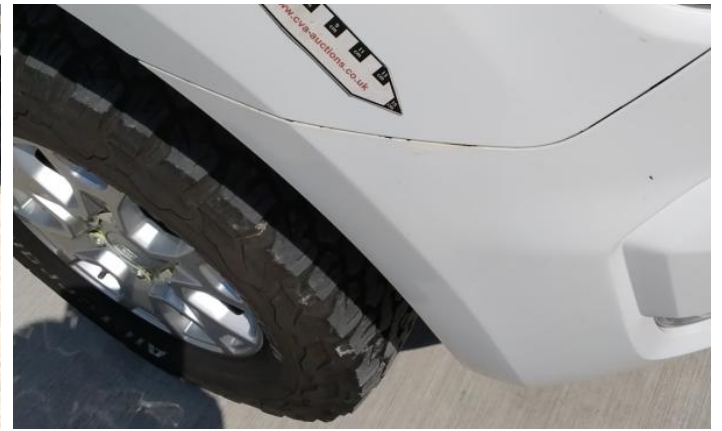
24: Bumper Front
Poor Previous Repair
Poor Paint

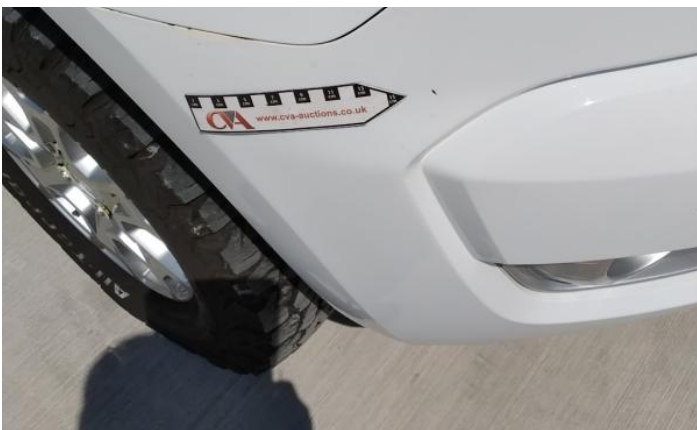
25: Bumper Front
Scratched
UpTo 25mm Thru Paint

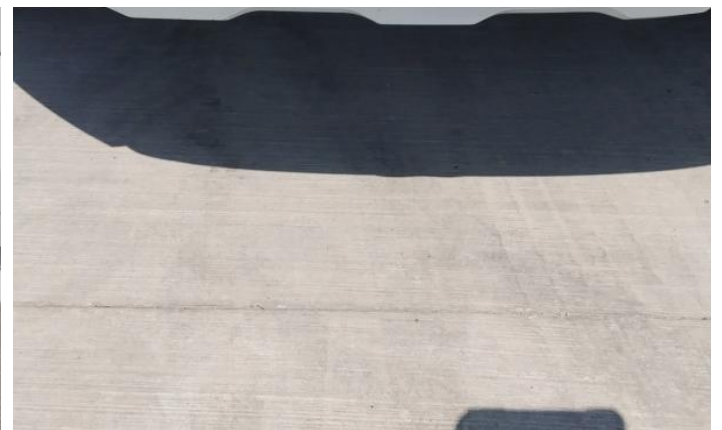
26: Bumper Front
Chipped
Multiple Chips
