# VEHICLE INSPECTION REPORT

**KP19SNB**

## Mercedes-Benz Sprinter 314 CDI

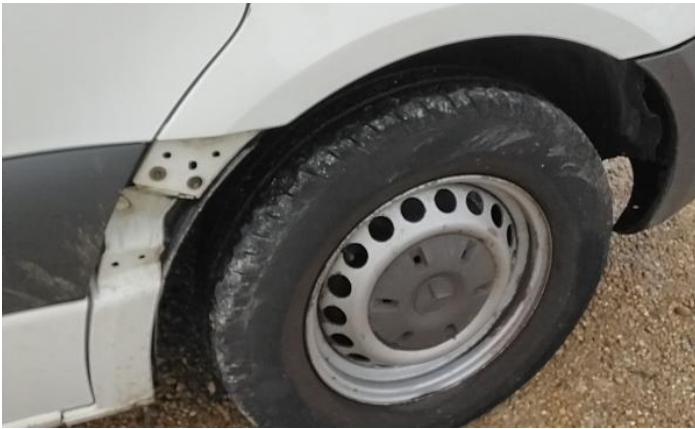
1: Wing Front Arch Extension os  
Missing  
Replace

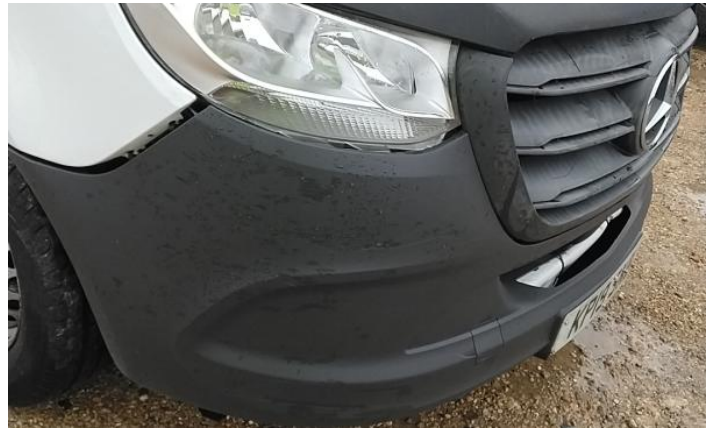
2: Bumper Front  
Insecure  
Action Required

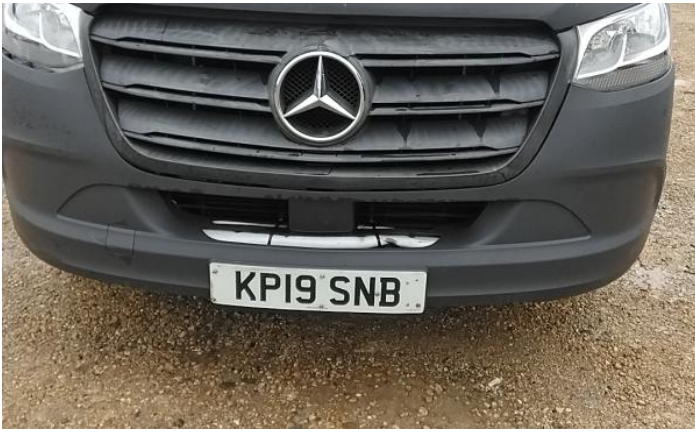
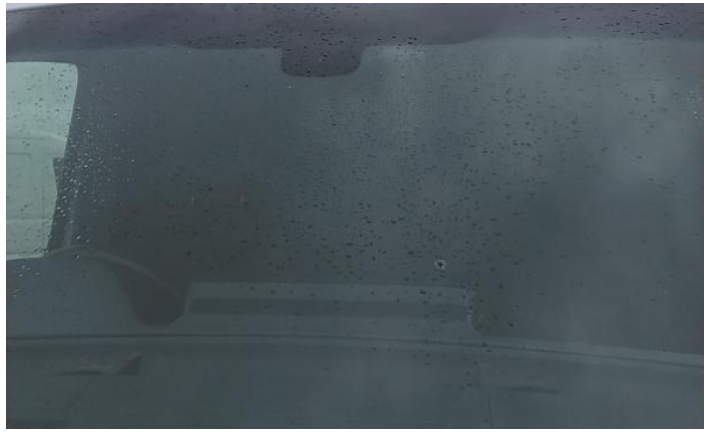
3: Bumper Front  
Insecure  
Action Required

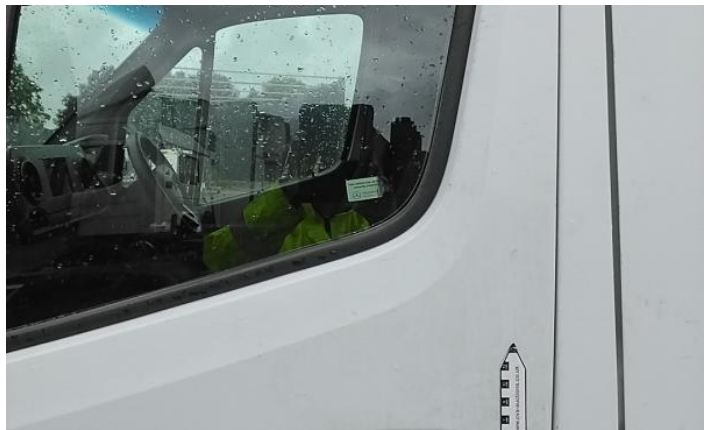
7: Door Moulding nsf  
Scuffed (Unpainted)  
Over 100mm

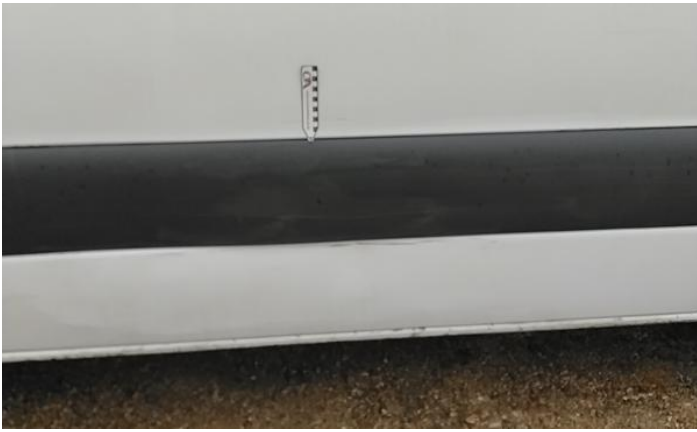
9: Door Moulding nsr  
Scuffed (Unpainted)  
Over 100mm

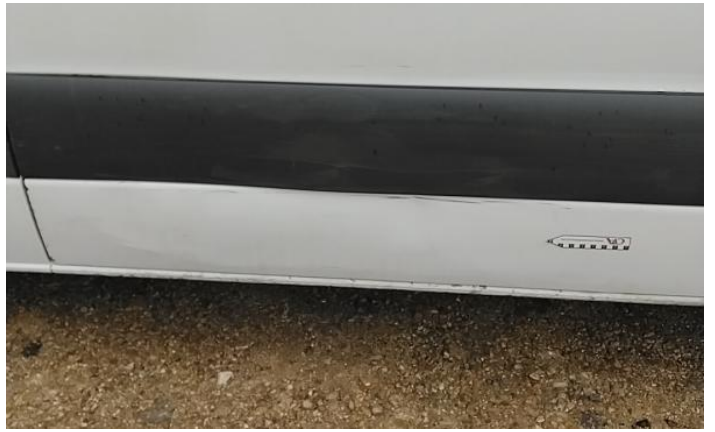
10: Door nsr  
Dented  
With Paint Damage

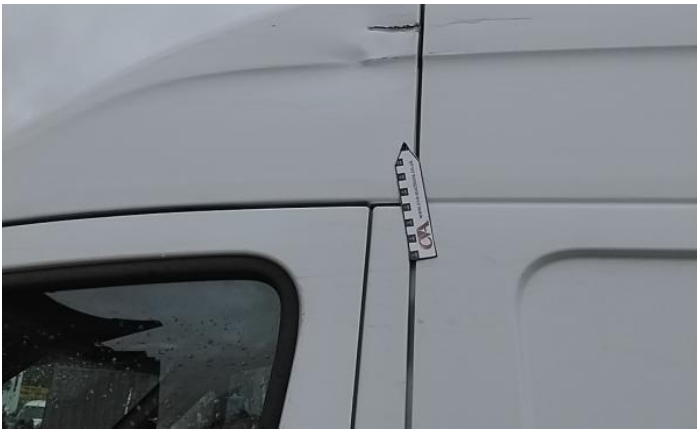
11: Roof  
Dented  
With Paint Damage

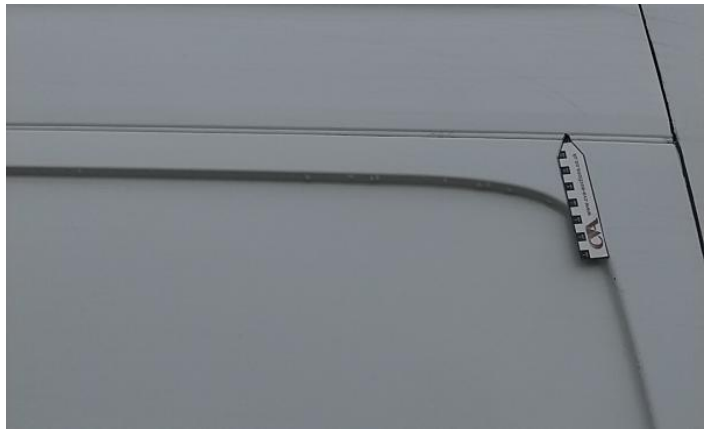
12: Roof  
Dented  
With Paint Damage

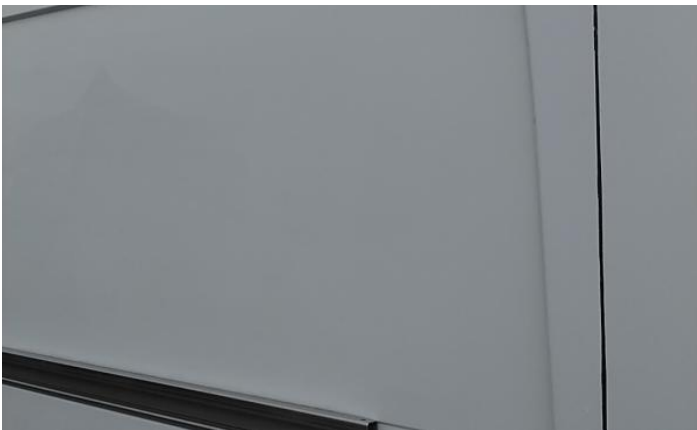
13: Qtr Panel nsr  
Scratched  
Over 25mm Not Thru Paint

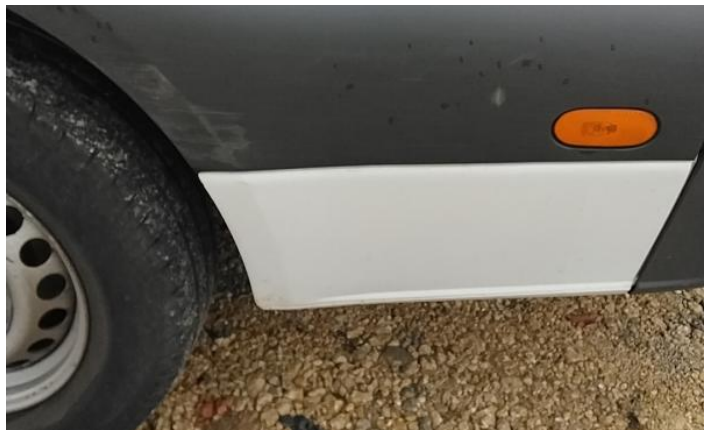
14: Qtr Panel Moulding ns  
Scuffed (Unpainted)  
Over 100mm

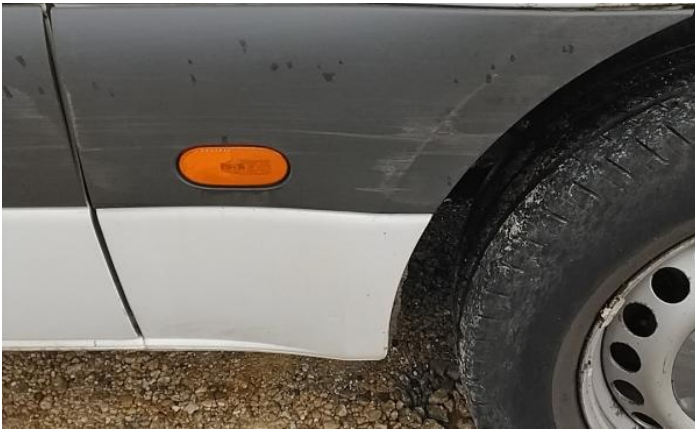
15: Qtr Panel Moulding ns  
Scuffed (Unpainted)  
Over 100mm

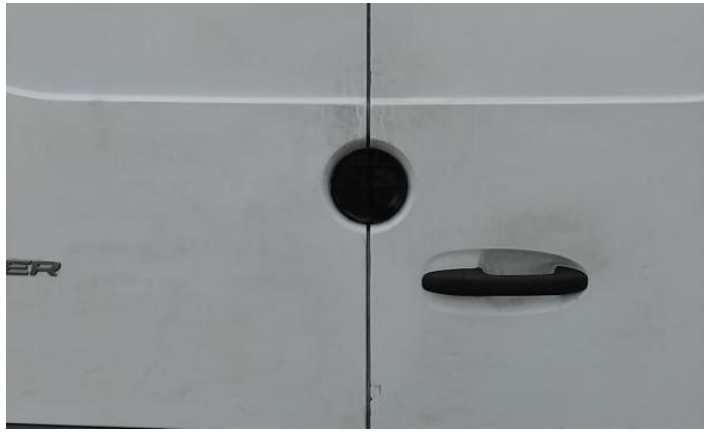
16: Badgedecal Rear  
Broken  
Replace

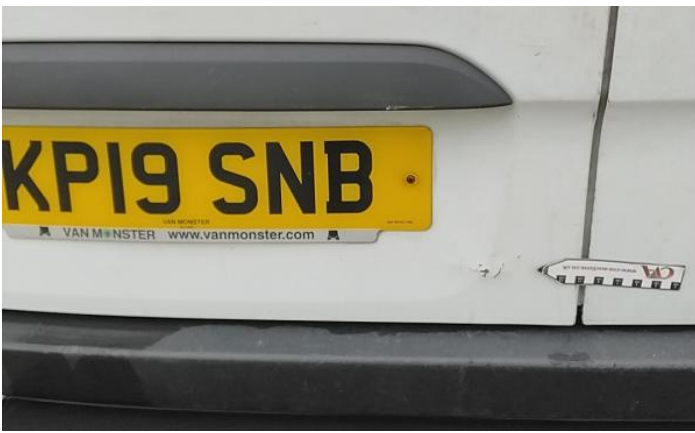
17: Door nsr  
Dented  
With Paint Damage

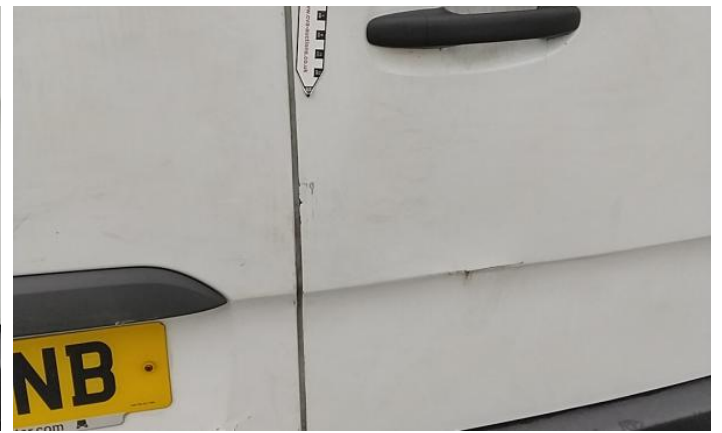
18: Door osr  
Dented  
With Paint Damage

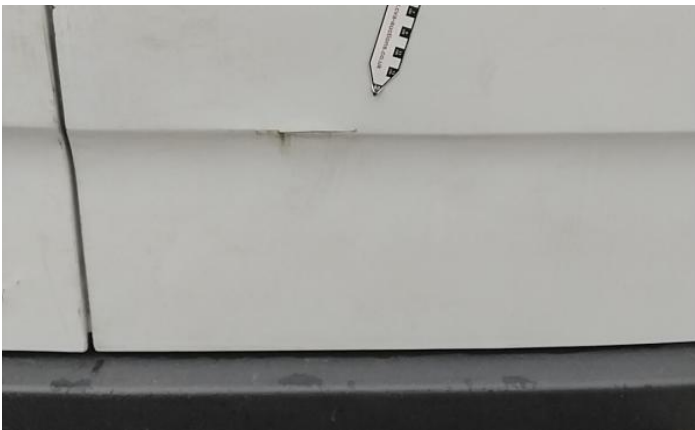
19: Door osr  
Scratched  
Over 25mm Thru Paint

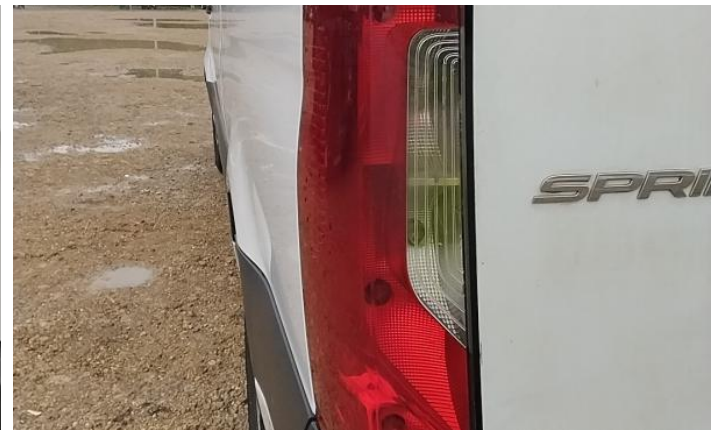
20: Lamp nsr  
Broken  
Replace

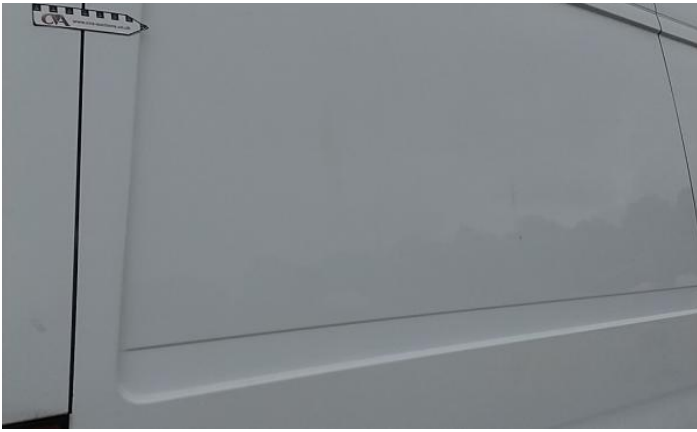
21: Qtr Panel osr  
Scratched  
Over 25mm Not Thru Paint

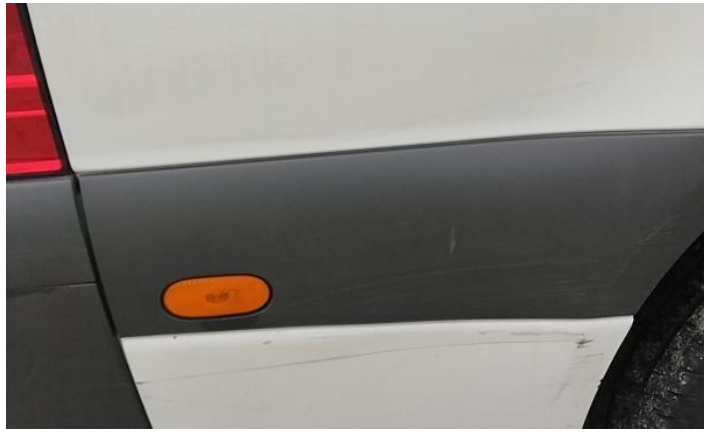
22: Qtr Panel Trim os  
Scuffed  
Over 25mm

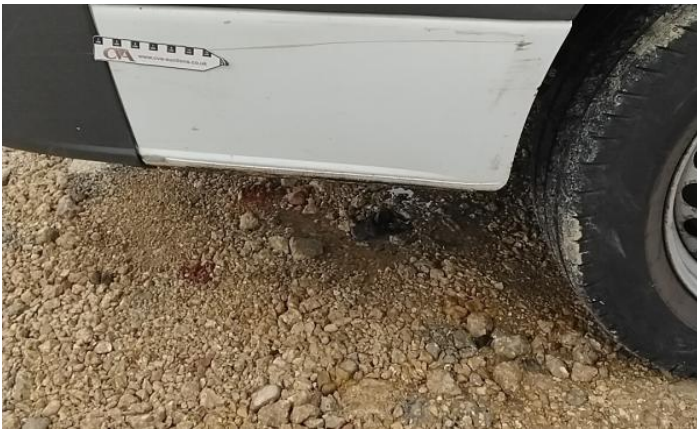
23: Qtr Panel osr  
Dented  
With Paint Damage

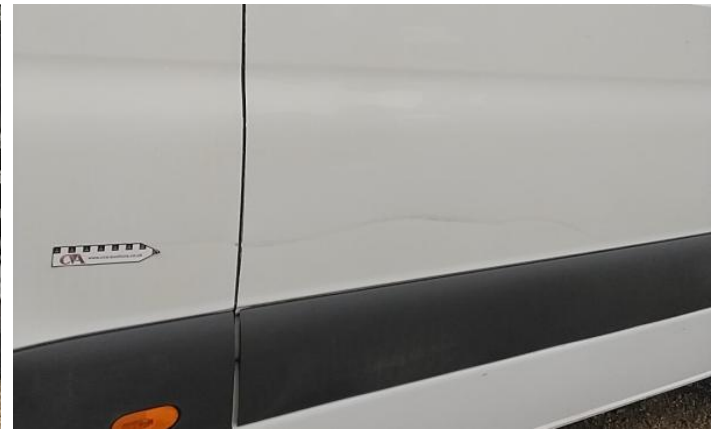
24: Qtr Panel osr  
Scratched  
Over 25mm Thru Paint

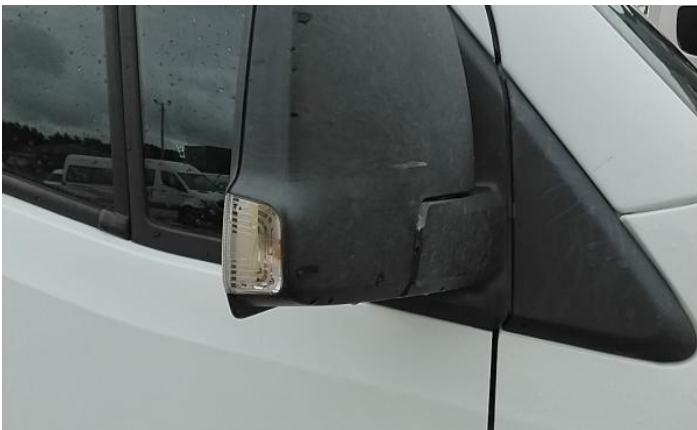
25: Door Mirror Assy osf  
Scuffed (Unpainted)  
UpTo 100mm

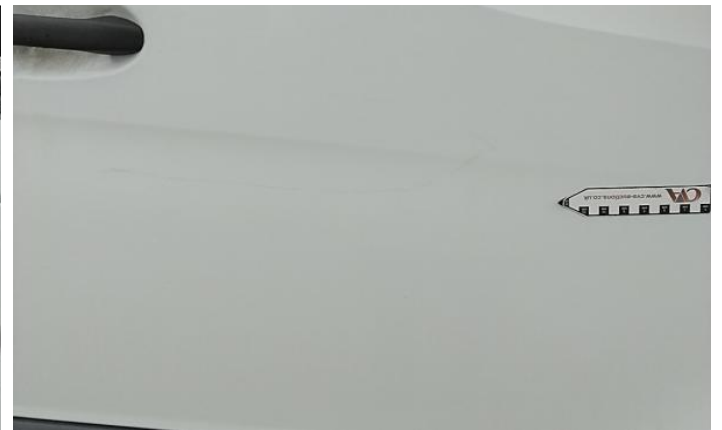
26: Door osf  
Scratched  
Over 25mm Thru Paint

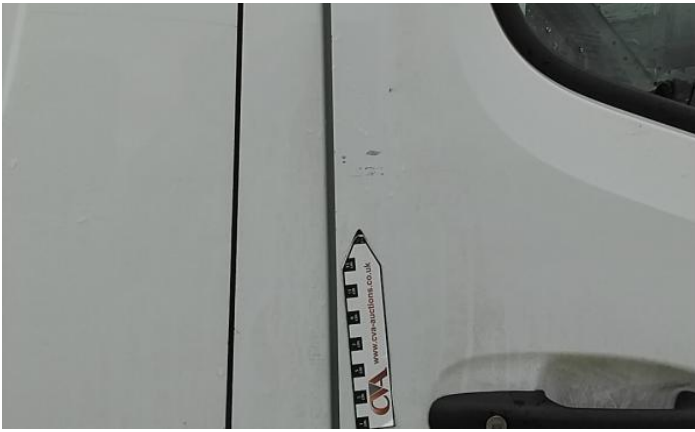
27: Door osf  
 Scratched  
 Over 25mm Not Thru Paint

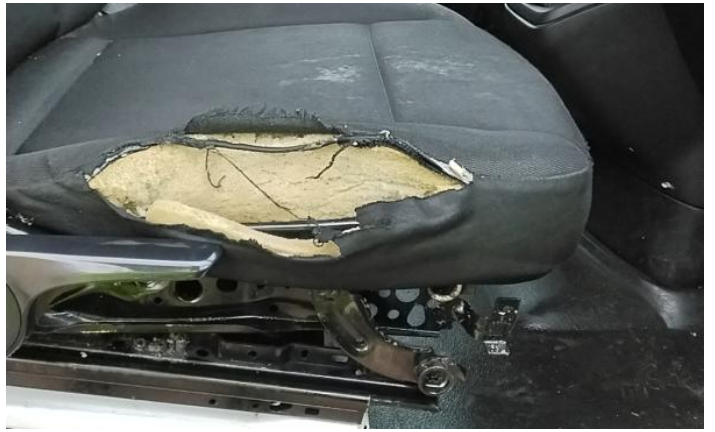
28: Seat Base Cover osf  
 Holed  
 Over 3mm

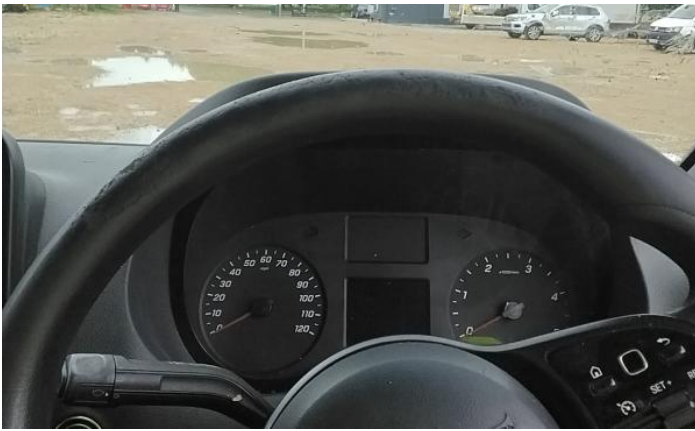
29: Steering Wheel  
 Damaged  
 Replace
