# VEHICLE INSPECTION REPORT

**WV74LVB**

## Maxus Deliver 9 2.0 D20 150PS

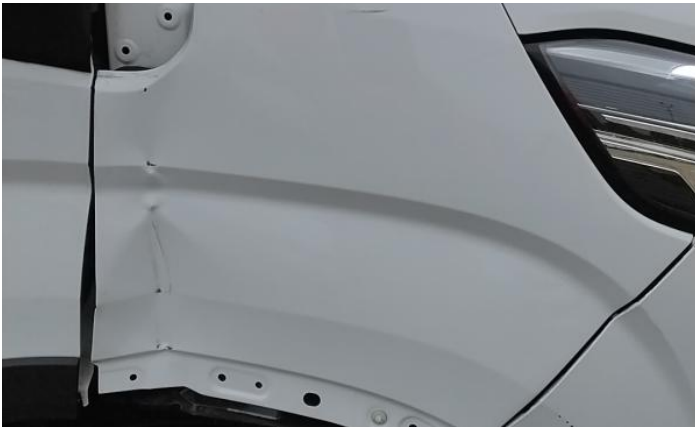
1: Wing osf  
Dented  
With Paint Damage

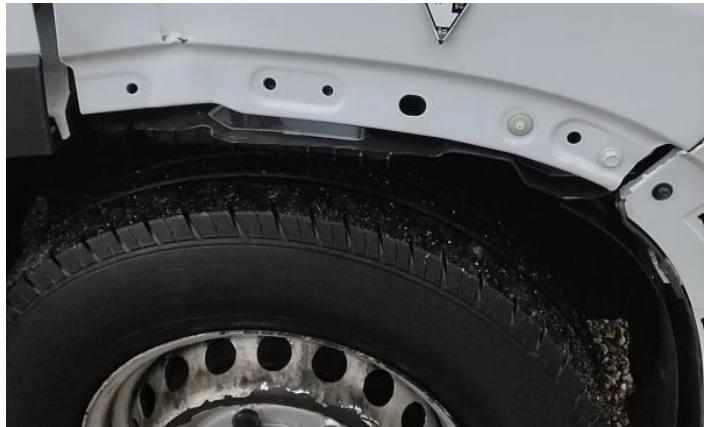
2: Wing Front Arch Extension os  
Missing  
Replace

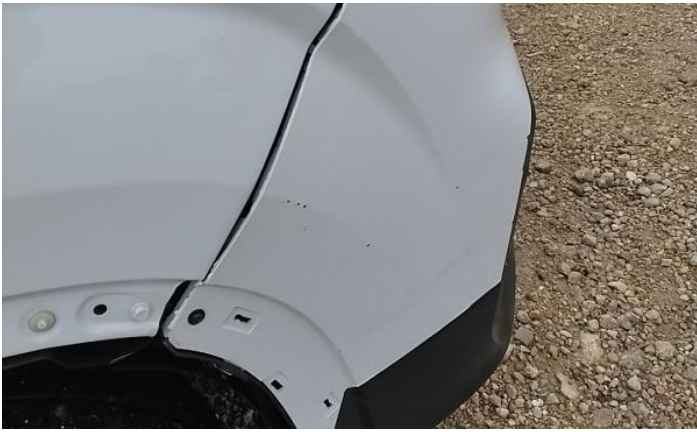
3: Bumper Front  
Insecure  
Action Required

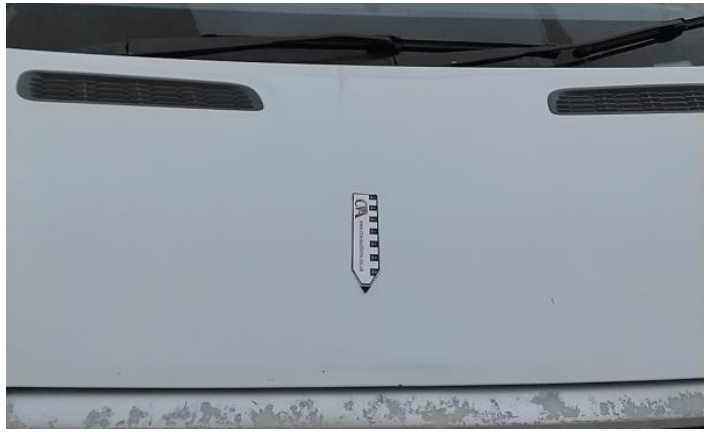
4: Bonnet  
Dented  
With Paint Damage

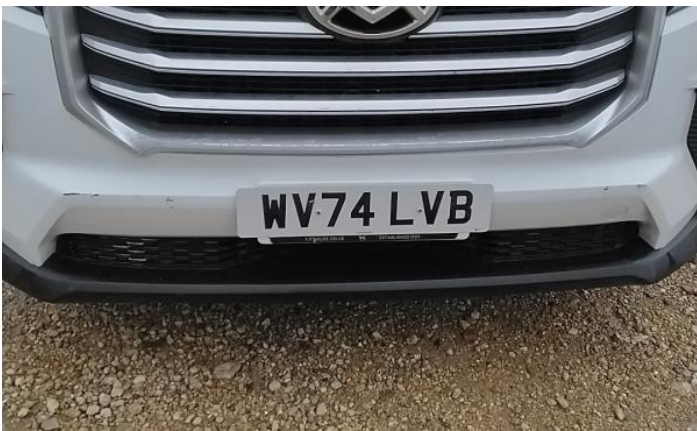
5: Bumper Front  
Scratched  
25 to 100mm Thru Paint

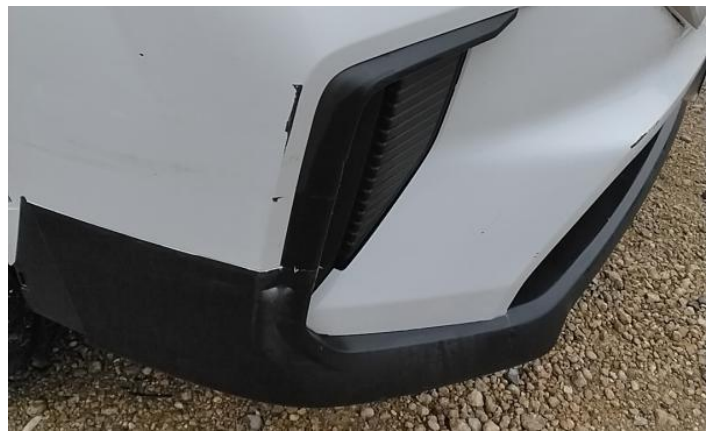
6: Bumper Front  
Scratched  
25 to 100mm Thru Paint

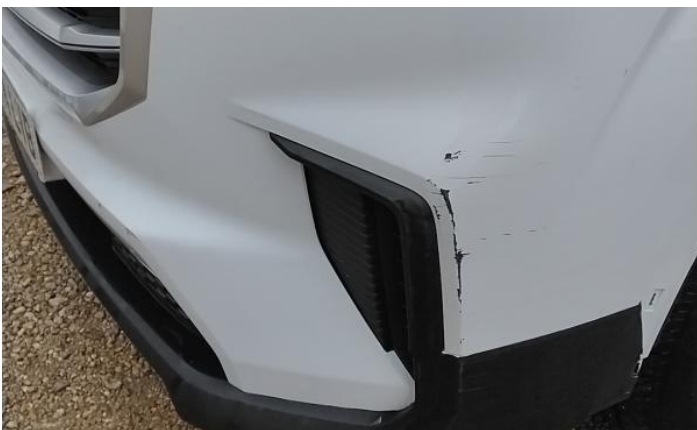
7: Bumper Front  
Scratched  
25 to 100mm Thru Paint

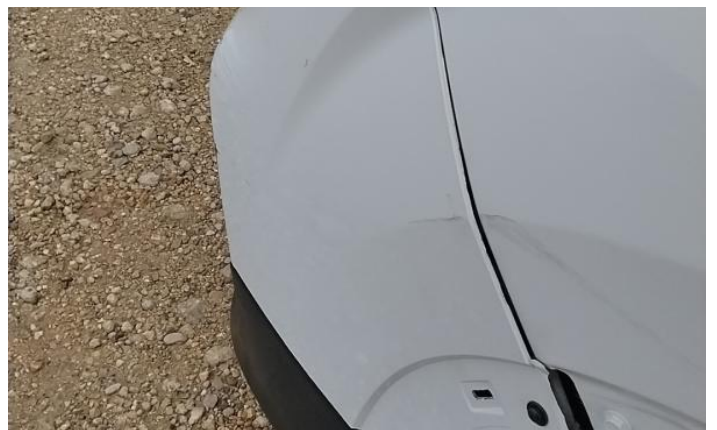
8: Bumper Front  
Insecure  
Action Required

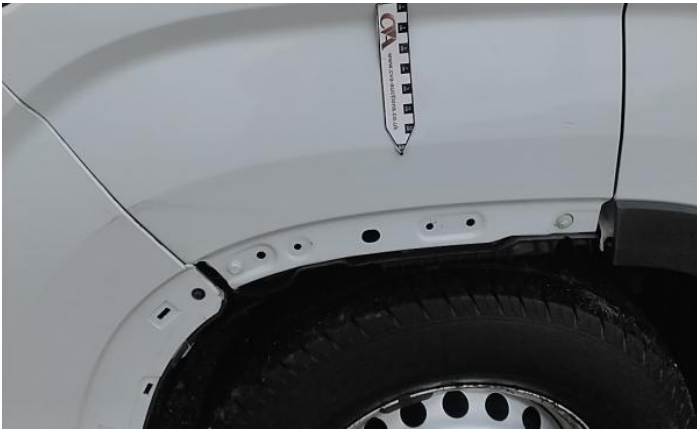
9: Wing Front Arch Extension ns  
Missing  
Replace

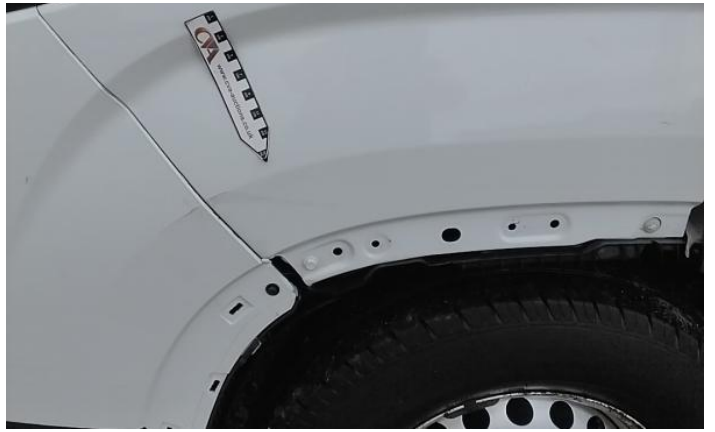
10: Wing nsf  
Scratched  
Over 25mm Not Thru Paint

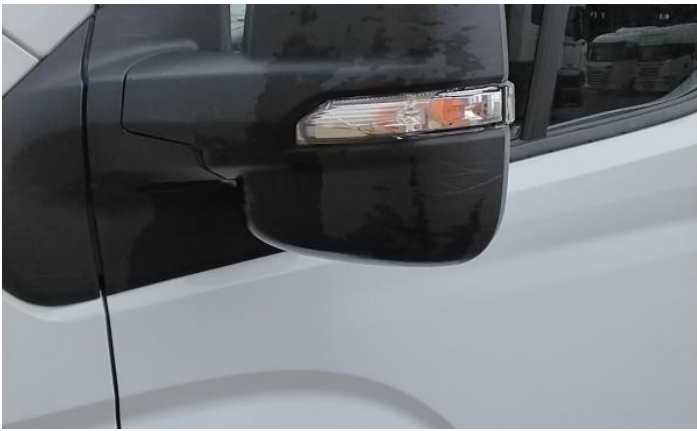
11: Door Mirror Assy nsf  
Scuffed (Unpainted)  
Over 100mm

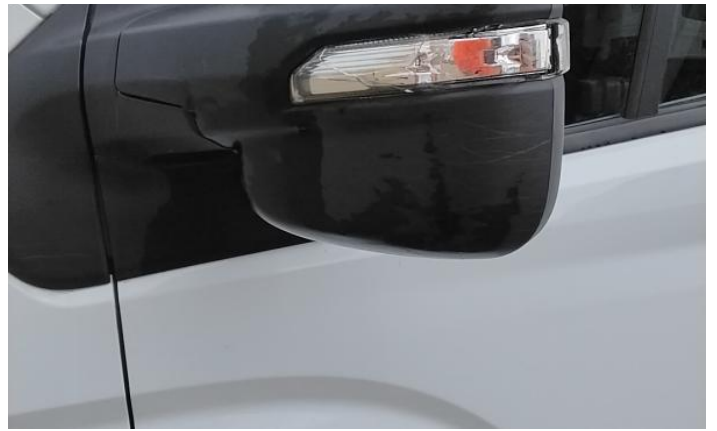
12: Flasher Side Repeater ns  
Broken  
Replace

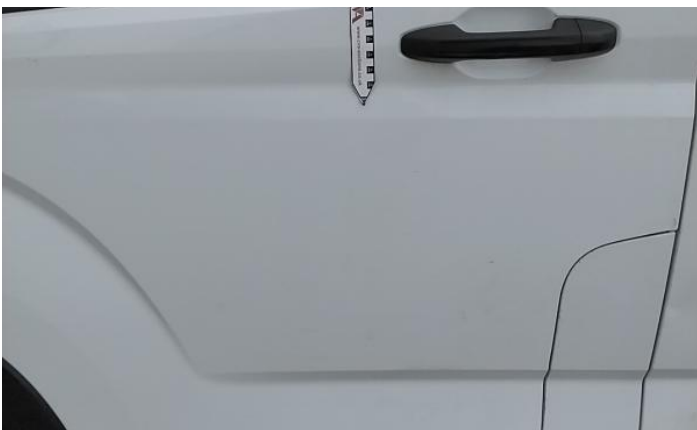
13: Door nsf  
Scratched  
Over 25mm Not Thru Paint

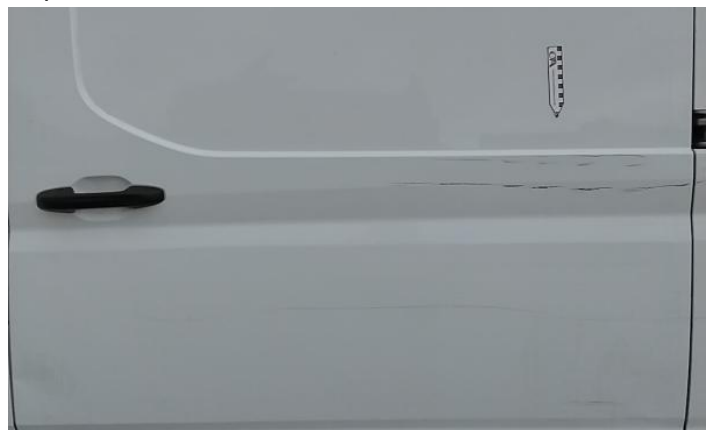
14: Door nsr  
Dented  
With Paint Damage

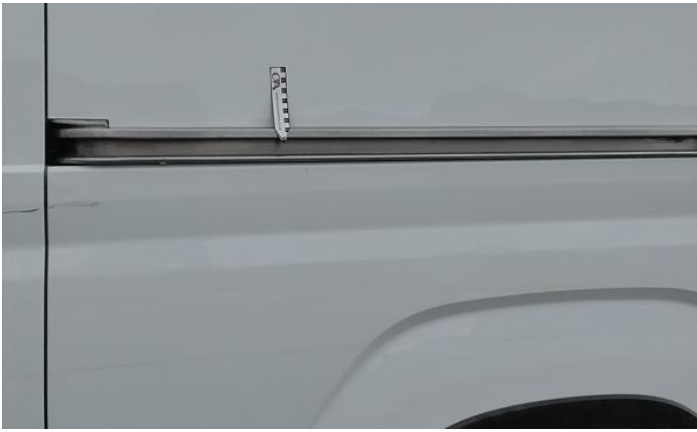
15: Qtr Panel nsr  
Scratched  
Over 25mm Not Thru Paint

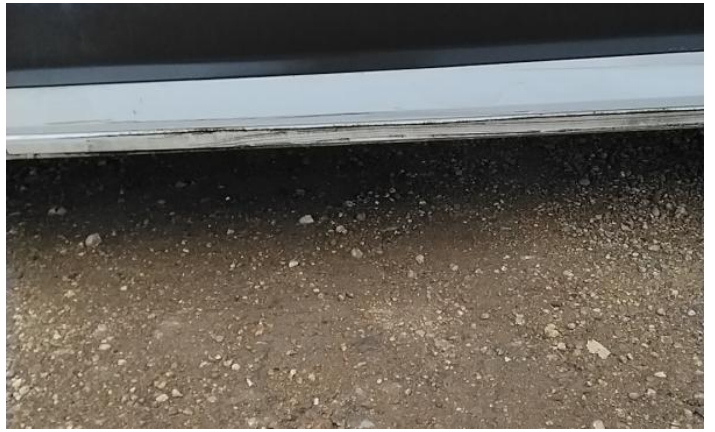
16: Sill ns  
Dented  
With Paint Damage

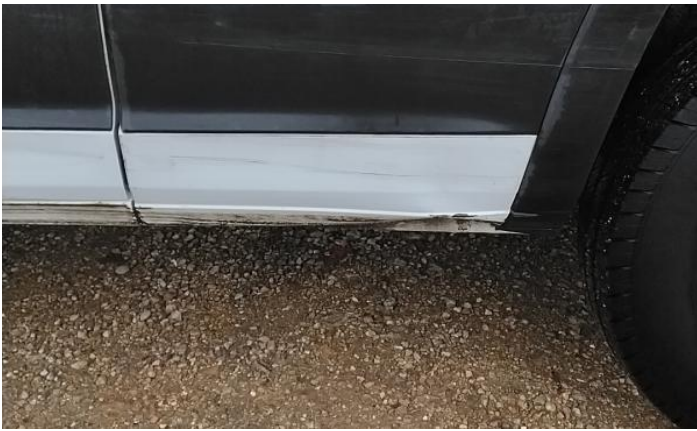
17: Sill ns  
Dented  
With Paint Damage

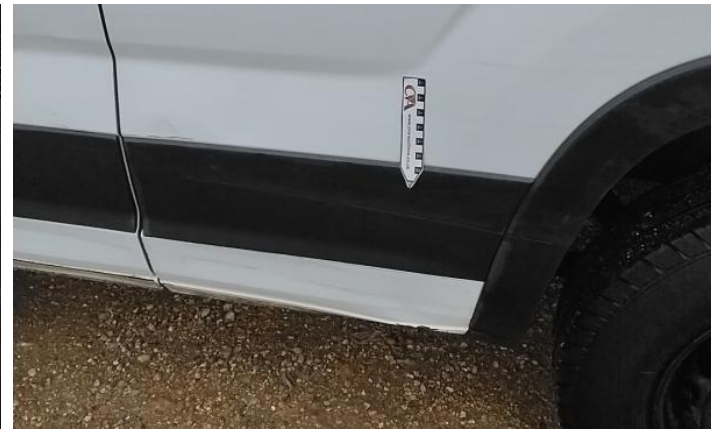
18: Qtr Panel Moulding ns  
Scuffed (Unpainted)  
Up To 100mm

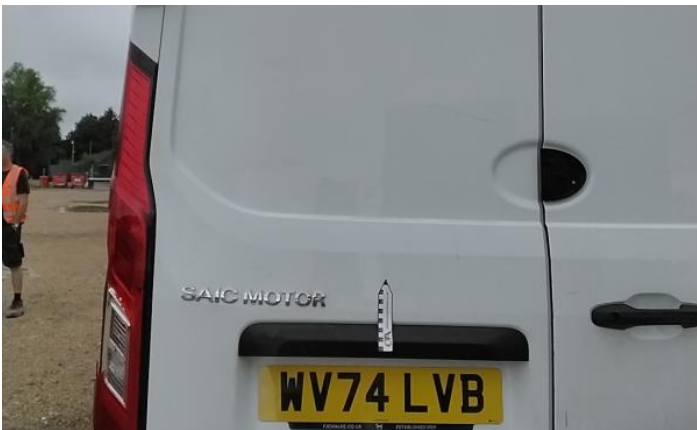
19: Door nsr  
Scratched  
Over 25mm Not Thru Paint

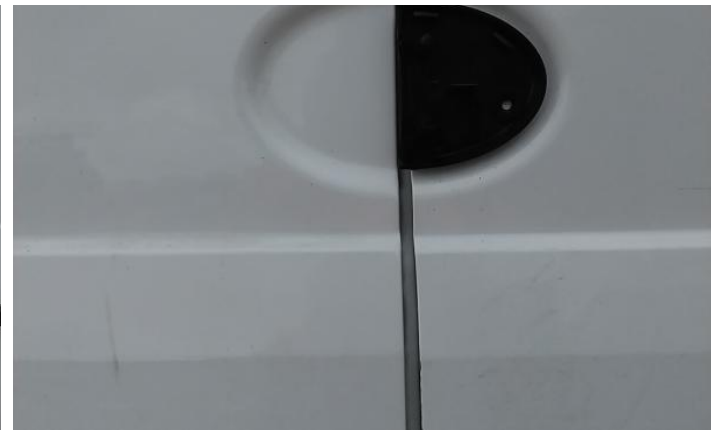
20: Badgedecal Rear  
Broken  
Replace

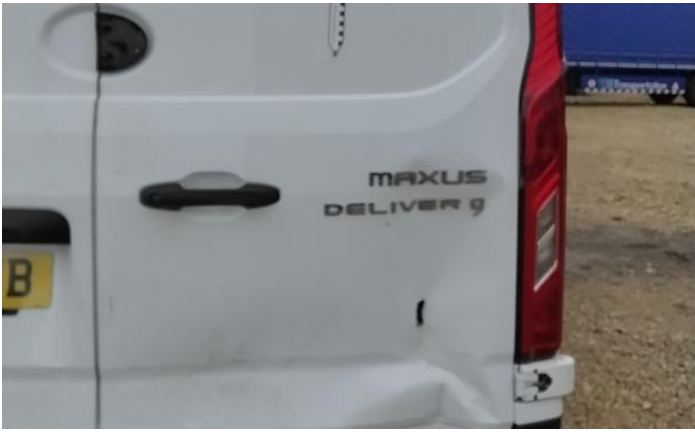
21: Door osr  
Dented  
With Paint Damage

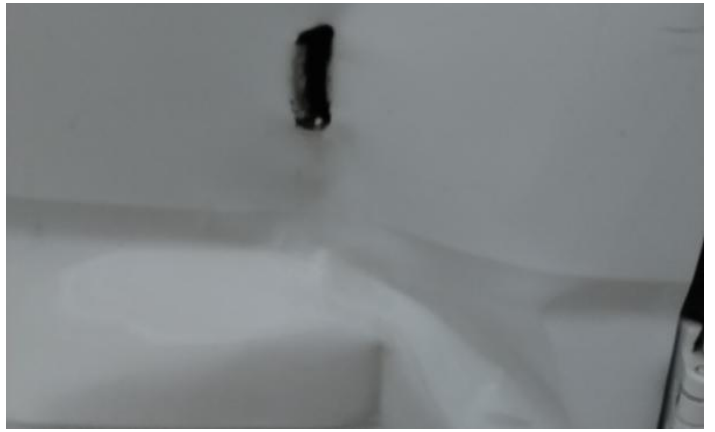
22: Door osr  
Hole  
Over 10mm

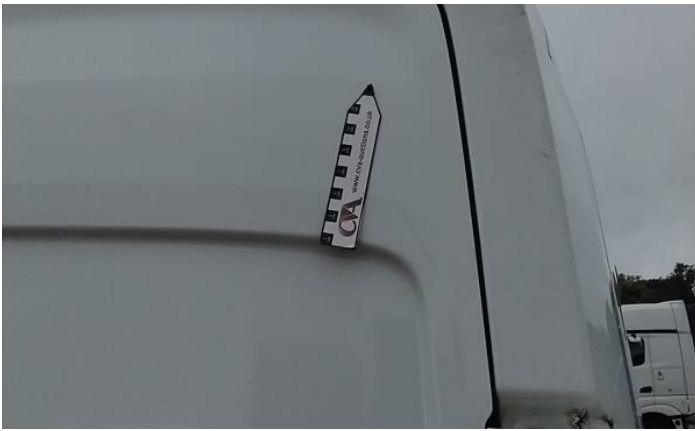
23: Roof  
Dented  
With Paint Damage

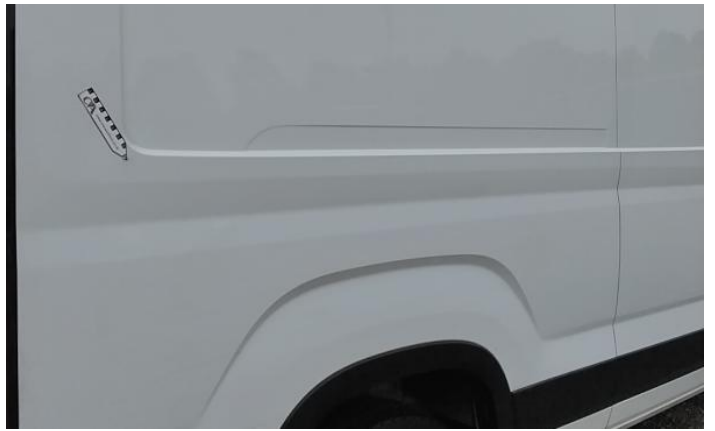
24: Qtr Panel osr  
Scratched  
Over 25mm Not Thru Paint

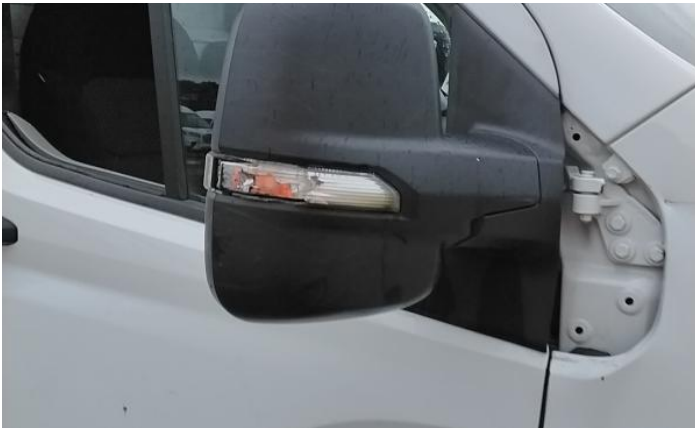
25: Door Mirror Assy osf  
Scuffed (Unpainted)  
Over 100mm

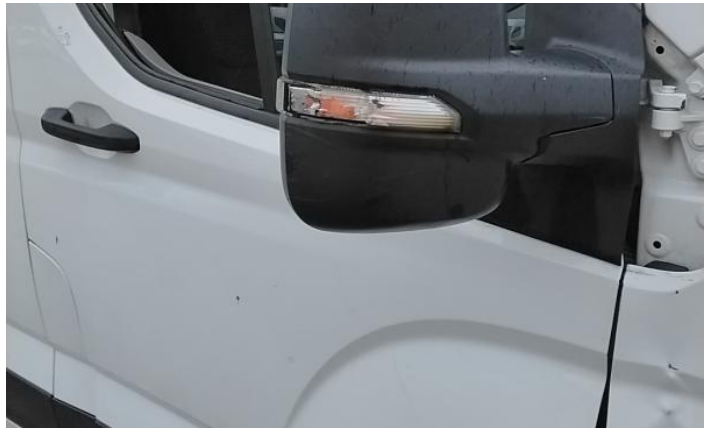
26: Flasher Side Repeater os  
Broken  
Replace

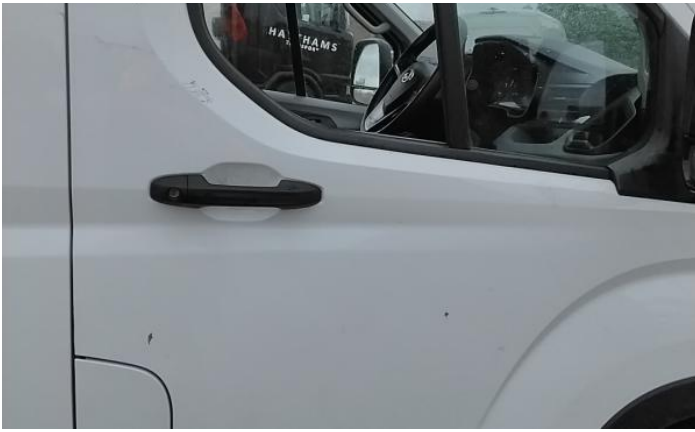
27: Door osf  
 Scratched  
 Over 25mm Thru Paint

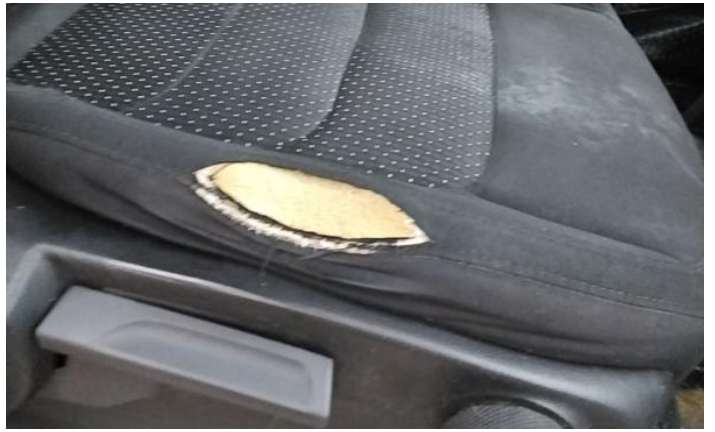
28: Seat Base Cover osf  
 Holed  
 Over 3mm

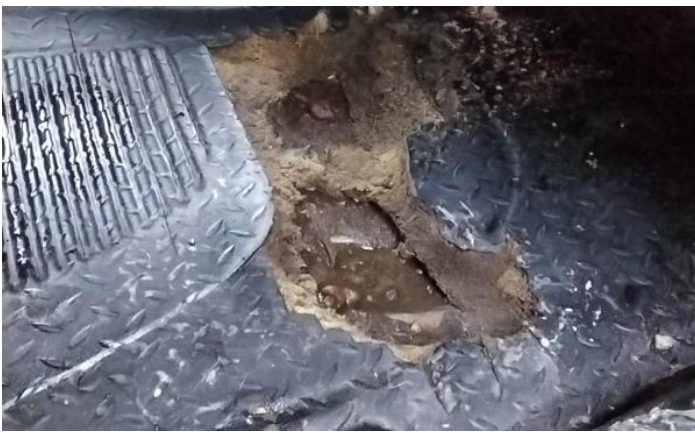
29: Carpets Front  
 Holed  
 Over 3mm
