VEHICLE INSPECTION REPORT

MC74DYA

Maxus Deliver 9 2.0 D20 150PS

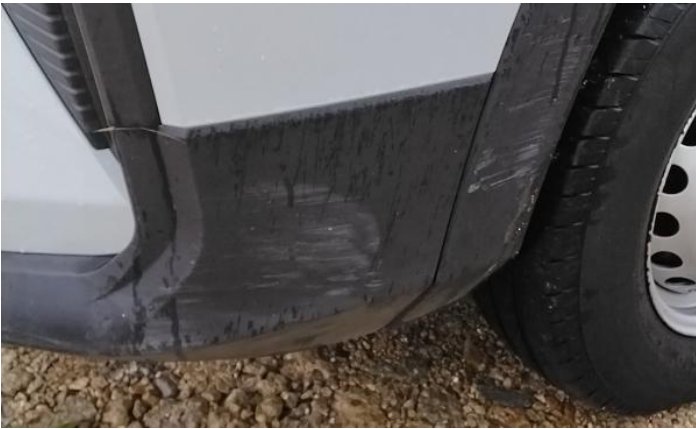
1: Bumper Front Moulding
Scuffed (Unpainted)
Over 100mm

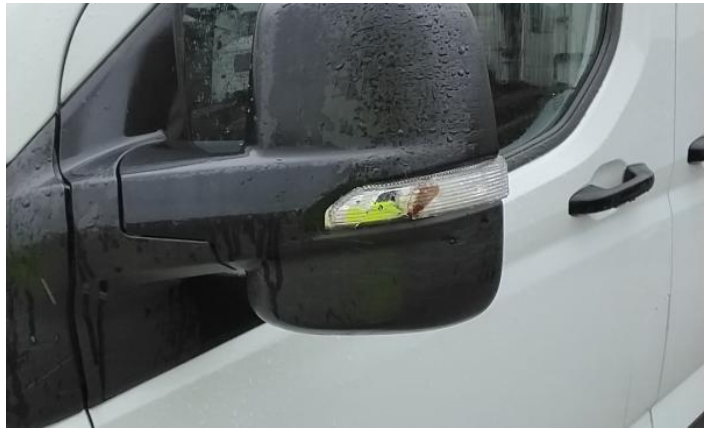
2: Door Mirror Assy nsf
Scuffed (Unpainted)
Over 100mm

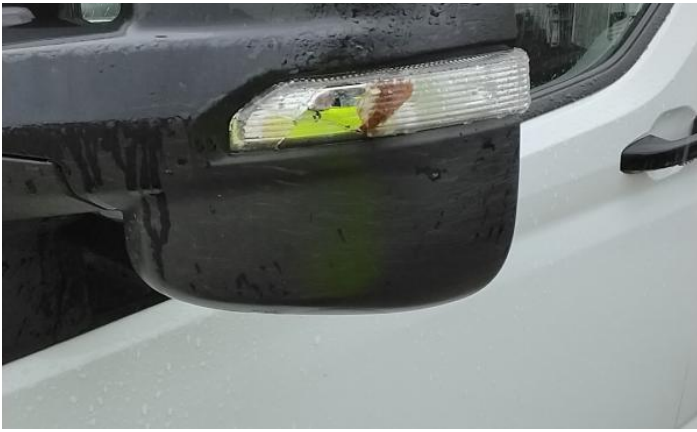
3: Flasher Side Repeater ns
Broken
Replace

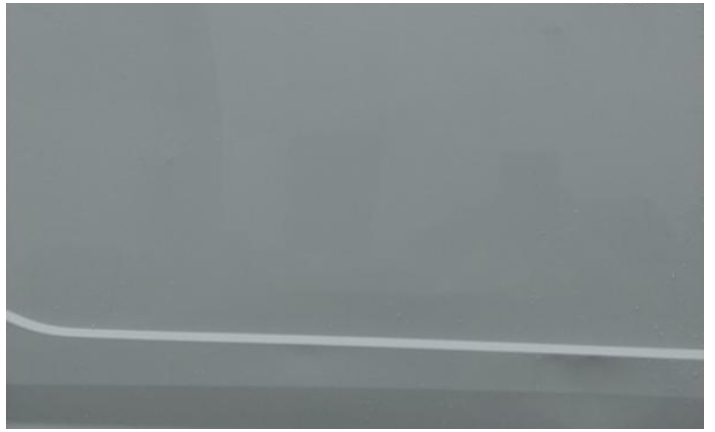
4: Door nsr
Scratched
Over 25mm Not Thru Paint

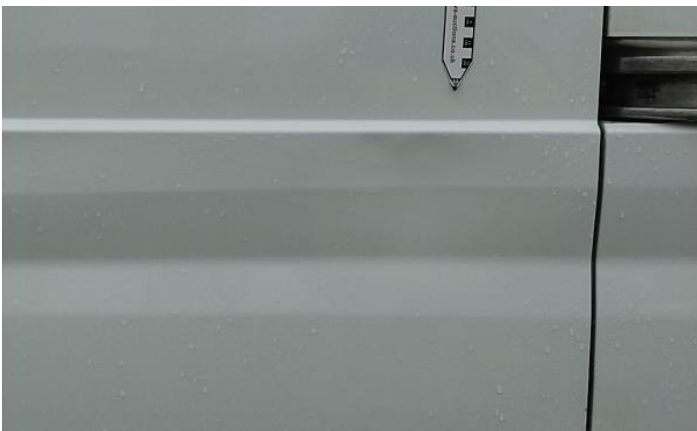
5: Door nsr
Dented
Over 30mm

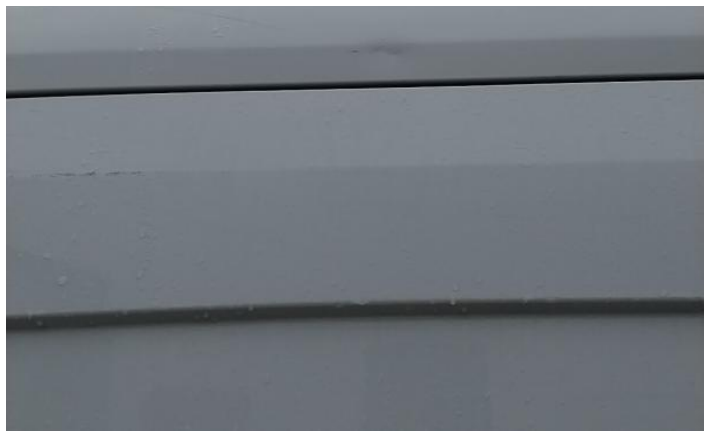
6: Roof
Dented
Between 10mm + 30mm

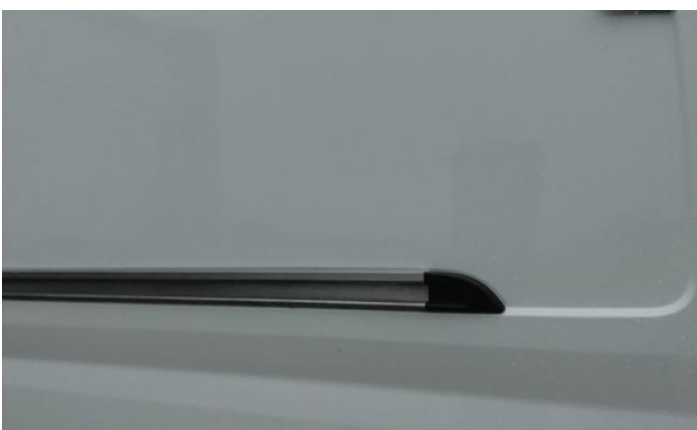
7: Qtr Panel nsr
Scratched
Over 25mm Not Thru Paint

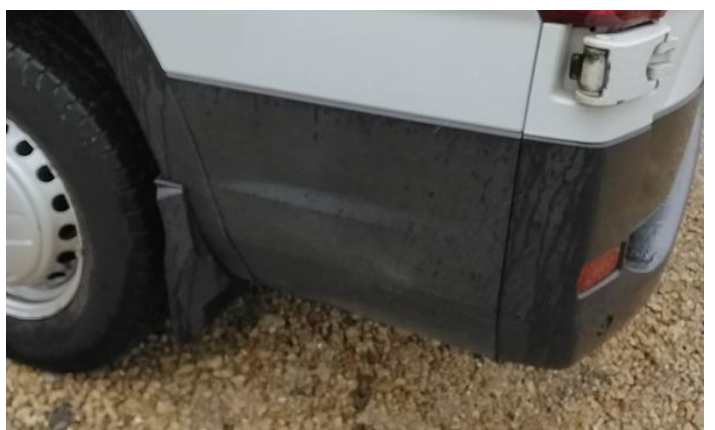
8: Qtr Panel Moulding ns
Scuffed (Unpainted)
Over 100mm

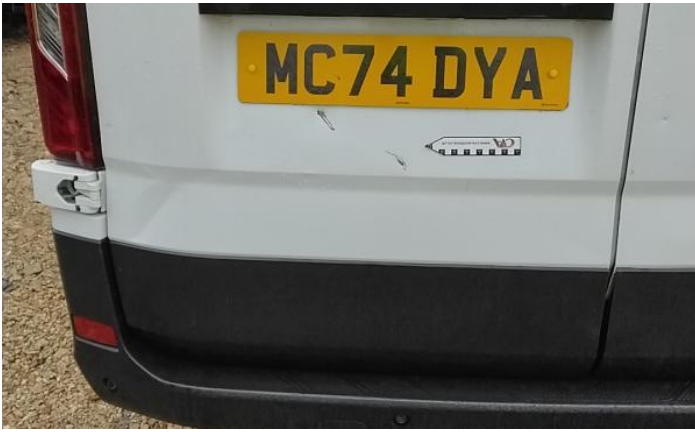
9: Door nsr
Dented
With Paint Damage

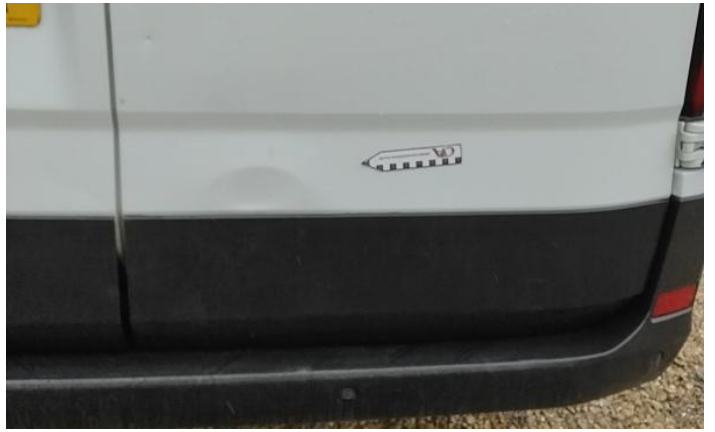
10: Door osr
Dented
Over 30mm

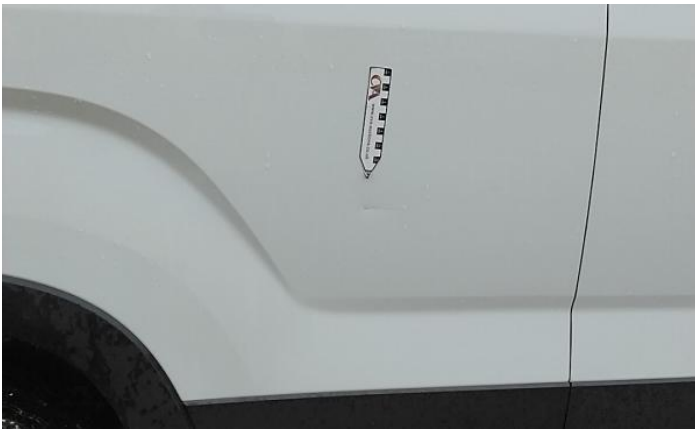
11: Qtr Panel osr
Dented
With Paint Damage

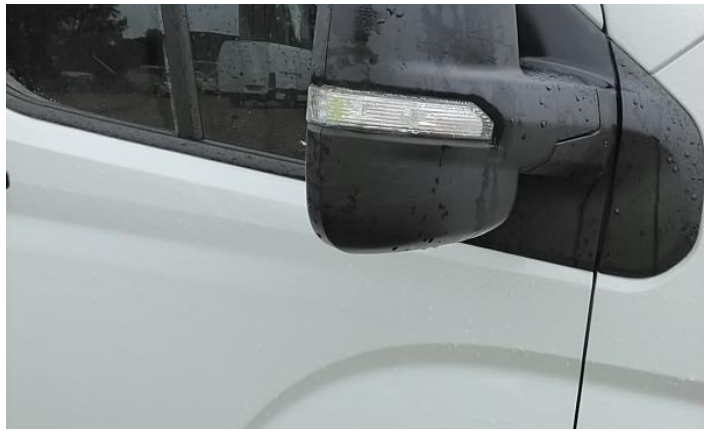
12: Door Mirror Assy osf
Scuffed (Unpainted)
Over 100mm

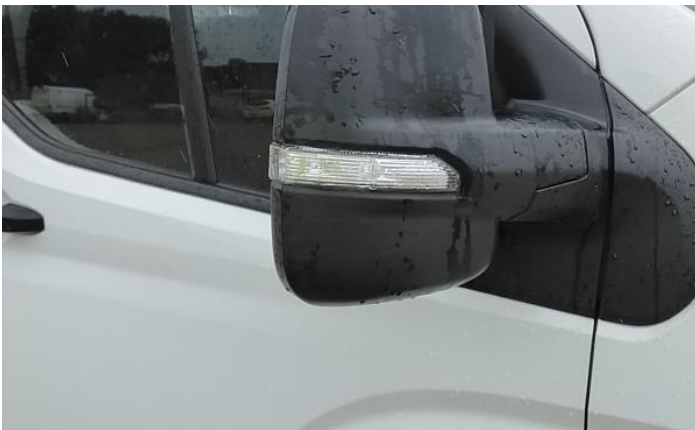
13: Flasher Side Repeater os
Broken
Replace

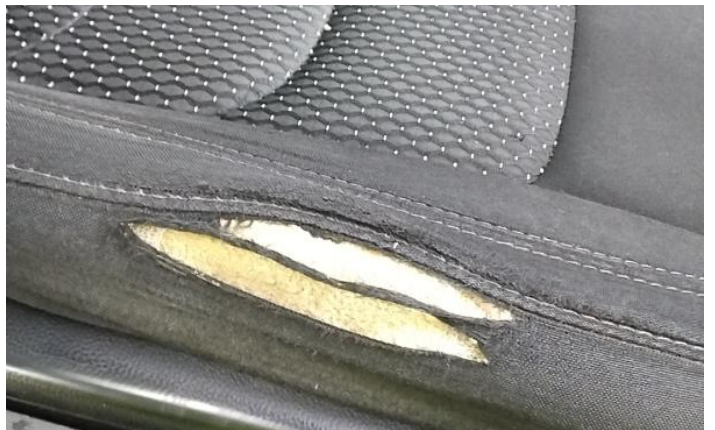
14: Seat Base Cover osf
Holed
Over 3mm
