VEHICLE INSPECTION REPORT

BT68LVU

Iveco Eurocargo 120-210

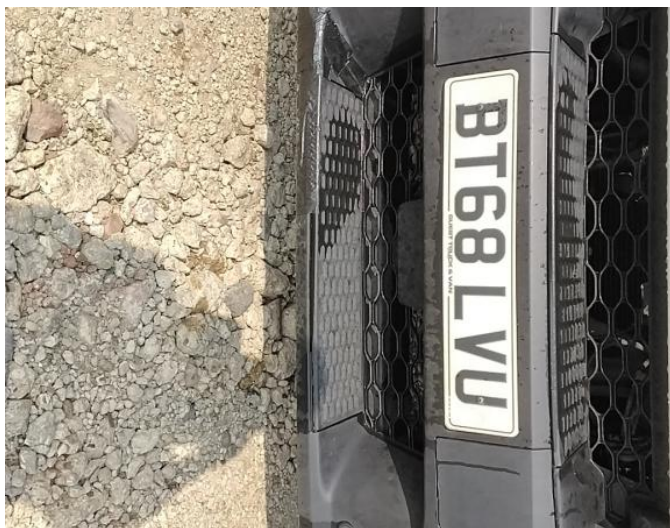
1: Bumper Front
Poor Previous Repair
Poor Paint

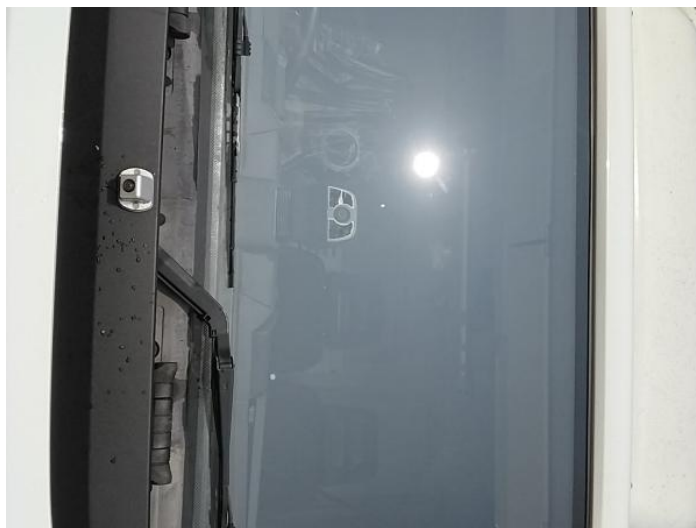
2: Screen Front
Chipped
UpTo 10mm

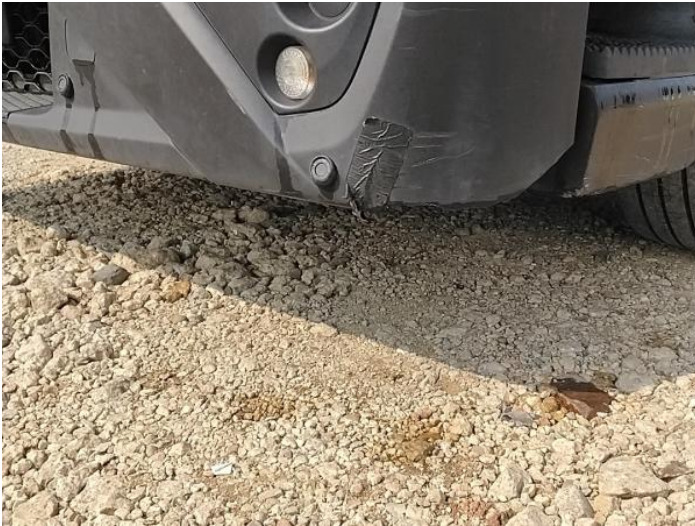
3: Bumper Front
Poor Previous Repair
Poor Paint

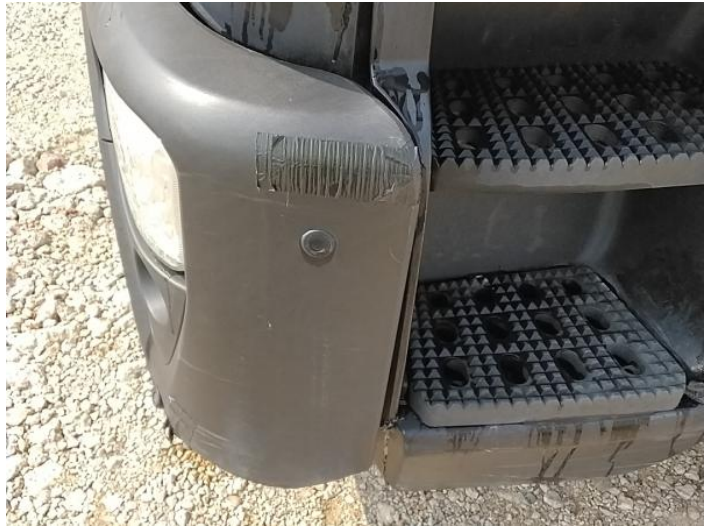
4: Bumper Front
Poor Previous Repair
Poor Paint

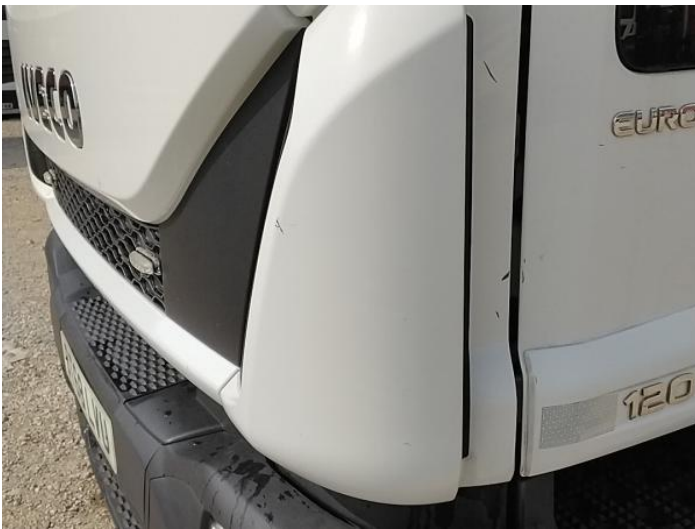
5: Moulding nsf Wing
Scratched (Painted)
Over 25mm Thru Paint

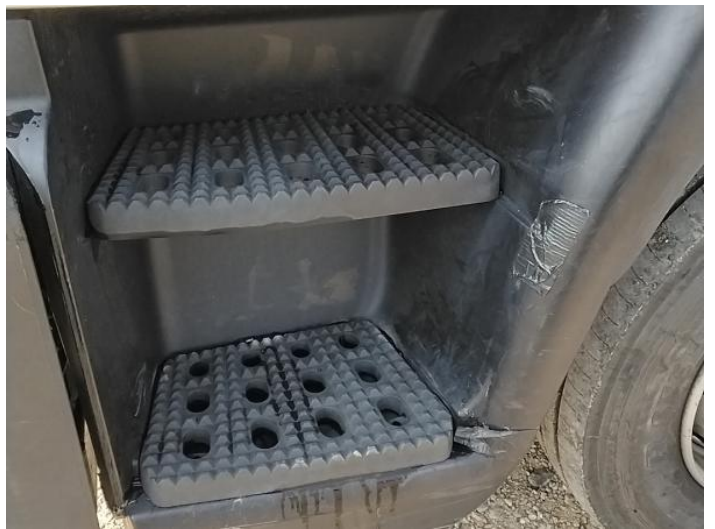
6: General Exterior
Soiled
Light

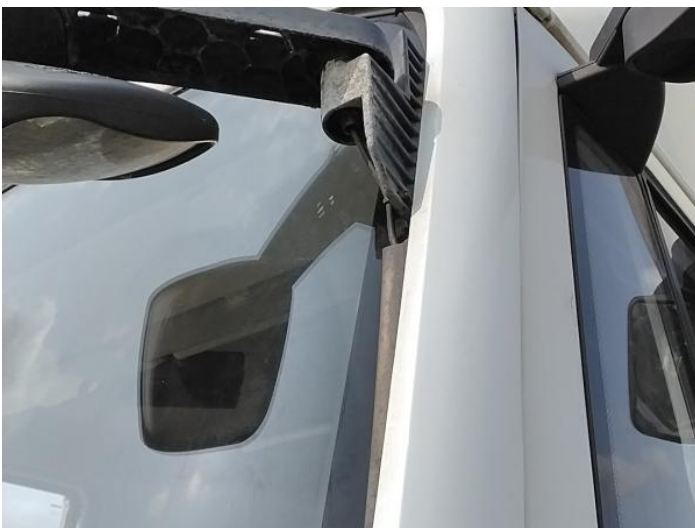
7: Door Mirror Assy nsf
Missing
Replace

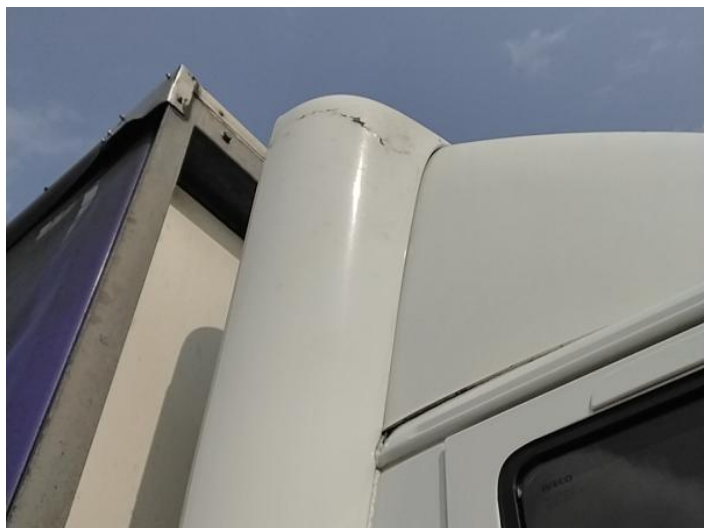
8: General Exterior
Soiled
Light

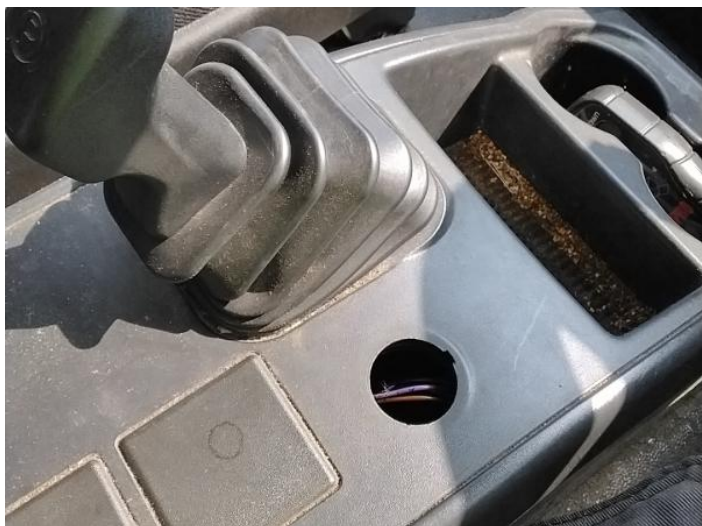
9: Fascia Panel
Missing
Replace
