VEHICLE INSPECTION REPORT

BN14WVA

Iveco Eurocargo 75E16S

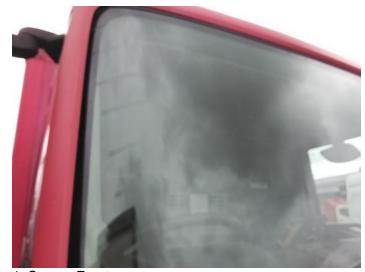
1: Screen Front Scratched Over 30mm

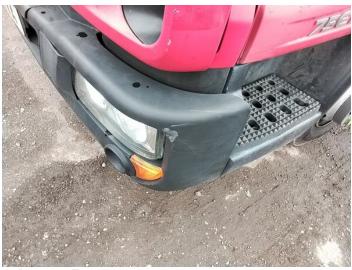
2: Bumper Front Scratched Over 100mm Thru Paint

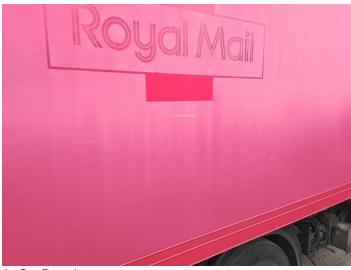
3: Qtr Panel nsr Scratched Over 25mm Thru Paint

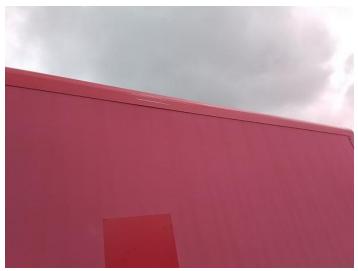
4: Qtr Panel Trim ns Scuffed Over 25mm

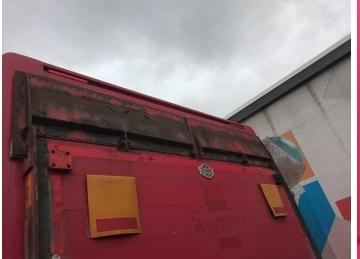
5: Tailgate Rusted Holed

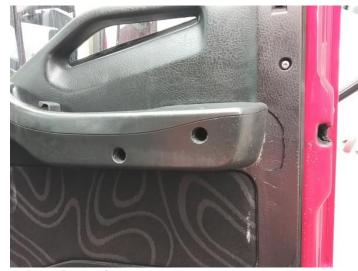
7: Door Pad osf Broken Replace

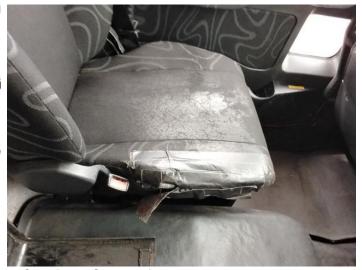
8: Seat Base Cover nsf Torn Over 3mm

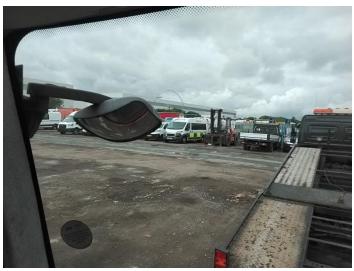
9: Screen Front Chipped Over 10mm
