VEHICLE INSPECTION REPORT

BU14FBD

Mercedes-Benz Econic 2629

OLYMPUS BODY, TERBERG SPLIT LIFT

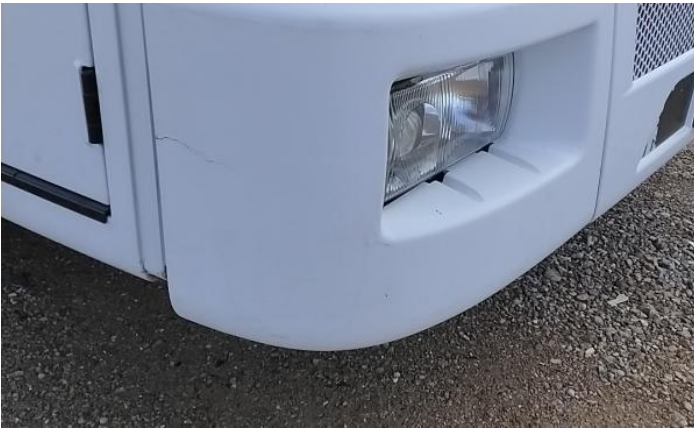
1: Bumper Front
Cracked
Over 25mm

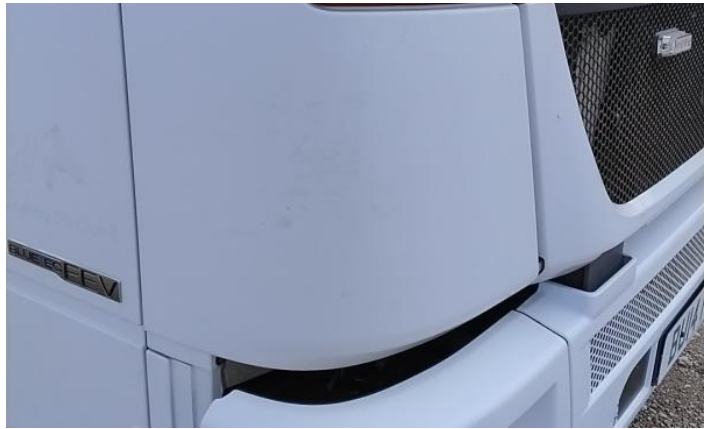
2: Wing of
Scratched
Over 25mm Not Thru Paint

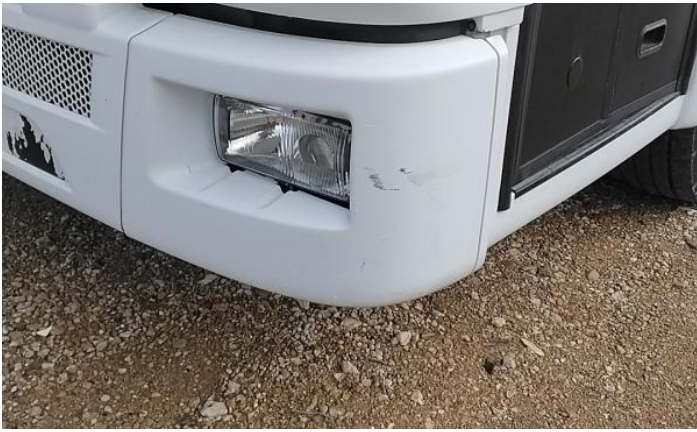
3: Bumper Front
Scratched
Over 25mm Not Thru Paint

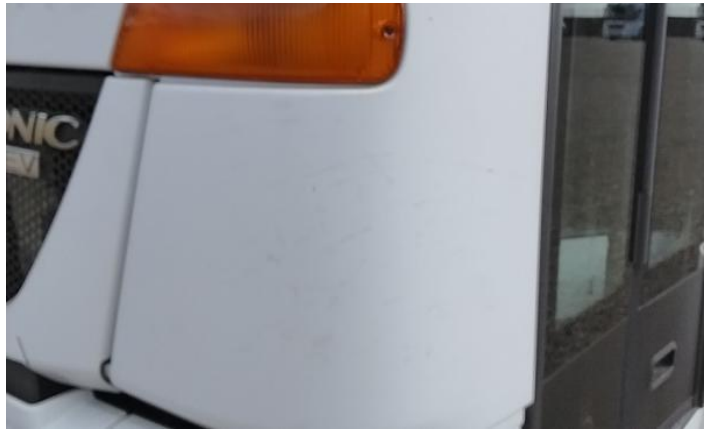
4: Wing nsf
Scratched
Over 25mm Not Thru Paint

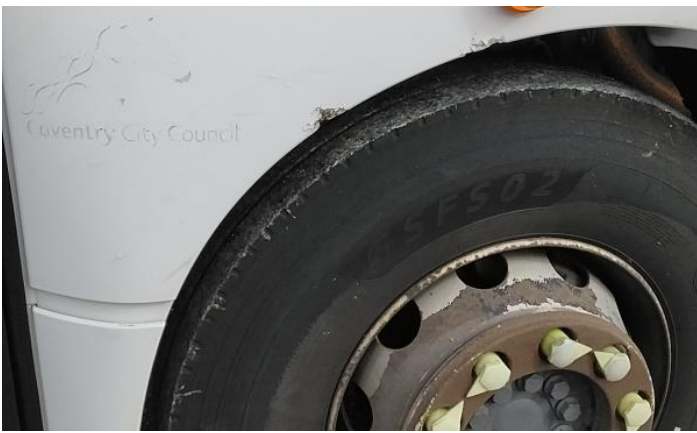
5: Wing Front Arch Extension ns
Broken
Replace

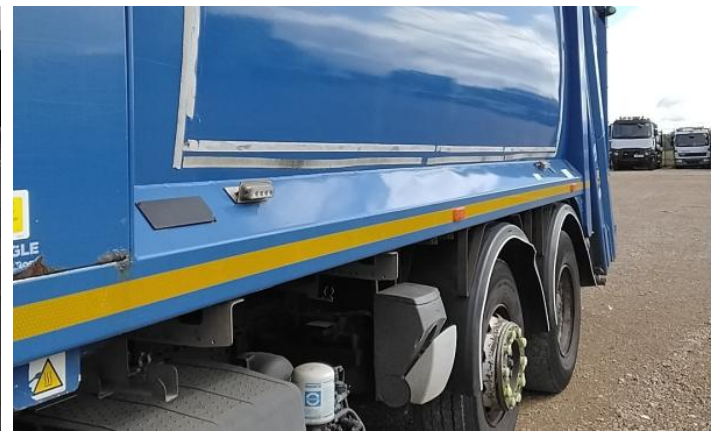
6: Qtr Panel nsr
Scratched
Over 25mm Not Thru Paint

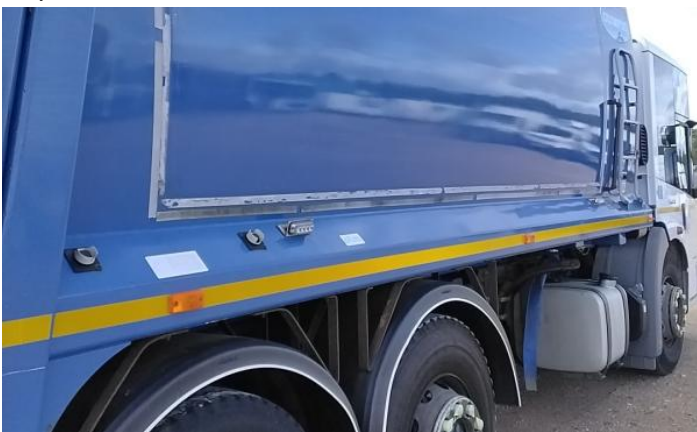
7: Qtr Panel osr
Scratched
Over 25mm Not Thru Paint

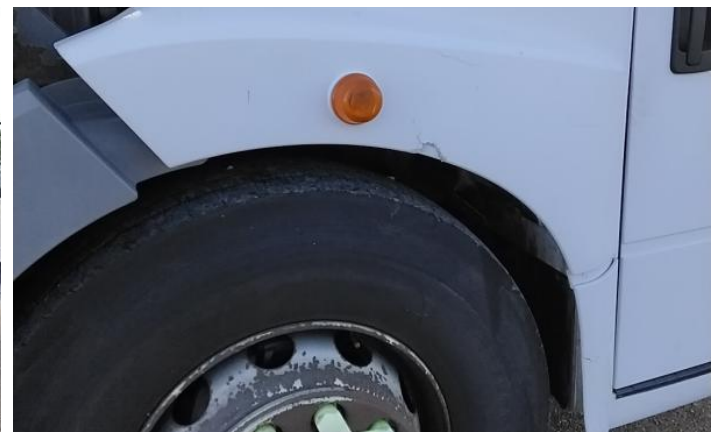
8: Wing Front Arch Extension os
Broken
Replace

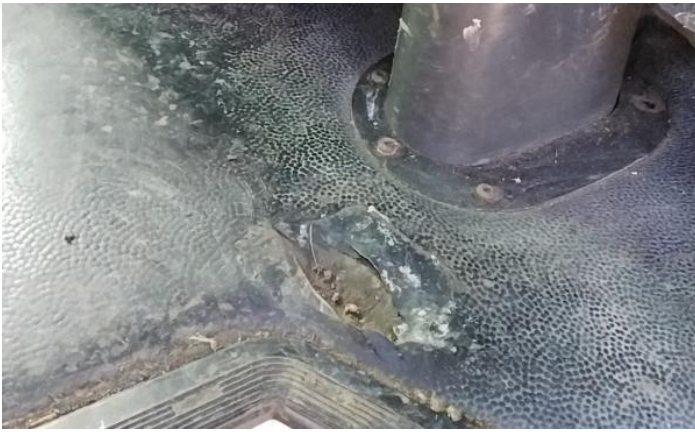
9: Carpets Front
Holed
Over 3mm

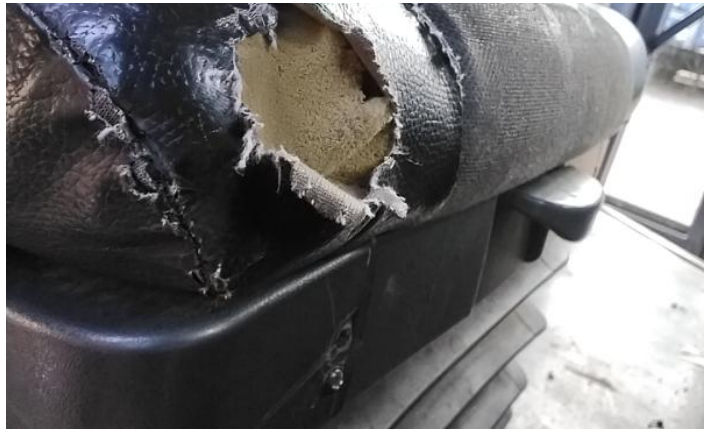
10: Seat Base Cover of
Holed
Over 3mm

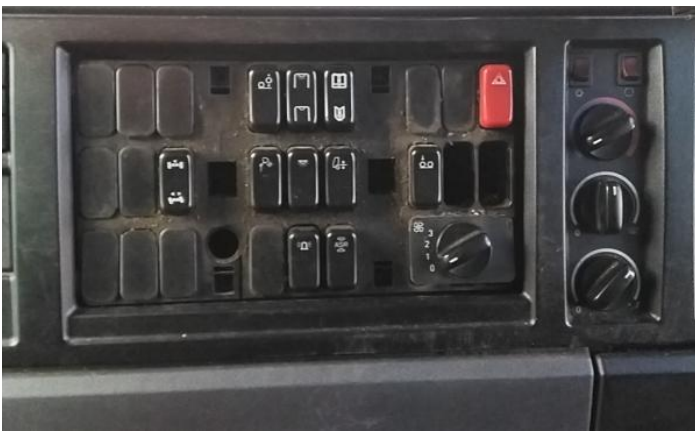
11: Switches And Controls
Broken
Replace
